**CPAT Report No. 1789**

# **Lletty Maengwyn, Abermule, Powys**

**Building Survey**

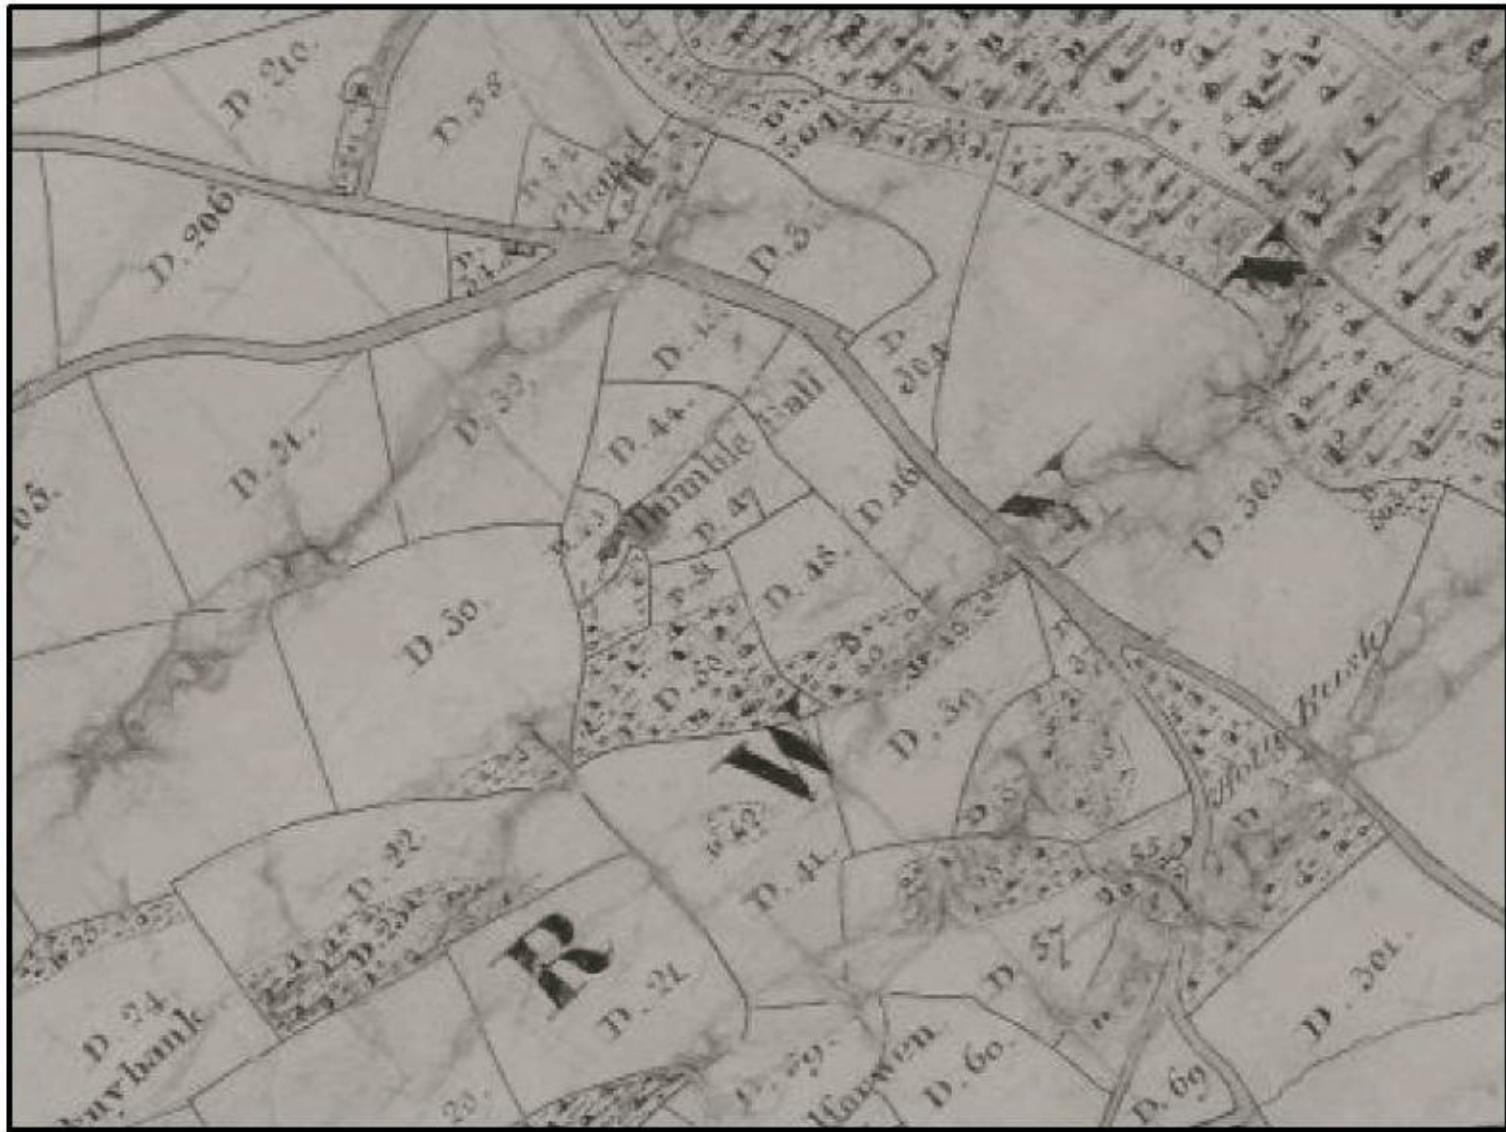
Fig. 2: Bettws Tithe map of 1840

- 2.3. The Bettws Tithe map of 1840 (Fig. 2) shows that the house was called 'Thimble Hall' at the time and is described as a tenement, occupied by Richard Williams and owned by the Powis Estate. The name suggests that this was a rather small building to be described as a hall and may have been a tongue-in-cheek reference to its size. The building appears to be rectangular and aligned approximately north/south, with what could have been a small extension to the east. Only a short time later, in 1853, there is a documentary reference to 'Thimble Hall' whereby a life interest in the property was sold by the Glansevern Estate to Richard Rogers, the then occupier.
