Bat Survey Report

Mains of Portlethen steading complex

Portlethen

September 2016

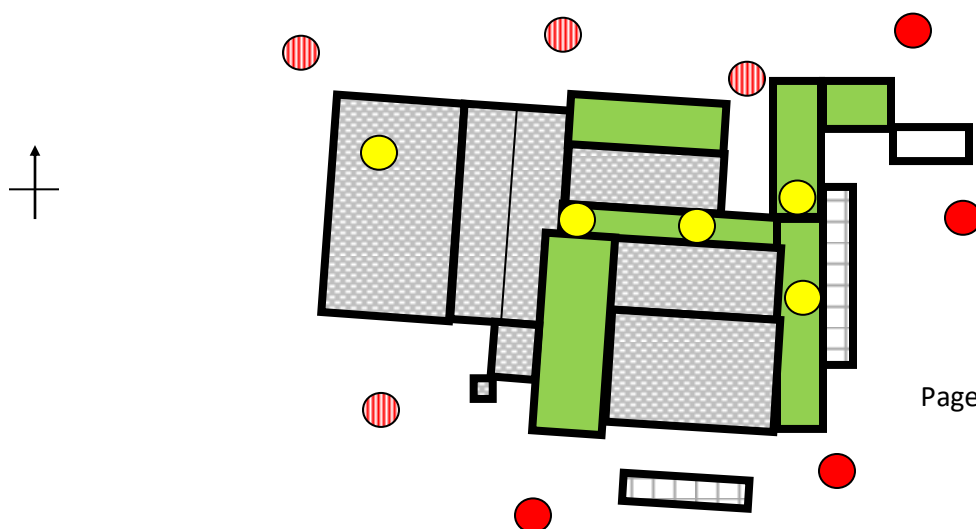
Surveyor locations (red dots) – static detectors inside buildings also marked (yellow dots)

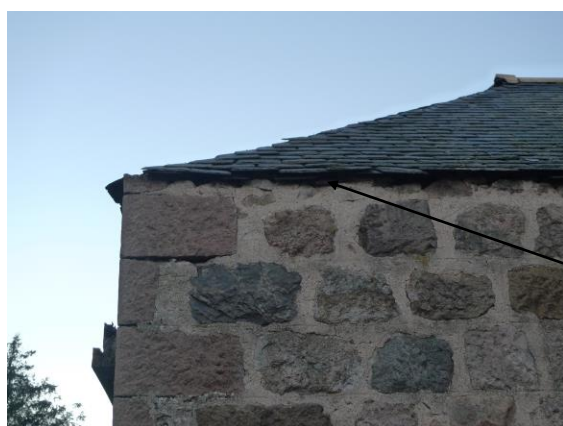
Roost A – one common pipistrelle went to roost at wall head

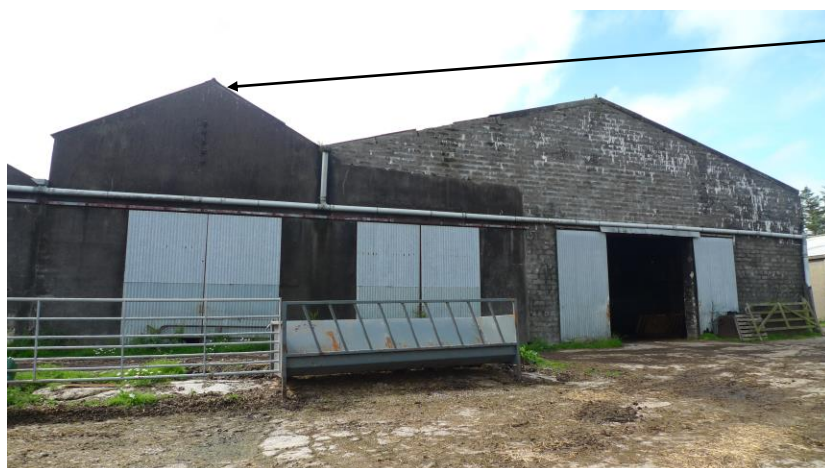
Roost B – one common pipistrelle went to roost at wall head under asbestos sheeting

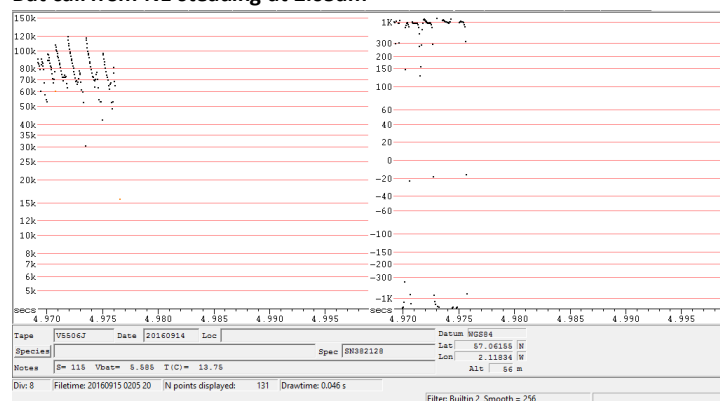
A detector was left in situ in the NE steading in an attempt to take the *Myotis sp.* to species level. Two short *Myotis sp.* calls were recorded – 9.18pm on the 14th and 2.05am on the 15th. Neither tie in with the expected emergence and re-entry times for a *Myotis sp.* bat but nonetheless they can be used to ascertain the presence of the species given the difficulty in detecting the bat during the activity surveys due to its quiet call and rapid entry/exit. The clearest of the calls is suggestive of a Natterer's bat since the call starts high (over 100kHz) and has a high slope. The only other *Myotis sp.* found in this area is the Daubenton's bat which has a lower start to its call.

Bat call from NE steading at 2.05am
