Existing windows & doors

Schnauber
 Address: 44 Mill Rd, Cambridge
 CB1 2AS
 Phone: 01223 929293
 email: info@schnauber.co.uk
 www.schnauber.co.uk

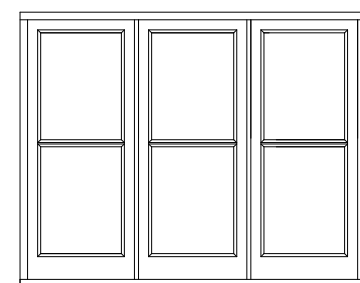
Lounge

- Some of the windows doesn't have any historical value as we believe it is 1980s replacement
- Current various windows design devalues historical building
- The majority of front windows rotten, moulded, and don't do their functions, which creates ventilation, fire escape and health and safety issues, and a beyond of repair.
- The window & door frames bowed and created drafts and CO2 pollution.
