# **GEO-ENVIRONMENTAL PHASE 2 SITE INVESTIGATION**

**2 CAMBRIDGE ROAD**

**HEATON CHAPEL  
STOCKPORT  
SK4 4QN**

Report No.: 201003-R03

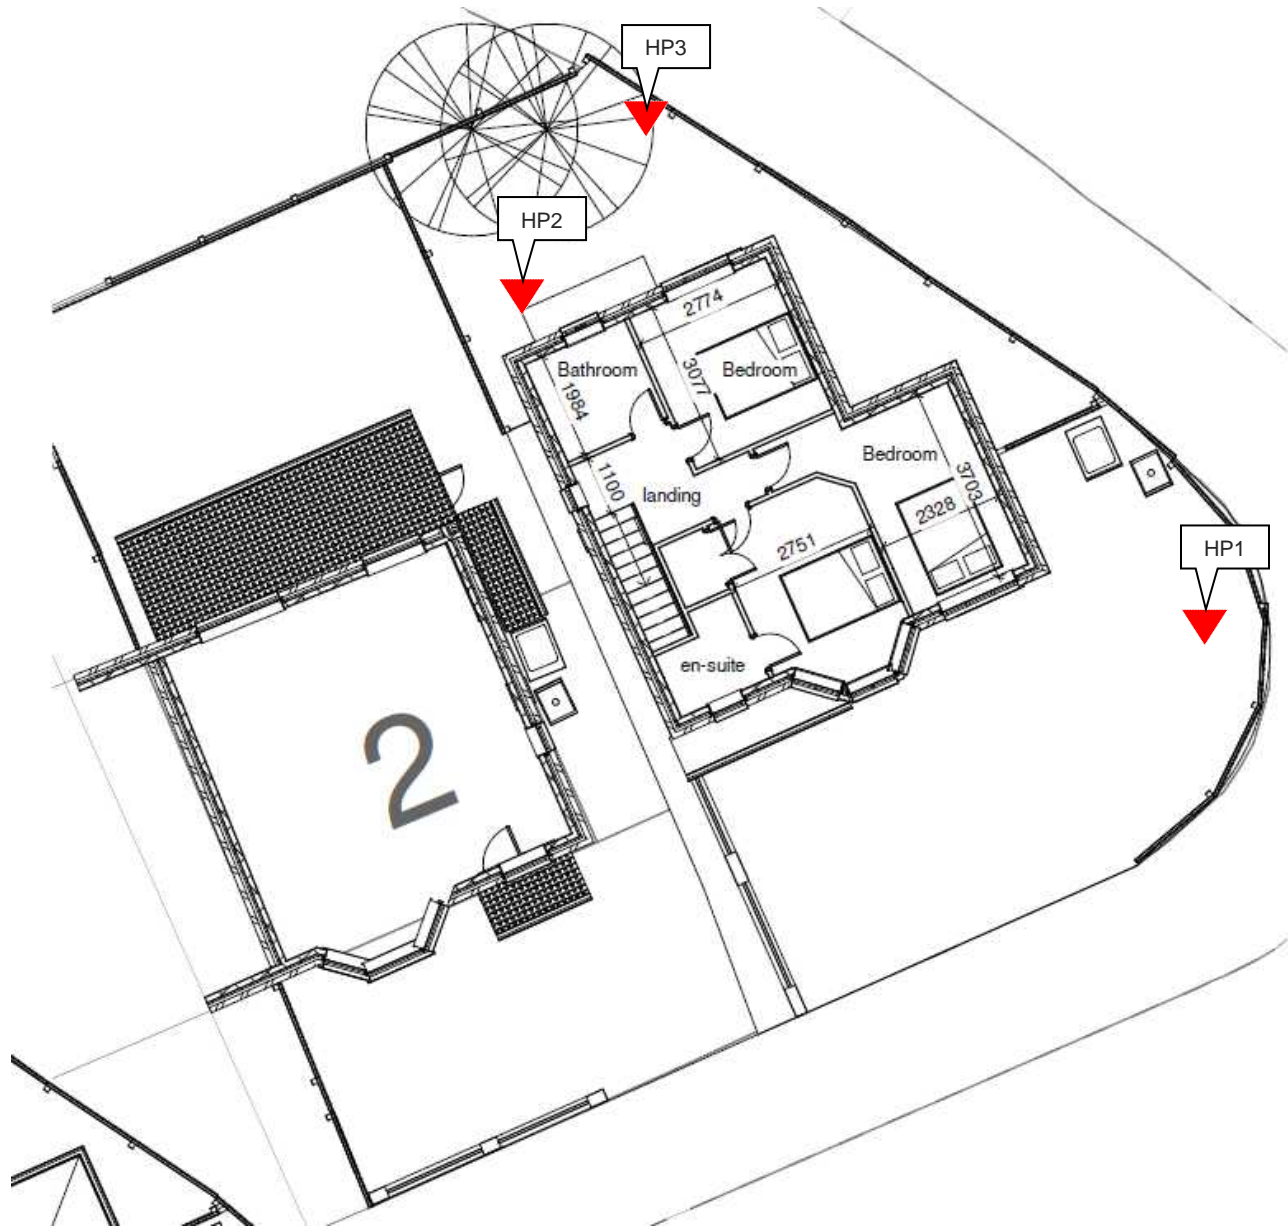
## APPENDIX A – SITE & EXPLORATORY HOLE LOCATION PLAN

Exploratory hole locations are marked on the plan in Appendix A. Photographs of the trial pits are attached as Appendix C.

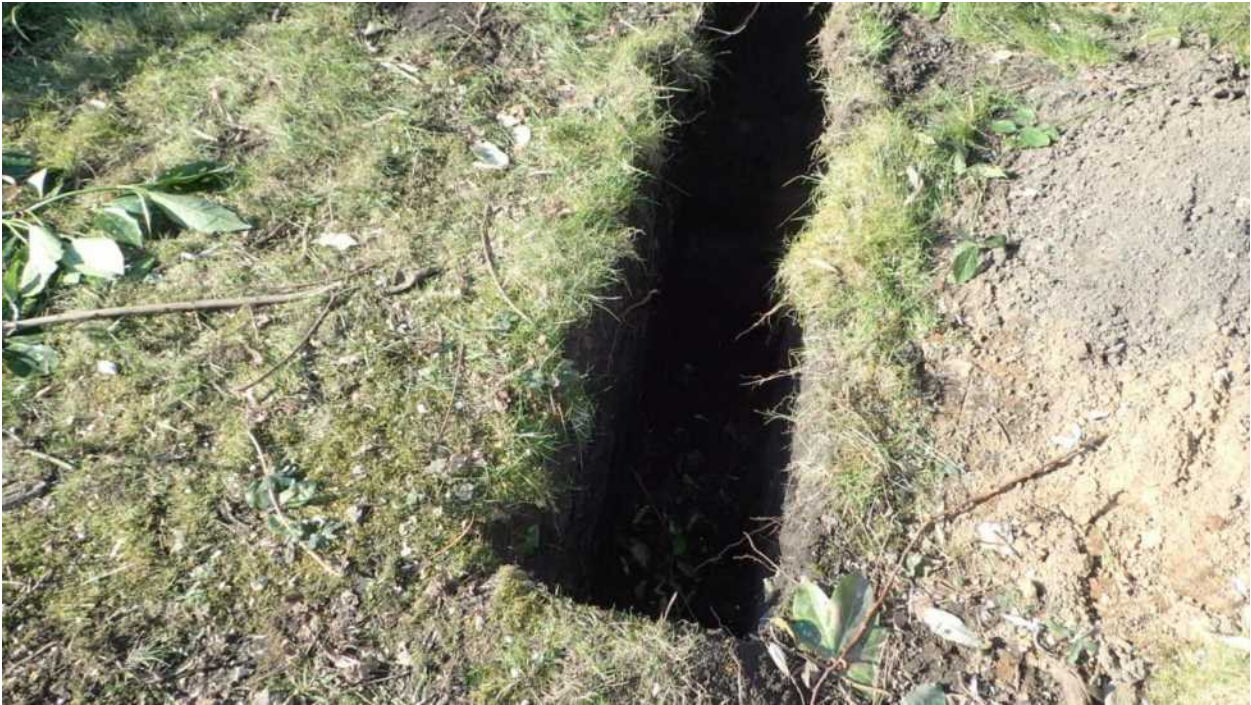
*C.1 - Trial Pit 1*

Location Reference* and Max Depth (mbgl)		Generalised Strata	Depth to Base (m)**	Samples
HP1	1.1	Brownish black slightly gravelly silty sand with some rootlets. Sand is fine to coarse. Gravel is fine to coarse brick, stone concrete, pottery with some ash. TOPSOIL.	0.4	HP1A-0.25m
		MADE GROUND: Brownish black slightly gravelly silty sand with low cobble content. Sand is fine to coarse. Gravel is fine to coarse brick, stone concrete, pottery with some ash. Cobbles are brick and concrete.	0.85	
		Light brown slightly clayey silty sand. Sand in fine to medium.	1.1+	
HP2	0.6	Greyish black silty sand with some rootlets. Sand is fine to coarse. TOPSOIL.	0.1	
		MADE GROUND: Black slightly gravelly silty sand with cobbles. Sand is fine to coarse. Gravel is fine to coarse brick, stone concrete, pottery with some ash. Cobbles are brick.	0.6	HP2A-0.3m
HP3	0.6	Greyish black silty sand with some rootlets. Sand is fine to coarse. TOPSOIL.	0.15	HP3A-0.1m

A circa 0.1-0.4m topsoil horizon was encountered in all three locations. However, in HP1 the topsoil did contain some notable anthropogenic matter.

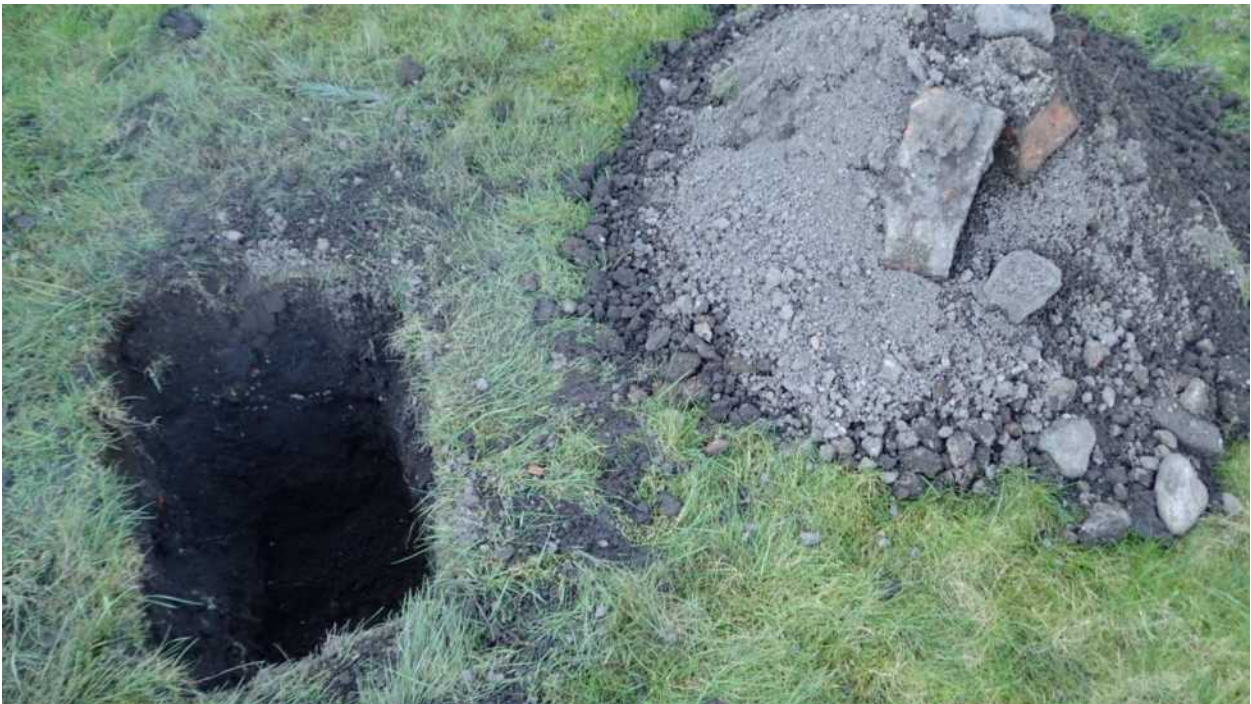
*C.2 - Hand Pit 2*

HP2 in particular encountered obvious construction and demolition waste in the form of full and half bricks.

However, items construction & demolition waste indicate a possibility of ACM being present.

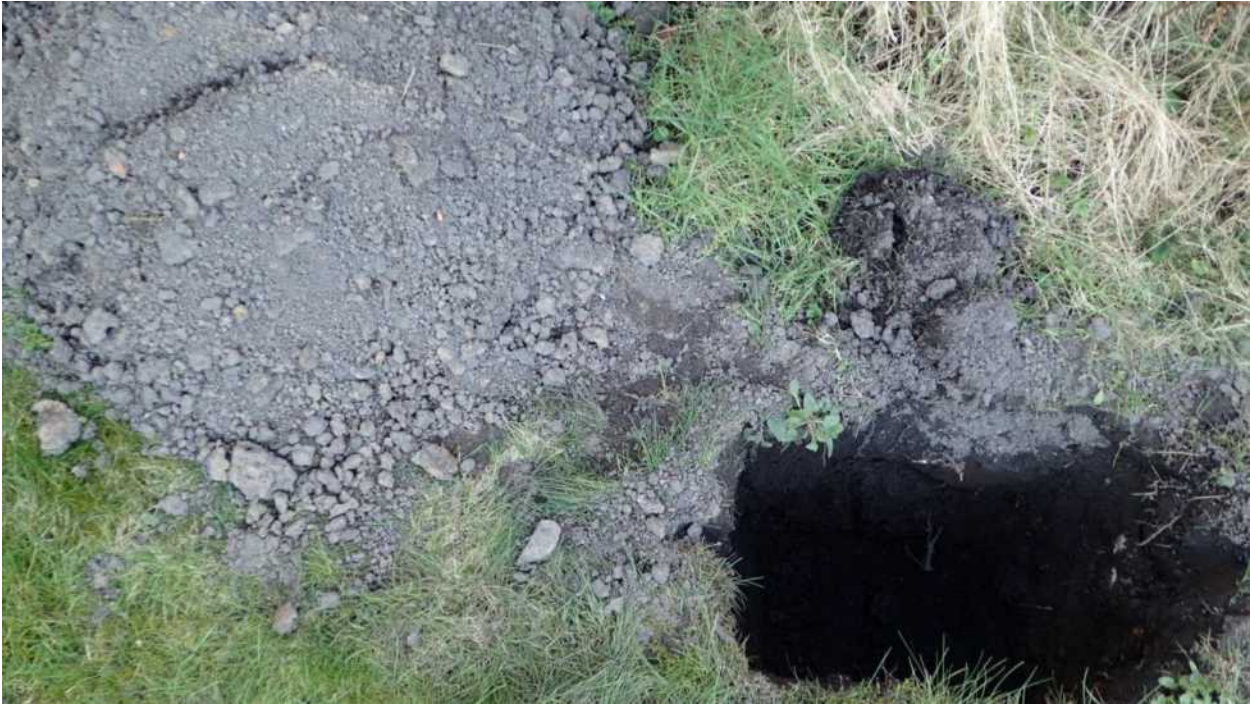
C.3 - Hand Pit 3

MADE GROUND: Black slightly gravelly silty sand with cobbles. Sand is fine to coarse. Gravel is fine to coarse brick, stone concrete, pottery with some ash. Cobbles are brick.	0.6	HP3B-0.35m
