# Preliminary Ecological Appraisal Report

Land off Lime Avenue, Camberley, Surrey

Client	Norris Hope-Ross
Reference	2018-079
Version	1
Date	14/01/2019

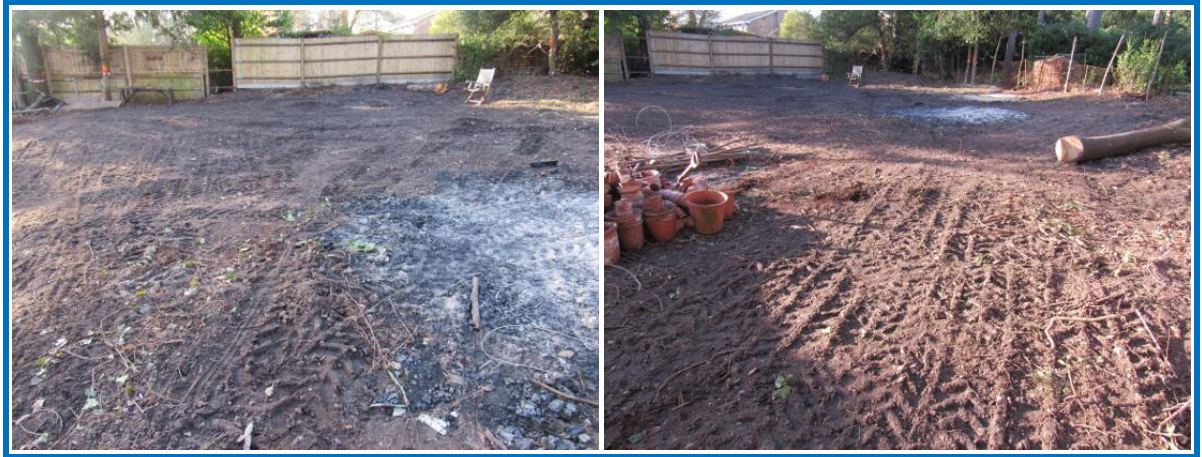
### Bare Ground

4.2.2 The majority of the site comprised bare ground with no vegetation present.

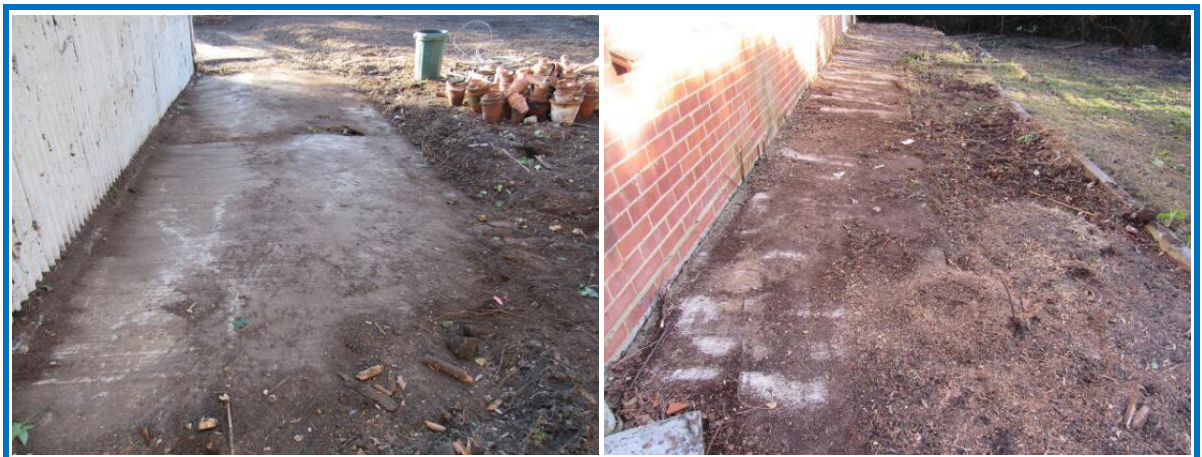
### Hardstanding

4.2.3 Areas of concrete hardstanding were present around the buildings.

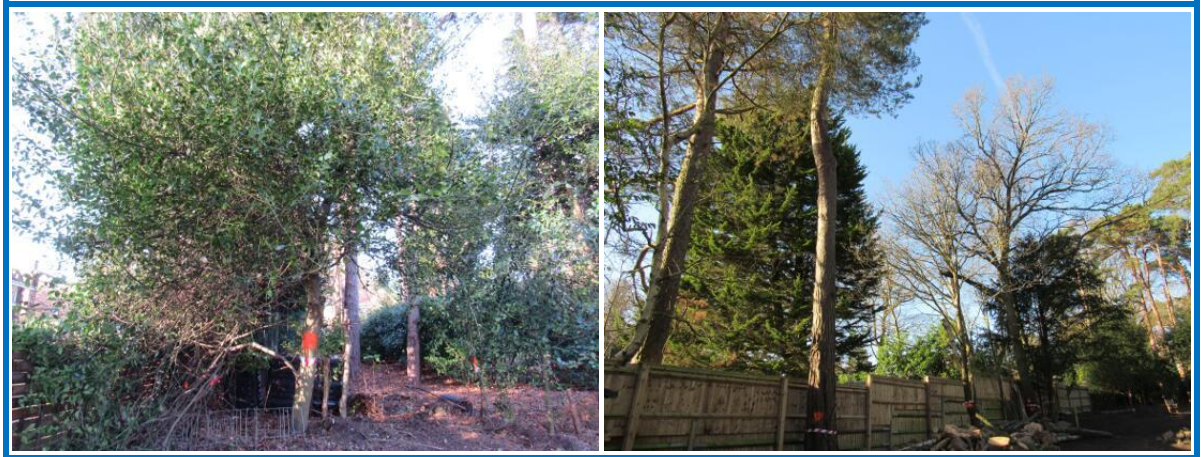
### Scattered Trees

- 4.2.4 Several scattered trees were located close to the site boundary. Species present included oak sp., holly, yew and Scots pine.

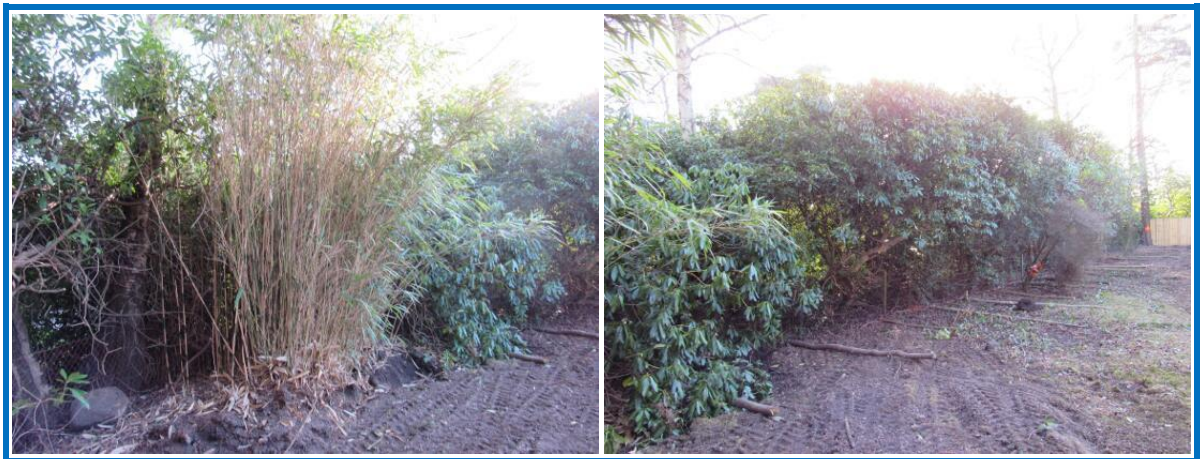
### Introduced Shrubs

- 4.2.5 A small stand of bamboo sp. was present along the northern boundary, and cherry laurel shrubs were present along the western boundary and adjacent to the eastern boundary, within the neighbouring property.

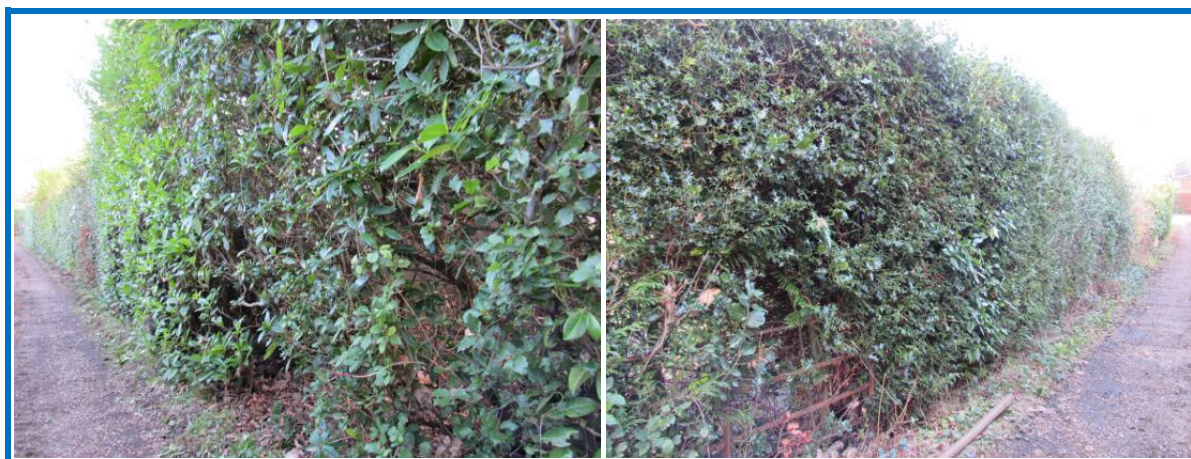
### Species-poor Hedgerows

4.2.6 Two managed, intact species-poor hedgerows were present on either side of the access track into the site, located within the gardens of neighbouring properties. Species included cherry laurel, holly, Leyland cypress, snowberry, and beech.

4.2.7 These hedgerows are classified as a priority habitat as they contain more than 80% coverage of at least one native woody species.

- 6.2.4 It is recommended that the hedgerows are protected during works by maintaining a protection zone delimited by a temporary fence or barrier tape or using suitable ground protection at least 5 m from the hedgerow's central point. This protection should be installed prior to works commencing and retained throughout the construction period.

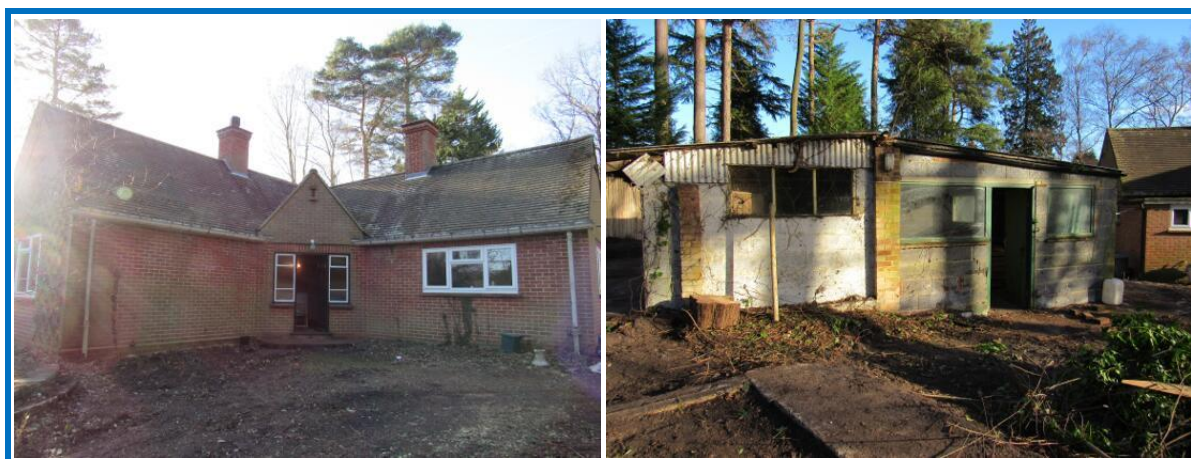
### Buildings

4.2.8 A residential property and a garage building were present on the site. These buildings were assessed primarily for their potential value for bats and birds; see Section 4.1.

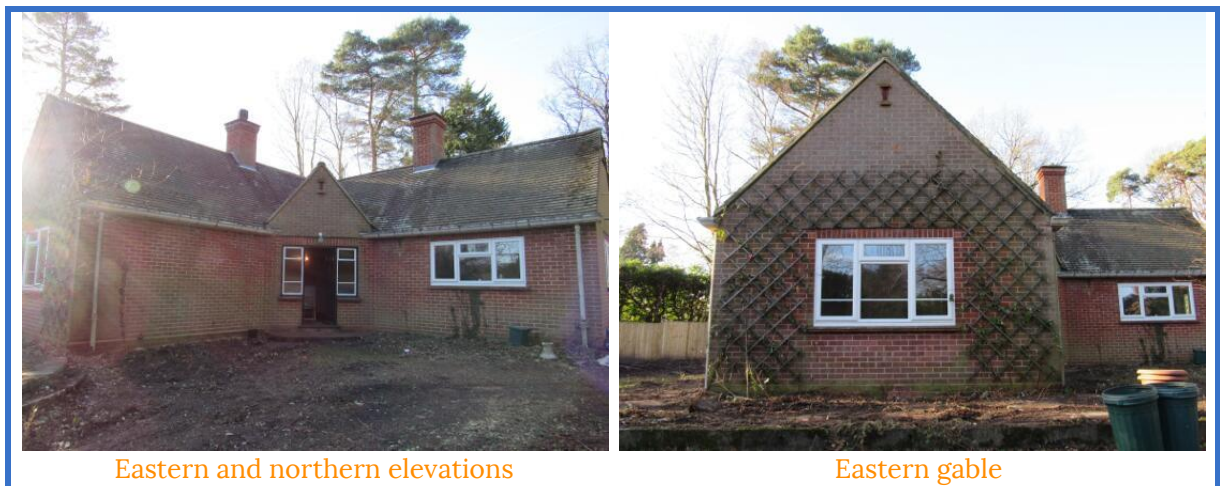
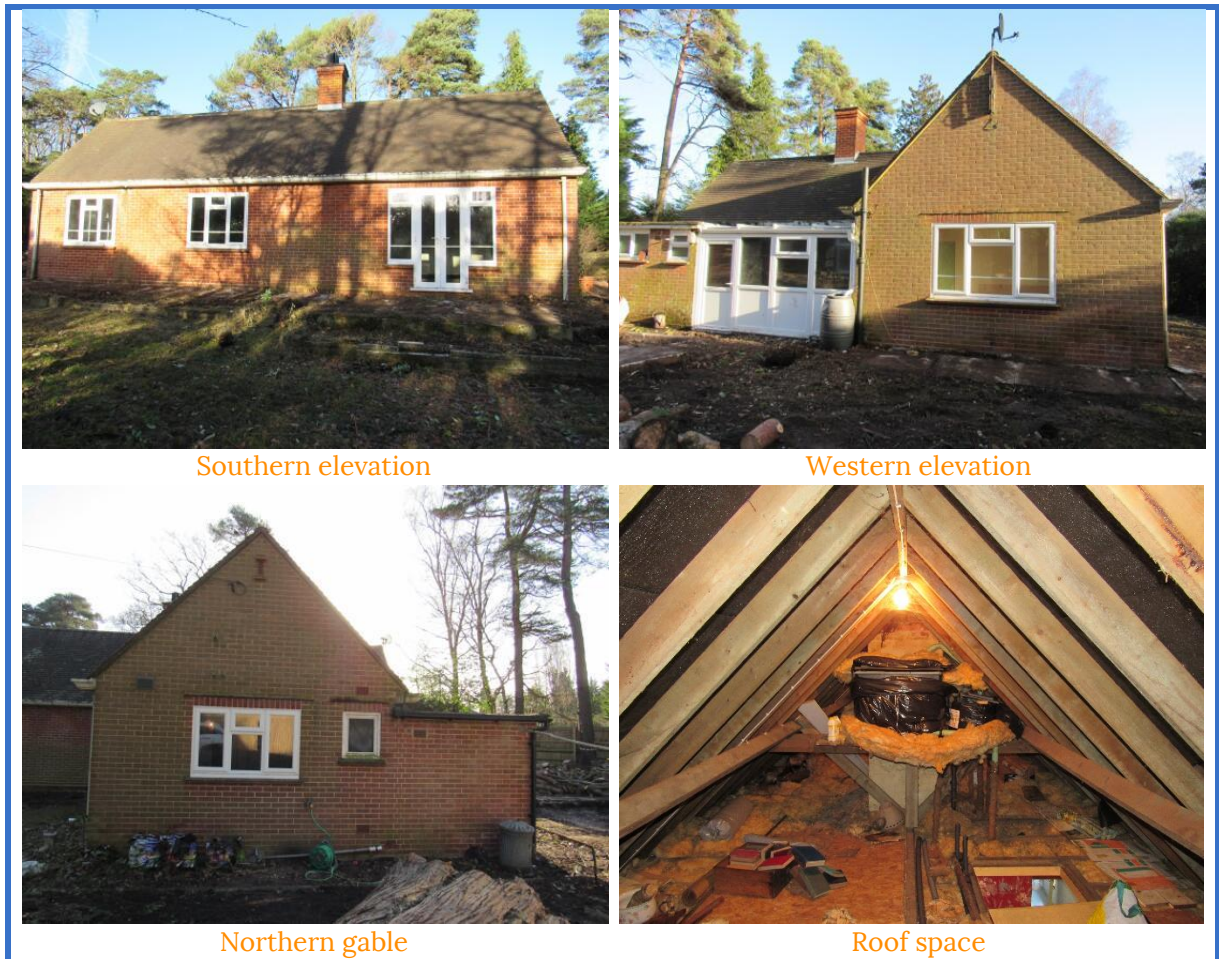
Figure 4-1: Photographs of the residential building

- 4.1.6 The residential building was uninhabited at the time of survey. It was a “T” shaped brick-built bungalow with one roof space and a pitched roof comprising flat concrete tiles. The roof ridges ran approximately north to south and east to west. The eaves were tight, comprising concrete guttering.

- 4.1.7 Several potential bat roost features were noted externally, as follows:
- Gap at the chimney base on the eastern roof slope where a tile was missing (P1).

- Two missing tiles and one slipped tile on the southern roof slope (P4 & P5).
  - Four lifted roof tiles on the northern roof slope near the ridge (P6).

- 6.1.1 The residential building has low suitability for roosting bats and therefore, in accordance with good practice guidelines (Collins, 2016), one emergence/re-entry survey is required. This survey would determine whether bats are roosting within the building. If bats are found to be roosting within the building then additional surveys would be required to provide further information on the number of bats present and roost status (e.g. maternity).
- 6.1.2 Emergence/re-entry surveys must be carried out between May and September with at least one survey undertaken between May and August. If additional surveys are required these should be spread across the season as bats use different roosts at different times of the year. Three surveyors would be required to view all elevations of the building.

- 6.2.5 Any required mitigation for roosting bats would be provided with the results of the emergence/re-entry survey(s).
- 6.2.6 One yew tree (TN2) was assessed to have low suitability for roosting bats. It is recommended that this tree is retained. If the tree does require removal it must be soft felled. The tree can

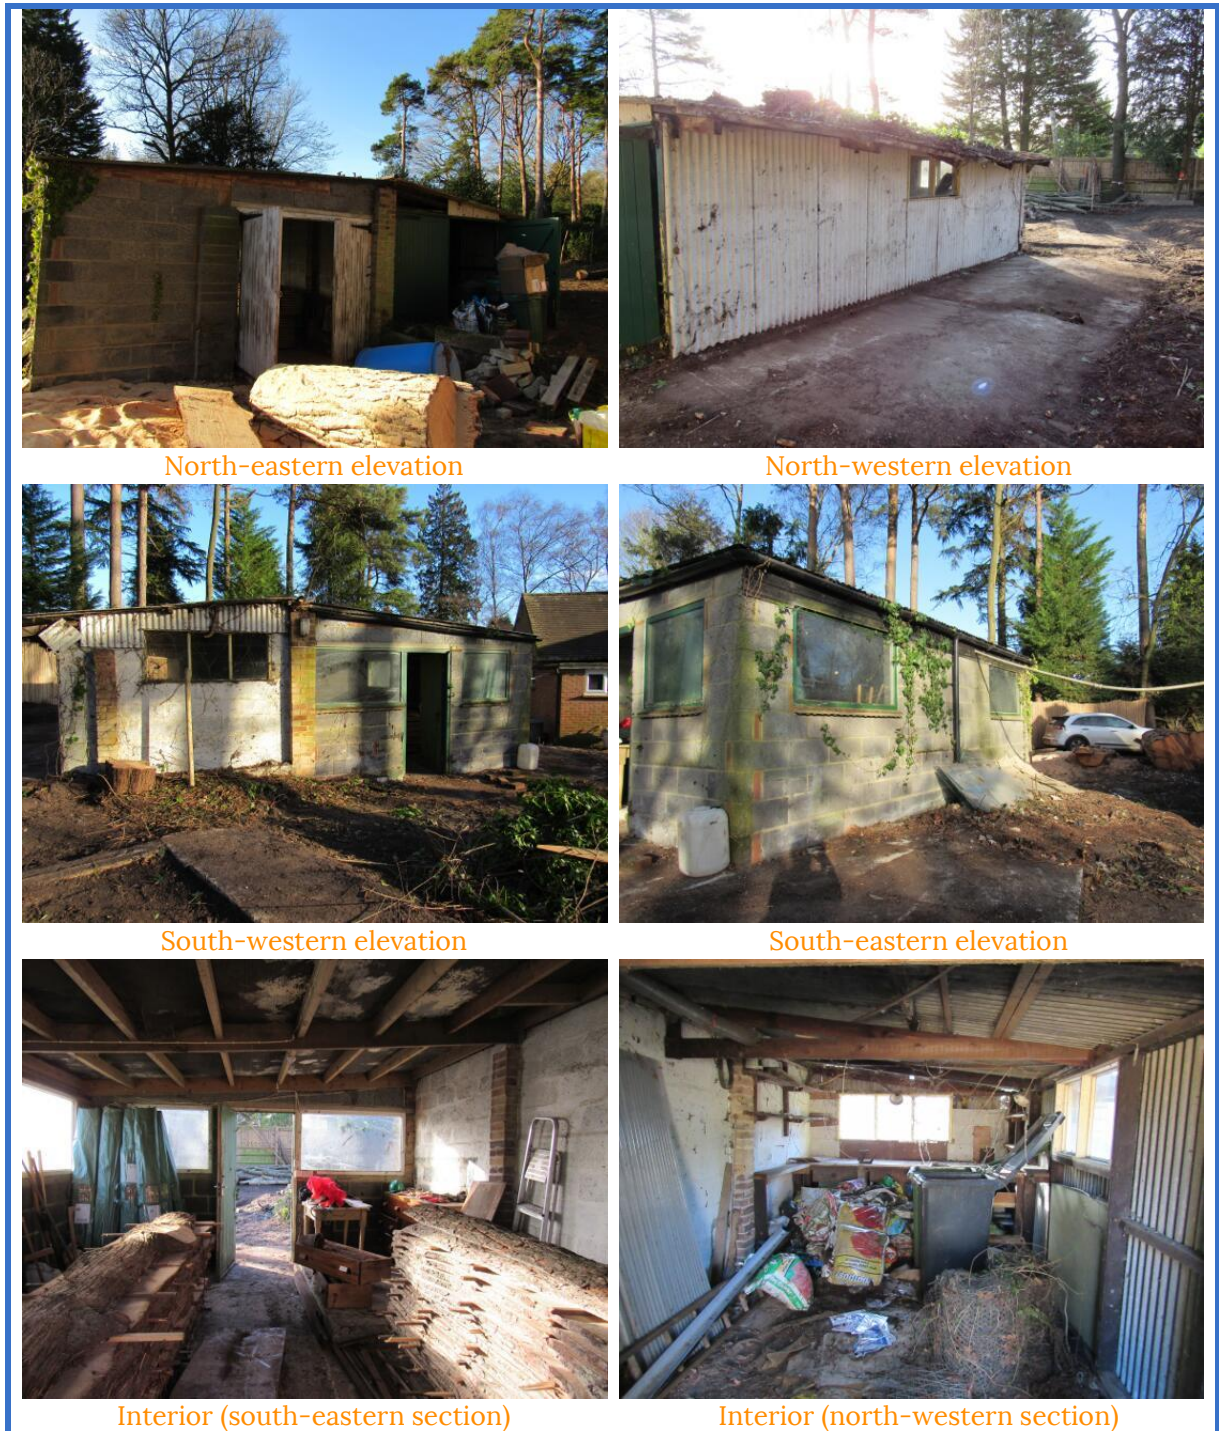
Figure 4-2: Photographs of the garage

4.1.12 The garage walls were formed by breeze block, with the exception of the north-western wall which comprised corrugated asbestos-type cement sheets. The garage was divided into two

- 4.1.13 The south-eastern section was approximately 6.3 m long, 4.3 m wide and 2.5 m high. Internally it comprised breeze block walls with machine cut timber roof supports. The corrugated metal roof sheets were lined with felt. Windows and doors were all tight providing no apparent access to the interior for bats. The interior was light due to the presence of windows, and there were no crevices or cavities with potential for roosting. Roof void dwelling bats could potentially roost on the roof timbers, although no droppings were noted below any of the timbers.

- 4.1.15 The garage is assessed to have **negligible suitability** for roosting bats as it does not provide suitable roosting features and no evidence of bat use was noted.

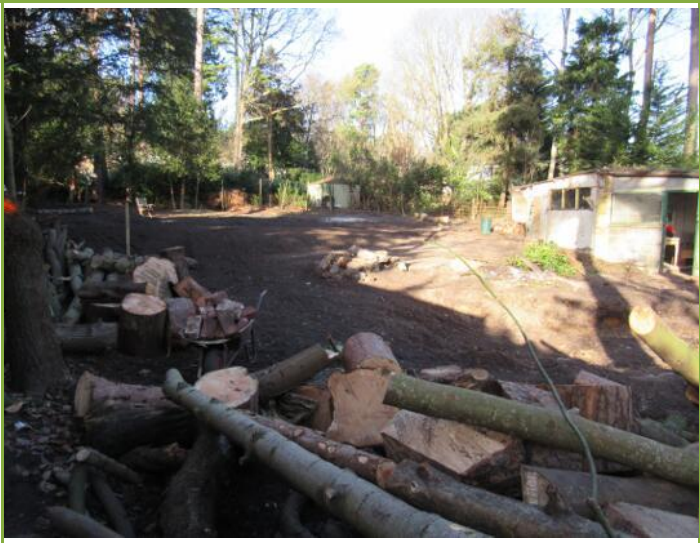
Number	Description	Photograph
TN1	Log pile which provided potential refuge habitat for amphibians and reptiles.

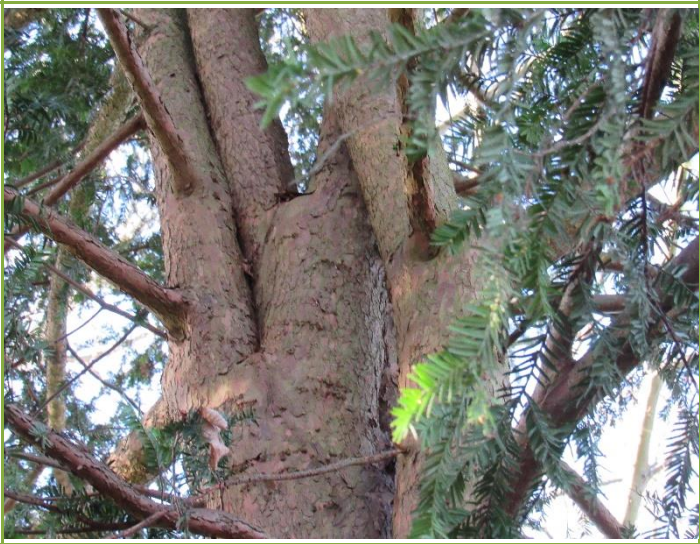
TN2	Yew tree with fluting, which provided low potential for roosting bats.

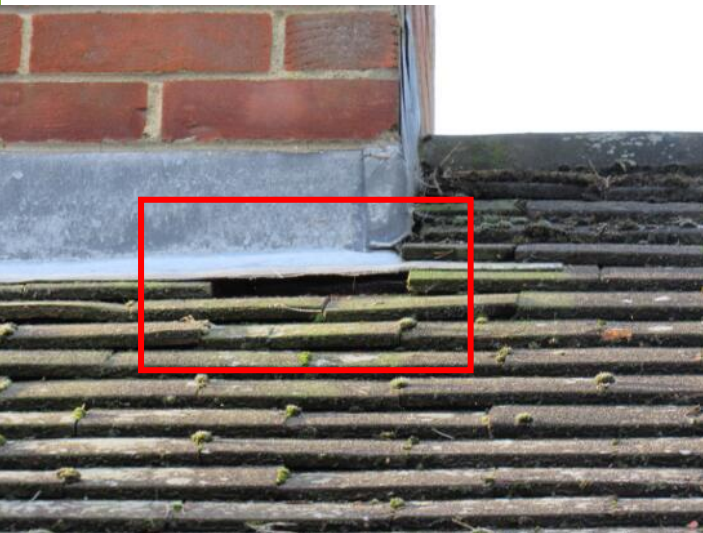
Number	Description	Photograph
P1	Gap at the chimney base on eastern roof slope where a tile was missing which provided a potential roost site.

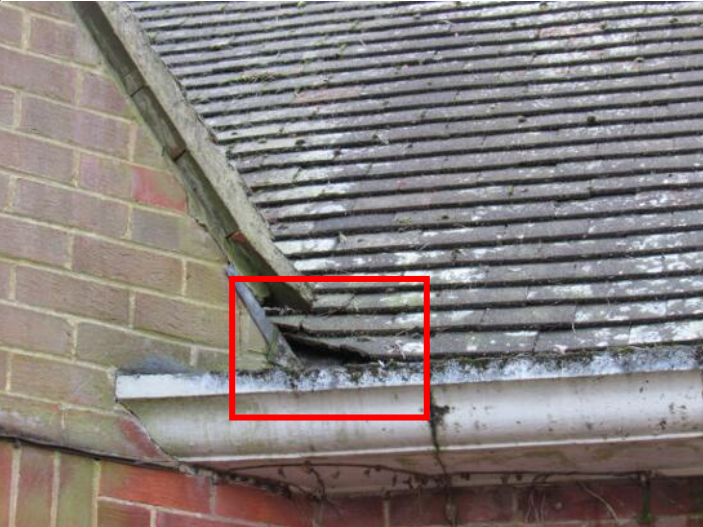
P2	Gaps under tiles at the valley on either side of the false gable where the eastern and northern roof slopes met which provided potential roost sites.

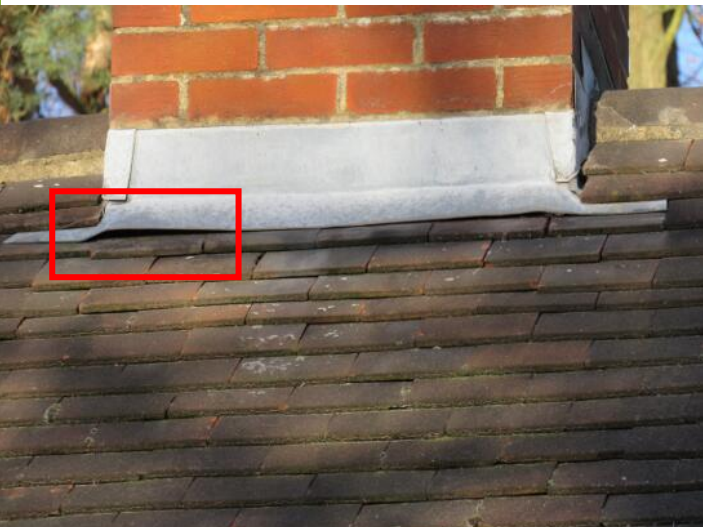
P3	Gap under lifted lead flashing at the chimney base on the southern roof slope which provided a potential roost site.

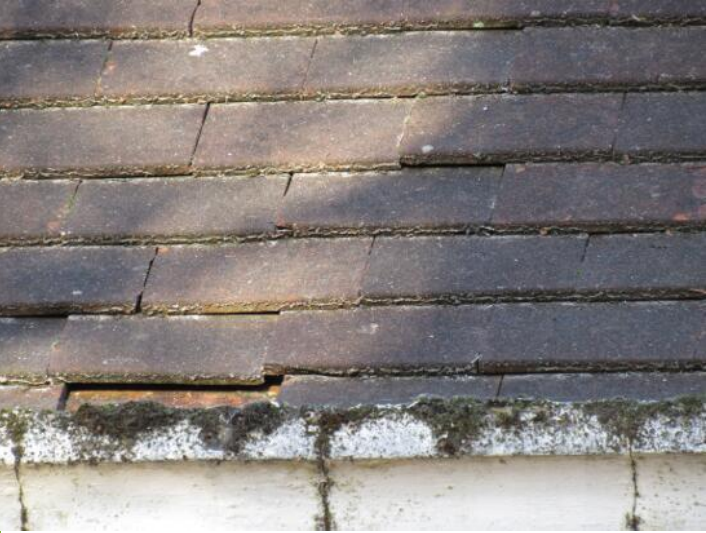
Number	Description	Photograph
P4	Example of missing tiles on the southern roof slope which provided potential roost sites.

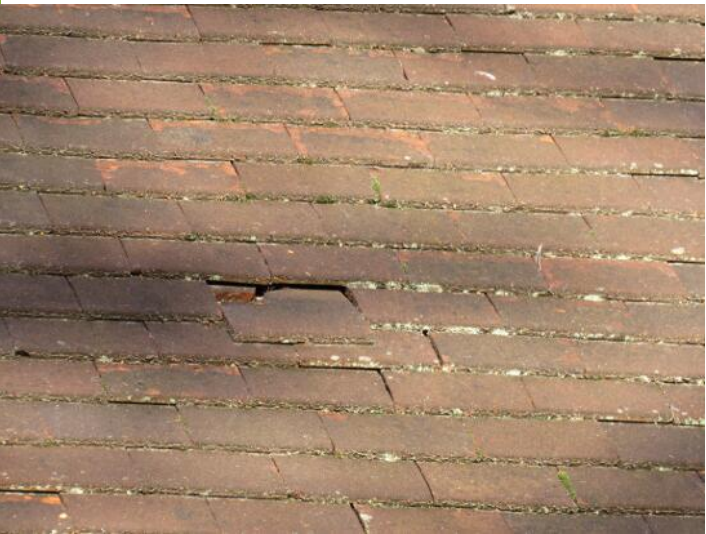
P5	Slipped tile on the southern roof slope which provided a potential roost site.

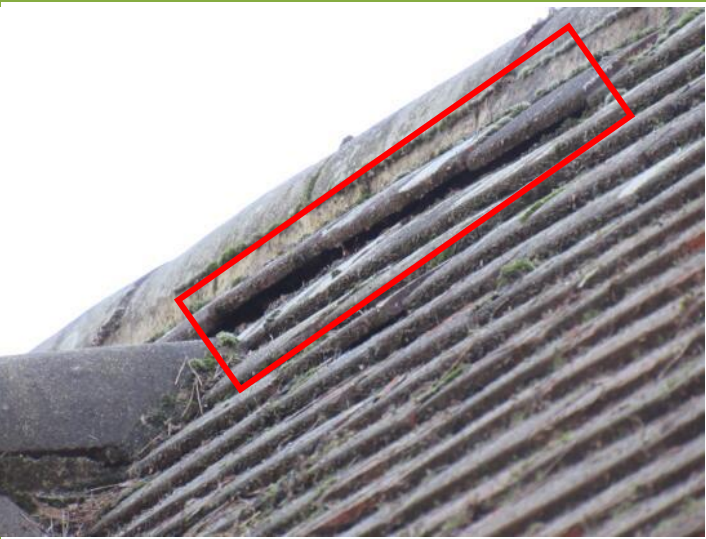
P6	Four lifted roof tiles on the northern roof slope near the ridge which provided potential roost sites.
