**31 Lampits Hill
Corringham
SS17 9AA**

Geo-Environmental Investigation

On behalf of Soil Investigation Eastern Ltd

Document Reference: 21-073

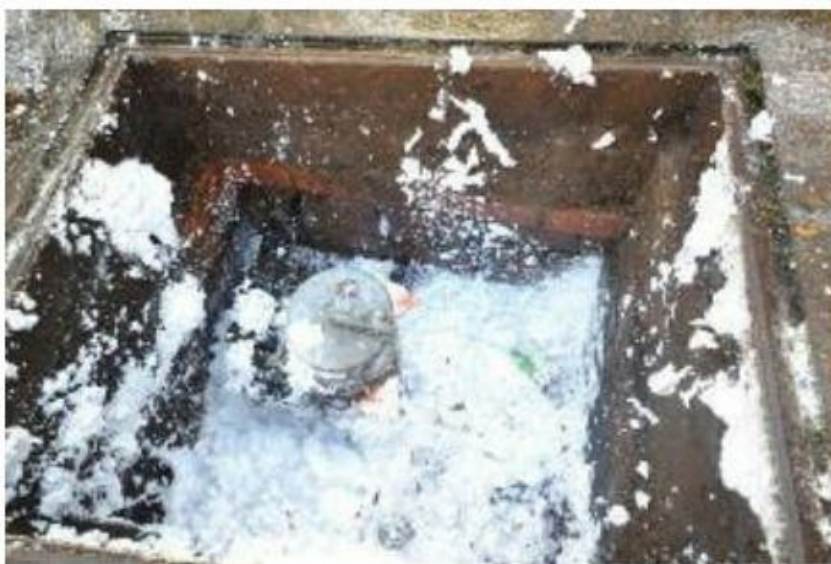
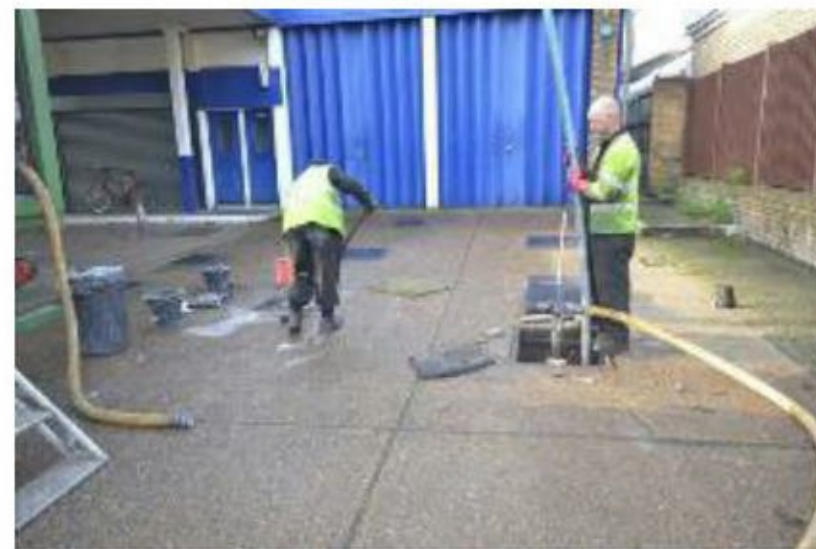
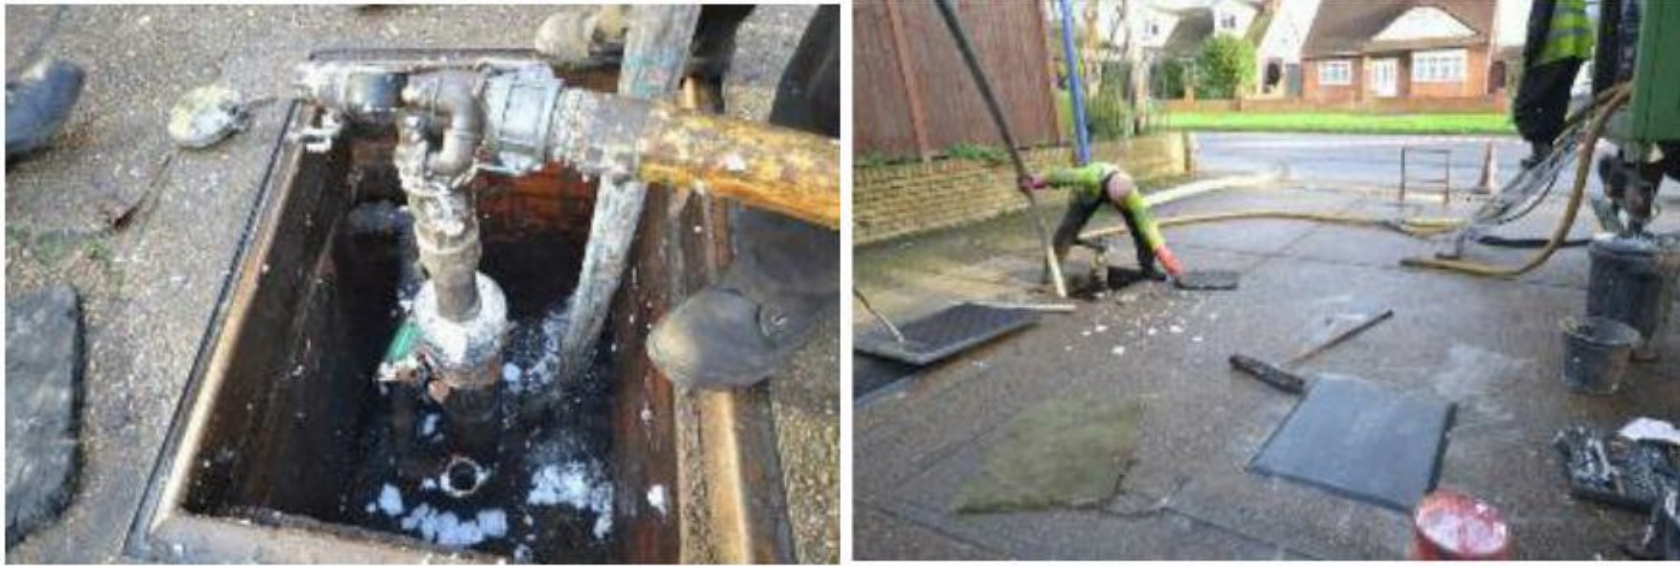
Photographs of foam decommissioning were received although it was unclear what tanks these related to.

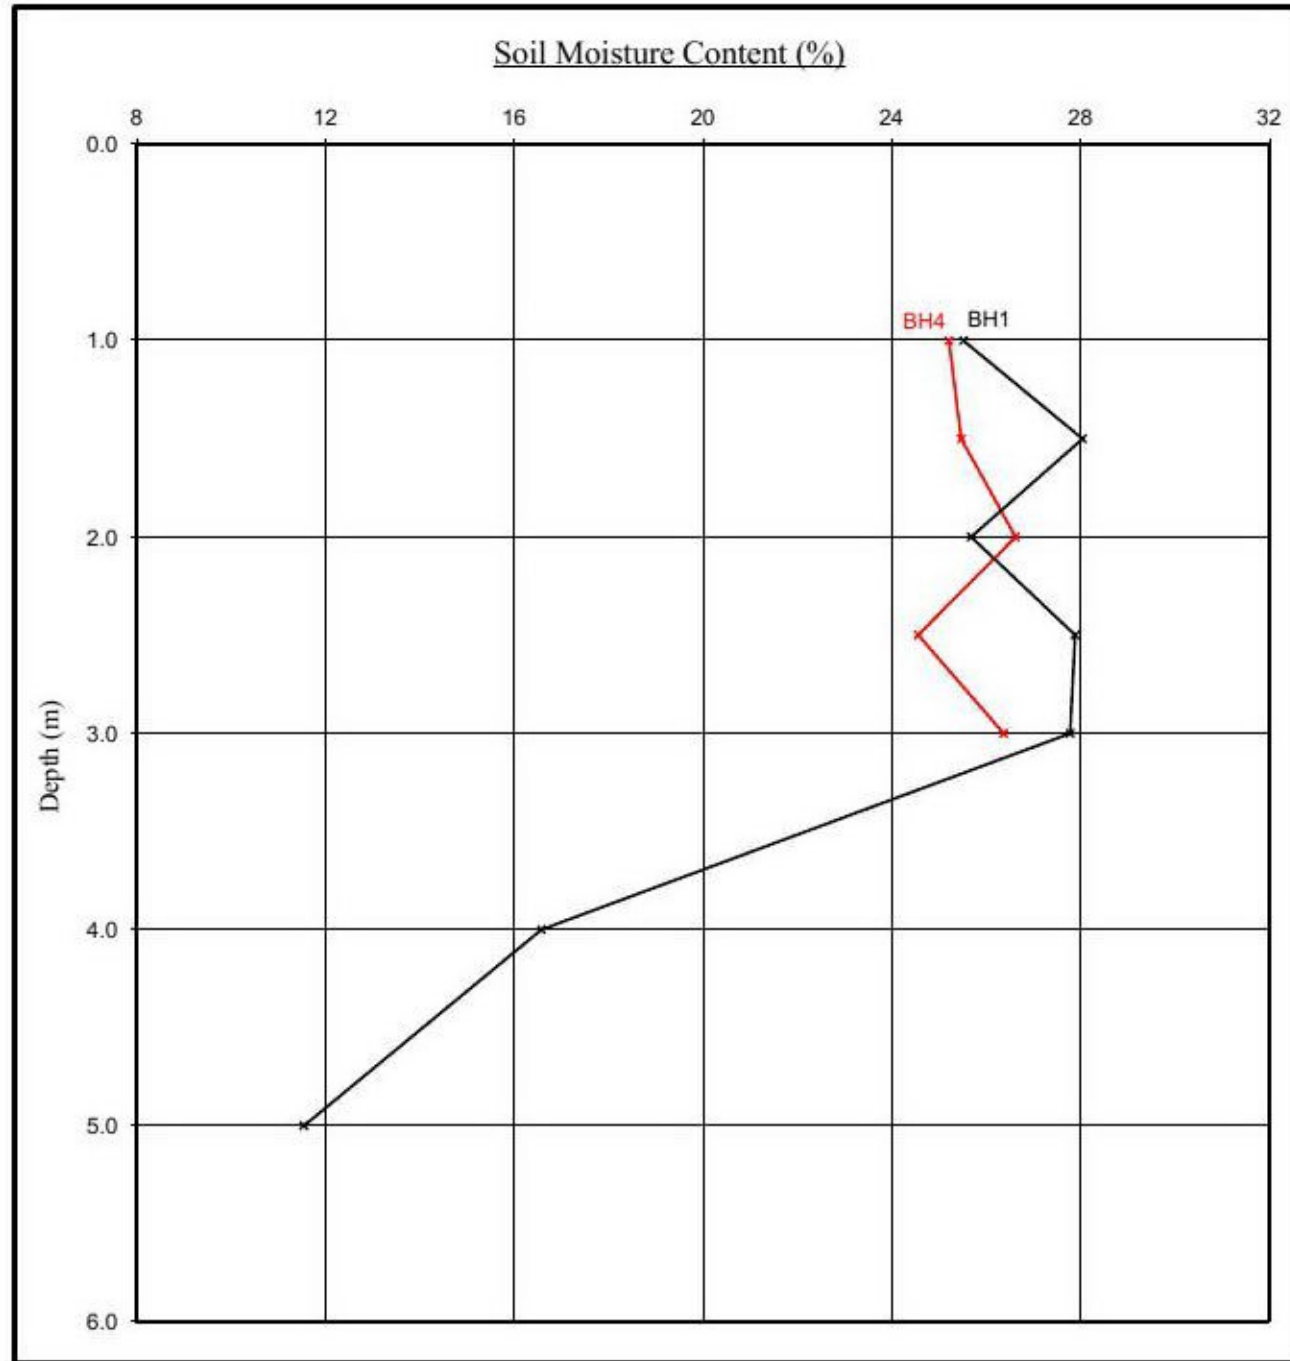
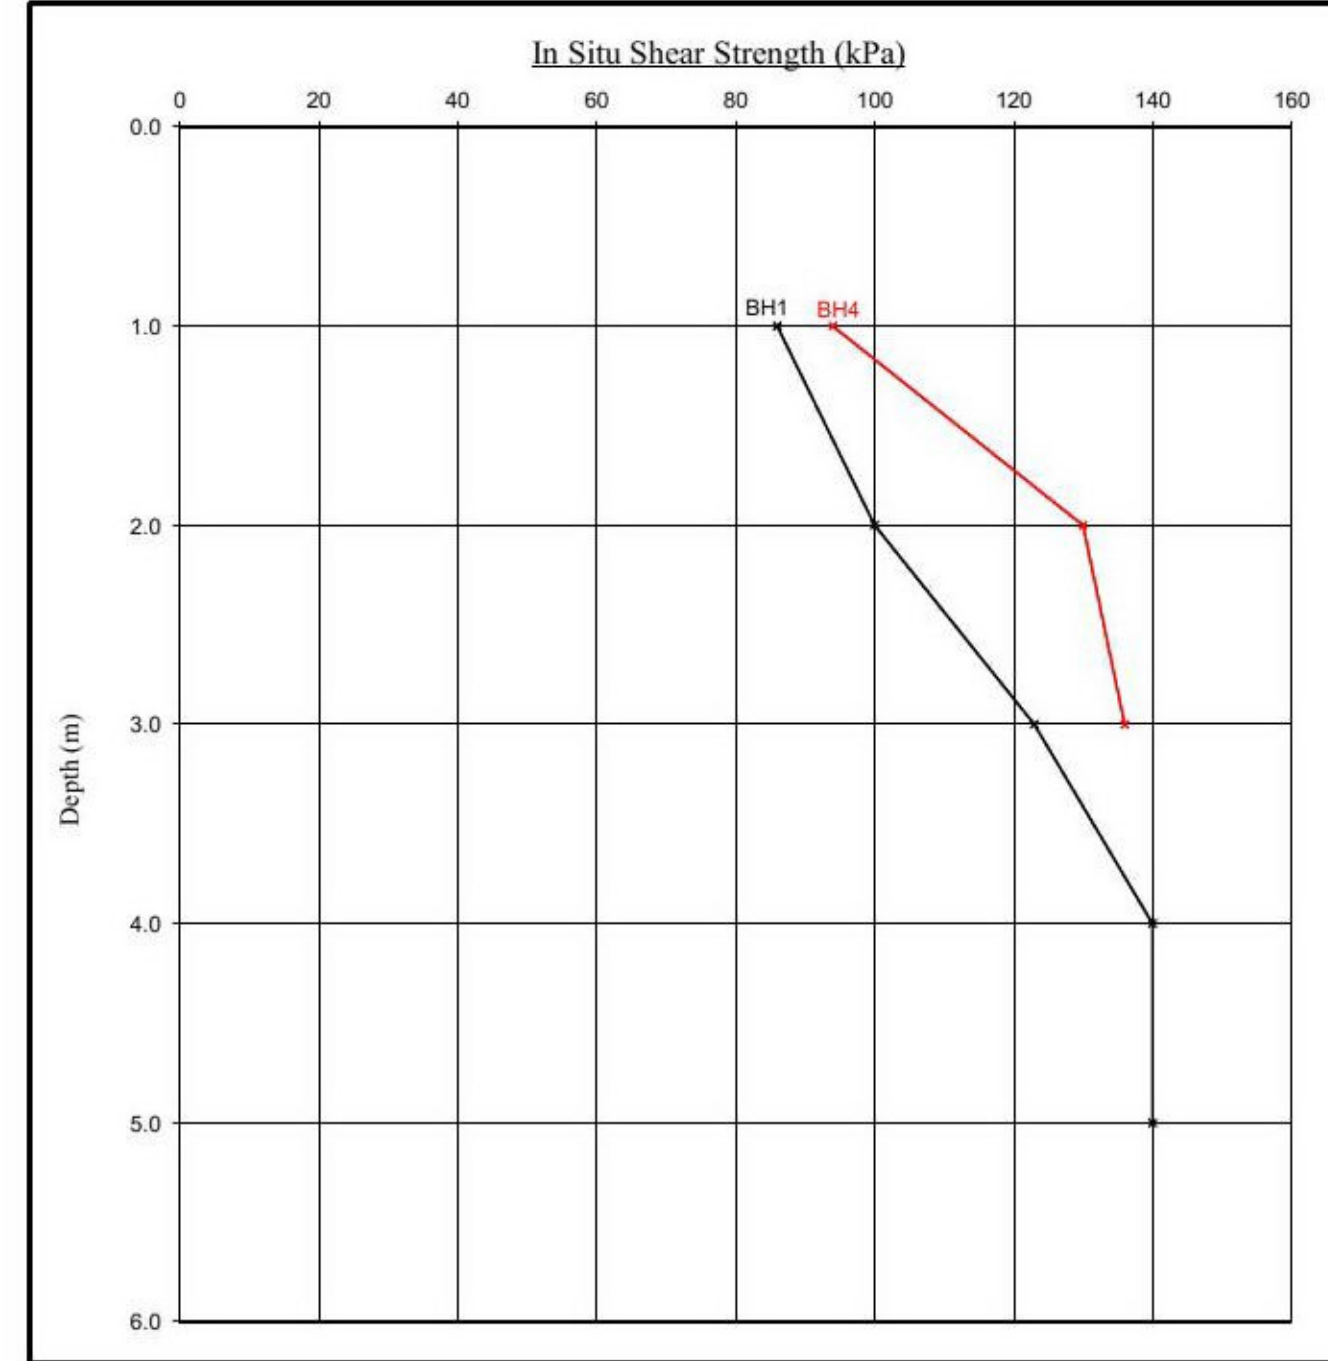
Moisture Content Profiles

1. If plotted, 0.4 LL and PL+2 (after Driscoll, 1983) should only be applied to London Clay (and similarly overconsolidated clay) at shallow depths.
2. Unless specifically noted the profiles have not been related to a site datum.

1. Unless otherwise stated, values of Shear Strength were determined in situ by CET using a Pilon Hand Vane the calibration of which is limited to a maximum reading of 140 kPa.
2. Unless specifically noted the profiles have not been related to a site datum.
