**Appendix 13.1**

**DESK STUDY, GROUND INVESTIGATION  
AND DATA ASSESSMENT**

# Fort Halstead

## Desk Study, Ground Investigation and Data Assessment

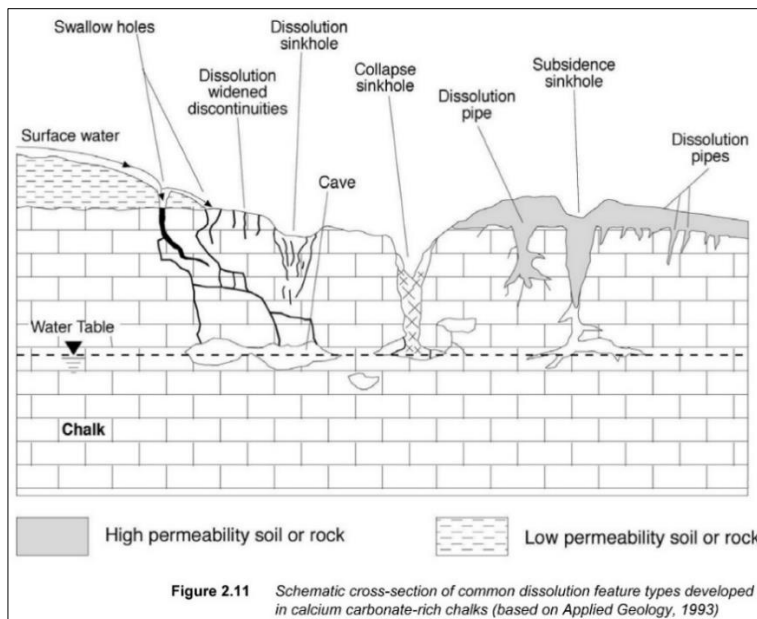
Figure 2.1: Chalk Dissolution Features (from CIRIA C574 Engineering in Chalk)

The presence of layers of dense or cemented materials or cohesive layers can prevent or restrict the void reaching the surface, but creating a potential for surface subsidence in the future when conditions change. The collapse of materials into voids can cause either voids, or loosened material which can extend in a zone surrounding the central core of the collapsed material. These features are illustrated in Figure 2.11 of CIRIA C574 which is reproduced as Figure 2.1 below:

The environmental database report indicates a 'moderate' risk of soluble rocks, close to surface. The Chalk is noted as being at risk of the formation of voids by the dissolution of the chalk. Groundwater derived from rainwater is naturally slightly acidic from the presence of dissolved carbon dioxide, which forms carbonic acid.

Dissolution features can include voids, collapse sinkholes, and dissolution widened discontinuities in the chalk with dissolution pipes. Subsidence sinkholes are caused by overlying granular materials collapsing into the chalk dissolution features. These often originate by material at depth collapsing into a dissolution void, causing a void to migrate upwards to form a subsidence feature at the surface.

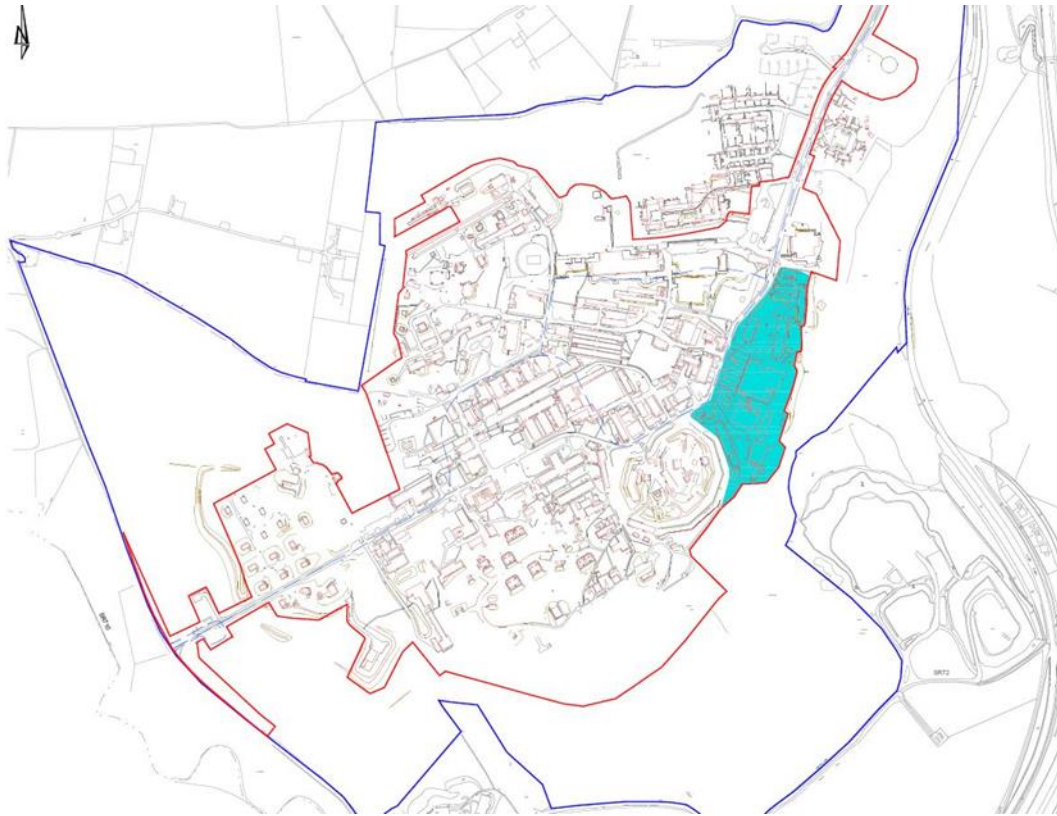
Figure 4.1: The 'A' Area

The 'A' area is located to the east of the site as shown in Figure 4.1.

Item	Brief Description
Present land use	Combination of office buildings and laboratories with a large car parking area along the eastern boundary. Several buildings have been used as laboratories resulting in chemical use or handling. There are several vacant buildings; the remainder were occupied by DSTL.
Potential Contamination	Waste chemical tanks beneath and above ground fuel storage at A28. Former waste disposal adjacent to A5. Former boiler house at A12. Former workshop at A5. Solvent, chemical and oil storage at A28.2

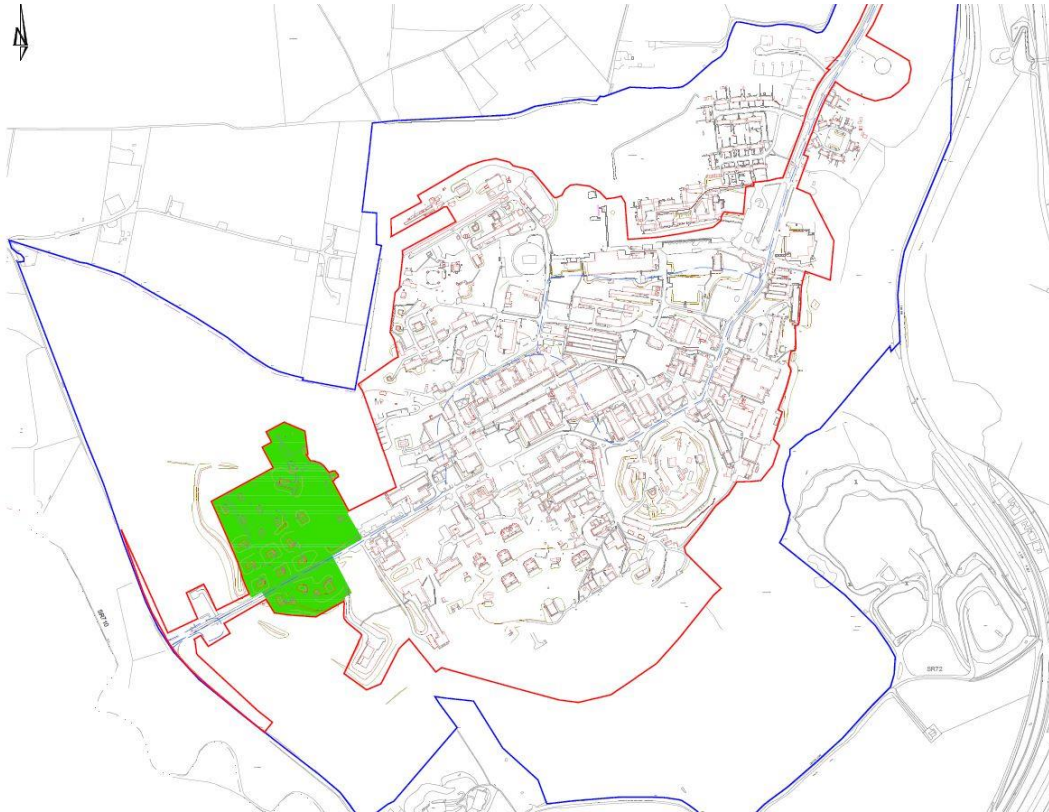
Figure 4.3: The 'M' Areas

The upper and lower 'M' areas (the magazines) are located to the west of the site as shown in Figure 4.3.

Item	Brief Description
Present land use	The current occupiers are the Defence Science and Technology Laboratory (DSTL). Within the area there are a series of buildings used for the storage of higher risk explosives. Between the buildings are grassed areas with several mature trees. A small 'burning ground' is located in the north. Crow Drive bisects the upper and lower M areas, each of which has its own gated access point.
Potential Contamination	Area used for storage of explosives. Burning ground.

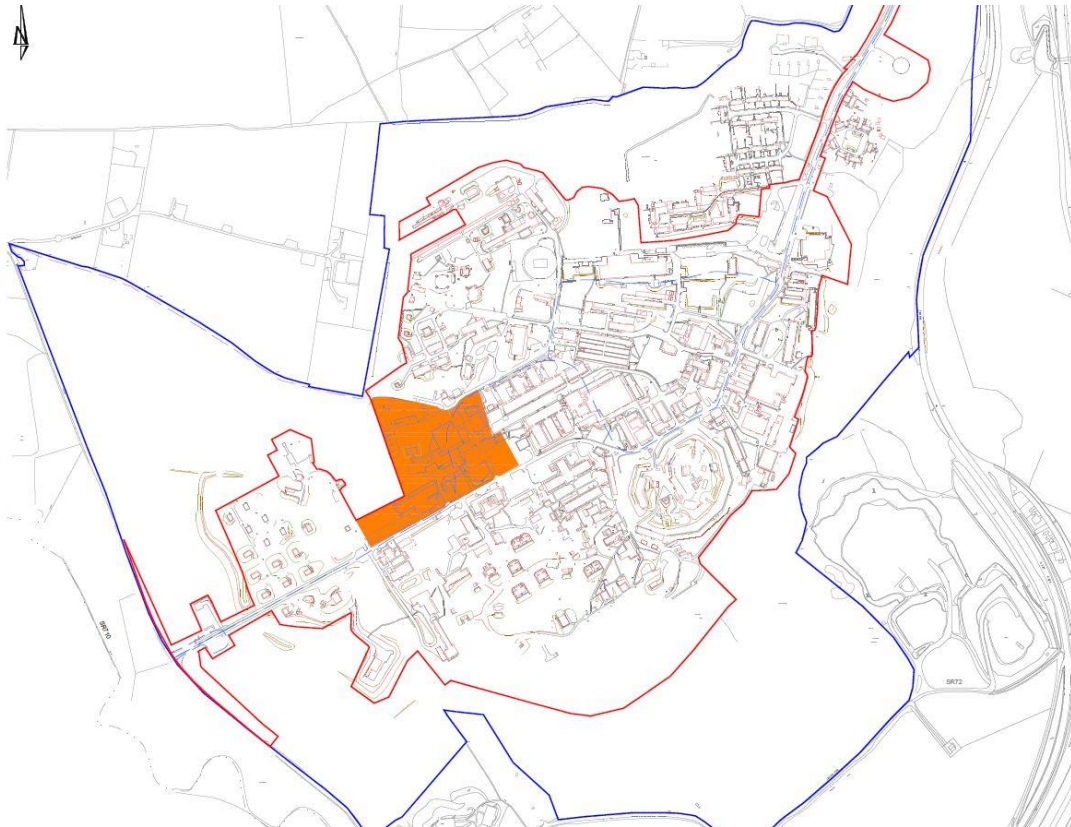
Figure 4.7: The 'S' Area

The 'S' area is located to the west of the site as shown in Figure 4.7.

Item	Brief Description
Present land use	This area contains offices, laboratories and several demolished buildings. The waste storage compound is also in this area.
Potential Contamination	Above ground fuel storage in vicinity of the boiler house at S2. Generators across 'S' area. Storage of liquid and scrap waste in a secure compound.

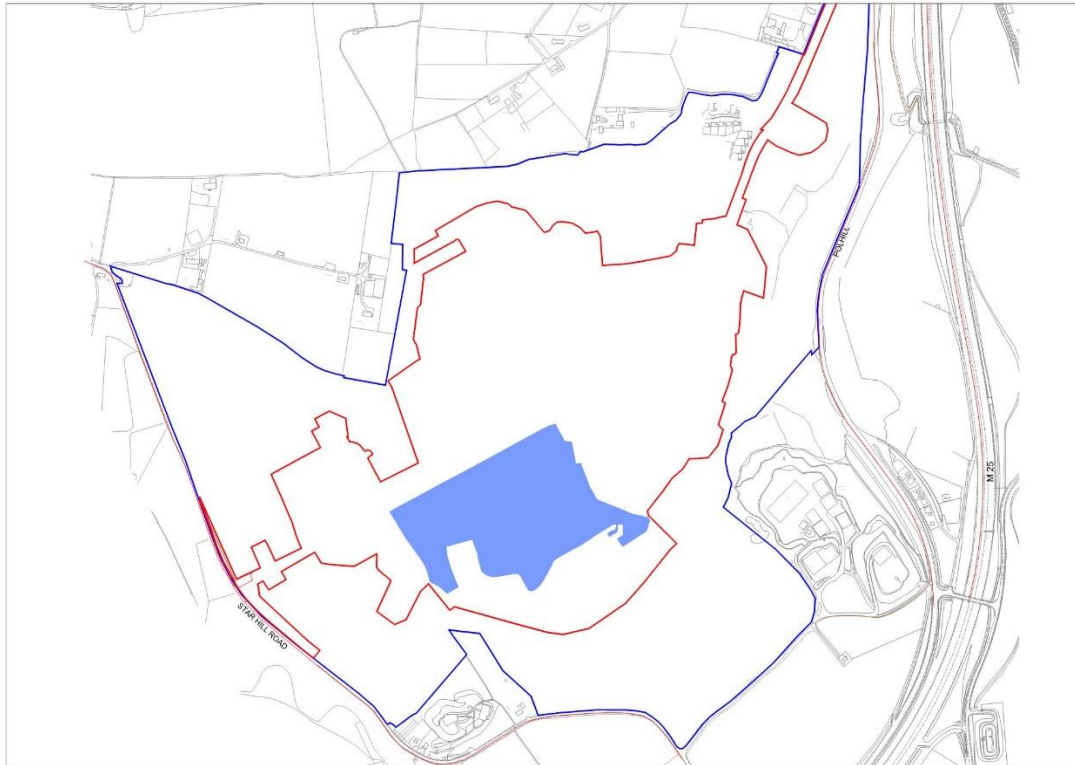
Figure 4.8: The 'X' Area

The 'X' area is located to the south of the site as shown in Figure 4.8.

Item	Brief Description
Present land use	The current occupiers are QinetiQ. Within the area there are a series of buildings used for the storage of higher risk explosives. Between the buildings are grassed areas with several mature trees. The area has its own gated access points.
Potential Contamination	Solvents and chemical wastes Explosive residues Asbestos rubble

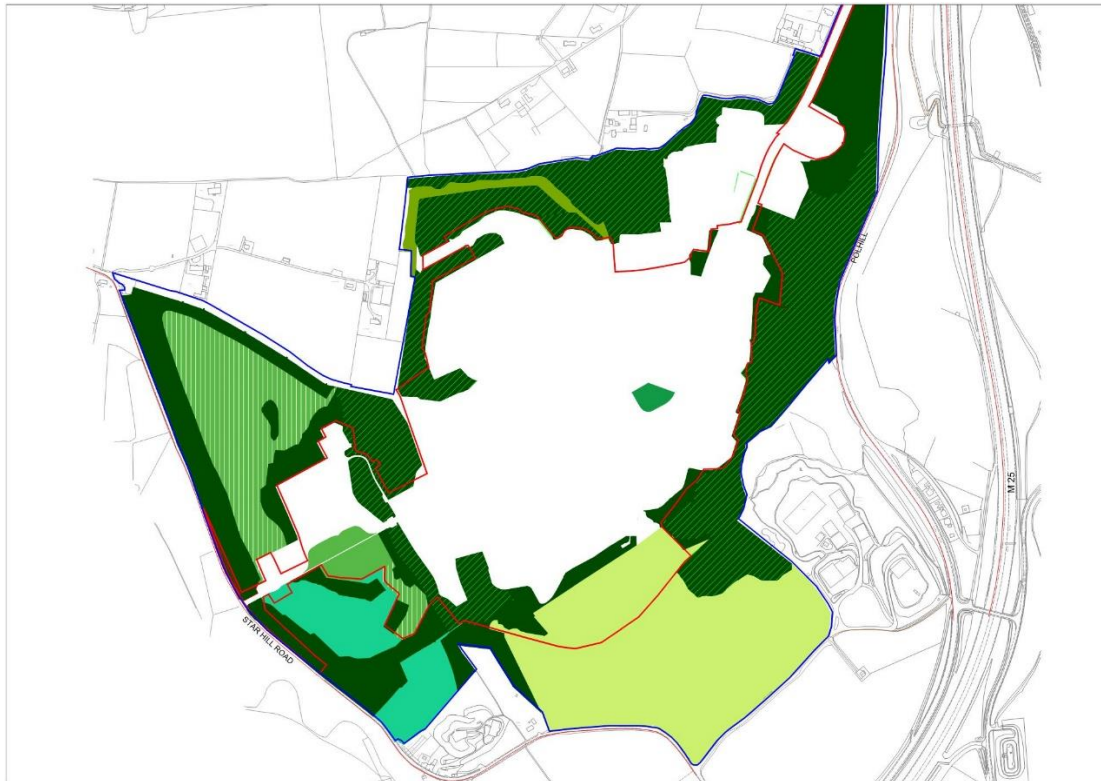
Figure 5.1: Public open space Park

The proposed land uses assessed as public open space park are located across the site as illustrated in Figure 5.1.
