# **SPILMAN ASSOCIATES**

## **Ling Developments Limited**

VILLAGE ROAD, CHILDS ERCALL

### **Report on Phase 1 Desk Study & Phase 2 Ground Investigation**

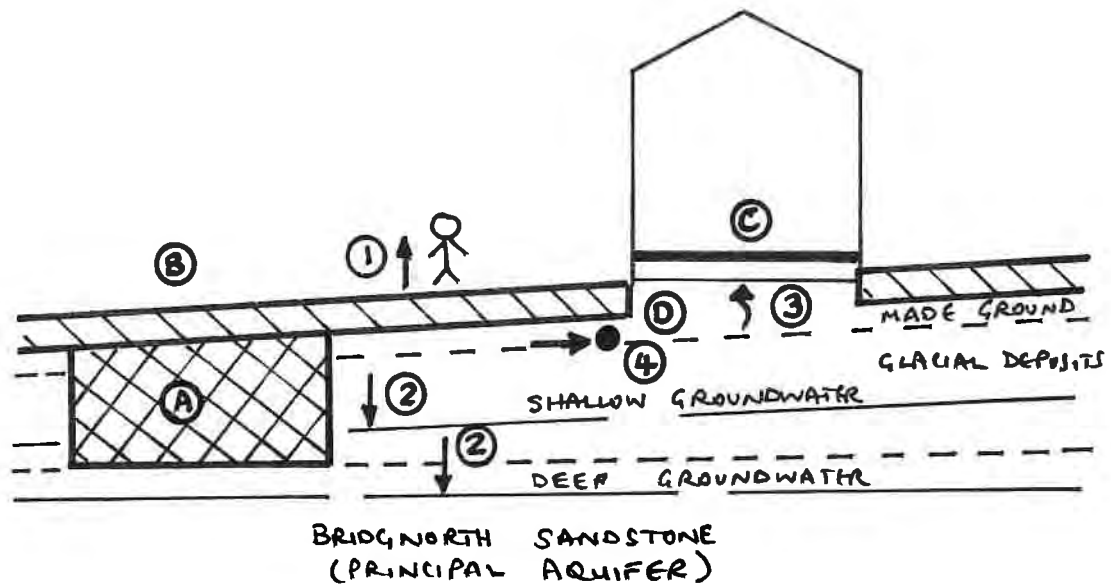
<b>SPILMAN ASSOCIATES</b> Geotechnical & Environmental Engineers  Tel: 01384 820578	Client Ling Developments Limited		Title Revised Conceptual Site Model	
	Scheme Village Road, Childs Ercall			
	Date March 2021	Ref P21004/01	Scale Not to scale	Fig 8

- A: OFF SITE DISPOSAL OF HYDROCARBON IMPACTED SOILS (SOURCE REMOVAL)
- B: 600mm CLEAN COVER LAYER TO GARDENS & LANDSCAPING AREAS (PATHWAY REMOVAL)
- C: GAS & HDROCARBON MEMBRANE & SUB SLAB VENTING (PATHWAY REMOVAL)
- D: APPROPRIATE MATERIALS FOR BUILDINGS & SERVICES (PATHWAY REMOVAL)

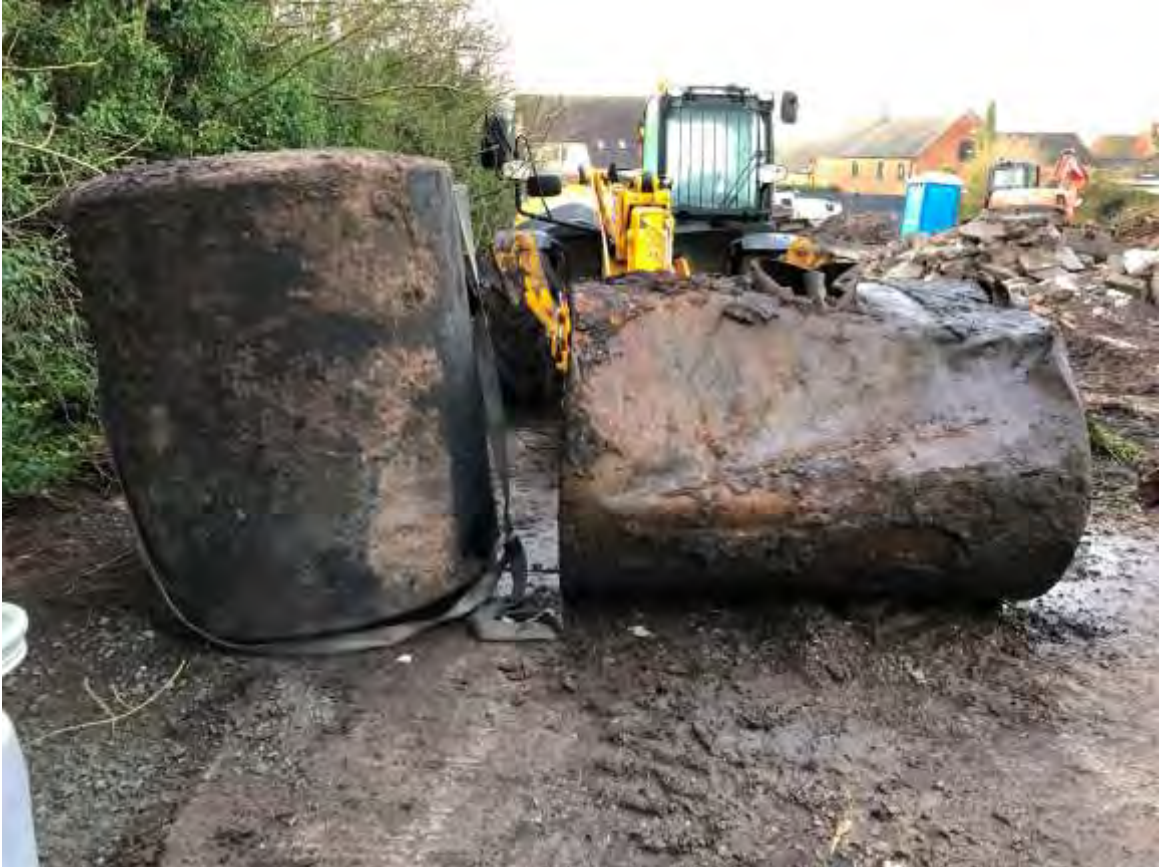
Photo 1: Excavated Underground Tanks Awaiting Off-Site Disposal

Two approximately 500 gallon capacity tanks were identified below a concrete slab at the position shown on Figure 7. The tanks were found to be fluid filled containing a mixture of water and diesel. The contents of the tanks were pumped out into IBCs for subsequent off-site disposal by specialist contractor.

The fuel tanks were then dug out. There was no evidence of a concrete surround around the tanks. The tanks were in direct contact with the surrounding soil which was noted to be visually and olfactorily impacted by hydrocarbons.

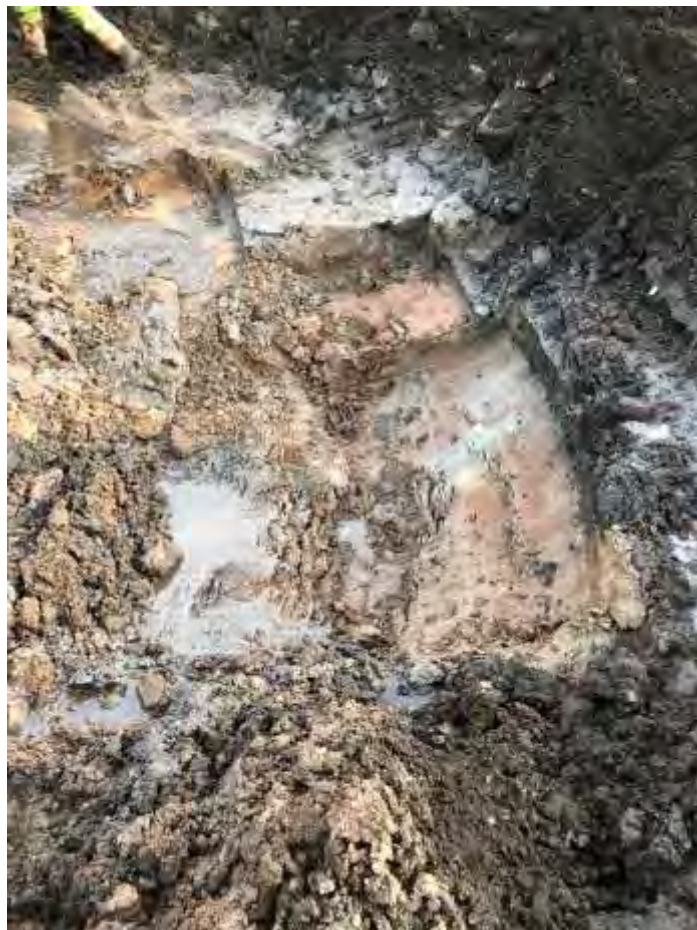
Photo 2: Natural Soils Below Former Underground Tanks

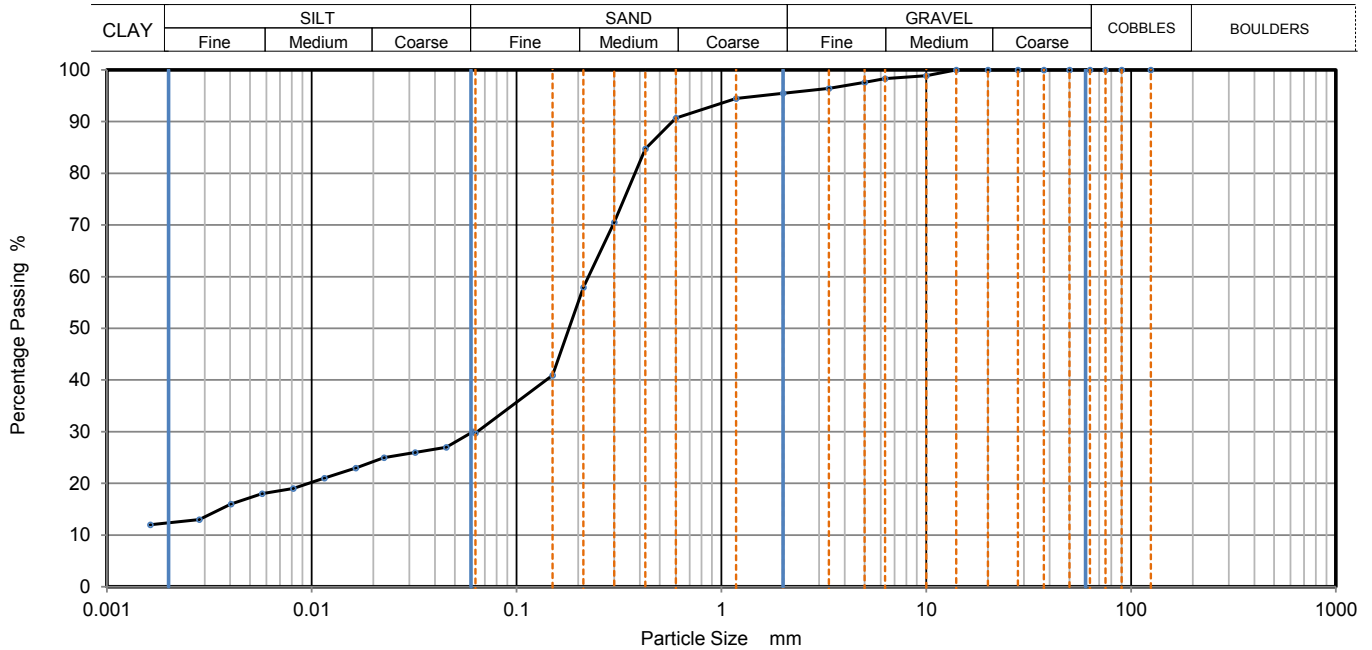
Site Name	Village Road, Childs Erccall		
Project No.	P21004	Client	Spilman Associates Ltd
Soil Description	Dark pinkish brown slightly gravelly clayey silty SAND (gravel is fm and sub-rounded to sub-angular)		
Test Method	BS1377:Part 2: 1990, clause 9.0

Sample Proportions	% dry mass
Very coarse	0.0
Gravel	4.5
Sand	65.8
Silt	17.4
Clay	12.3

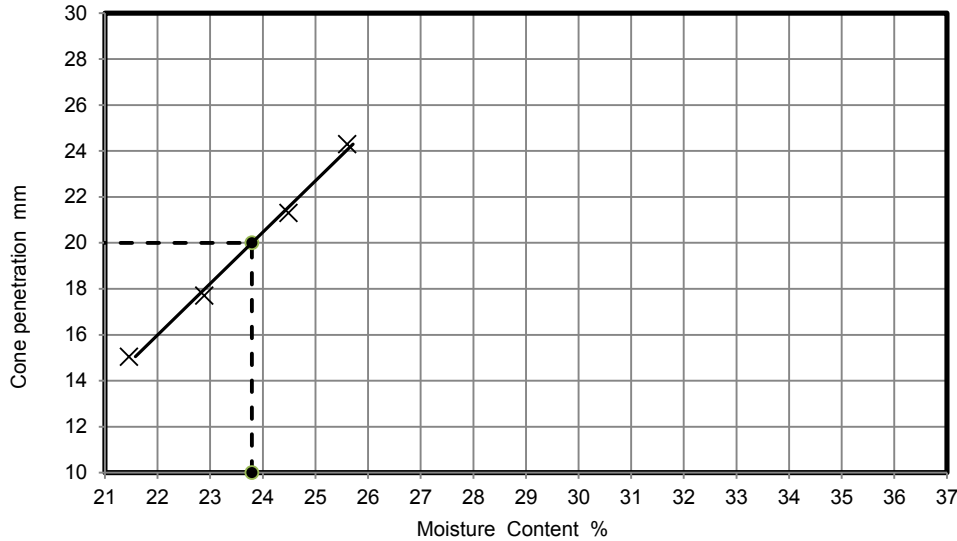
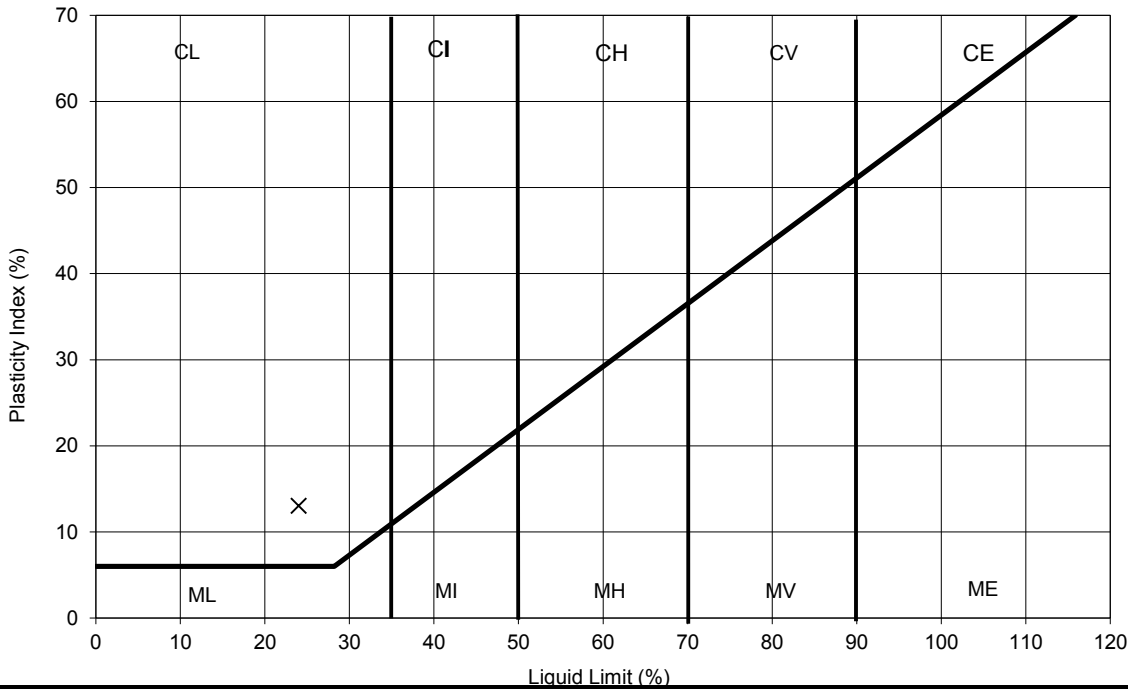
### PLASTICITY INDEX

NATURAL MOISTURE CONTENT	16	%
% PASSING 425µm SIEVE	85	%
LIQUID LIMIT	24	%
PLASTIC LIMIT	11	%
PLASTICITY INDEX	13	%
