## **Phase I Geo-Environmental Desk Study**

### **Wootton Street**

**EPS Project Reference:** UK20.4975

**Date Issued:** 22<sup>nd</sup> December 2020

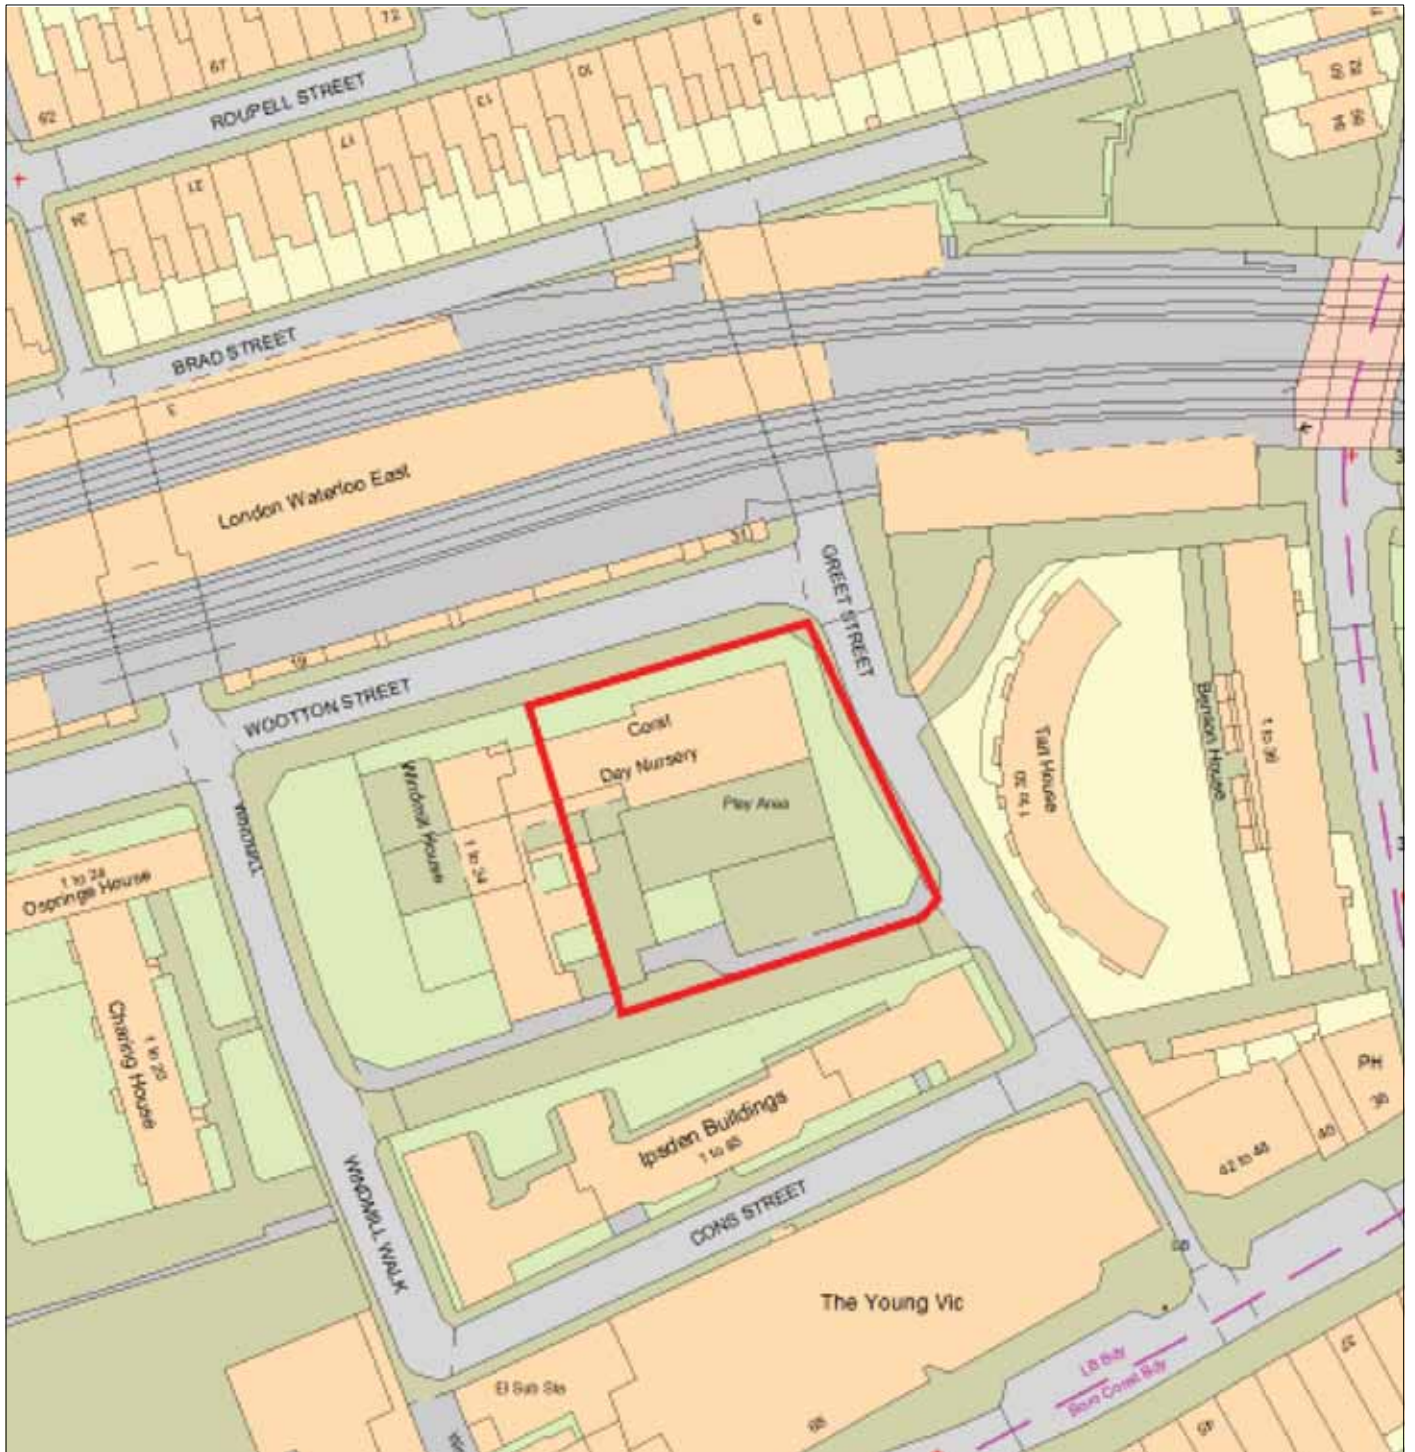
Dwg No: Wootton/1220/02

A plan showing the site location is provided as Figure 1, the current site layout is detailed on Figure 2 and an aerial photograph is included as Figure 3. Furthermore, relevant extracts of a Landmark Envirocheck report are included as Appendix C.

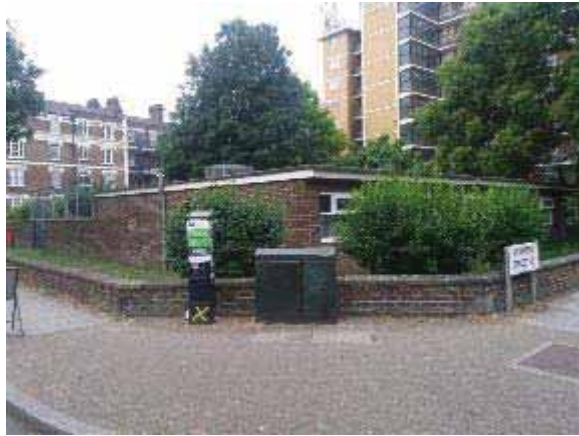
Photo 1: Image of the site from the junction of Greet Street and Wootton Street.

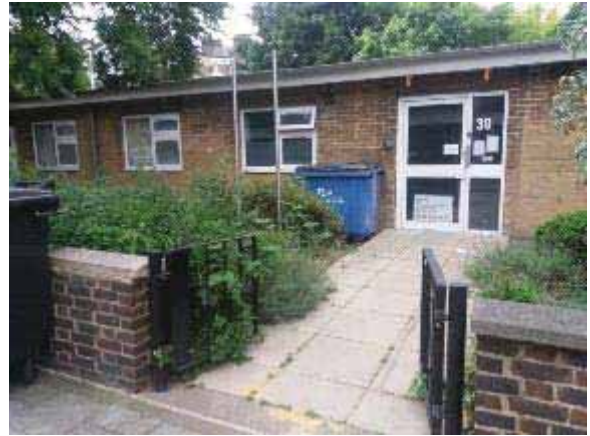
Photo 2: View of the pedestrian entrance to the day nursery, located along the northern boundary.

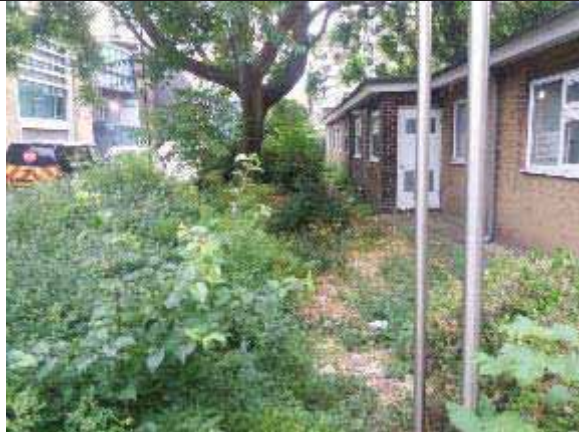
Photo 3: Photograph showing the nature of the soft landscaping along the northern face of the existing building.

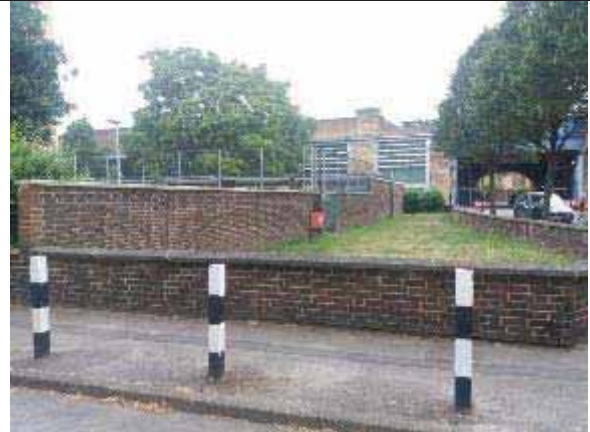
Photo 4: Image looking north, along the eastern boundary.

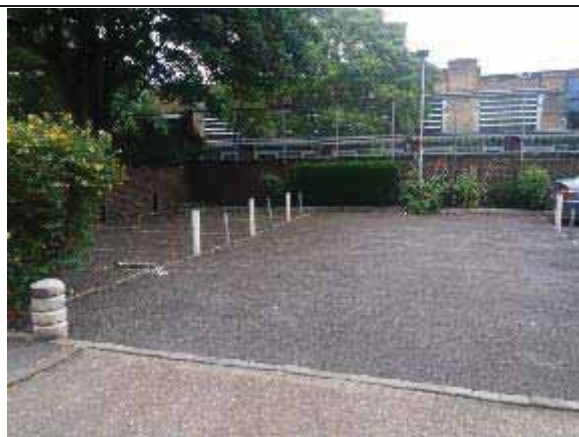
Photo 5: Image of the car park located in the southern area of the property.

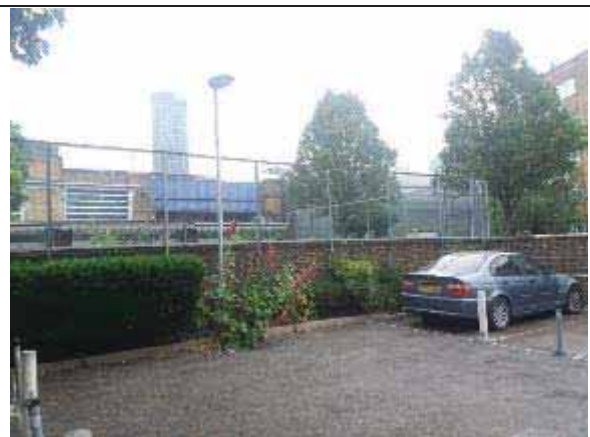
Photo 6: View looking towards the enclosed playground area, at the rear of the day nursery.
