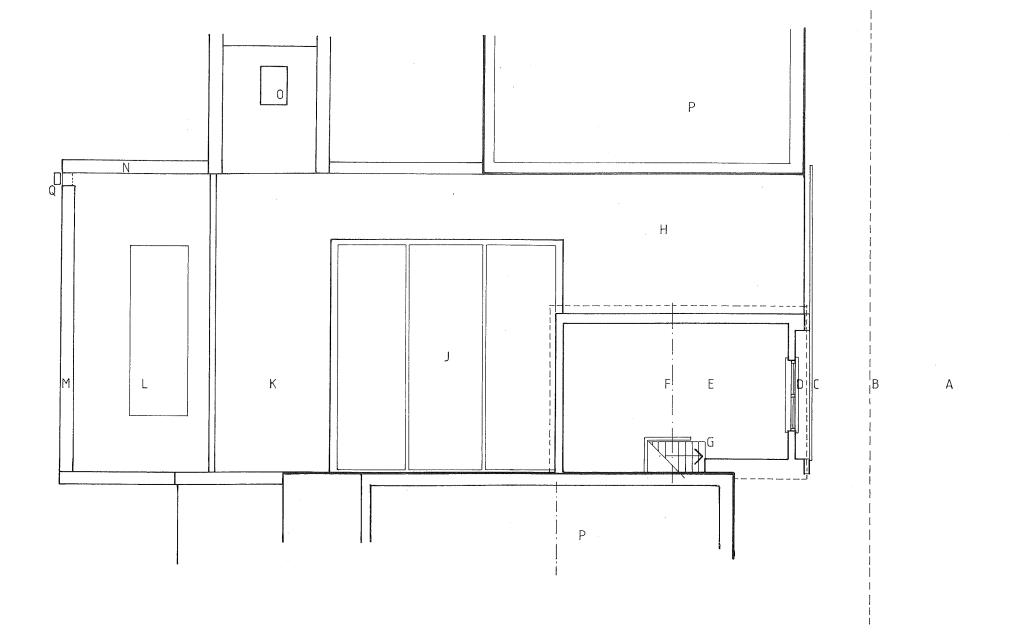
A Wolseley Road carriageway below B Northern kerb line below shown dashed C Wolseley Road Garage signage D Window to office at first floor E First floor admin office F Ridge line over reflected in raked ceiling G Stairs up from workshop level H Flat roofs J Polycarbonate glazing to raised ceiling over main workshop area K Rear flat roofed area over workshop L Rooflights over rear workshop area within flat roof M Rear parapet upstand wall N Side parapet wall O Rooflight over redundant stairs within pitched roof P Neighbours' houses Q Hopper head rain water downpipe through parapet wall R Courtyard garden at the rear of No 68 Gloucester Road
