# **Preliminary Roost Assessment**

**27 West Farm Court  
Broompark  
Durham**

**FE-101-001-400-R-01-V1**

**April 2021**

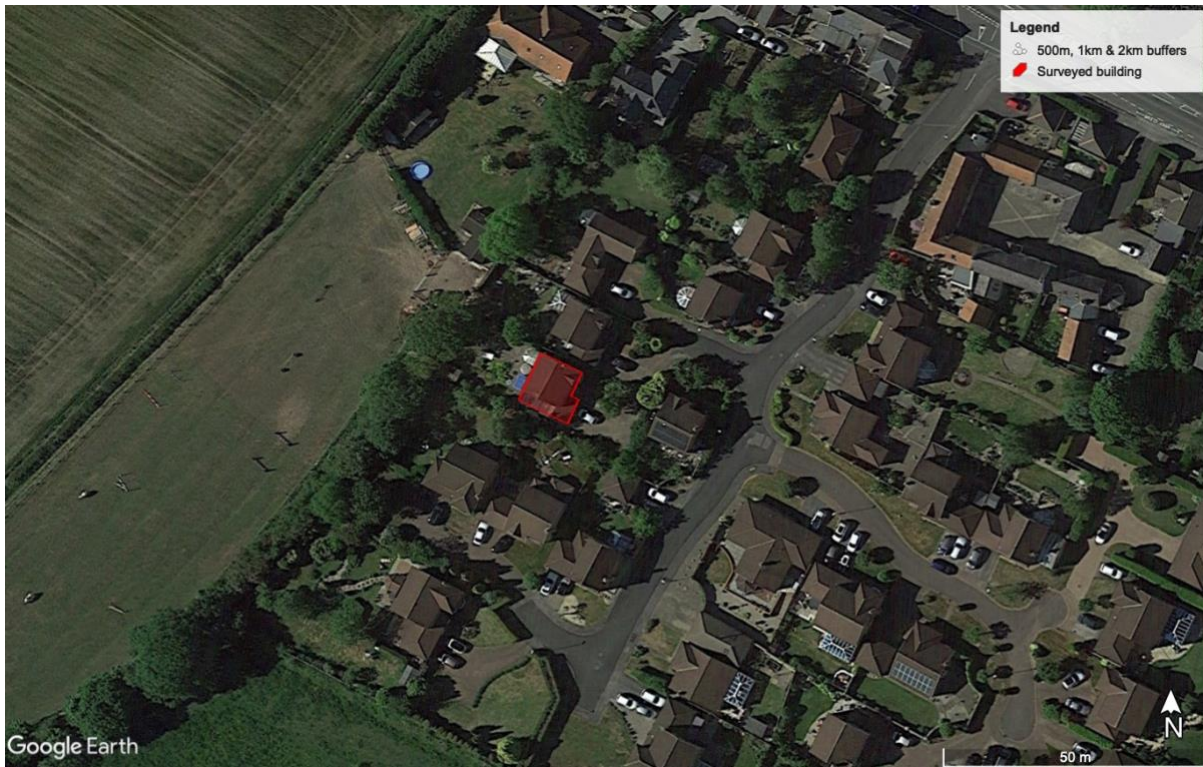
**Figure 1: Surveyed building.**

- 1.2.1 The surveyed building was a detached three-bedroom residential property and was occupied by the Client at the point when the survey was undertaken.
- 1.2.2 The address of the surveyed building was 27 West Farm Court, Broompark, Durham, County Durham, DH7 7RN. The central Ordnance Survey grid reference for the surveyed building was NZ 24224 41776 and was ~105m above sea level. The location of the surveyed building is shown in Figure 1 (page 2).
- 1.2.3 The surrounding habitats of the surveyed building was dominated by mixed (arable & pasture) farmland, deciduous woodland and other residential properties within the estate. The surrounding area of the surveyed building with 500m, 1km and 2km buffers are shown in Figure 2 (page 2).
- 1.2.4 The surveyed building was within the administrative area of Durham County Council.

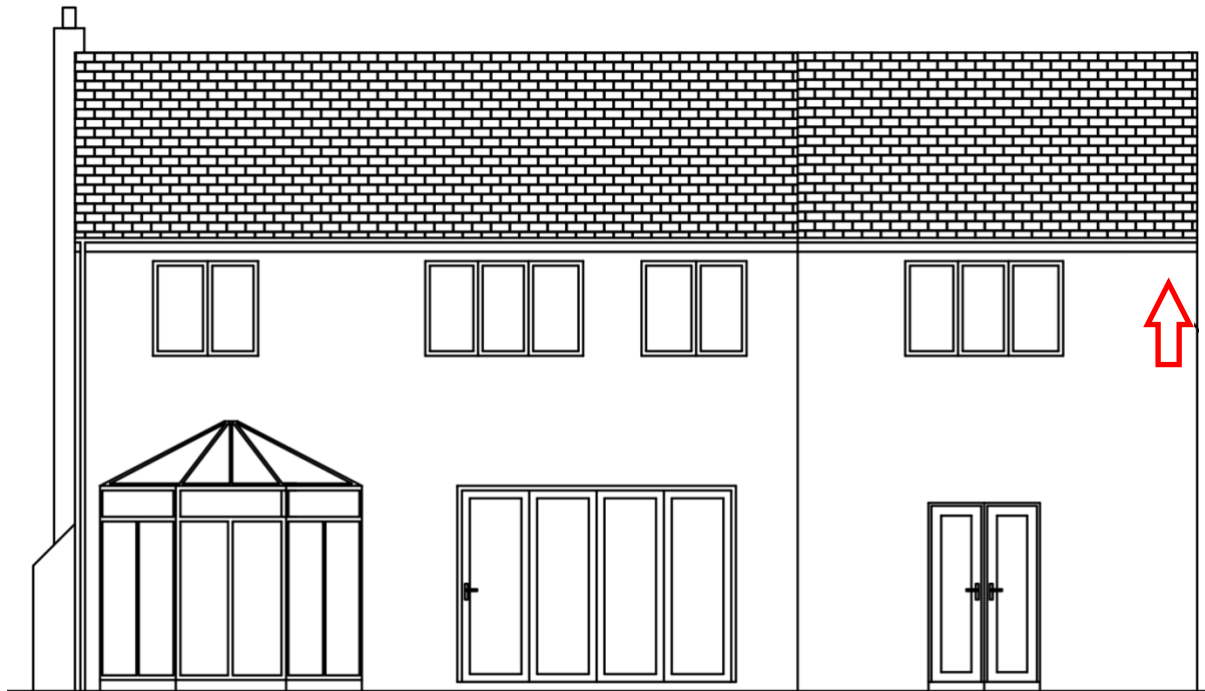
**Figure 4: Proposed location of the integrated bat box.**

PROPOSED REAR ELEVATION

5.1.1 In order to fulfil the latest National Planning Policy Framework which includes Biodiversity Net Gain into proposed developments, it is recommended that an in-built bat box be installed as part of the proposed development. Examples of an integrated bat box is shown in Figure 3 below (but not exclusively this design). The recommended locations of the integrated bat box is shown in Figure 4 (page 12). No security lighting or up-lighting should be located near or directed at the integrated bat box.

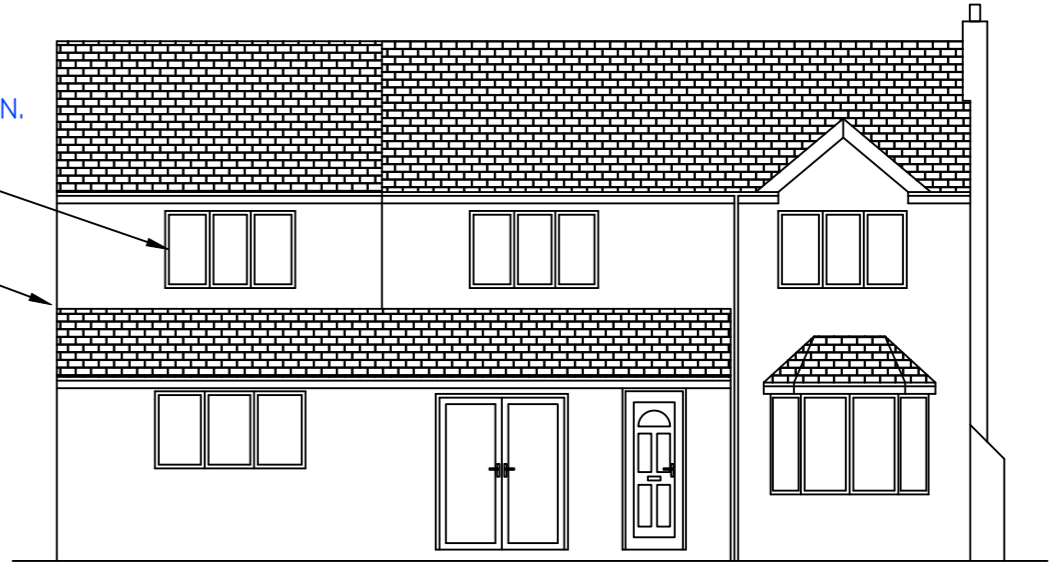
PROPOSED FRONT ELEVATION

800 x 700 CLEAR OPENING SIZE WINDOW WITH NON LOCKING FASTENER. CILL HEIGHT TO BE NOT MORE THAN 1100mm FROM FLOOR. TO PROVIDE ESCAPE AND RAPID VENTILATION.  
LEAD FLASHING CHASED INTO BRICKWORK. CAVITY TRAY TO BE INSTALLED WITH TWO COAT SILICONE WASH APPLIED TO EXTERNAL MASONRY.

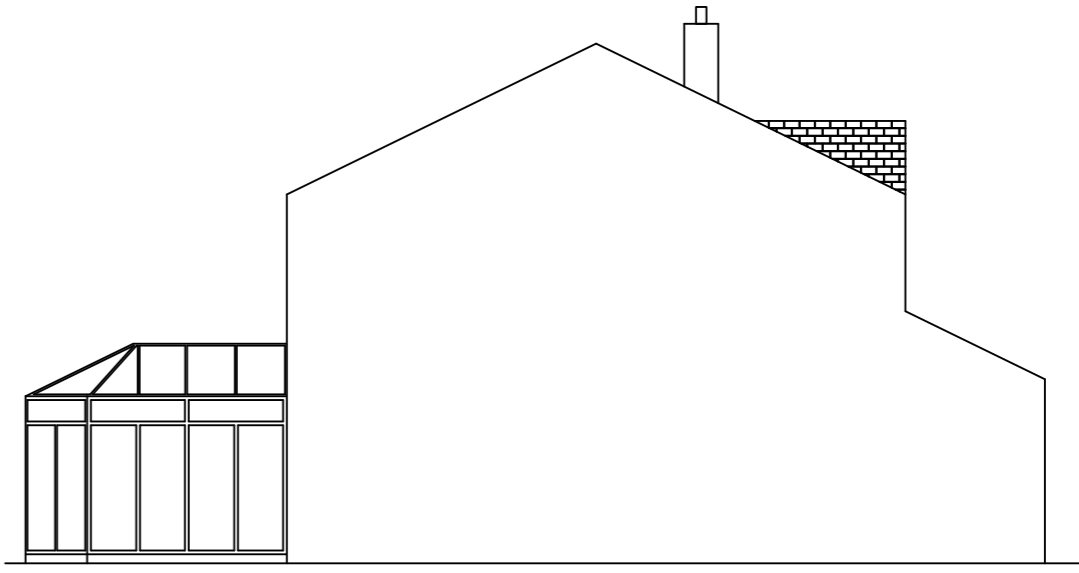
PROPOSED GABLE ELEVATION

VENTILATION REQUIRED TO RIDGE EQUIVALENT TO A 5mm CONTINUOUS RUN.

VENT TILES TO ROOF

VENTILATED SOFFIT TO EAVES EQUIVALENT TO A 25mm CONTINUOUS RUN.

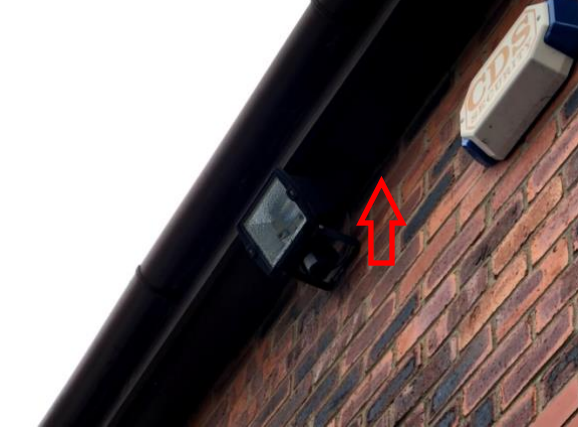
6	Roof void

- 3.2.6 The internal inspection included an inspection of the roof void. No evidence of roosting bats, including droppings were recorded within the roof void. Furthermore, no claw marks or staining were recorded on the roof trusses during the survey. No ridge beam was present.
- 3.2.7 A bitumen roofing underlay/felt was present during the survey and there were cuts and gaps in the bitumen underlay where external light could be observed. However, these gaps were covered in cobwebs and were dusty which likely indicates that these are not used as access points by roosting bats. External light was visible from within the roof void around the eaves.

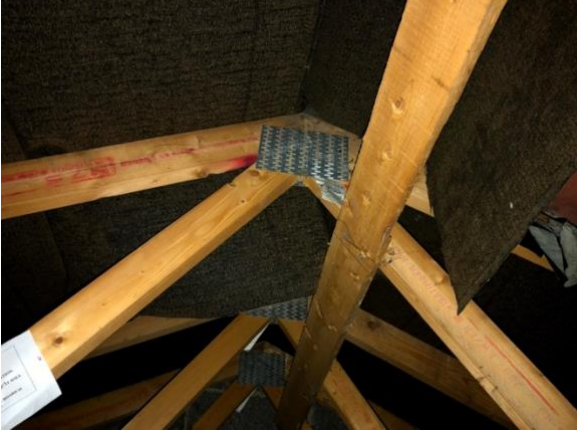
8	Roof void
