Ecological Impact Assessment and Bat Survey

**SOUTH WING, BOLTON HALL, ALNWICK,
NORTHUMBERLAND**

Summer 2020

Ecological Impact Assessment for South Wing, Bolton Hall, Alnwick, Northumberland

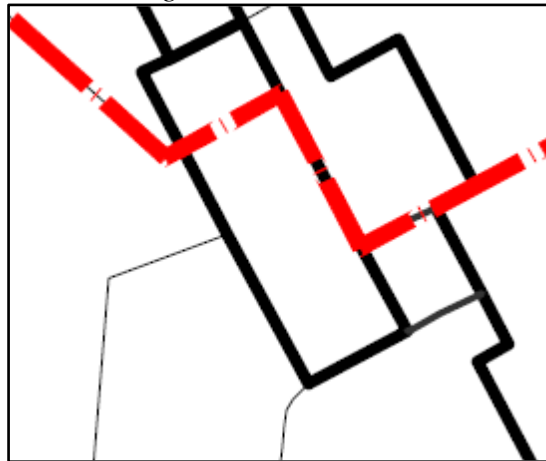
Figure 2. Survey area - central building within the redline

The survey area covered the building and garden only within the red line boundary as shown within Figure 2 and included searching for signs of any wildlife using the site with the key aspects listed below.

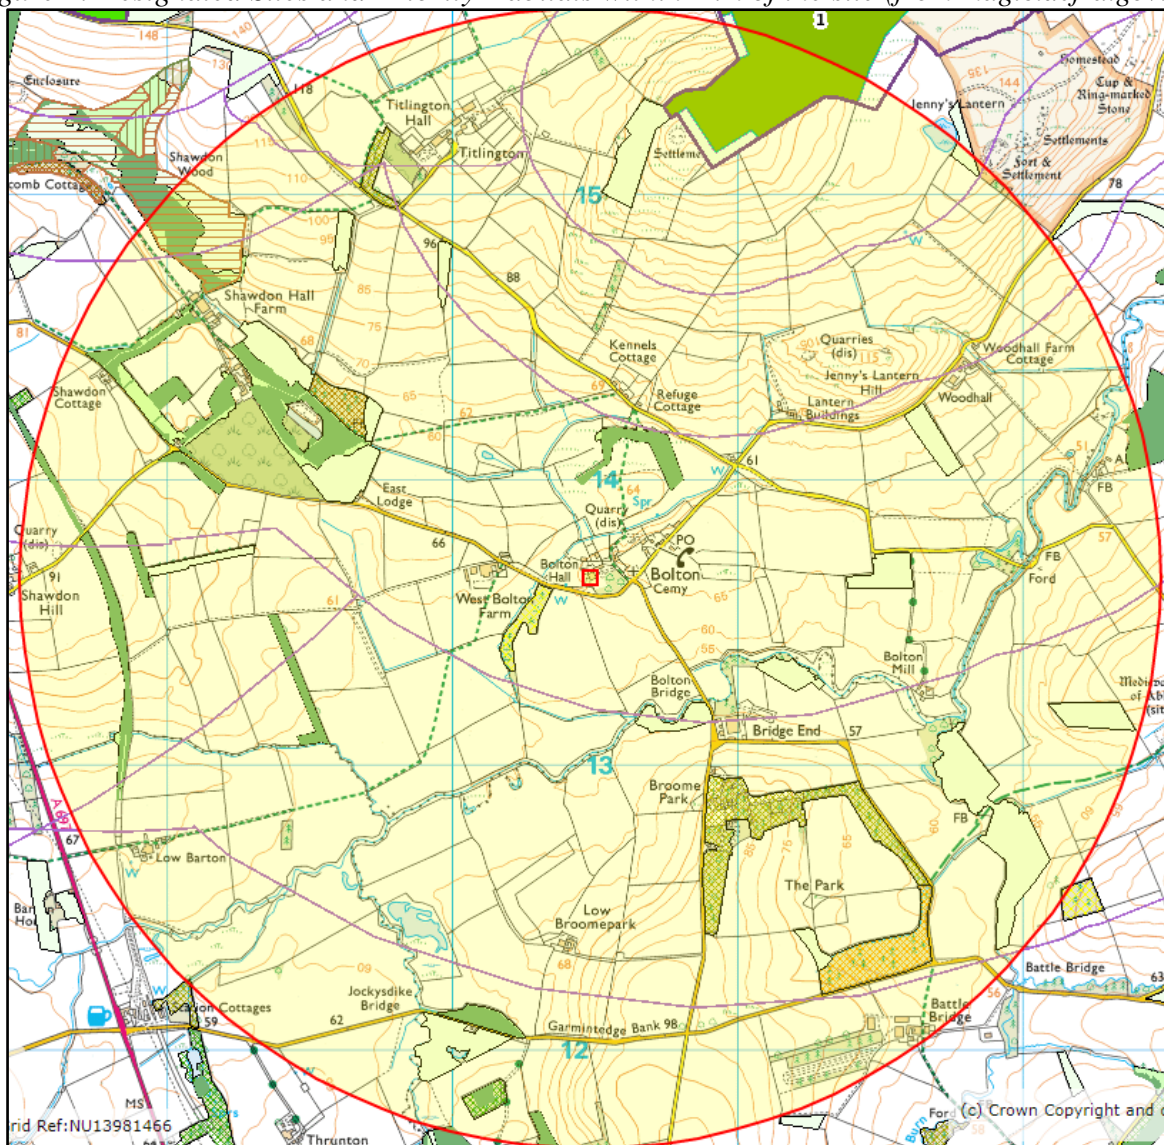
Figure 4. Designated Sites and Priority Habitats within 2km of the site (from magic.defra.gov.uk)

There is one statutory designated sites within 2km of the site. This is Bewick and Beanley Moors SSSI (Upland Heath), 1.6km to the northeast. The development site falls within the impact risk zones for SSSI's in the wider area.

Figure 4 shows BAP Priority Habitats, within 2km (listed under Section 41 of the Natural Environment and Rural Communities Act 2006). These habitats are deciduous woodland, upland heathland (bright green), wood pasture and parkland and ancient and semi-natural woodland to the northwest, all within 2km of the site.

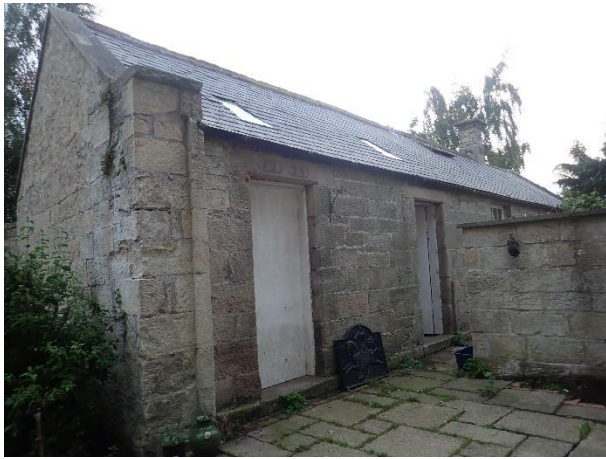
West wall of the outbuilding

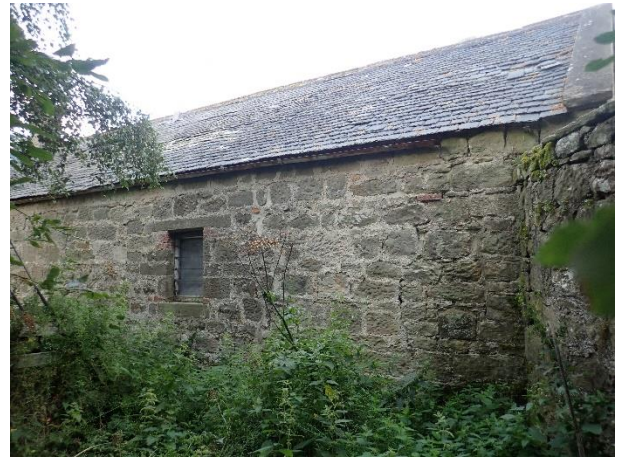
The outbuilding from the southeast

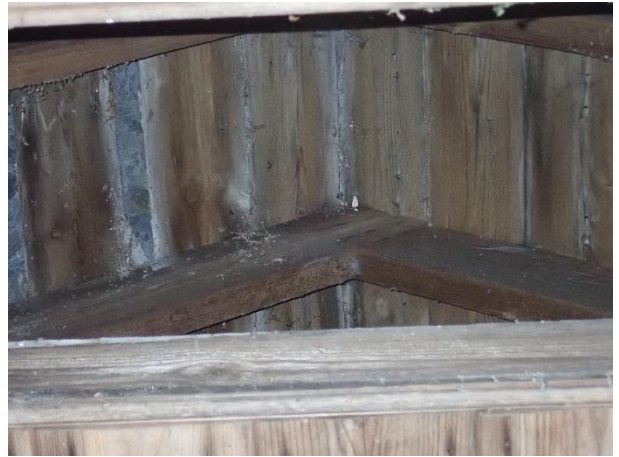
Well spaced wood sarking present

A traditional bitumen felt (F1) or wood sarking that would give bats some grip will be used in the region of any bat roost potential and not a more modern smooth or breathable roofing membrane (BRM) that may fray and entrap bats.

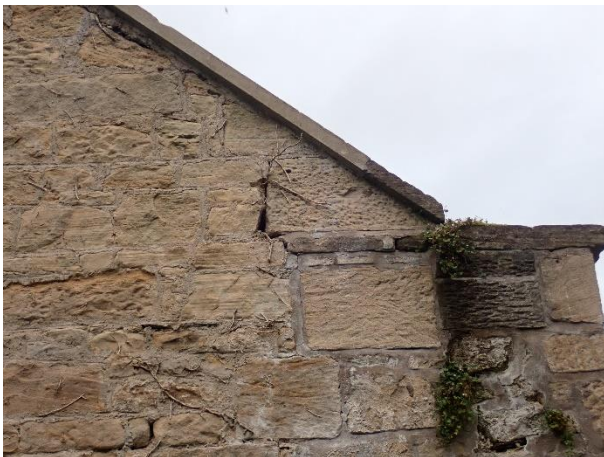
Two storey eaves of the South Wing where a bat re-entered above the window.

Roosts identified in the main building will be retained as at present.

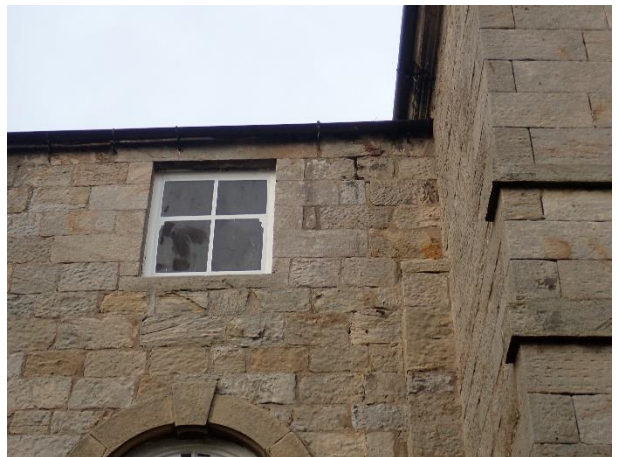
Inspection results of the exterior revealed that the building surveyed had loose slates and gaps beneath the ridge tiles with mortar missing. No evidence of bats was noted externally or internally. The building was assessed as having moderate bat roost potential due to the crevices present and two emergence/dawn surveys were carried out.

Crevices in the mortar

Bat access will be created through the mortar fillet to beneath the ridge tiles and above the ridge/sarking board on the converted outbuilding by ensuring that the ridge tile is not totally filled with mortar. Access through the mortar fillet measuring 20x20+mm will be created leading to a larger gap measuring 400mm long below the ridge tile, a section of split pipe can be used to give access from ridge tile to ridge tile. **No BRM (Breathable Roofing**

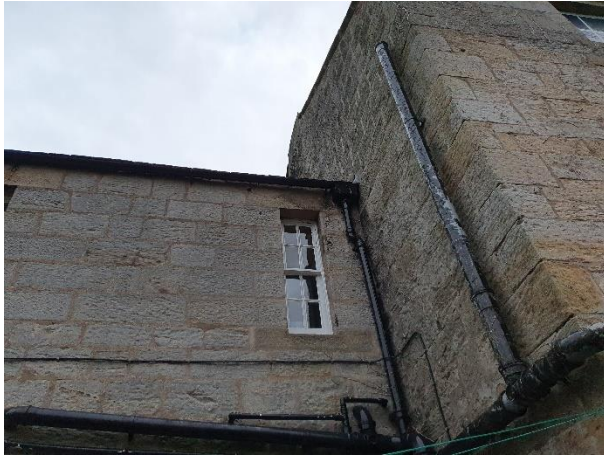
Bat re-entered above window of the neighbours.

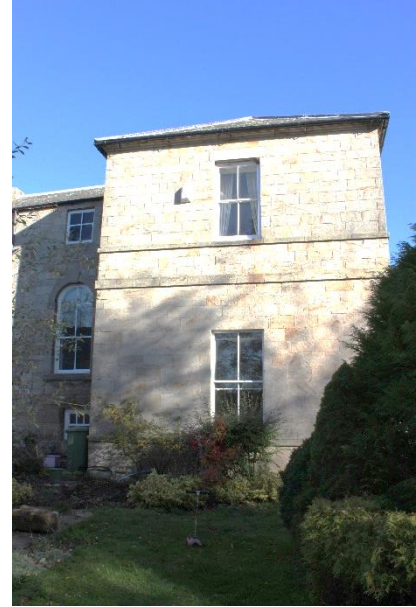
Location of the proposed link with the garden room, pointing sound.
