Preliminary Bat & Bird Assessment

102 Southgate Street, Redruth, Cornwall TR15 2ND

18th February 2021

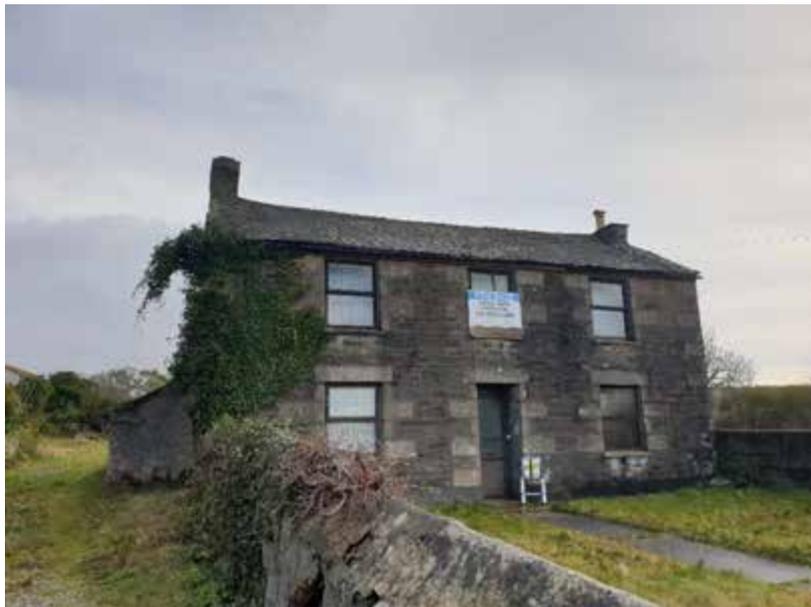
102 Southgate Street comprises a stone built two-storey cottage with a pitched scantle slate roof, which extends in a slight lean-to projection at the rear (north eastern elevation) (Figs. 1-7). The external walls are either bare stone or they have been rendered with cement. There are three brick chimneys on the roof, which are rendered with cement. There is a large hole in the roof on the north eastern elevation approx. 1 m wide x 0.6 m high which enables potential access for bats into the interior of the roof void (Fig. 5). The building features timber fascias, glazed windows with timber frames and slate/ granite sills, timber doors and metal gutters and downpipes. There are ridge tiles present, although their composition could not be determined due to the cement covering. The windows on the north eastern elevation of the property have been boarded up (Fig. 2).

Figure 1: South western elevation of 102 Southgate Street

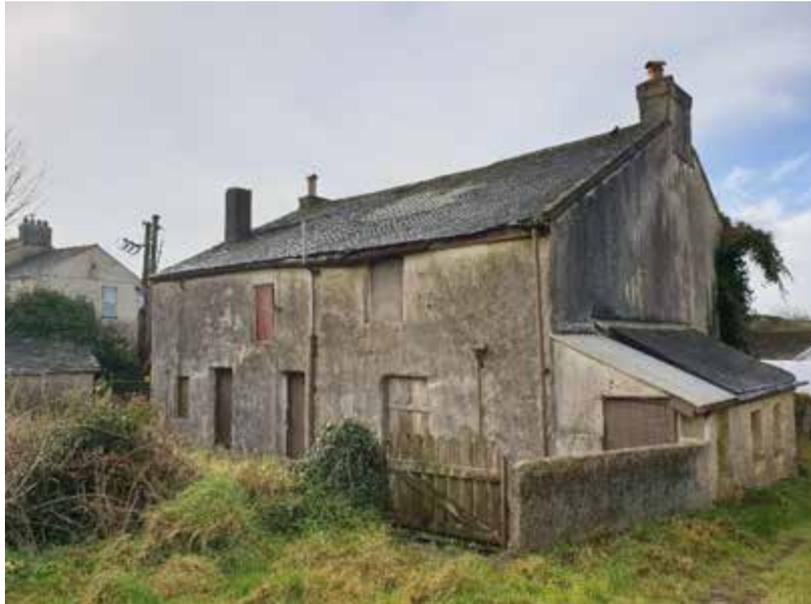
Figure 2: North eastern and north western elevations of 102 Southgate Street

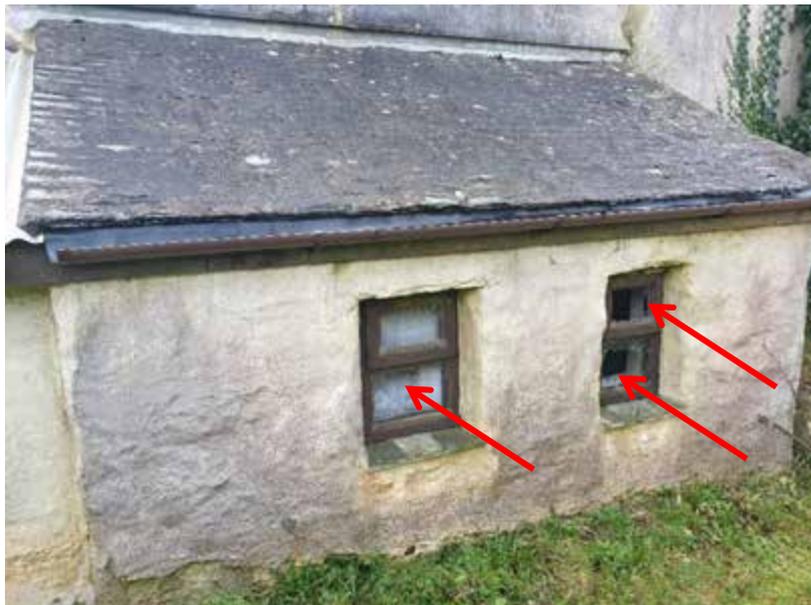
There is a single-storey lean-to with a mono-pitched roof part covered with corrugated metal and part with scantle slate on the north western elevation of the property (Figs. 3-4). At the rear of the property is a small, detached outbuilding to the north east with a pitched scantle slate roof (Figs. 5 & 7). It is partially built into an earth bank that forms part of the field surrounding the property. The outbuilding is constructed from stone which is rendered with cement externally and features a timber door and two windows, one of which is open and unglazed. There is ivy growth on the roof which may obscure potential bat roost features.

Figure 3: North western elevation of lean-to on 102 Southgate Street, showing broken windows (red arrows)

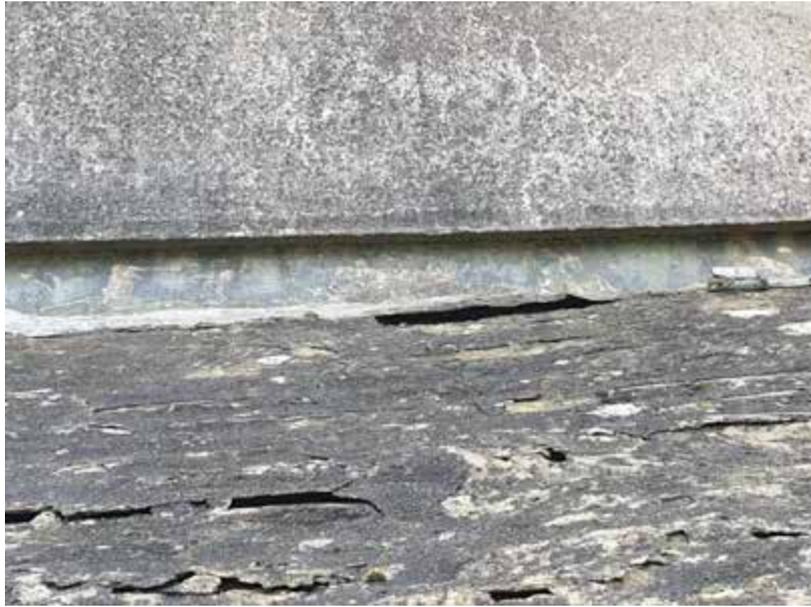
On the main building there are notable gaps behind the fascia boards, underneath lifted slates, under the ridge tiles and lead flashing, all of which provide potential roosting opportunities for crevice-dwelling bats and potential access into the building interior. There are also gaps underneath lifted slates on the outbuilding which provide potential for roosting bats. The unglazed window on this building and broken window on the lean-to provide potential access for bats into the interior of both buildings. The wall tops on the gable ends of the main building appear well-sealed with no notable gaps.

Figure 4: Gaps under lifted slates and lead flashing on lean-to at 102 Southgate Street (viewed towards the south east)

Works to 102 Southgate Street and its outbuilding must be informed with two bat emergence or re-entry surveys undertaken between May and September; one of which should be carried out between May and August. The survey information will be required to inform the planning application and subsequent works. These surveys will determine whether bats are present and, if so, the species, number of individuals, bat access points and timings of usage.

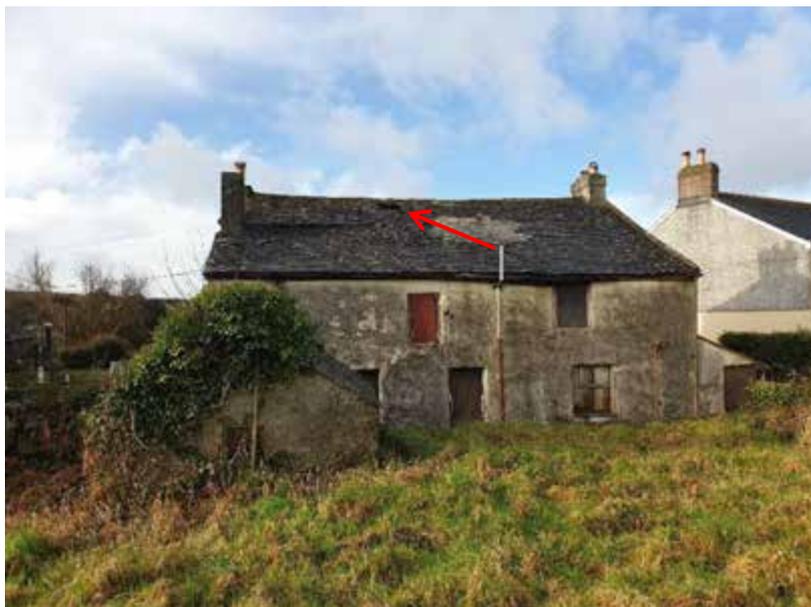
Figure 5: North eastern elevation of 102 Southgate Street and detached outbuilding, showing hole in the roof of the cottage (red arrow)

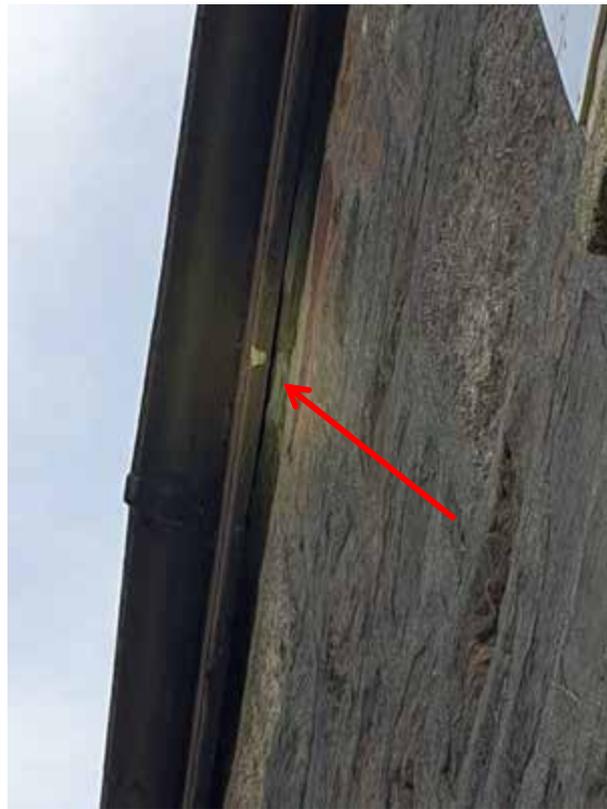
Figure 6: Gap behind fascia board on south western elevation of 102 Southgate Street (red arrow)

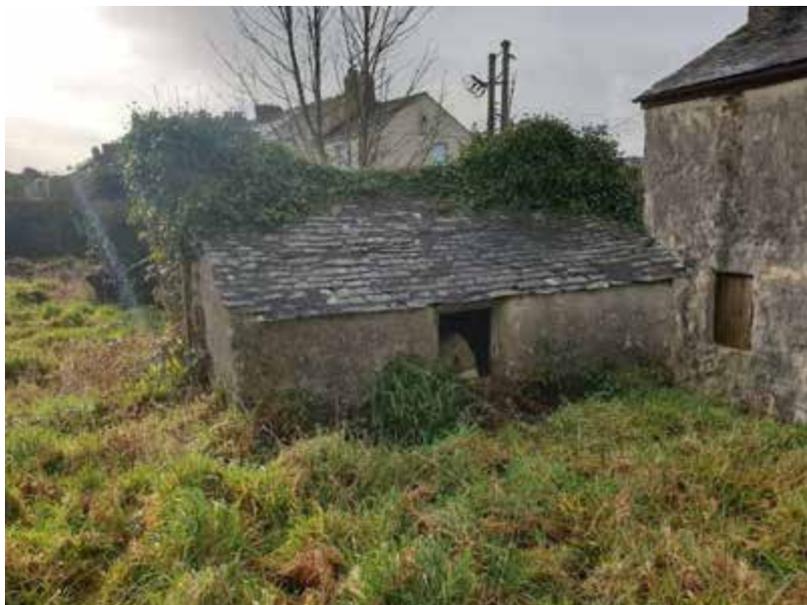
Figure 7: North western elevation of detached outbuilding at 102 Southgate Street

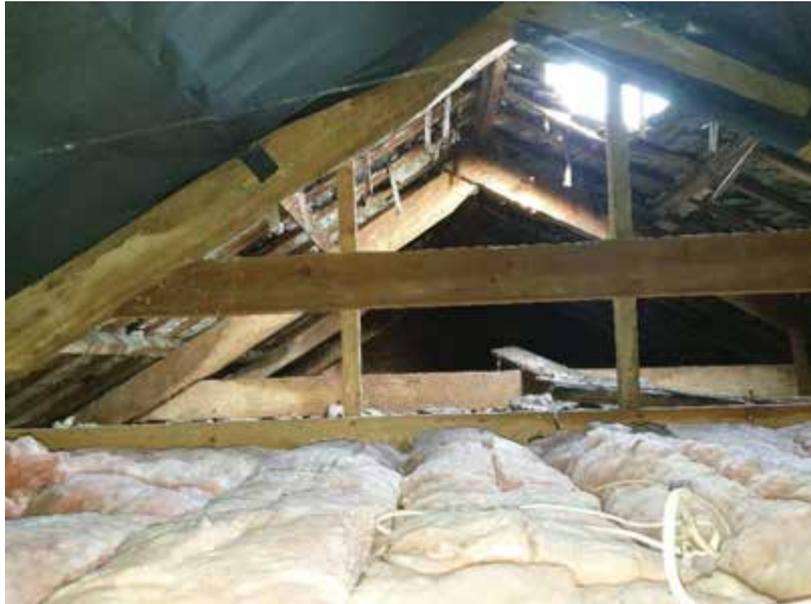
Internally there is a single roof void over the main building, which is light and very draughty due to the presence of the large hole in the roof. The floor is covered with mineral fibre loft insulation, the roof is partly lined with a plastic roof membrane and partly unlined and there are crossing timbers present (Fig. 8). The internal rooms of the cottage are disused and have fallen into disrepair and are open to one another. On the first floor at the rear the rooms are built into the underside of the lean-to projection, the underside of which is boarded. Most of these rooms are

Figure 8: Interior of roof void at 102 Southgate Street, showing hole in the roof (viewed towards the north west)

No evidence of the use of the buildings by nesting birds was found. A dead house sparrow (*Passer domesticus*) was noted within the roof void over the main building close to the hole in the roof, which indicates that birds may use the building for nesting. In addition, the ivy growth on the outbuilding provides potential nesting habitat for birds.

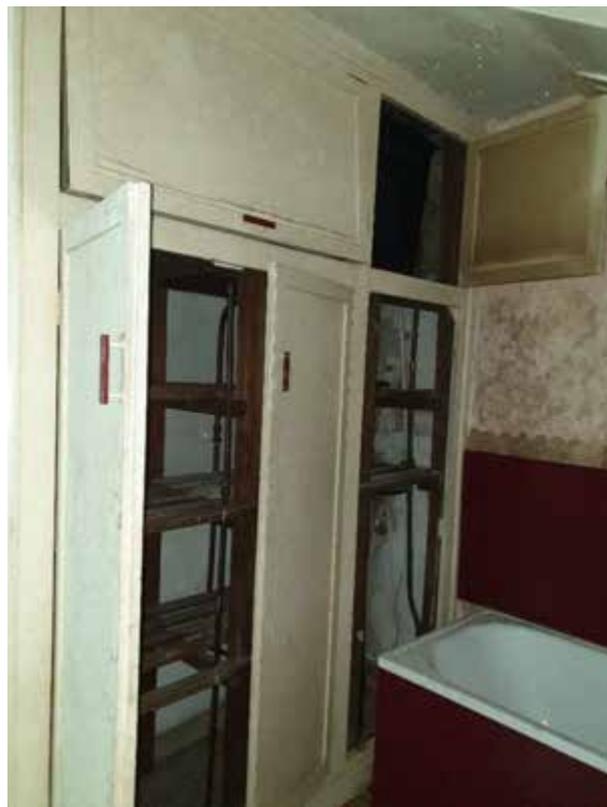
light and open with negligible potential for roosting bats, although there are a number of features such as cupboards within the bathroom and under the stairs which are dark and partially enclosed, providing potential opportunities for roosting bats (Fig. 9). There appears to be a narrow roof void underneath the slate roof of the lean-to, although this could not be accessed.

Figure 9: Bathroom cupboards on first floor of 102 Southgate Street (viewed towards the south)

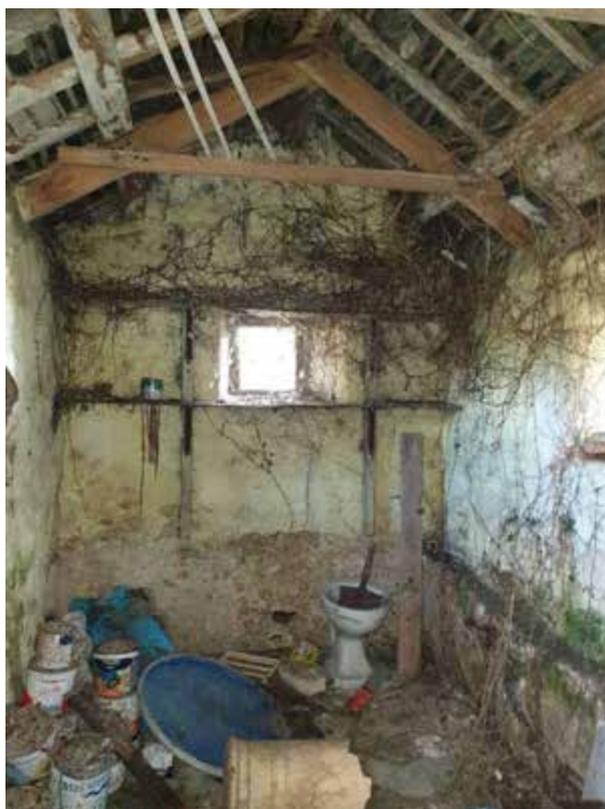
The interior of the outbuilding is light and draughty and is open from the concrete floor to the underside of the roof, which is unlined. The interior stone walls have been whitewashed and there is ivy growth coming through the roof and down the walls. The wall tops appear well-sealed and enclosed (Fig. 10). The light, draughty nature of the outbuilding is likely to have reduced the overall likelihood of bats day roosting within the interior, although it has potential to be used for night roosting by bats.

Figure 10: Interior of detached outbuilding at 102 Southgate Street (viewed towards the east)

Works to the buildings, including removal of the ivy, should be undertaken between October and February, when birds will not be nesting (provided these timings do not conflict with subsequent bat mitigation requirements, to be confirmed following the further bat surveys), or, alternatively, preceded with a thorough search for nesting birds (to be undertaken by a suitably experienced ecologist). If, during construction works, an active bird nest is uncovered, works within at least 5m of the nest must stop immediately (as soon as it is safe to do so) and delayed until nesting activity has ceased. Works are most likely to be delayed between April and July.
