# HERITAGE, DESIGN AND ACCESS STATEMENT FOR PROPOSED WORK ON 1 BRIDEWELL STREET CLARE

This heritage, design and access statement has been prepared in support of an application for permission to refurbish the south and east exterior of the building. The property is a Grade II listed building that lies towards the northern end of the Clare Conservation Area.

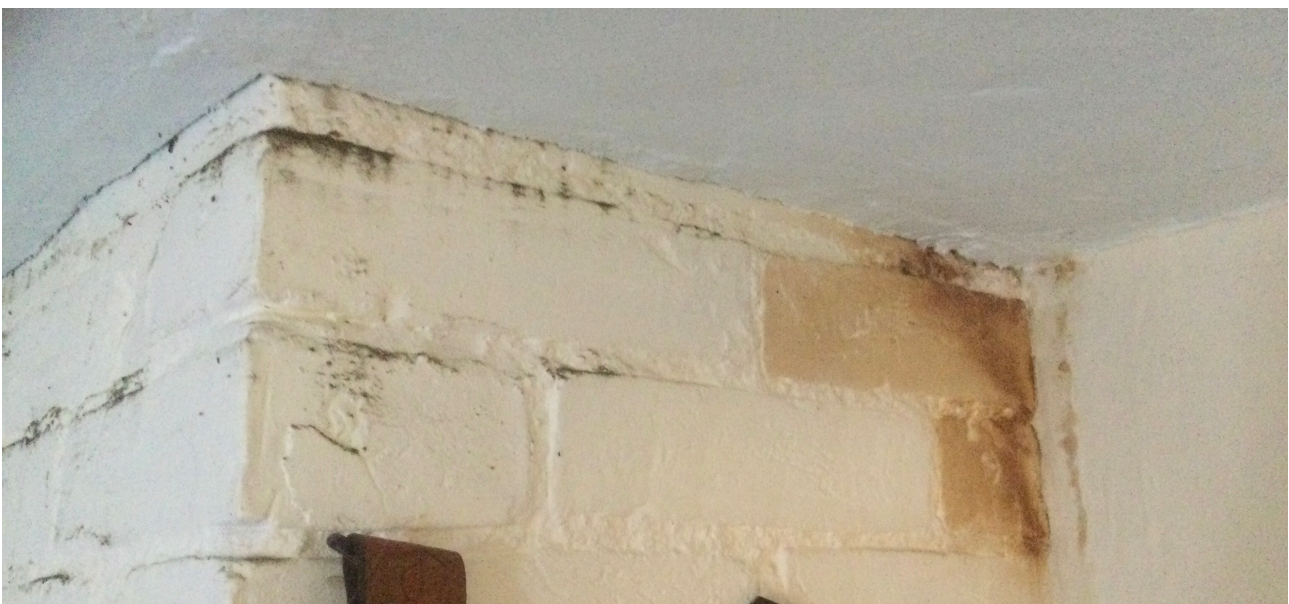
The aim of the proposed work is to maintain the property. It is currently not watertight to south westerly rain which has saturated the south wall, leaking into the chimney space.

Further inspection will probably reveal the whole of the external render is impervious cement render, probably late 20th century. This is now mechanically incompetent.

The proposal is to remove the current incompetent render and replace with approved lime render by Mr Dee Maunders, who has recently re-rendered No 48 Bridewell Street, the house immediately opposite.
