Appendix 06
Coal Authority Report
(February 2017, Ref: 51001370839001)

CON29M Non-Residential Mining Report

SITE AT ALLOA
CLACKMANNANSHIRE

**Records of Exploratory Trial Pit Logs
(Mason Evans Partnership Ltd, August 2017)**

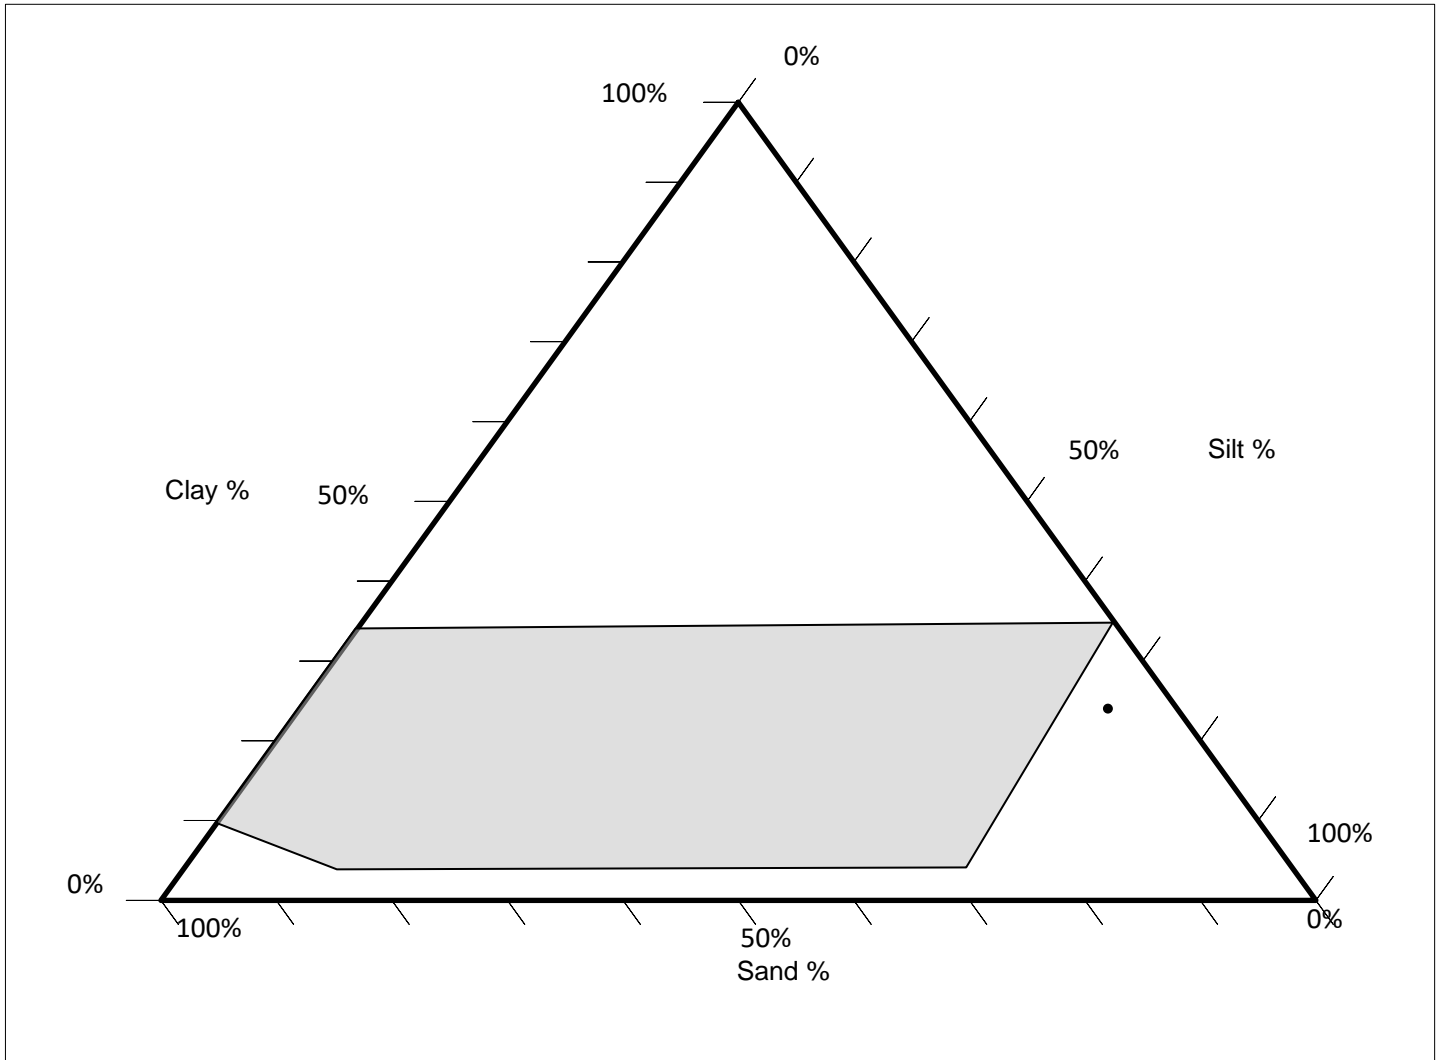
Figure 1

Results: Proportion in class (%)			Help messages
Clay	Silt	Sand	must sum to 100
24	70	5

The textural class is required to be in the shaded area to be compliant with BS3882:2015

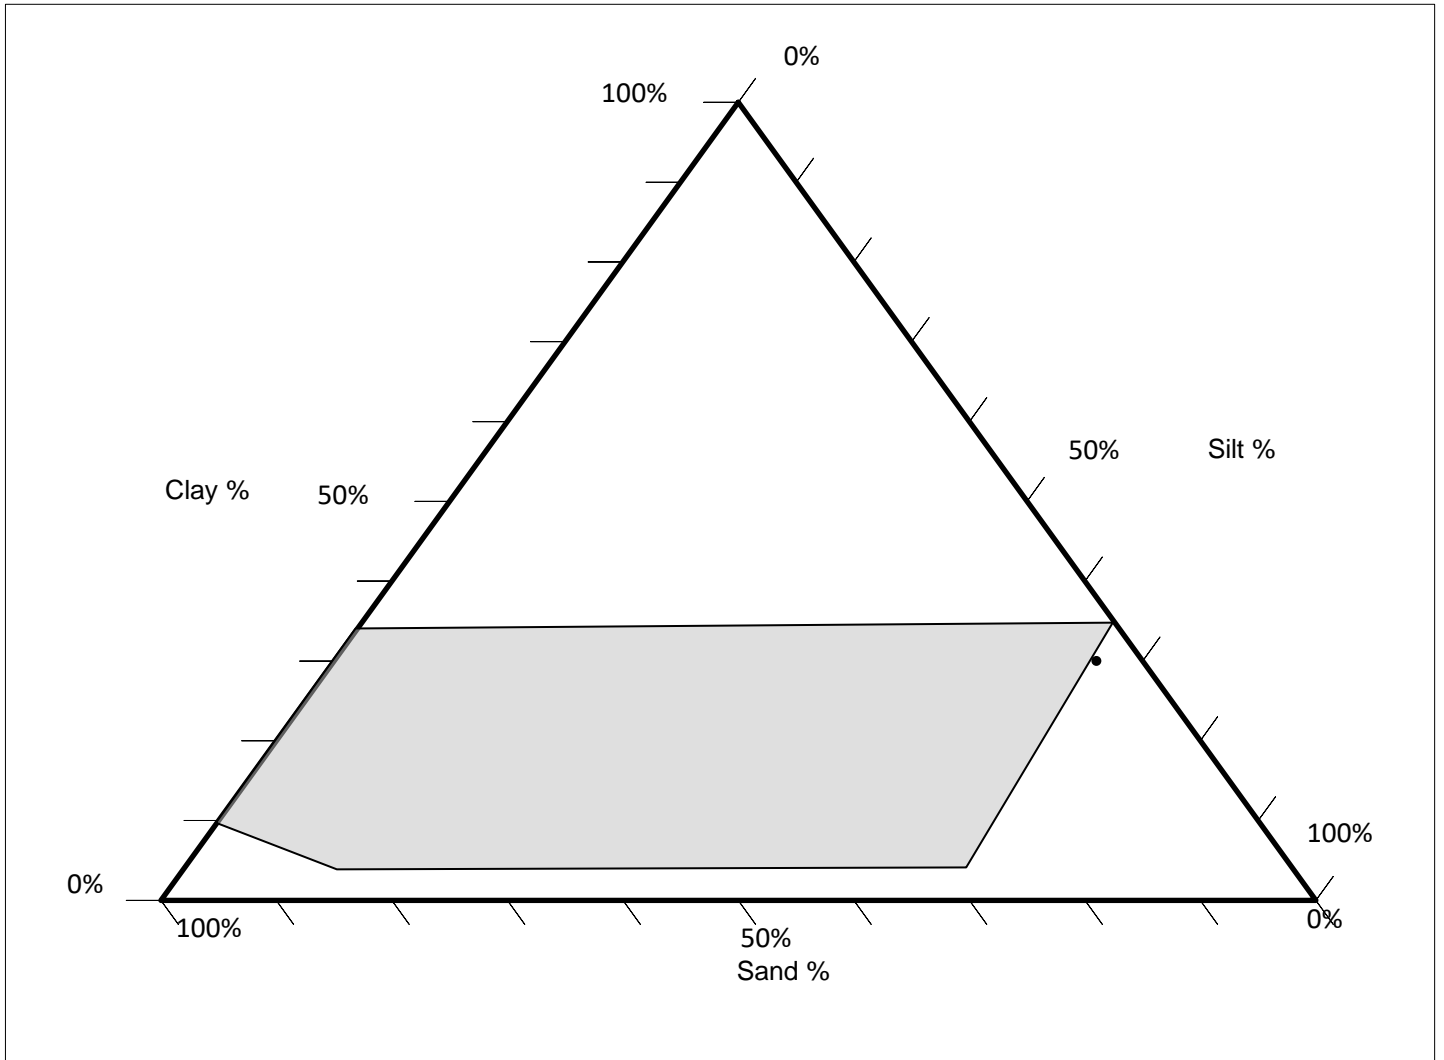
Figure 1

Results: Proportion in class (%)			Help messages
Clay	Silt	Sand	
30	66	4

The textural class is required to be in the shaded area to be compliant with BS3882:2015

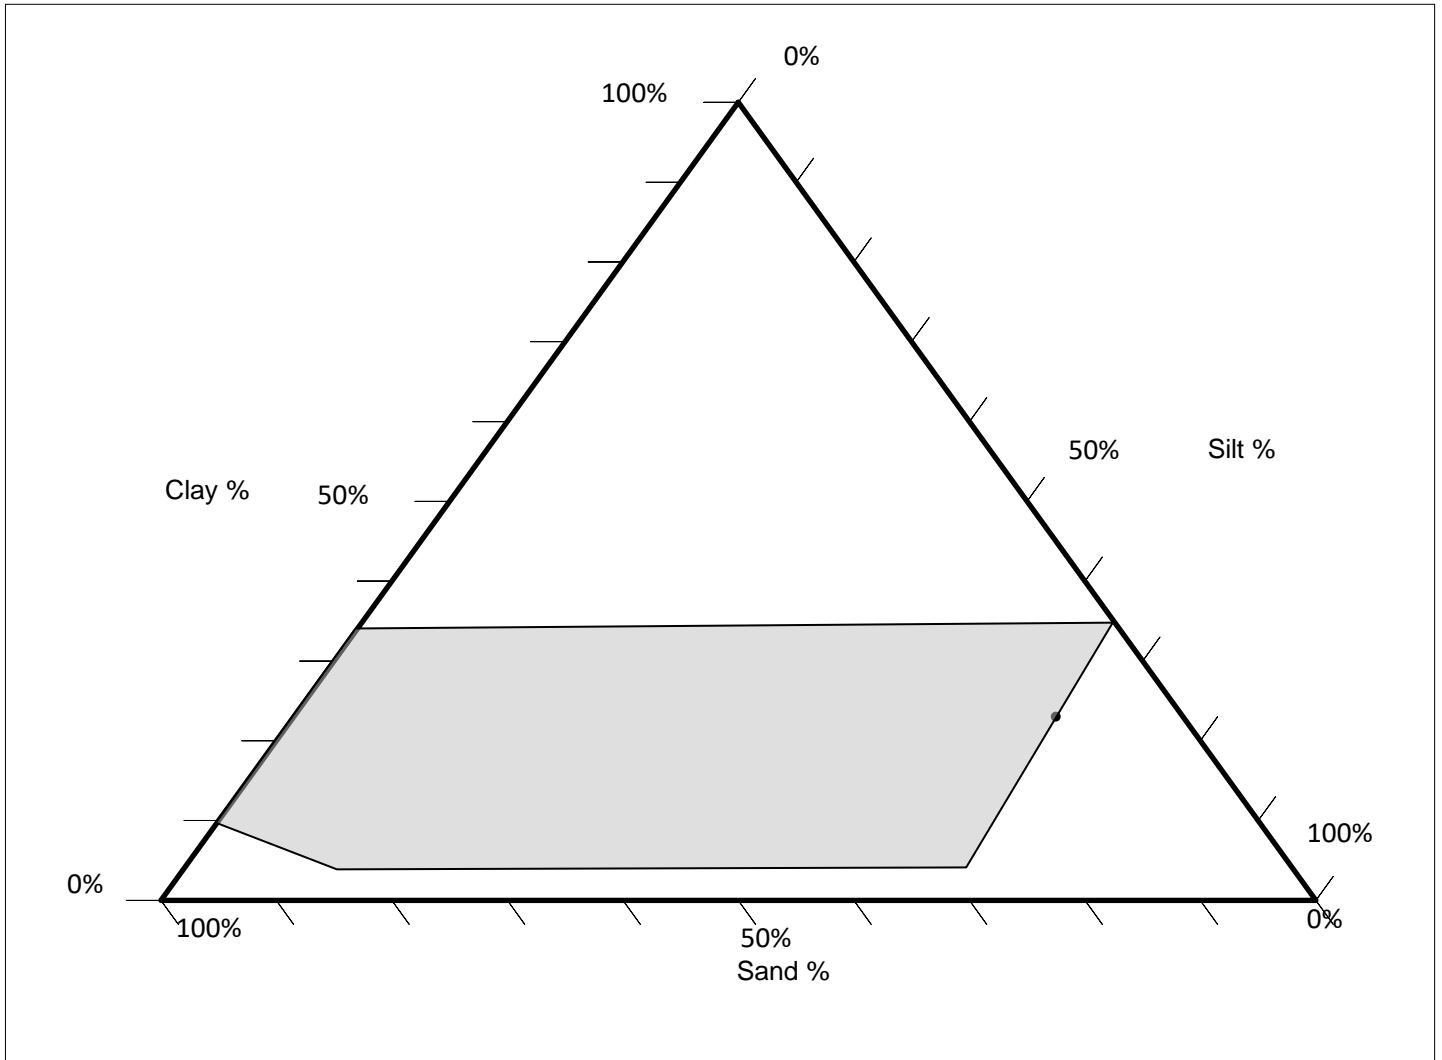
Figure 1

Results: Proportion in class (%)			Help messages
Clay	Silt	Sand	must sum to 100
23	66	10

The textural class is required to be in the shaded area to be compliant with BS3882:2015
