**BAT AND BARN OWL SURVEY OF PROPERTIES ASSOCIATED WITH
MAWGAN PORTH BEACH FRONT REGENERATION,
MAWGAN PORTH, NEWQUAY, CORNWALL, TR8 4BA**

January 2021

**Bat and Barn Owl Survey of properties associated with the Mawgan Porth Beachfront Regeneration Project,
Mawgan Porth Cornwall, TR8 4BA,
January 2021**

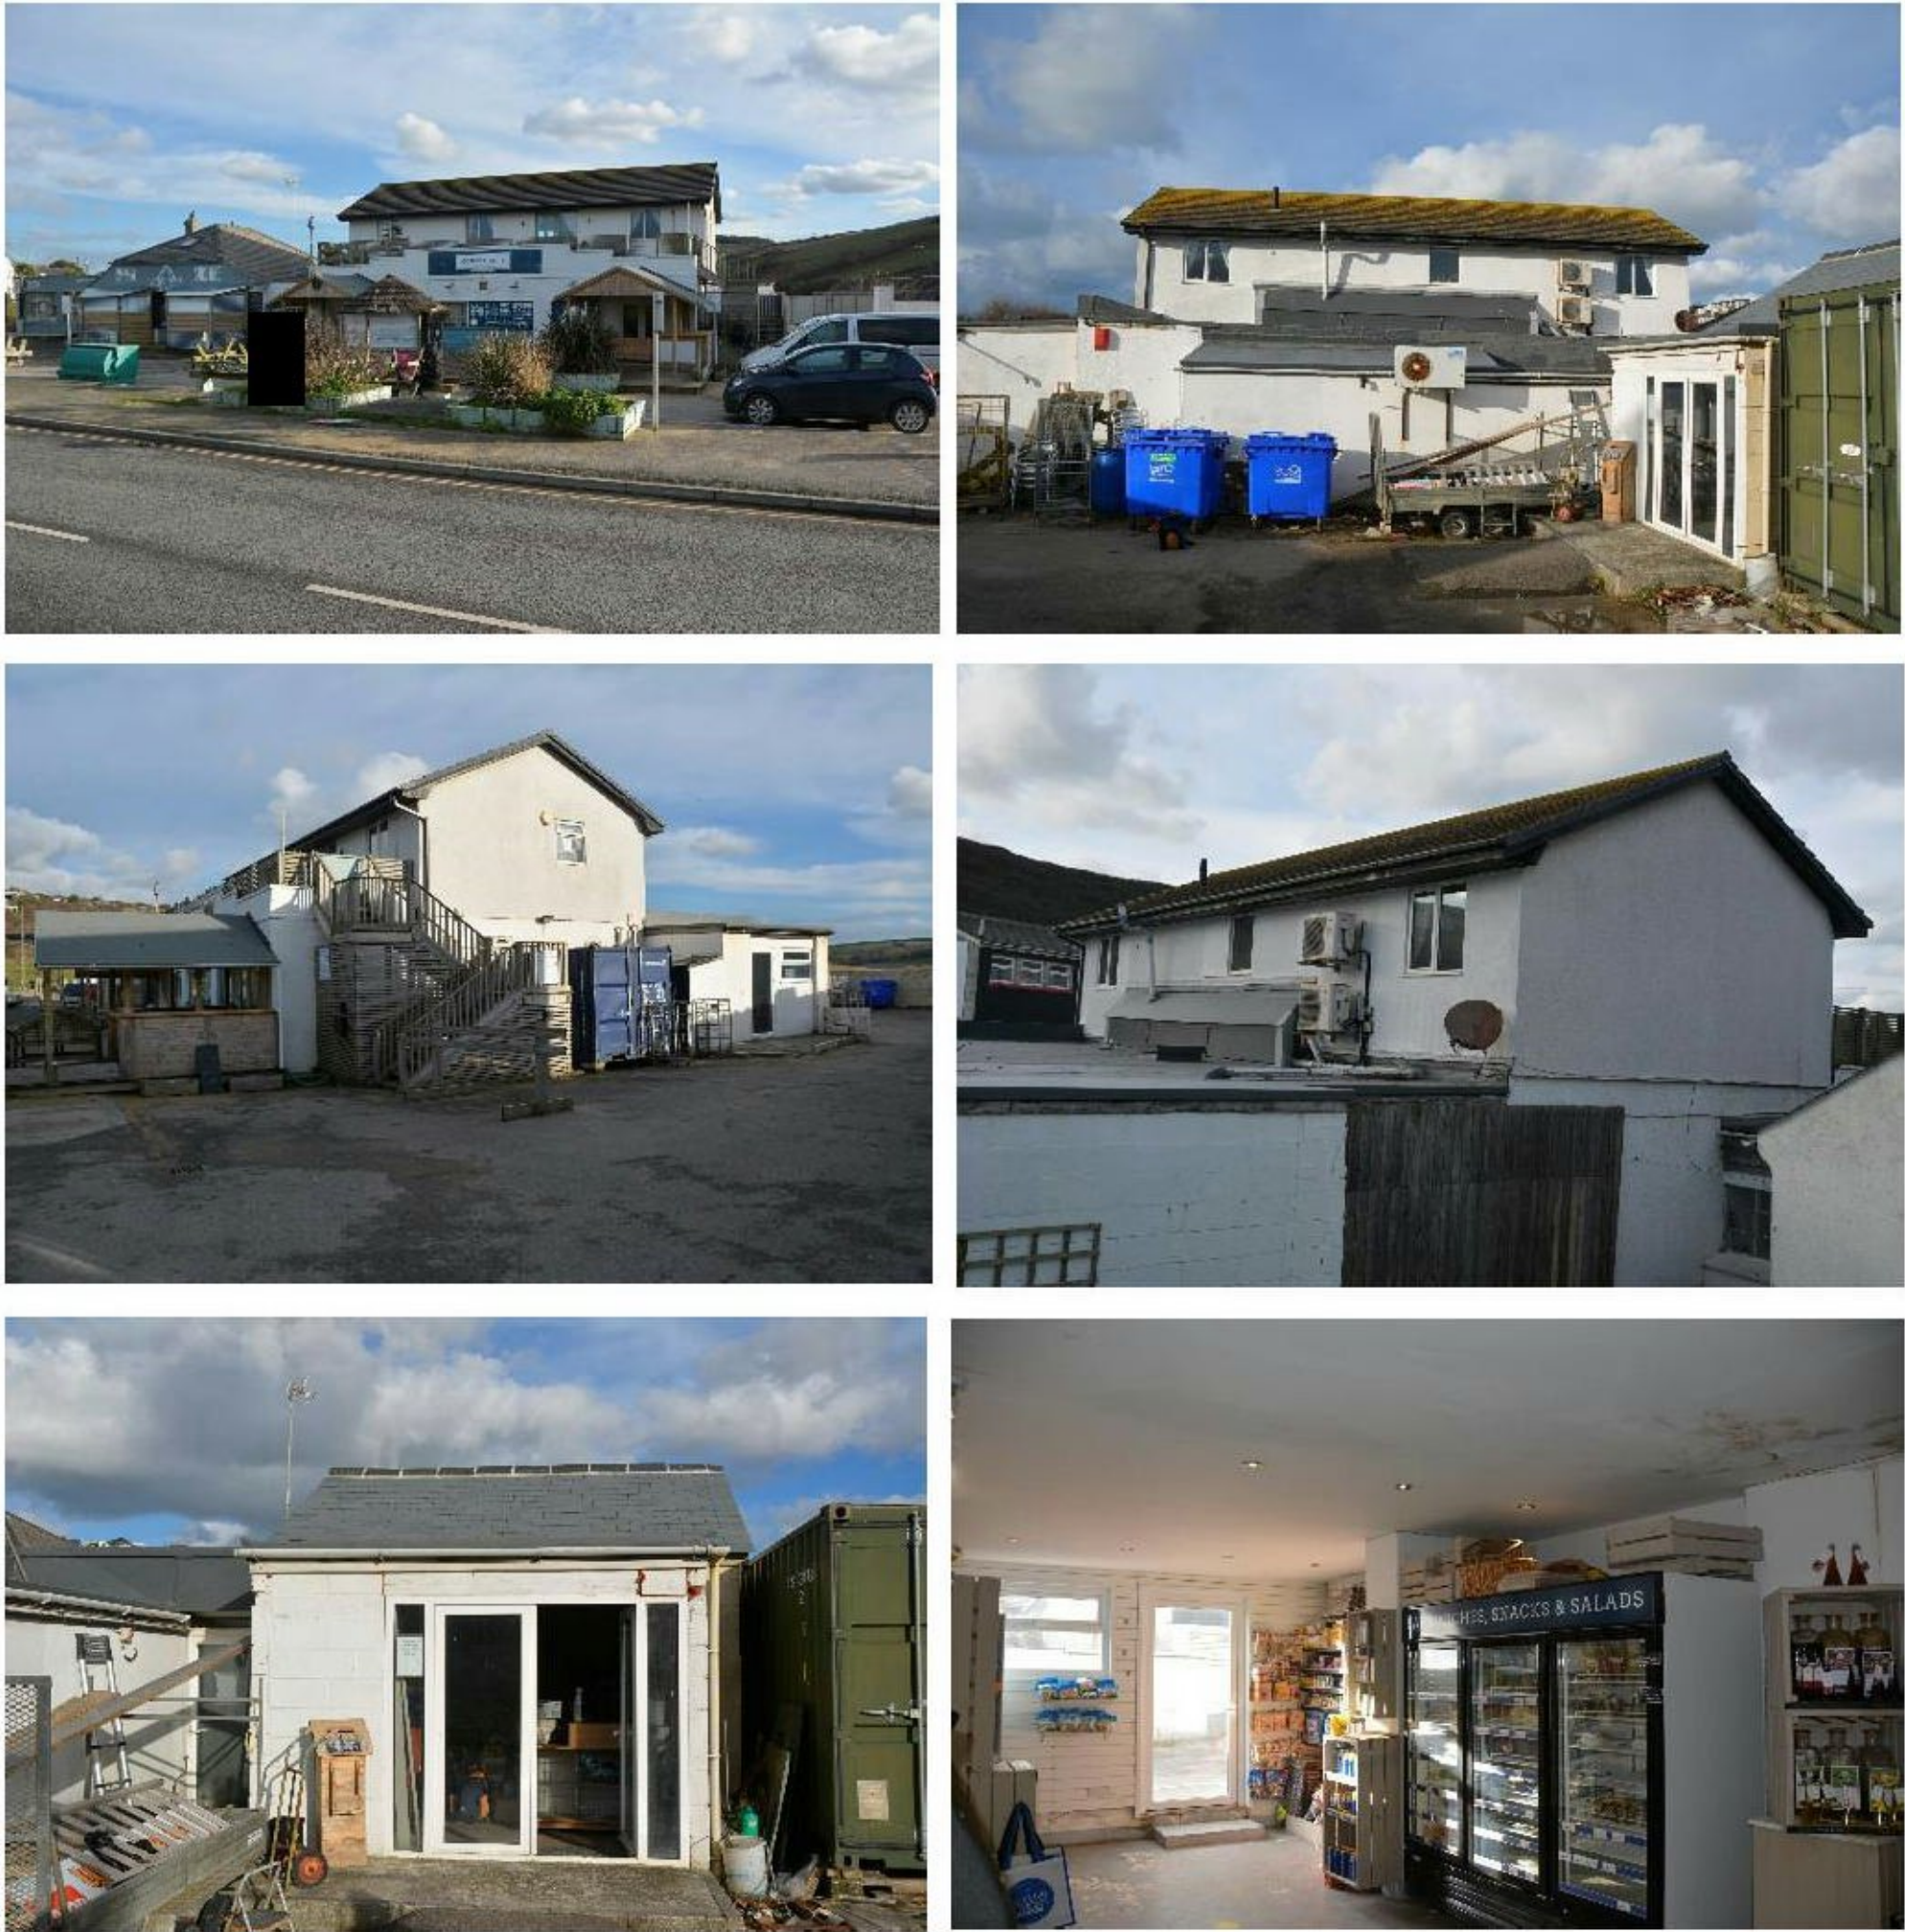
Figure 4: External elevations of Cornish Fresh

Top: Front and rear elevations of Cornish Fresh. Note the multiple extensions and flat roofs at the rear of the central building of which the upper floor is accommodation.

Middle: The southern gable end provides access to the flat via a wooden staircase note the wooden soffit board. The right hand image is taken from the garden of the Surf Shop.

Bottom: Image of the shed at the rear of the property with a slate roof and ceramic ridge. The right image shows the shop interior looking south through the porch extension.

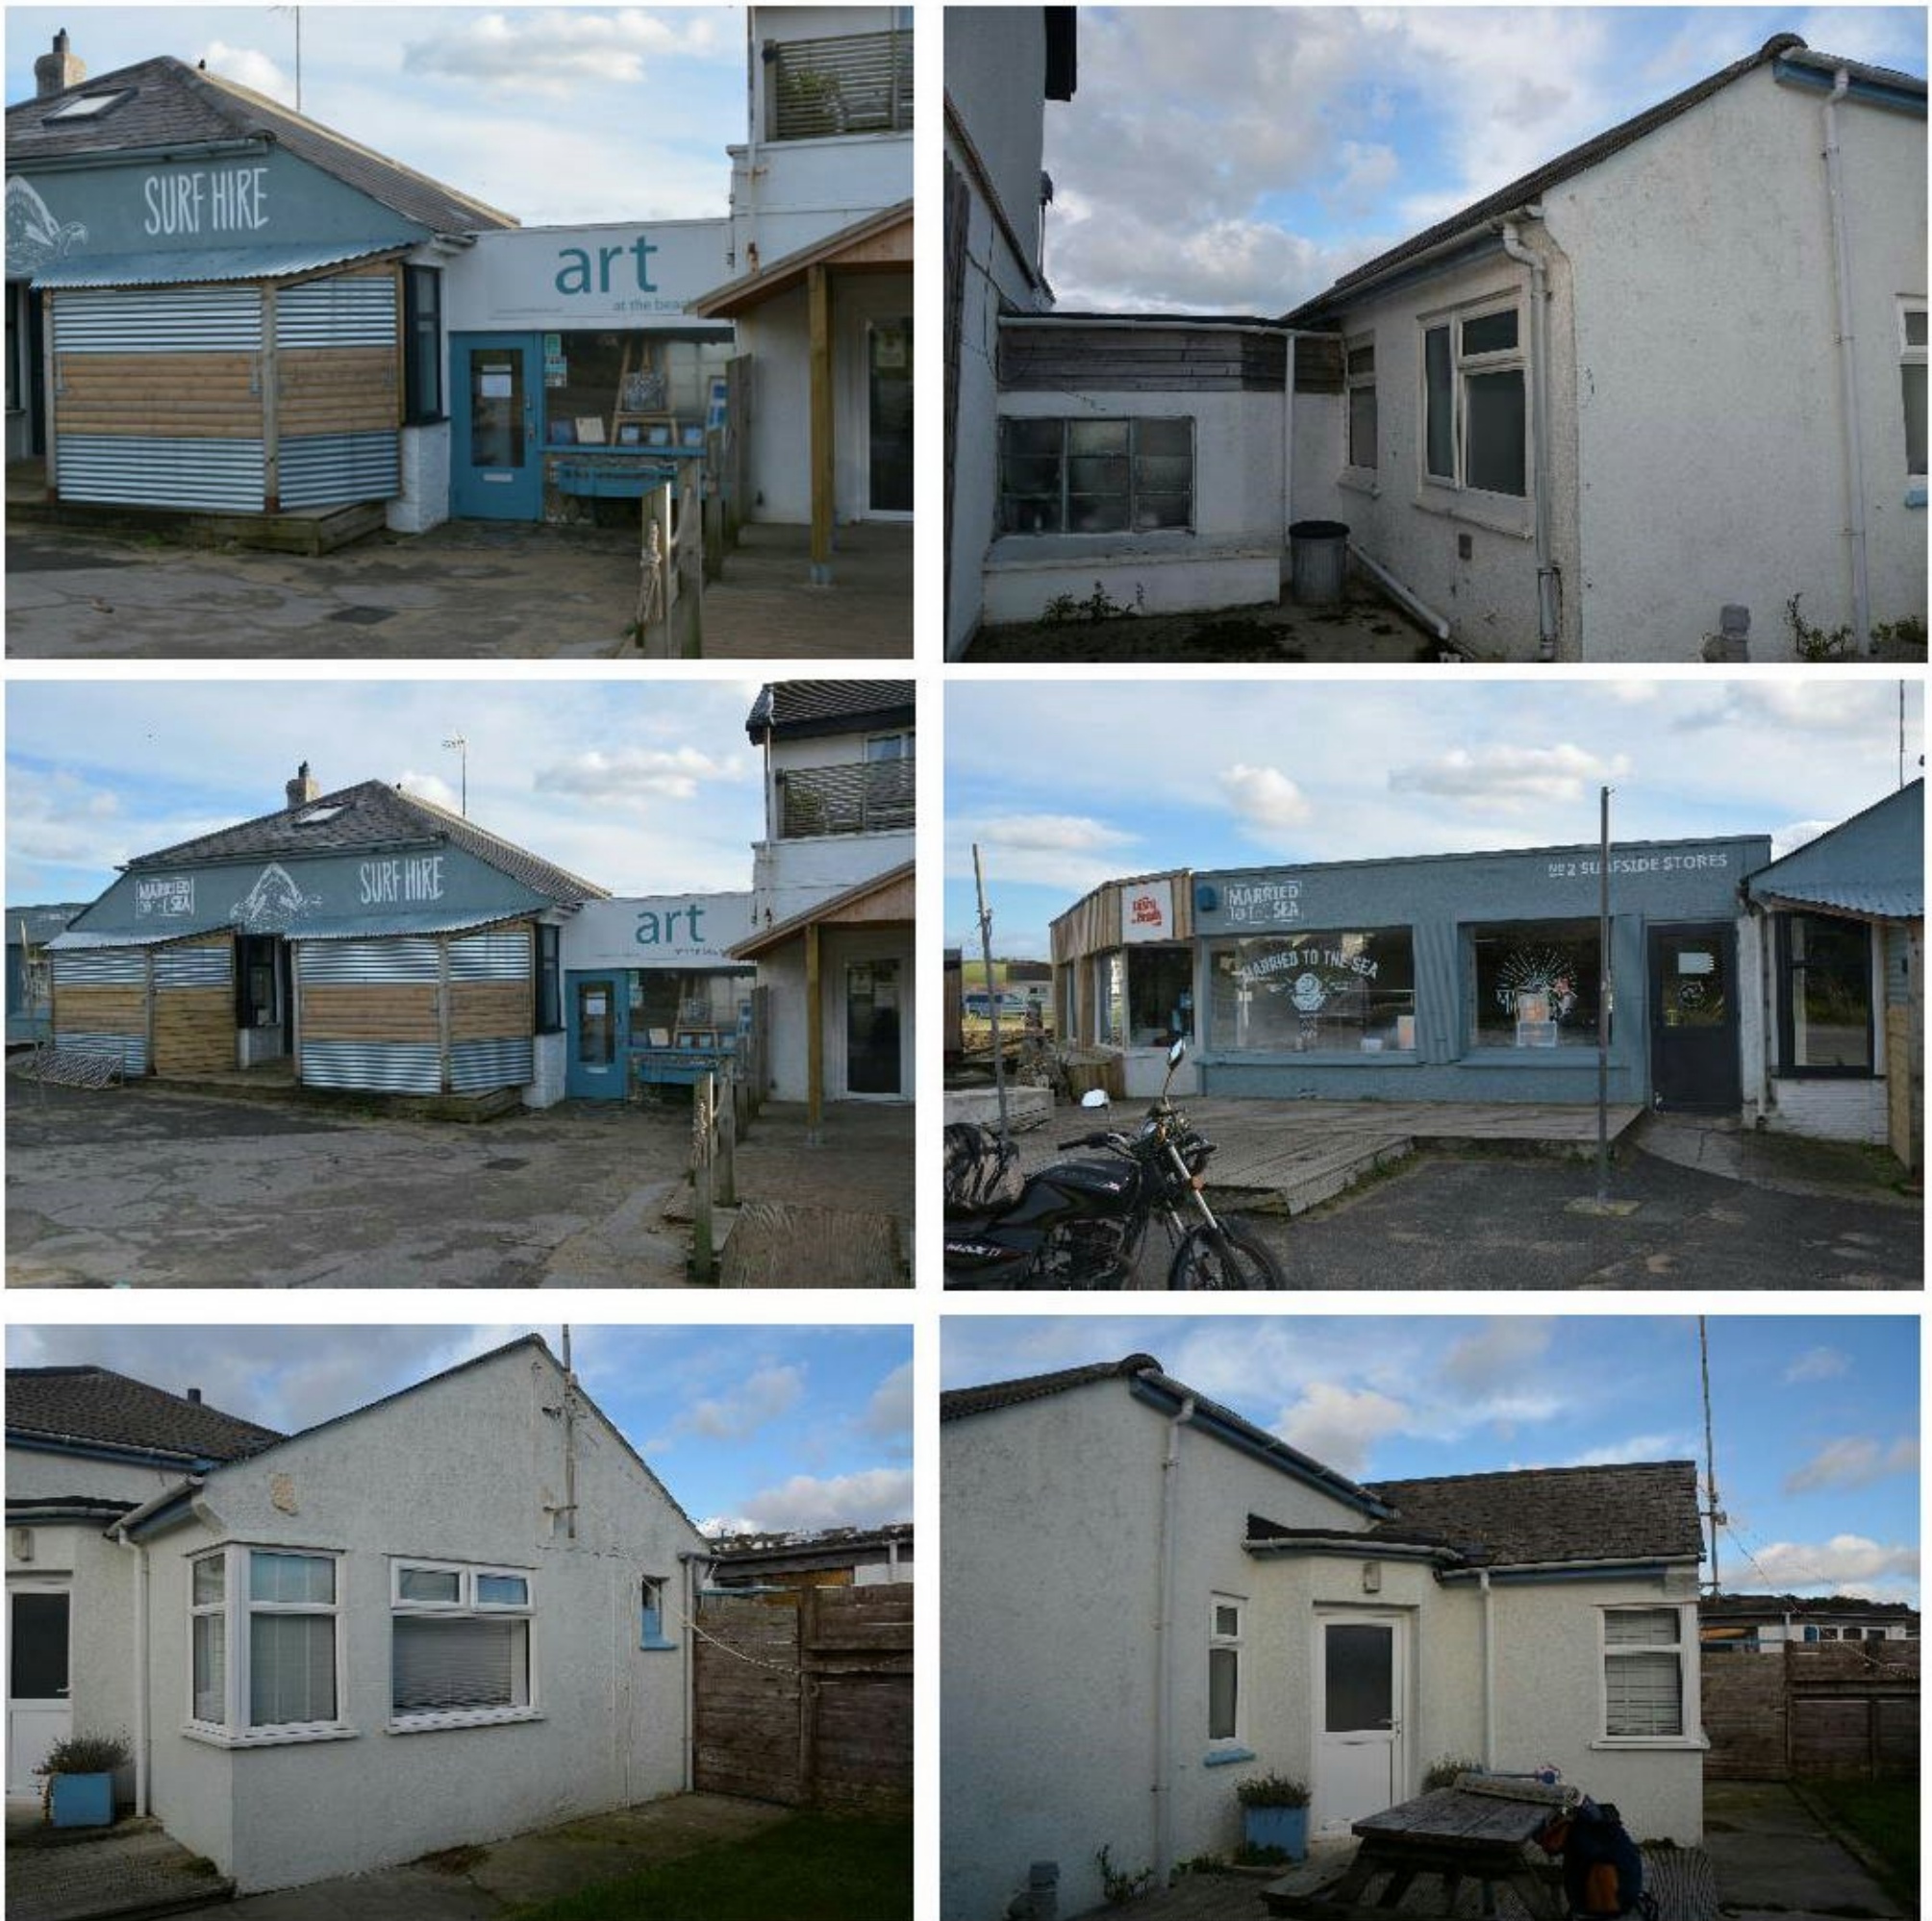
Figure 5: External elevations of Art at the Beach and Married to the Beach (Inc. Surf Shop)

Top: Front and rear elevations of Art at the Beach. Note the flat which borders the northern side of the shop and extends eastwards into a small enclosed garden.

Middle: The Surf Shop with its slate roof and the single storey flat roof extension to the north which also forms part of the retail area.

Bottom: Images of the flat showing the flat roof porch entrance and the hipped roof of the Surf Shop behind. A lower pitched slate roof extends into the garden which is bordered on its eastern boundary by the Surf School. The flat shares part of its space with Disco Beads which uses toilet and storage facilities facing their own business unit across a narrow private yard.

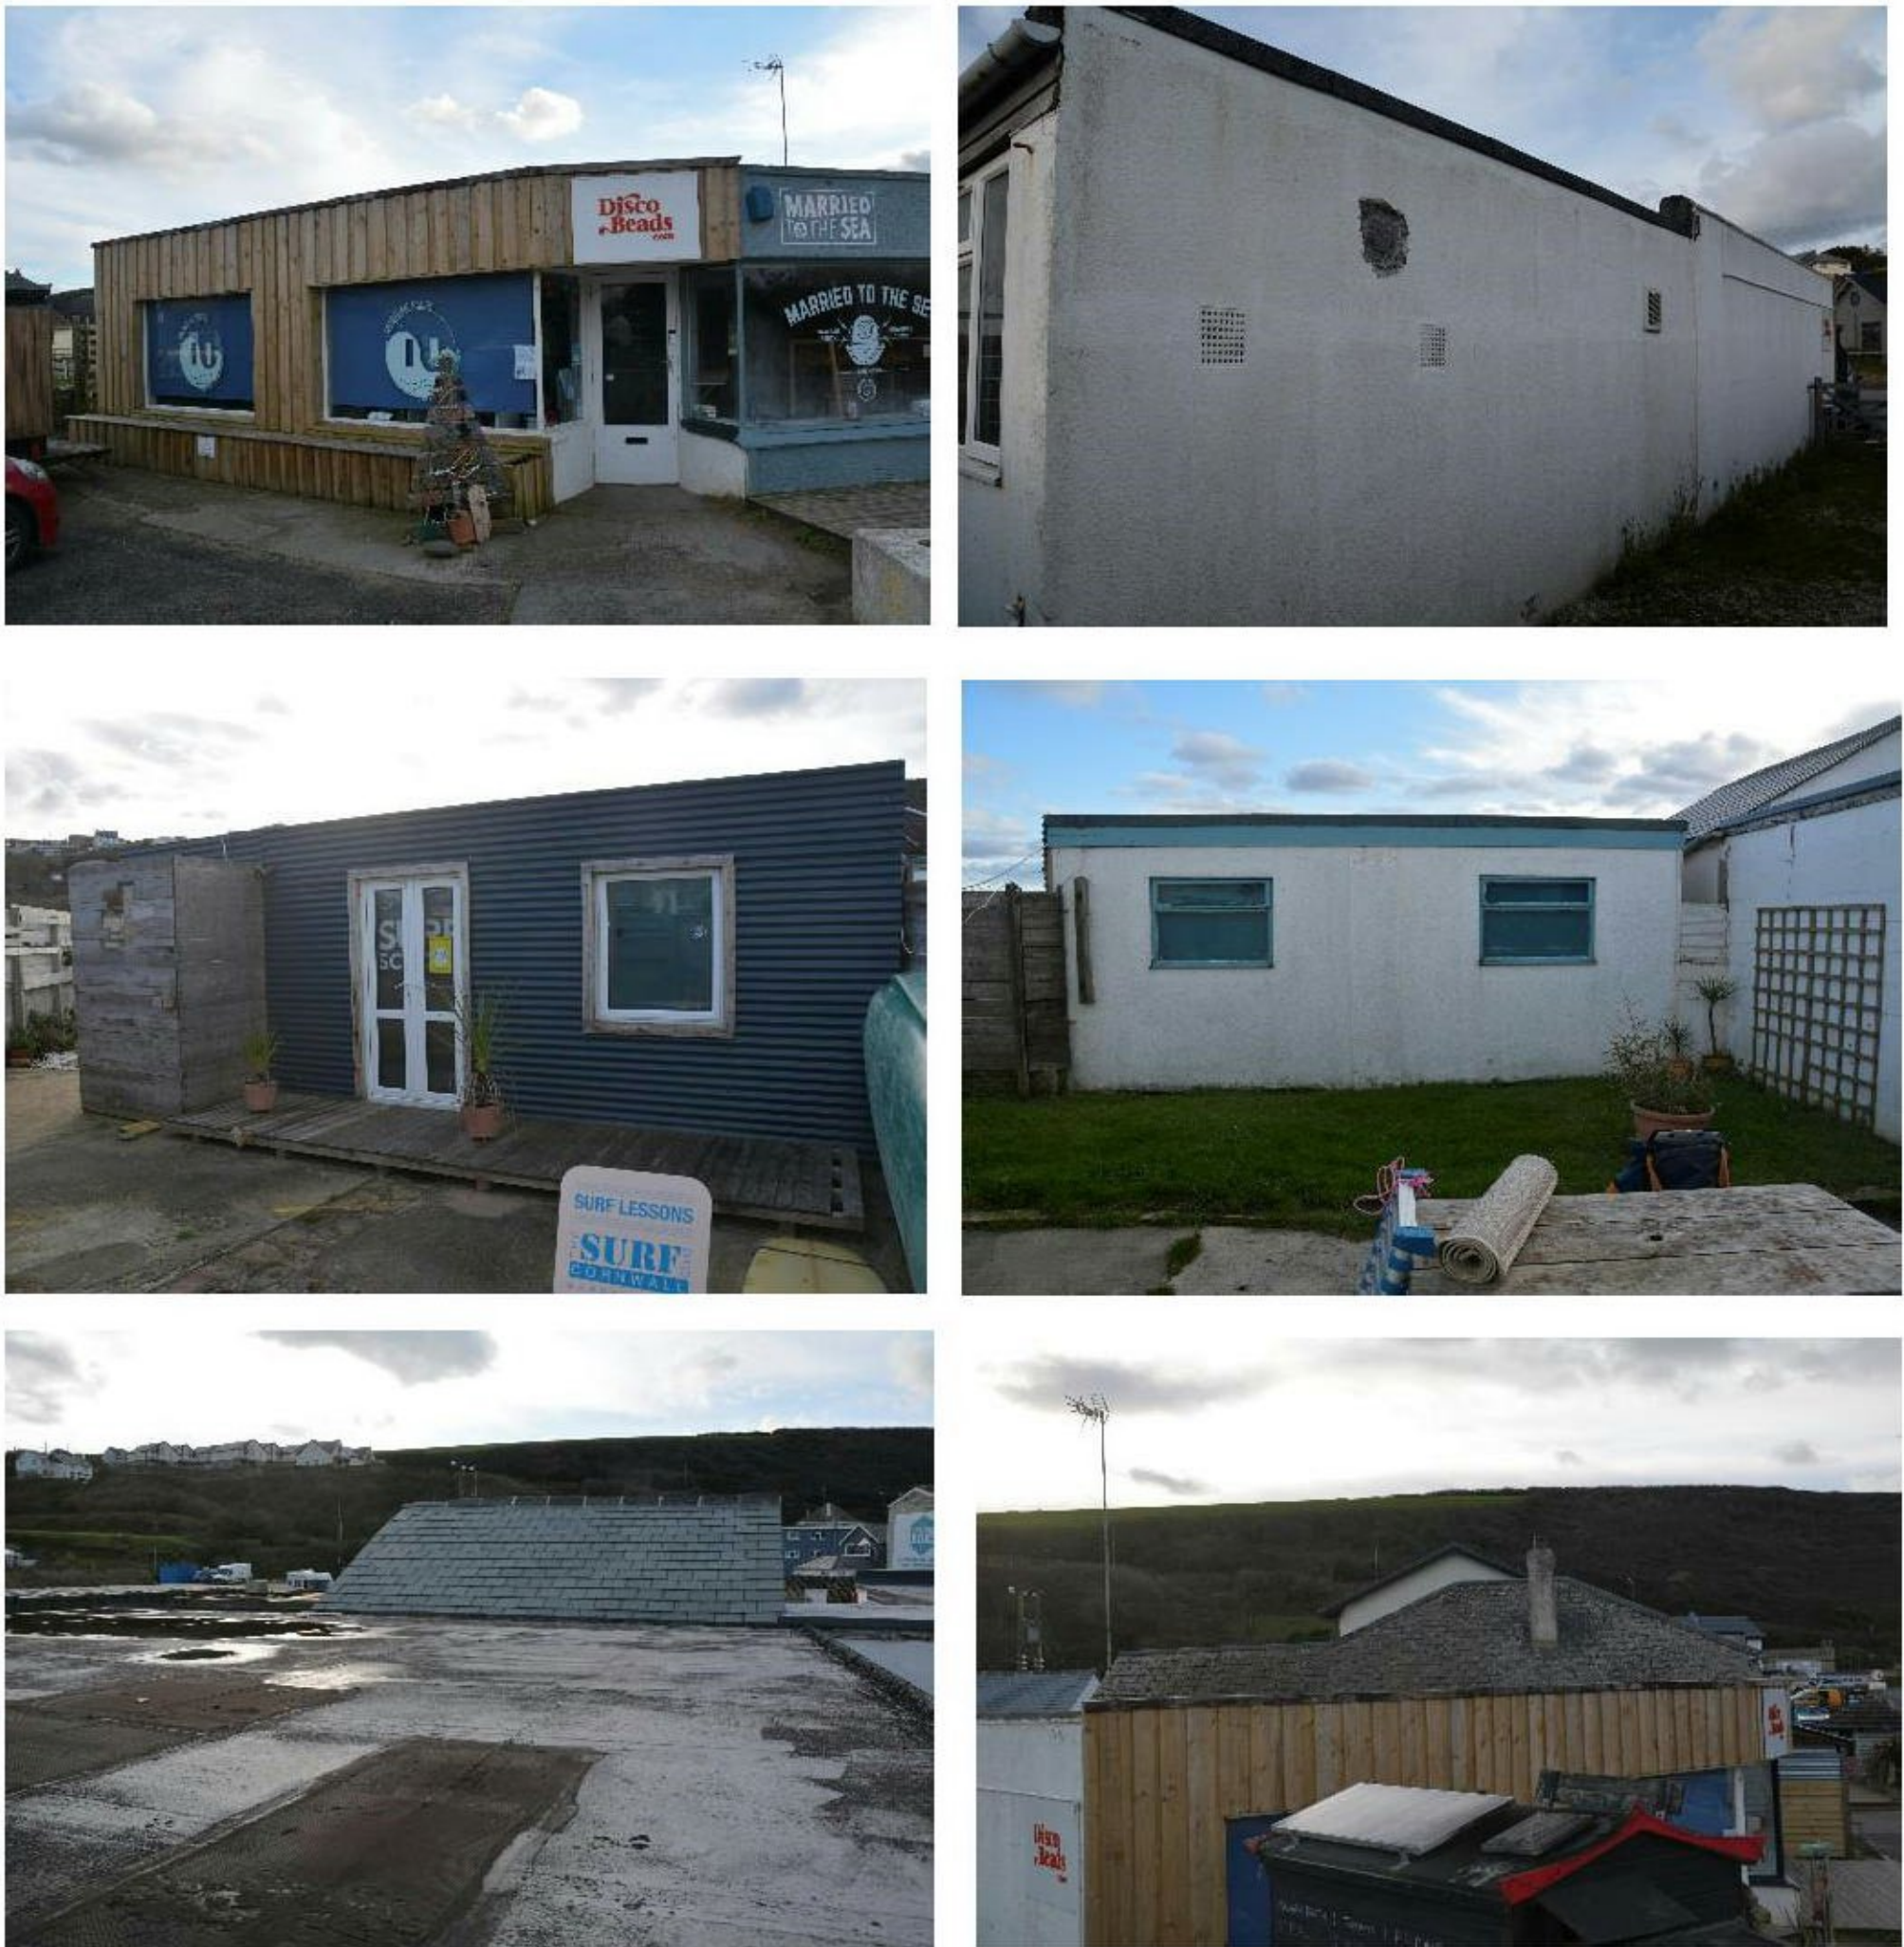
Figure 6: External elevations of Disco Beads and the Surf School

Top: Front and north elevations of Disco Beads. Note the use of timber cladding on the front elevation

Middle: The Surf School front elevation with tin cladding and western wall which borders the flat's garden.

Bottom: Image of the flat roof of the Surf School looking south towards the Cornish Fresh yard with the shed in the middle distance. Lower right image shows a view looking south over the Disco Beads unit with the northern roof slope of the Surf School showing the lower extension which covers the flat.

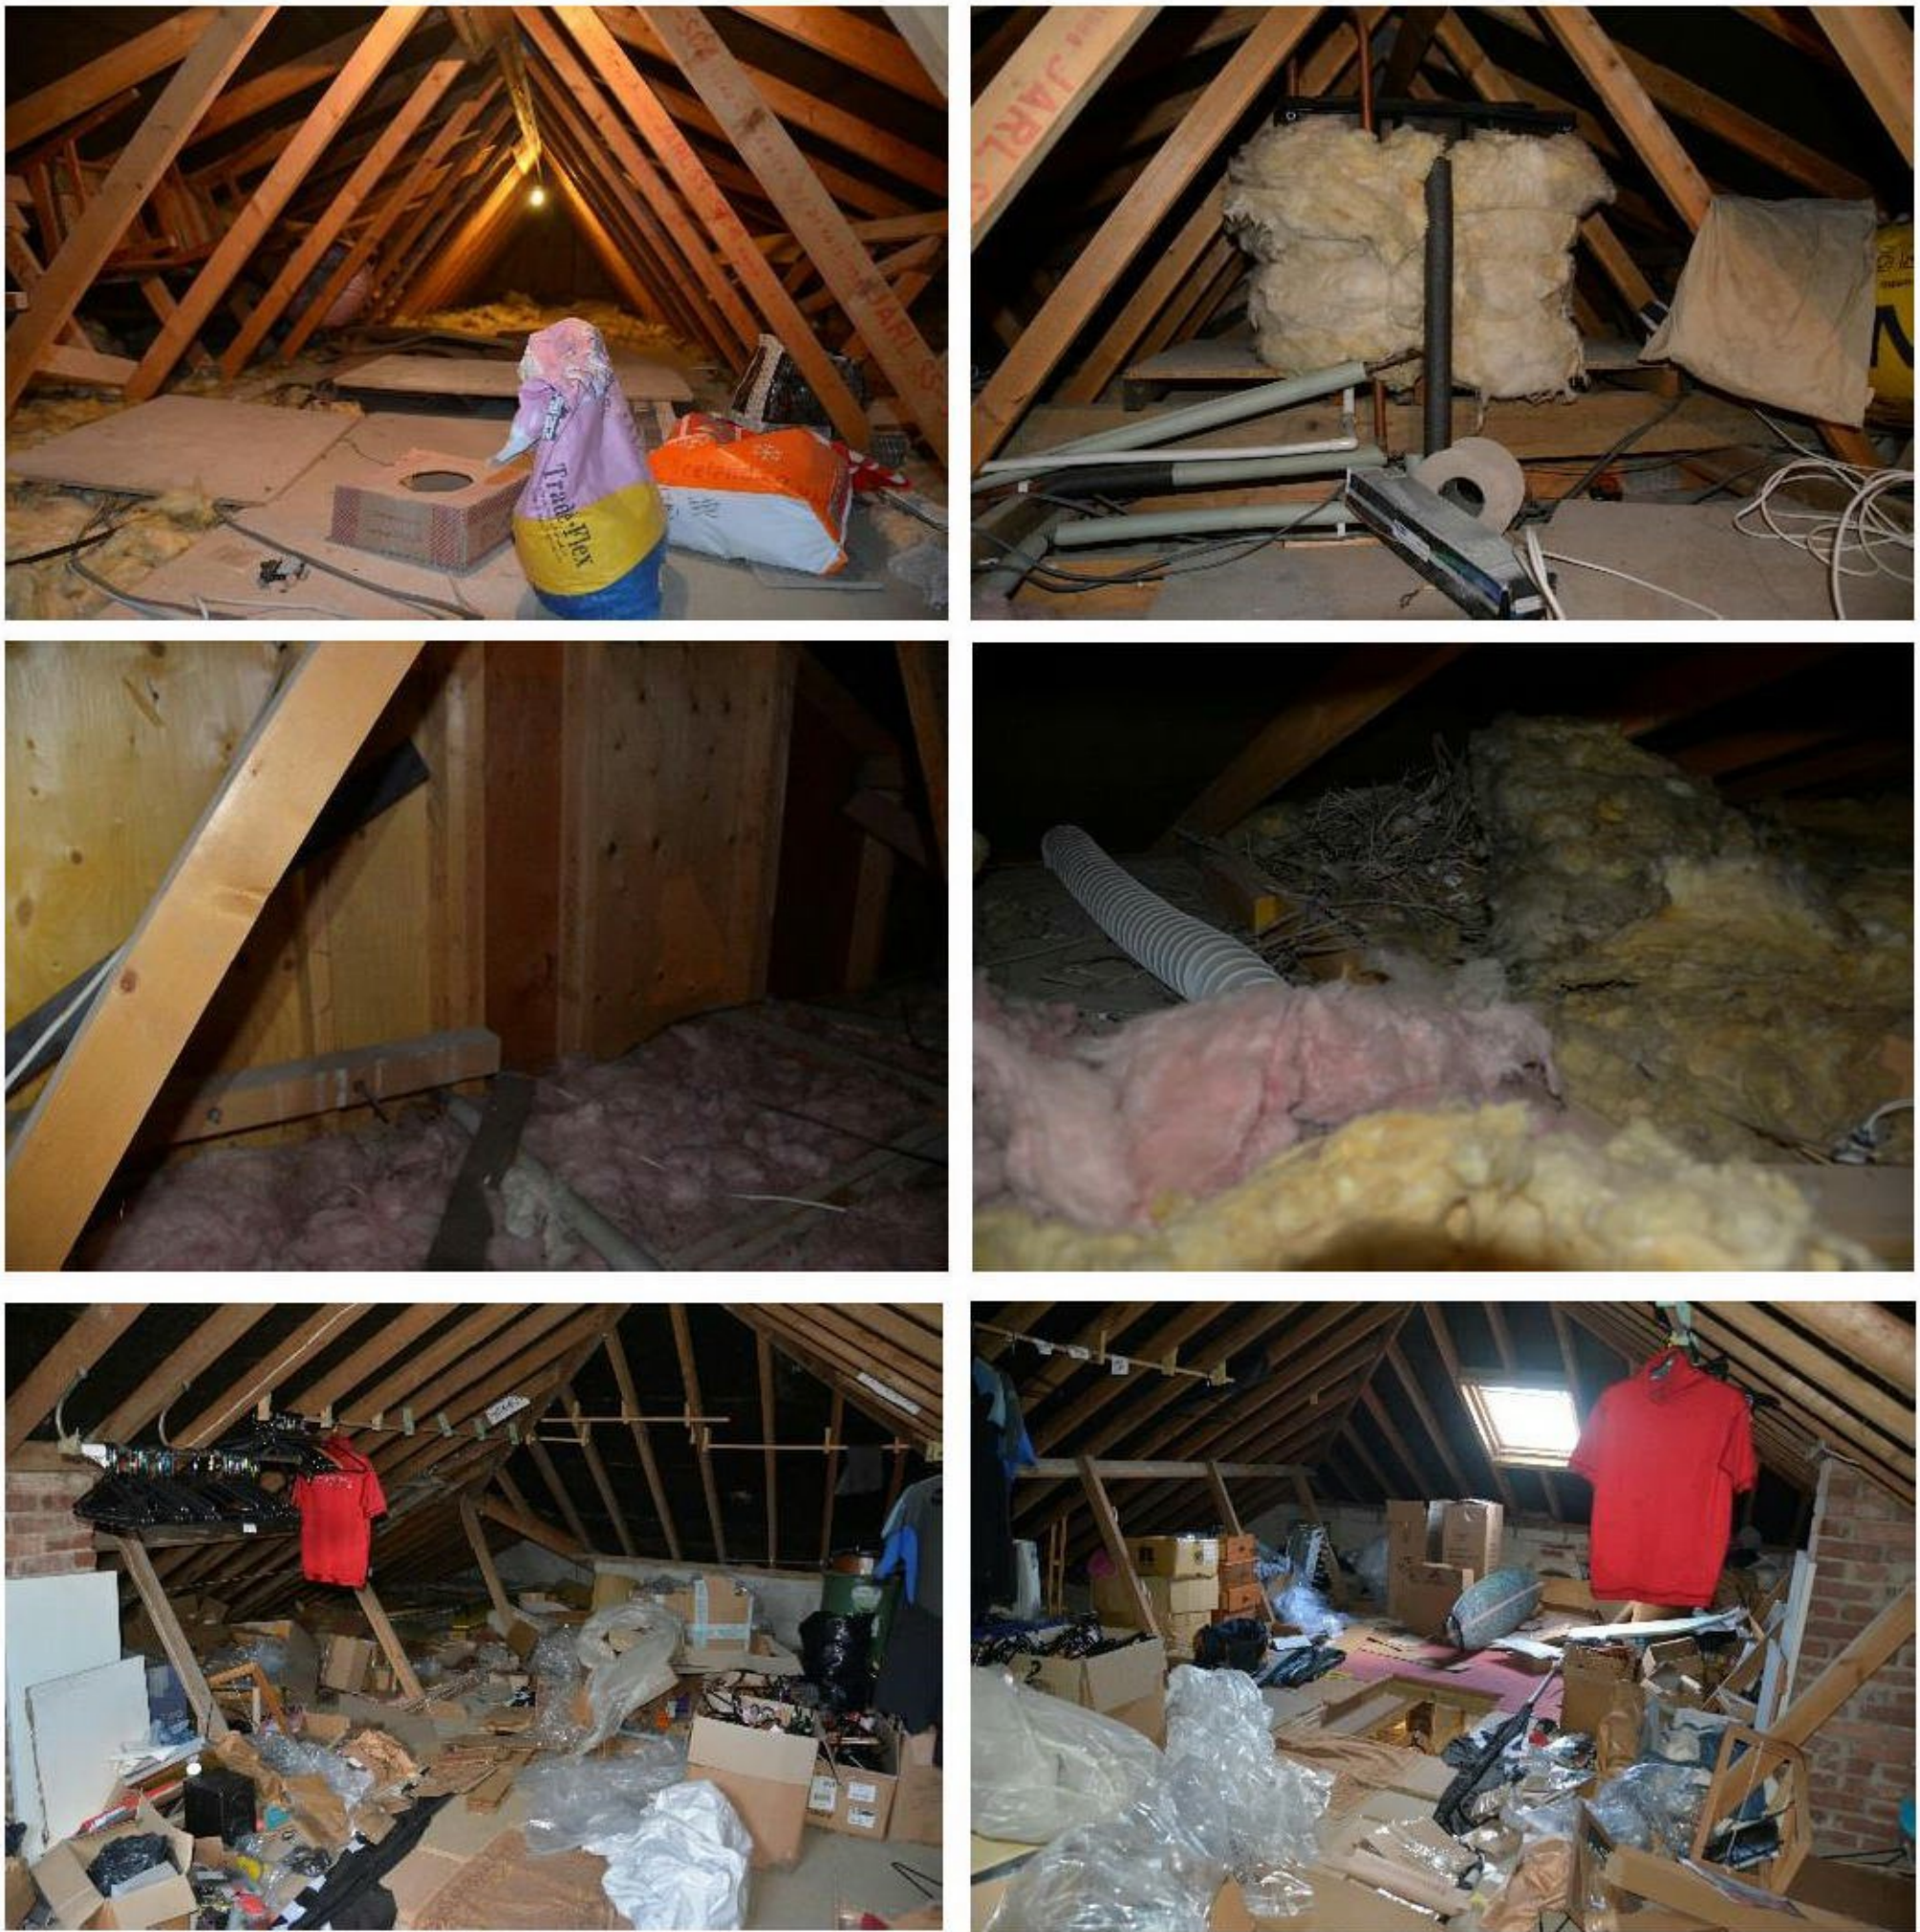
Figure 7: Images of the Cornish Fresh and Surf Hire shop (Married to the Sea) roof voids

Within the roof space of Cornish Fresh at least one historic corvid nest was observed against the wall head on the eastern elevation. It appeared that a missing section of ply on the soffit had allowed birds access to the roof space but this was now secured and there was no fresh evidence of birds using the space.

Top: Views of the Cornish Fresh roof void above the living accommodation. Note the partial boarding, storage of furniture and clean insulation. The water tank is close to the gable which is vertically boarded.

Middle: Close up of the northern gable with timber cladding and thick insulation. Right hand image shows an old corvid nest built close to the wall head. Access was via damage to the soffit on the eastern elevation.

Bottom: View of the light and large interior of the Surf Shop which is used for storage and shop stock. In the north eastern corner, a lower section of roof covers the flat below. The area has deep insulation and is well boarded. No signs of droppings were observed on the many surfaces provided by the various items loosely stored in the space.

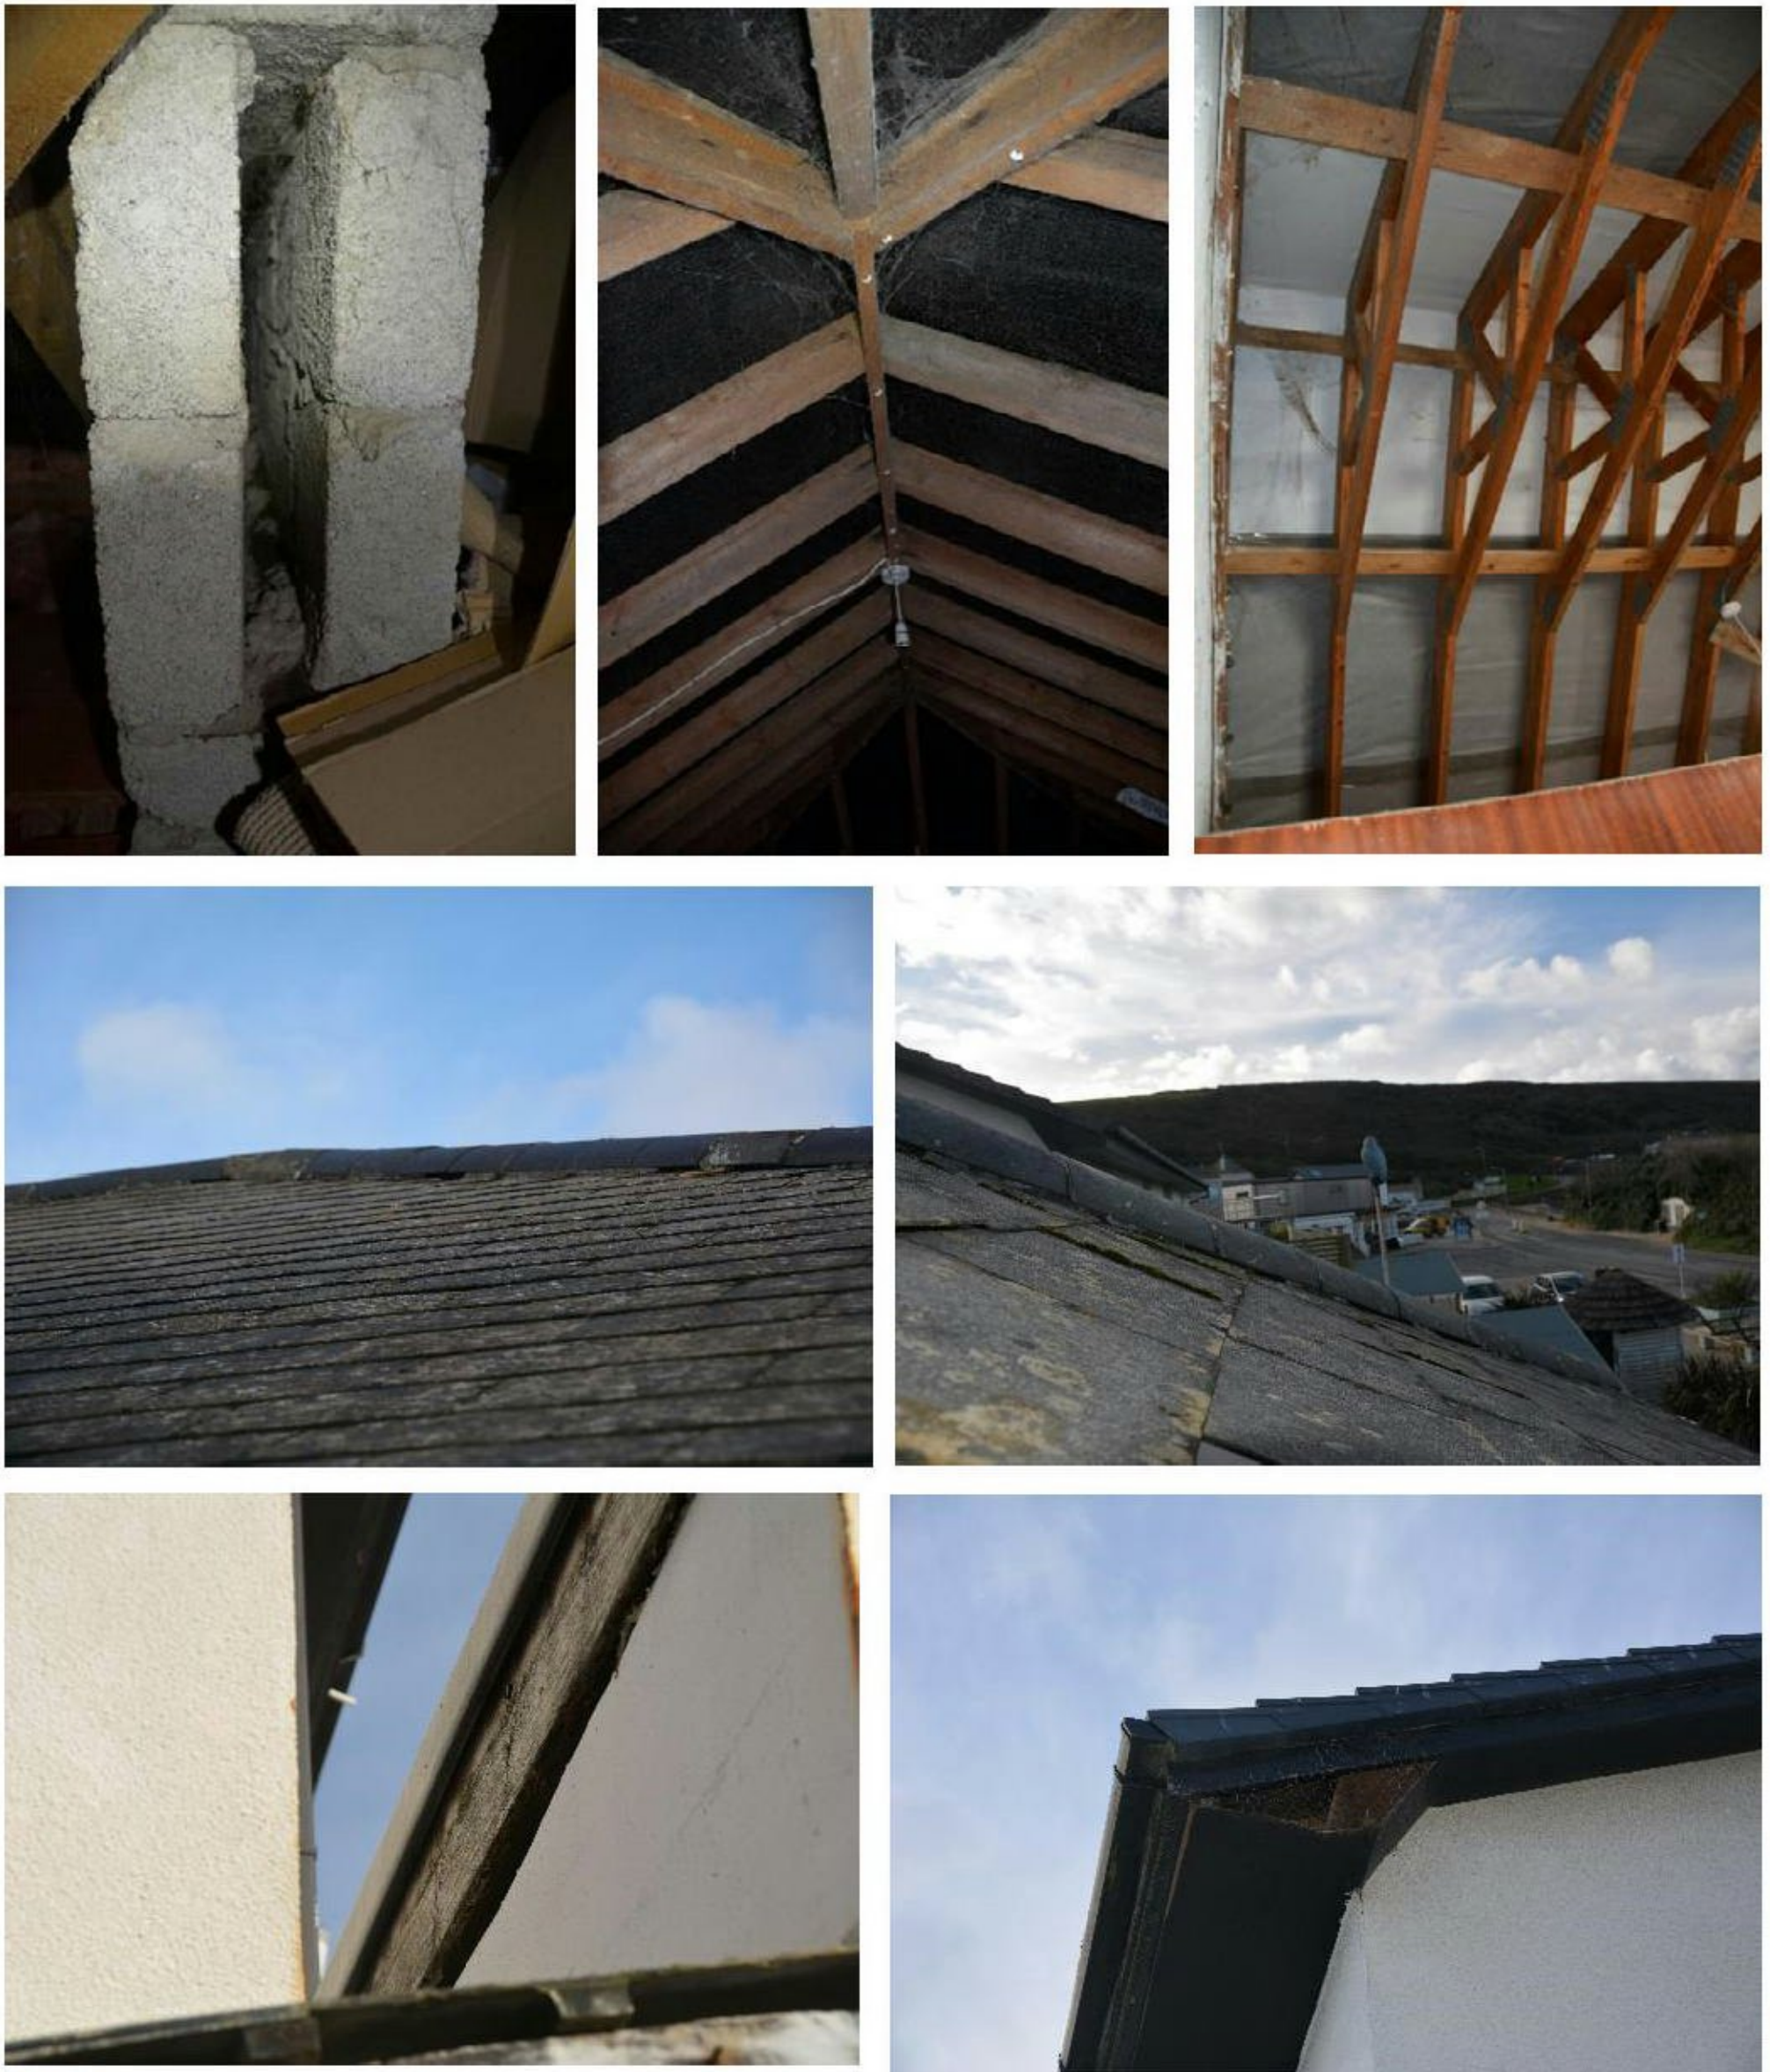
Figure 8: Images of Internal and External roof features

A thorough search was made of the roof space of the living accommodation of Cornish Fresh and the Surf Hire shop without revealing any indications of bats being present. Limited roosting potential was noted behind a few external fascias and ridge tiles but no conclusive evidence (current or historic) of bats using any of the buildings was observed.

Top: Cavity wall, cobwebbed ridge (Surf Hire) and Swallow nests in the Cornish Fresh store shed.

Middle: Surf Hire slate roof with ceramic ridge with missing mortar creating roost potential

Bottom: Fascia and Soffit boards provide opportunities for some species of bat to use external elevations

Based on the preliminary roost inspection survey the buildings are considered as having a ‘low’ potential to support roosting bats. However, some external features such as fascia boards and ceramic ridge tiles (Surf Shop) are considered to have a slightly higher potential. **We would therefore recommend that prior to demolition a watching brief is agreed with the contractor to strip and remove these specific features in the presence of suitably qualified ecologist.** Ideally works should be take place in the autumn or early spring in line with best practice guidance but if not feasible they should proceed with the watching brief as set out above.
