## **Phase I DESK TOP STUDY REPORT**

**Former Cherry Garden School,  
Macks Road,  
Bermondsey,  
London  
SE16 3XU**

**October 2019  
Report No. 15629**

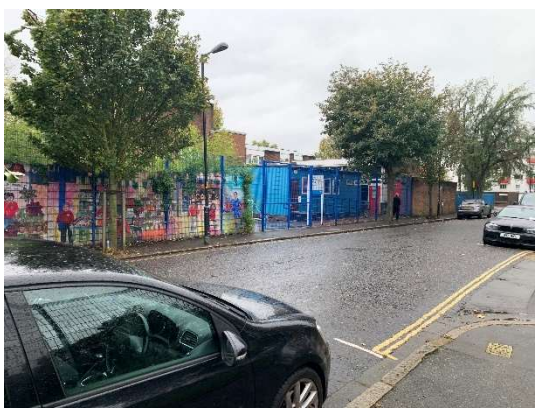
Print 1	View of the site area looking from the opposite side of Alexis Street	Print 2	View of the parking area within the west of the site area looking to the south

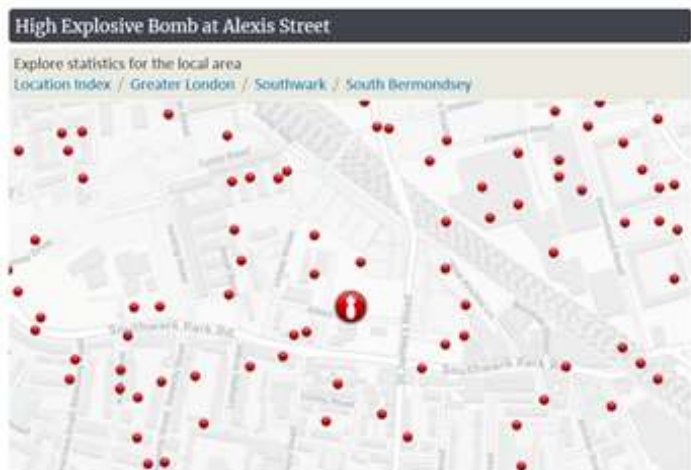
A review of the Bomb Sight web site notes the following incident in 1941, which would account for the redevelopment of the dwelling within and surrounding the site area shown within the historical mapping. This is likely to promote increased fill within and surrounding the site area. A UXO survey may be required for the site area.

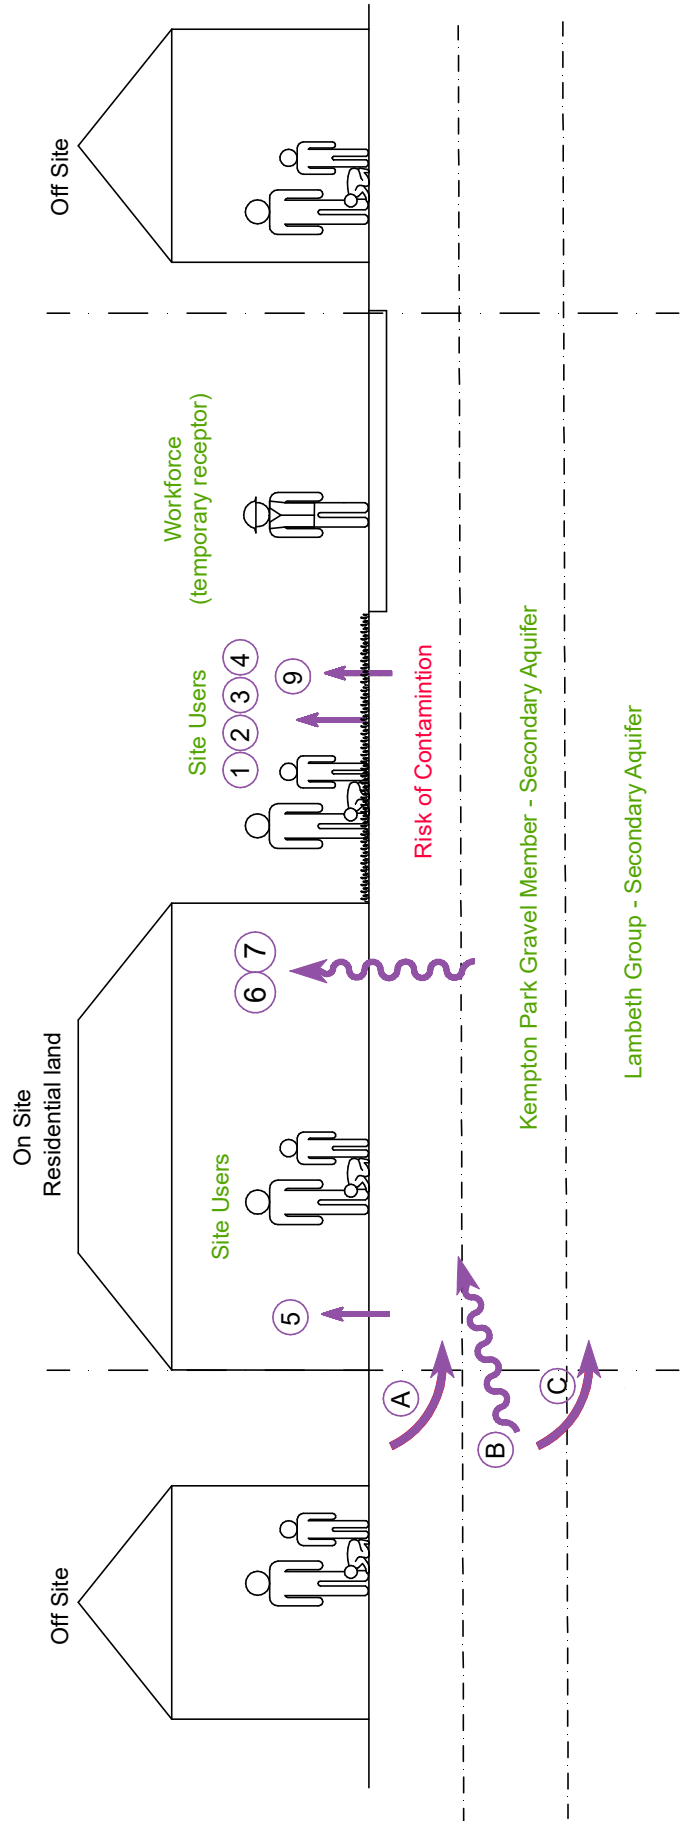
Sketch No: DTS / 15629 / 01 / 01

Purple = Possible pathways  
 Green = Possible receptors  
 Red = Possible sources

- Potential Pathways
- Human Health
- 1 Direct contact with contaminants in soil/dust or water
  - 2 Inhalation of contaminants through soil/dust/particles
  - 3 Dermal Contact
  - 4 Ingestion of home grown produce
  - 5 Ingestion of contaminated water through water main pipework
  - 6 Inhalation of Land Gas and Vapours
  - 7 Inhalation of Vapours from Groundwater
  - 8 Migration to off site Adjoining Land Owners
- Flora
- 9 Plant Uptake & Direct Contact with soil
- Controlled Surface Water, Ground Water & Abstraction Well
- 10 Leaching, lateral migration of shallow groundwater to a target receptor
- Off Site Sources
- A Migration of contamination to the site area
  - B Migration of land gases/ Vapours to the site area
  - C Migration of contaminated groundwater to the site area
