Phase III REMEDIATION REPORT

**Former Cherry Garden School,
Macks Road,
Bermondsey,
London
SE16 3XU**

**June 2020
Report No. 15629**

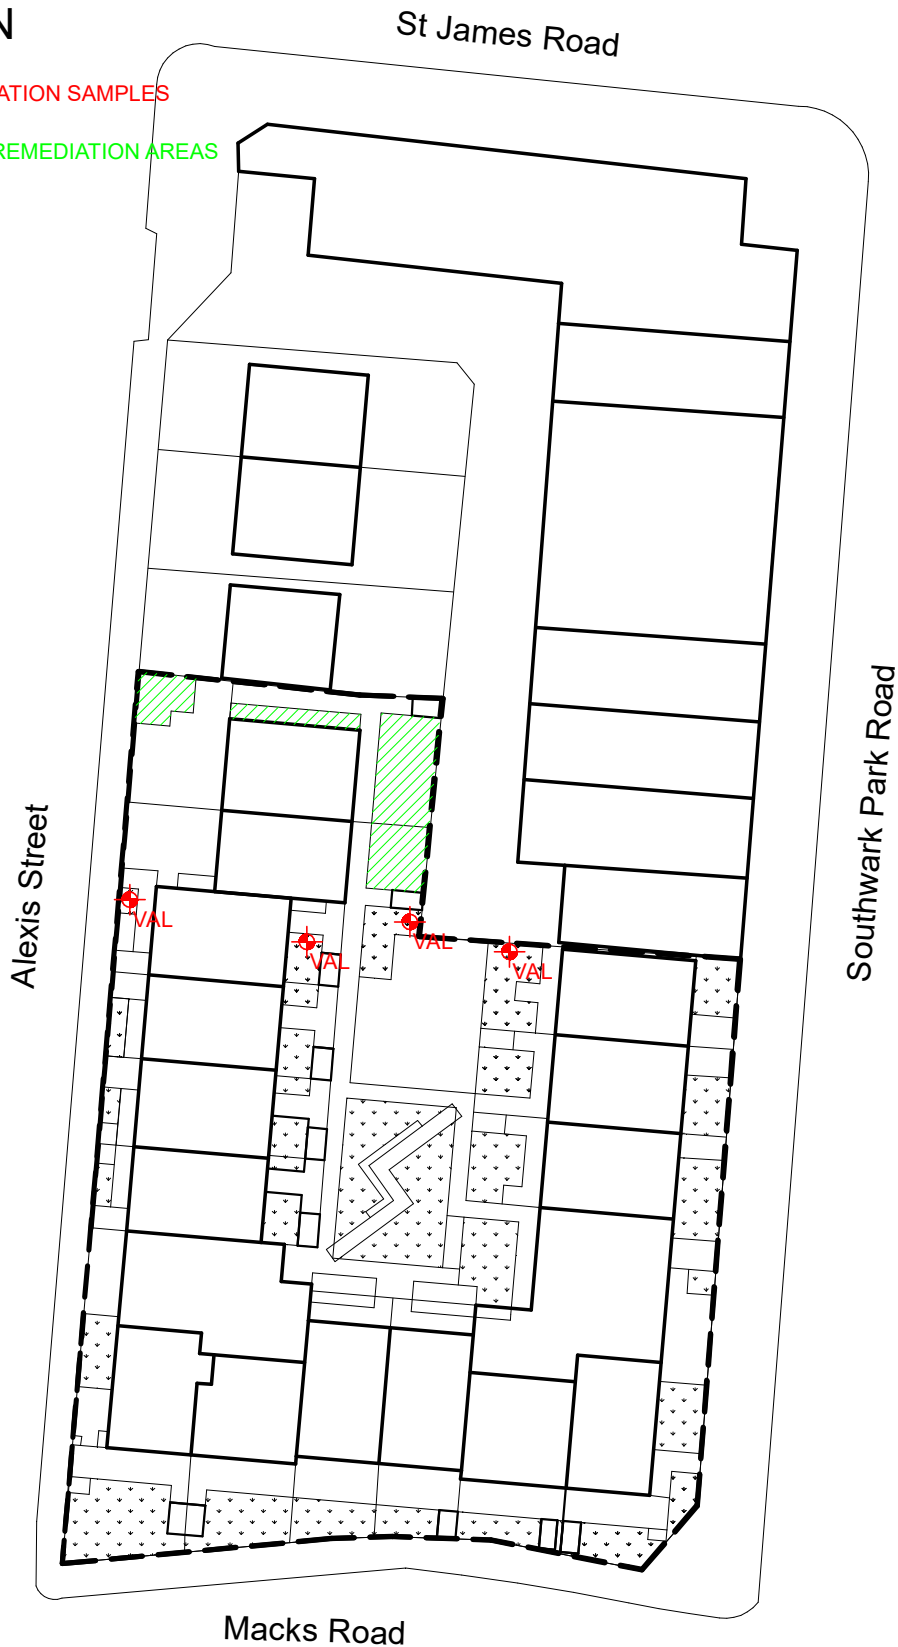
Not to Scale
Sketch No. : REM / 15629 / 01 / 03

PROPOSED REMEDIATION AREAS

Area of site	Works to be observed	Person to observe works
Remediation Cell 1	Ensure minimum depth of capping soils have been completed at the site and ensure a warning membrane has been installed at the base prior to install of topsoil / subsoil	Site Agent / Groundworker / Environmental Engineer.
Foundation Excavations	General watching brief through foundation excavations.
