PROTECTED SPECIES (BAT) SURVEY

**BARN 4
GREAT NORTH ROAD
TORWORTH
NOTTINGHAMSHIRE
DN22 8NU**

April 2020

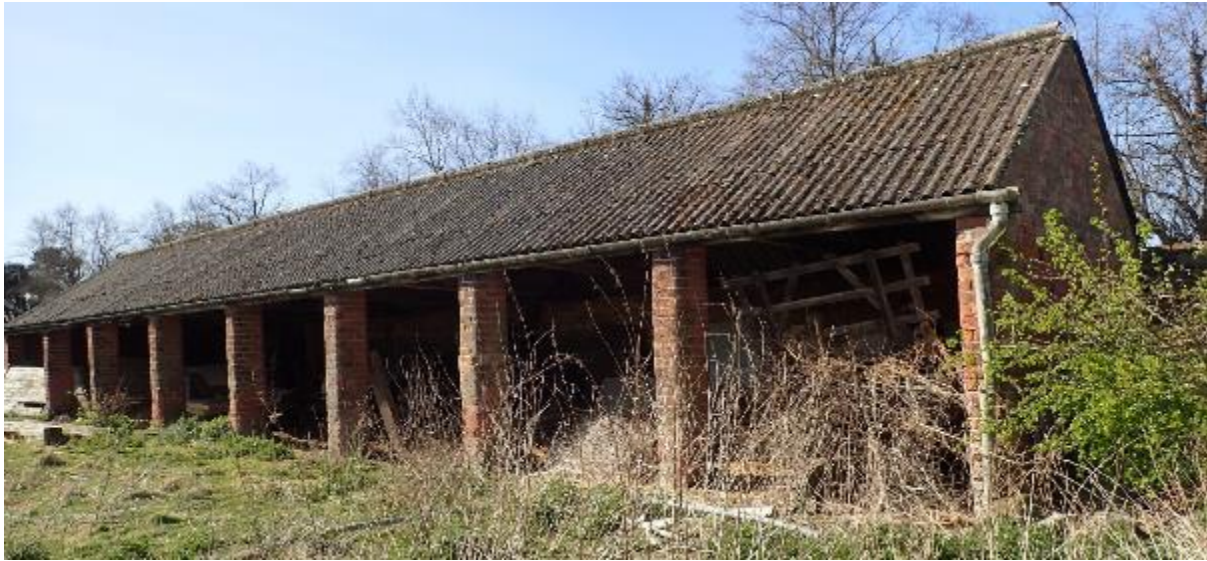
Photograph 2: East elevation of Barn 4

Barn 4 is situated on the west boundary of the proposed development plot immediately adjacent to the A638 highway. At the north gable are the remnants of the walls of a previous structure which has subsequently been encroached by vegetation.

The west elevation of Barn 4 is constructed from stone. The gables are constructed from solid brick. An open window with a stone lintel is present at the south gable. The building is open at the east elevation and the structure is supported by eight brick pillars.

The roof is pitched and covered with corrugated cement fibre sheets overlaid over a traditional king post timber roofing frame. The verges are sealed with mortar. The interior contains one single cell which is open from the ground to the underside of the roof covering.

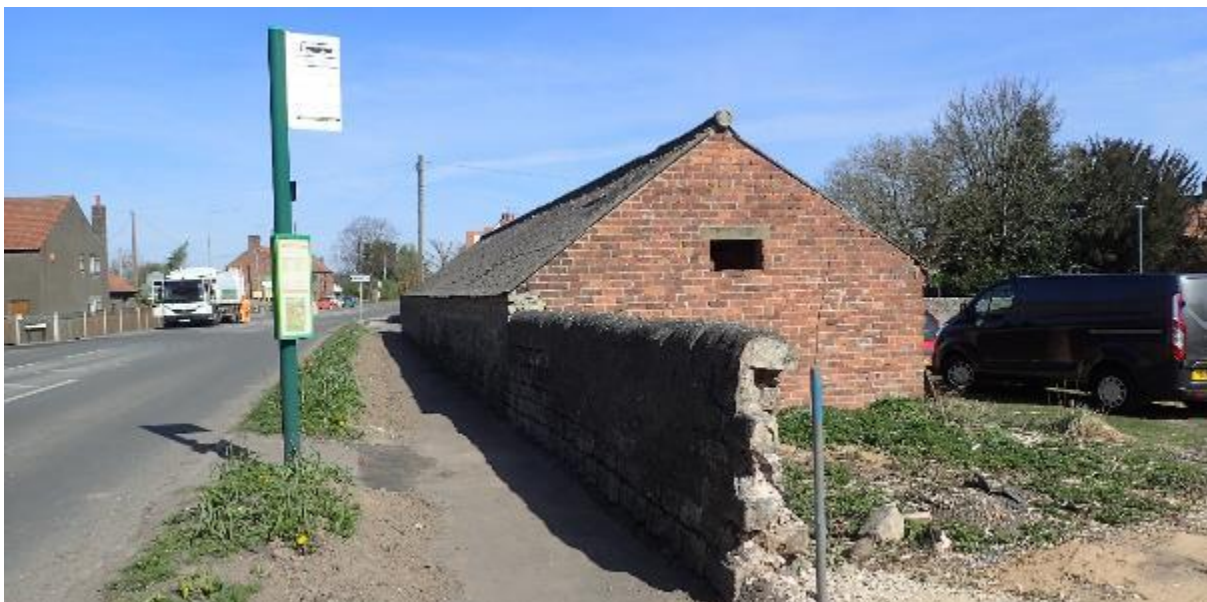
Photograph 3: South gable and west aspect of Barn 4

At the south gable areas of missing mortar were noted at the verge thereby resulting in potential for bats to roost between the top of the wall and underside of the roof covering. At the south gable apex a gap is present beneath the ridge covering.

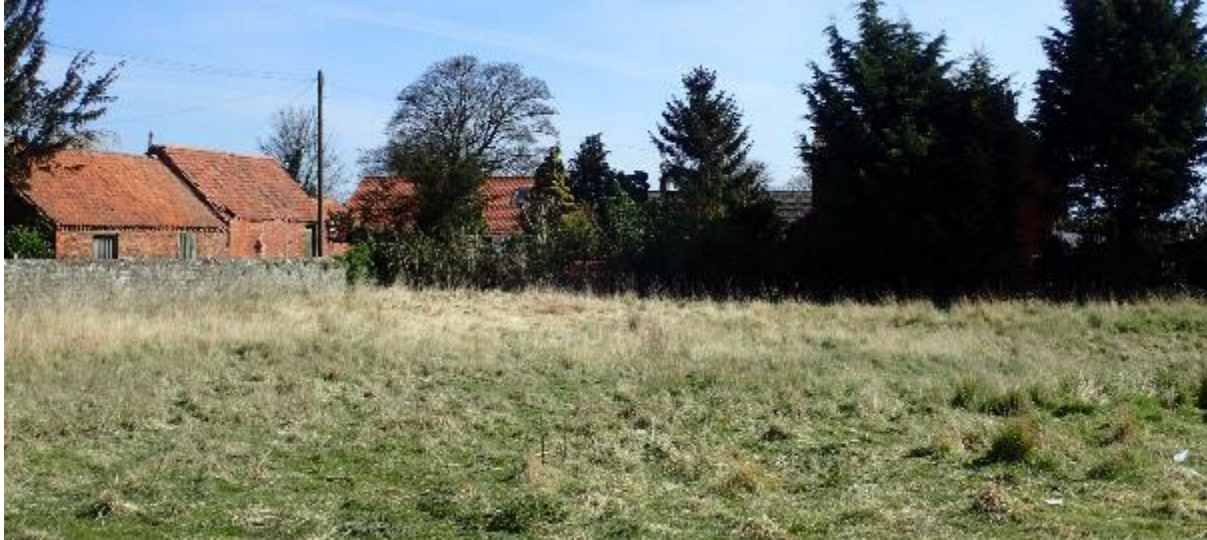
Photograph 4: Land to the east of Barn 4

At the north east aspect of Barn 4 is a disused manure heap. Rough grassland is present at the east aspect. Stone walls form the north and west boundaries of the site. The A638 highway at the west aspect has street lighting however there is potential commuting and foraging habitat for bats in the form of a treeline containing mature trees and a hedgerow which runs along the west side of the A638 opposite Barn 4.

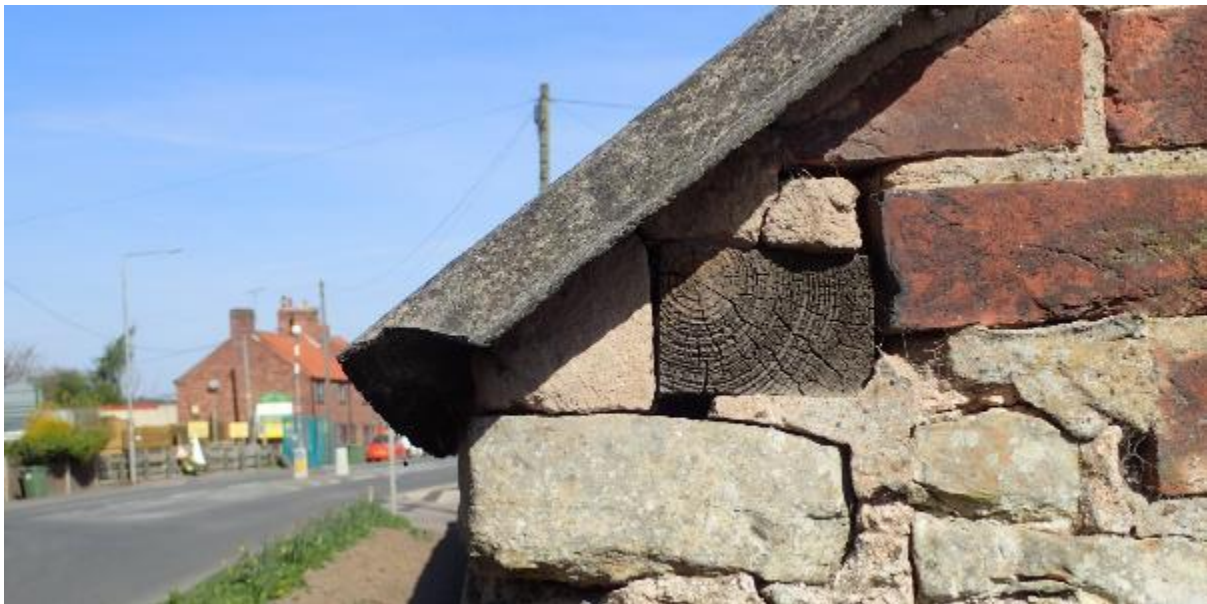
The visual inspection of the construction materials identified features with the potential to support roosting bats. One of these features is gaps around the timber wall plate at the south west corner of the building. Along the south elevation small gaps were found at the eaves which have potential to support roosting by crevice dwelling species. Gaps were also found in the stonework at this elevation which also have potential to be utilised by roosting bats.

Photograph 6: Gaps around wall plate at south elevation

The assessment of Barn 4 has been made based on the extent of the potential roost features and context within the surrounding area. Barn 4 is assessed as having features with low potential of supporting roosting bats. The National Guidelines (2016) specify that to provide confidence in the absence of roosting bats from building is categorised as of “low bat roost potential” a single emergence and activity survey should be undertaken.

The survey must be undertaken when bats are active between May to the end of August and in suitable weather conditions. If a bat roost is identified during the survey or behaviour is observed to indicate a roost site is present then further surveys will be recommended to inform a mitigation strategy and satisfy EPS licence criteria. If multiple surveys are necessary they must be separated by a minimum interval of two weeks.

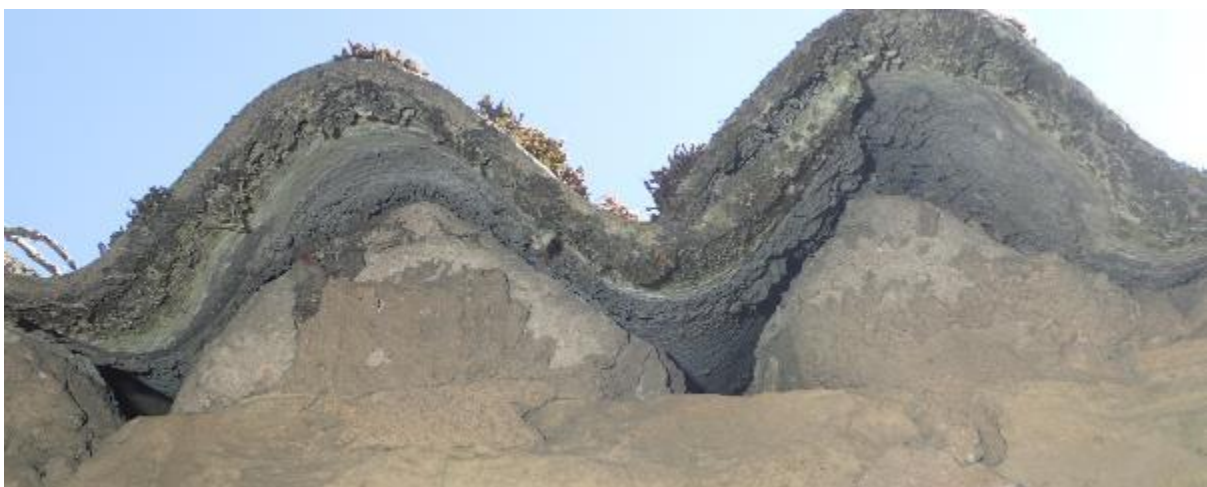
Photograph 7: Gaps at eaves of west elevation

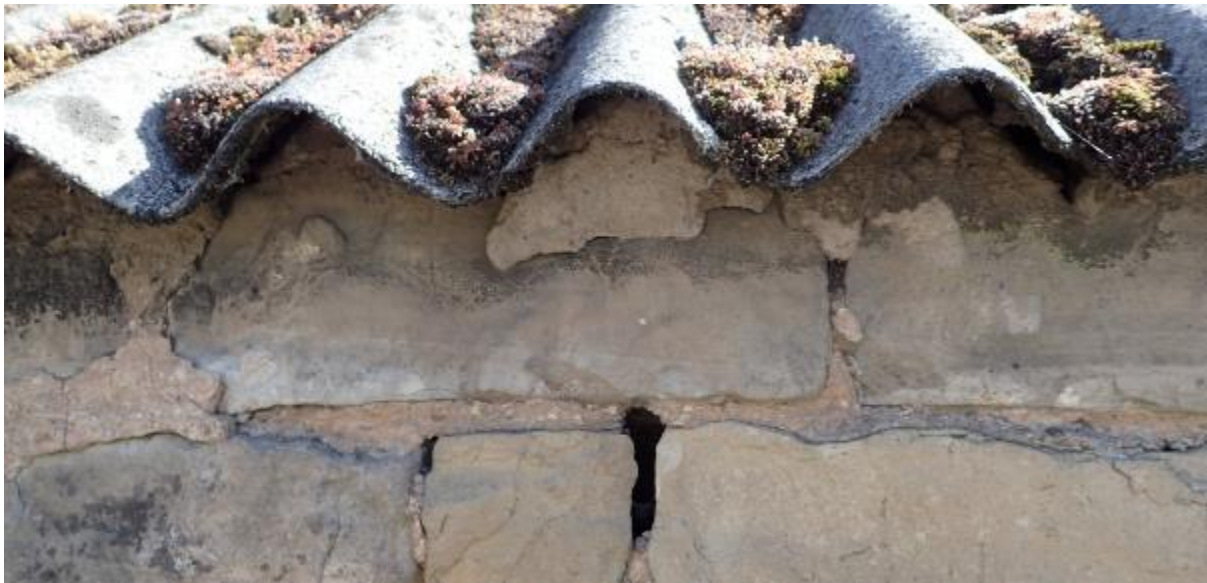
Photograph 8: An example of gap in stonework at west elevation

Nesting birds we are actively reading within the barn and furthermore habitat was identified inside the building and the crevices within the exterior stonework that has the potential to support breeding birds. If the commencement of works is within the bird breeding season, variable from March to September, the project maybe constrained by legislation designed to protect breeding birds.

If works are to commence during the bird breeding season (March to September inclusive) then a nesting bird survey will be required and should be undertaken by a competent ecologist. Note that the discovery of a bird's nest would lead to the requirement to delay any work in that immediate vicinity. The area around the nest site of approximately five metres around and above would need to be cordoned off until the young have hatched and have fledged and left the nest.
