**SEVENOAKS GASHOLDER SITE,
CRAMPTON'S ROAD, SEVENOAKS**

BAT SURVEYS

Report No: RT-MME-152714-02 Rev A

Date: March 2021

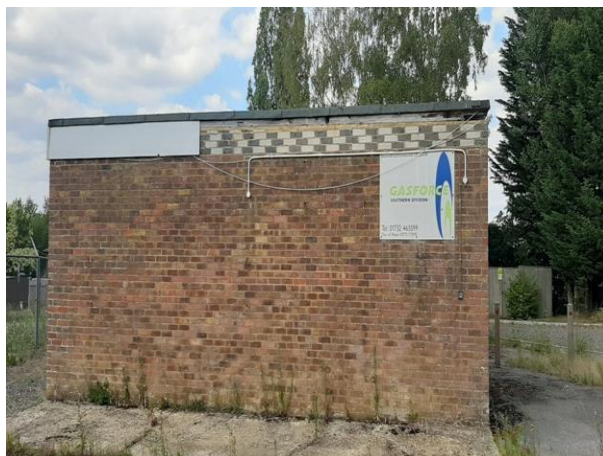
Plate 4.1: Building B1 (Southern Elevation)

Building B1 was a single-storey, brick-built structure with a flat bitumen felt roof (Plate 4.1). The building was relatively modern in age and design. The building was boarded up and disused at the time of the survey.

The roof was comprised of flat bitumen felt which was fitted flush to a dilapidated uPVC fascia along the brick cap joining points. No gaps or tears were recorded within the areas of fitted bitumen felt roof. Brick walls were found to be in good repair, yet gaps were recorded at the eaves of the building where sections of the uPVC fascia were missing. Windows and doors were boarded-up, restricting internal access to the building, yet a single gap was recorded above the doorframe which provides access into the internals of the building. Dense ivy *Hedera helix* concealed the eaves of the building along the northern elevation.

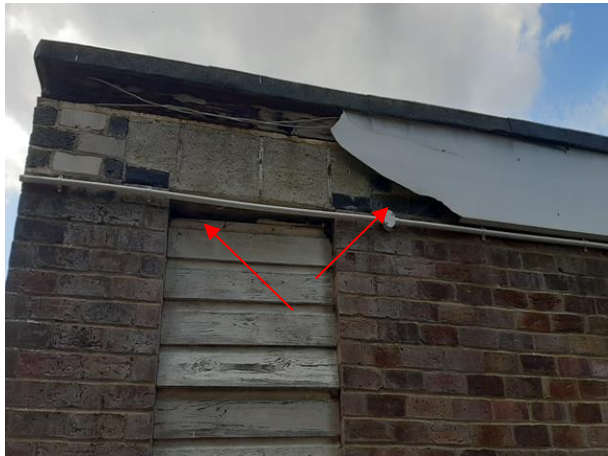
Gaps were recorded around the eaves where sections of the dilapidated uPVC fascia were missing and above the boarded-up door which provided direct access to the interiors of the building (Plate 4.2). Furthermore, the gaps around the dilapidated uPVC fascia (Plate 4.3) provided access to a crevice feature present between the external brickwork and uPVC fascia. This feature was found to be clear of cobwebbing and detritus, indicating potential recent access by bats or other fauna.

Plate 4.2: Gaps Above Doorframe and Between Fascia Board and External Brickwork

It was not possible to fully inspect the gaps at the eaves where the sections of dilapidated uPVC fascia were missing and the gaps above the boarded-up doorframe due to the extent of the feature, it was not possible to establish if bats had used these features to enter a roost location at the time of surveying. No evidence of roosting bats, e.g. droppings, urine staining, feeding remains or scratch marks, was recorded within the features that could be fully inspected during the survey.

The gaps around the dilapidated uPVC fascia provided access to a crevice feature present between the external brickwork and uPVC fascia. This feature was found to be clear of cobwebbing and detritus, indicating recent use by bats or other fauna.

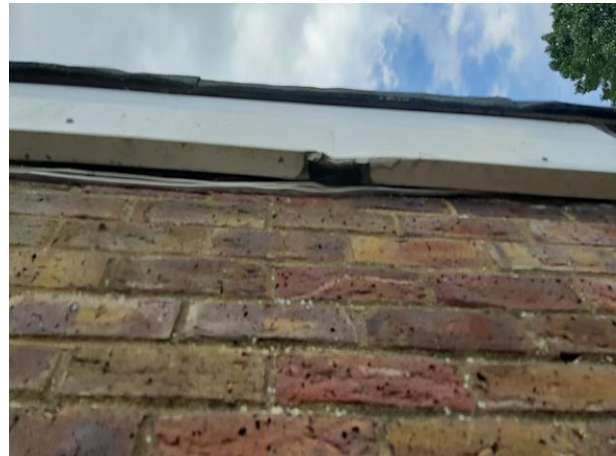
Plate 4.3: Gap in Fascia Board

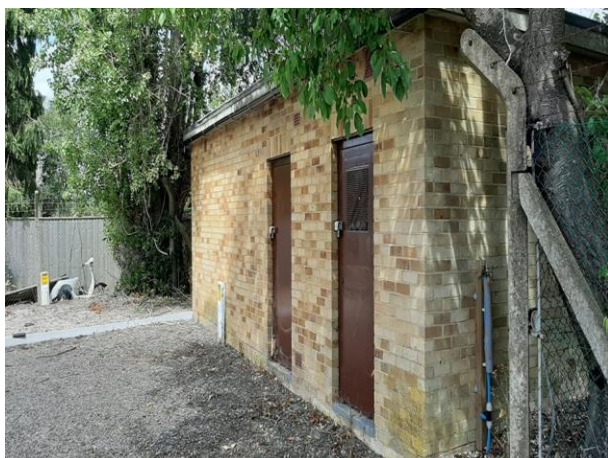
Building B2 was a small, single-storey, brick-built substation with a flat bitumen felt roof (Plate 4.4 and 4.5). The building was relatively modern in design and of a general good state of repair, with no cracks or gaps noted between the brickwork. The roof comprised of flat bitumen felt which was fitted flush to an intact wooden soffit box along the brick cap joining points. No gaps or tears were recorded within the areas of fitted bitumen felt roof. The eaves of the building were tightly fitted with no gaps or holes recorded. A wooden soffit was present across all elevations of the building which was tightly fitted to the external wall and of a general good state of repair. Doors were presented in wooden frames and were fitted flush to the external brickwork of the building with no gaps recorded.

No features were recorded during the external assessment of Building B2 which could be utilised by bats to gain entry into the internal areas of the building. In addition, no external features suitable for roosting bats were noted on the building. The building was in good condition and tightly sealed with no potential ingress points or features for bats.

Plate 4.4: Building B2

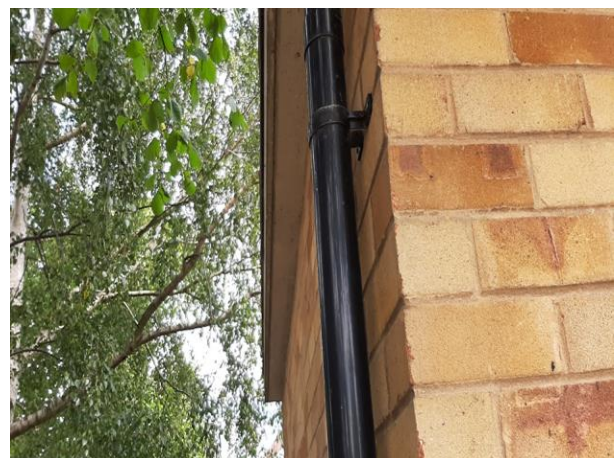
Plate 4.5: Wooden Soffit Box

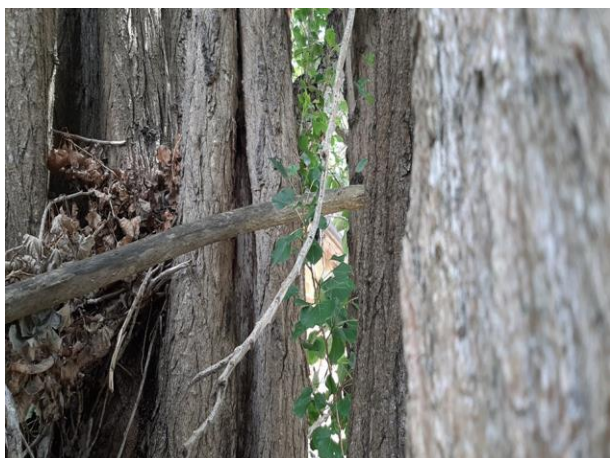
Tree Ref.	Species	Plate No.	Age	Approx. Height and Diameter at Chest Height (m)		Potential Roost Feature	Additional Notes	BCT Suitability
				H	DCH			
T1	Lombardy poplar	4.7, 4.8.	EM	22.0	0.95	Large rot hole on one of the stems extending up the stem.	No bat evidence recorded. Holes were clear of cobwebbing and detritus indicating recent disturbances or movements by bats or other fauna. Not fully inspected due to nature and extent of the feature.	High

Plate 4.7: Tree T1 – Lombardy Poplar

The Preliminary Bat Roost Assessment has identified that Tree T1 has suitability to support roosting bats. A large rot hole was identified on one of the multiple stems which extended vertically up the tree and into a cavity, which could be utilised by bats to access a potential roosting location. The feature was largely clear of cobwebbing and detritus at the access point, indicating recent disturbances or movements by bats or other fauna. Whilst no evidence of roosting bats, e.g. droppings, urine staining, feeding remains or scratch marks, was recorded within the section of the feature that could be inspected, it was not possible to complete a full inspection due to the height and extent of the rot hole. Therefore, Tree T1 is considered to provide high potential to support roosting bats.

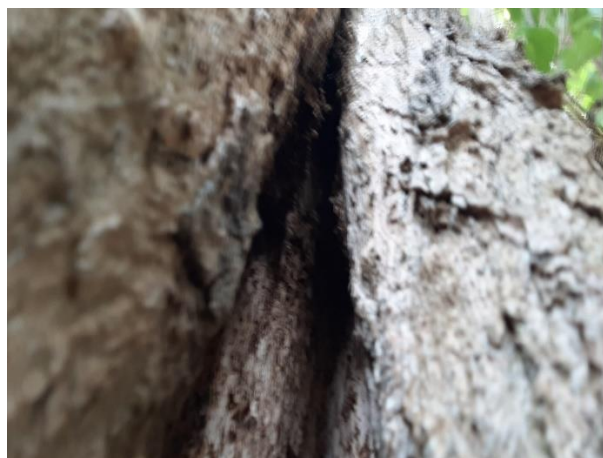
Plate 4.8: Potential Roost Feature – Rot Hole
