The results detailed in this report show the levels of contaminants found at different locations on the Sevenoaks site.

- 2.09 Investigations were made to determine the historical use of the site, these investigations included:
- i) Discussion with the Environmental Health Department of Sevenoaks District Council. They had no knowledge of the historical use of the site but had not encountered any problems caused by possible contamination of the site.

RESIDENTIAL DEVELOPMENT, CRAMPTONS ROAD, SEVENOAKS
 TRIAL PIT LOCATION PLAN

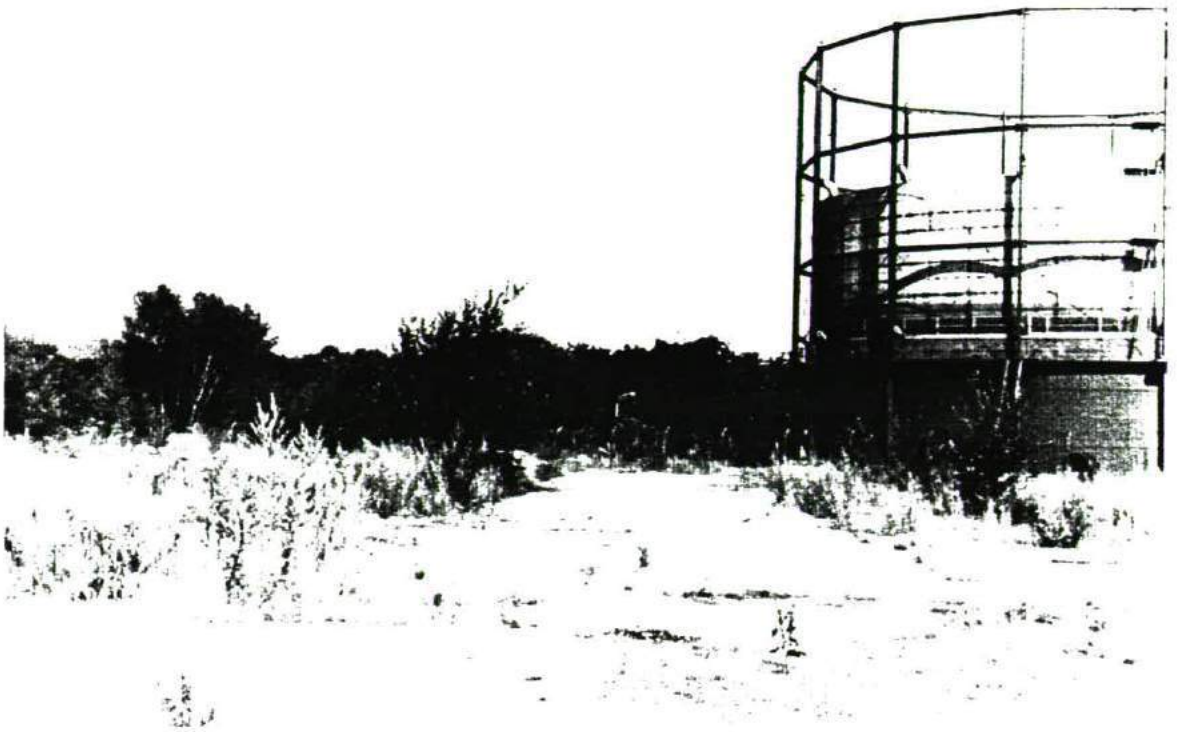
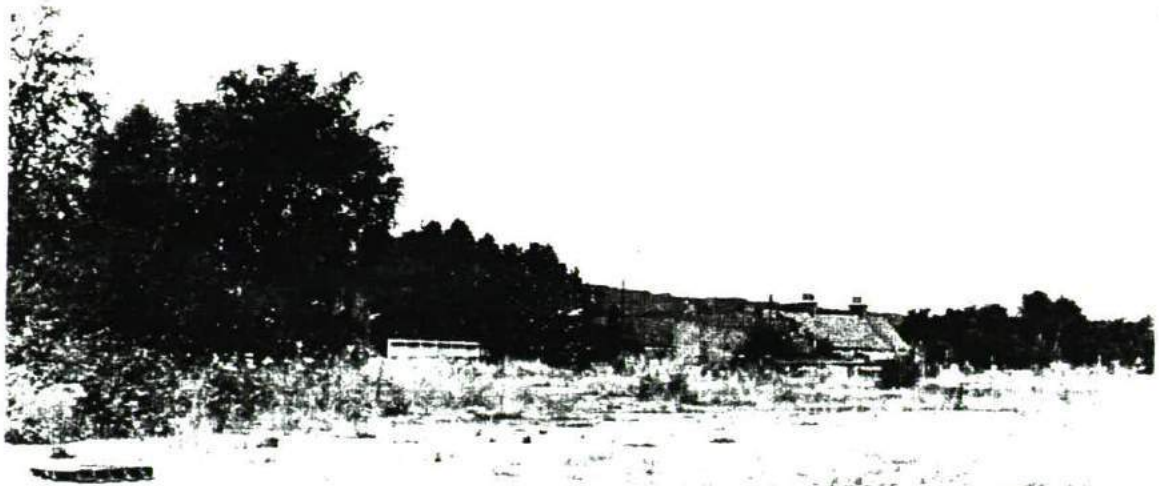
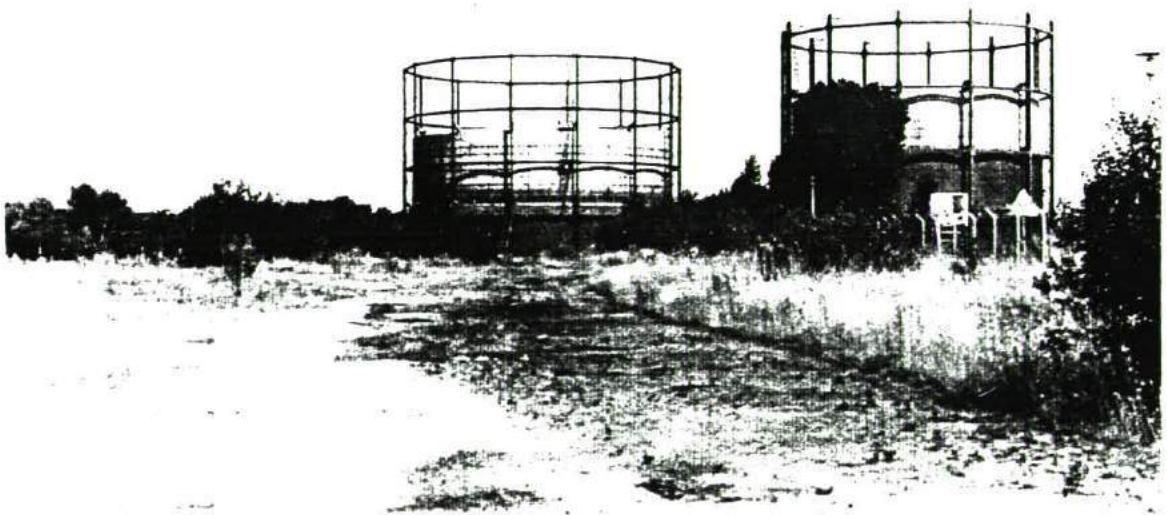
FIG.3 SITE PLAN
 SHOWING SAMPLING GRID

Fig. 3 shows the sampling locations chosen for the site. The locations are based on a 25 metre grid. Choosing such a system as a grid ensures that there is no bias as to where the samples are taken.

Also, it can be seen in Fig. 3 that a number of extra sample points were chosen. These represent areas where higher levels of contamination may be expected due to the existence of particular items of plant.

The results have been grouped together with reference to the bore hole. The codes correspond to the grid markings on the plan of the site (Fig.3).
