**DETAILED ASSESSMENT
REPORT**

**SEVENOAKS HOLDER STATION,
CRAMPTONS ROAD, SEVENOAKS, KENT**

July 2001

**SCOTIA GAS NETWORKS
FACTUAL SITE INVESTIGATION REPORT
CRAMPTONS ROAD, SEVENOAKS**

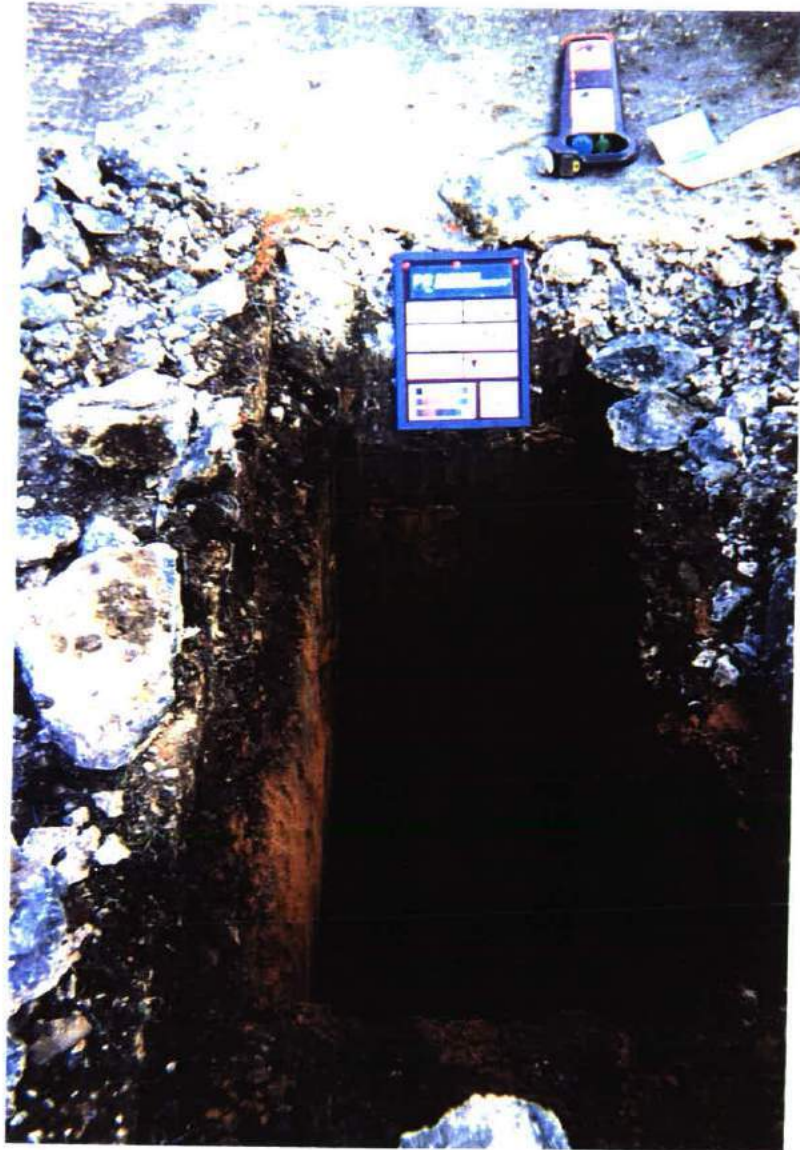
Photo 1a

3.2.4 In trial pit TP1 a gravely sand was found to be underlying the spent oxide, clinker and coke horizon. The base of the Made Ground was not encountered due to the presence of unmarked buried pipework.

Sevenoaks Holder Station – Trial Pit TP1 – View West

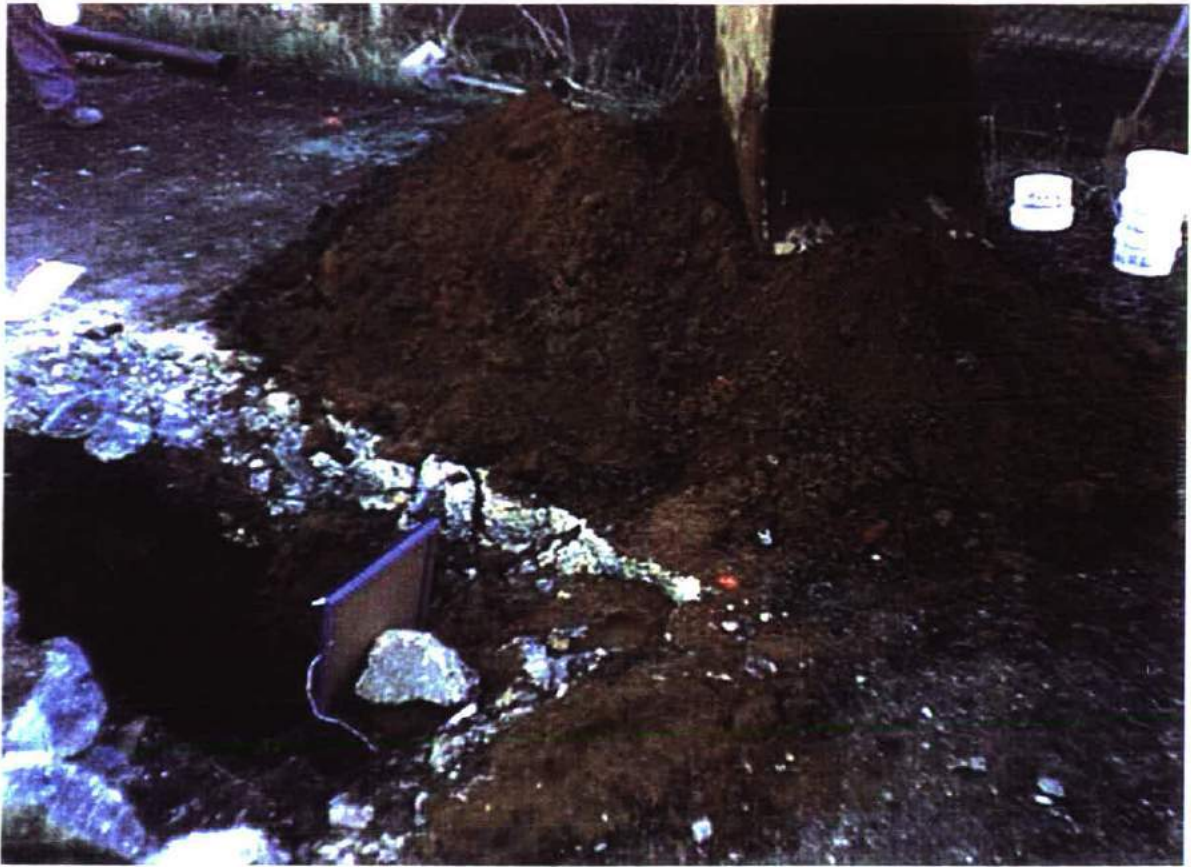
Photo 1b

Sevenoaks Holder Station – Arisings Trial Pit TP1 – View South East

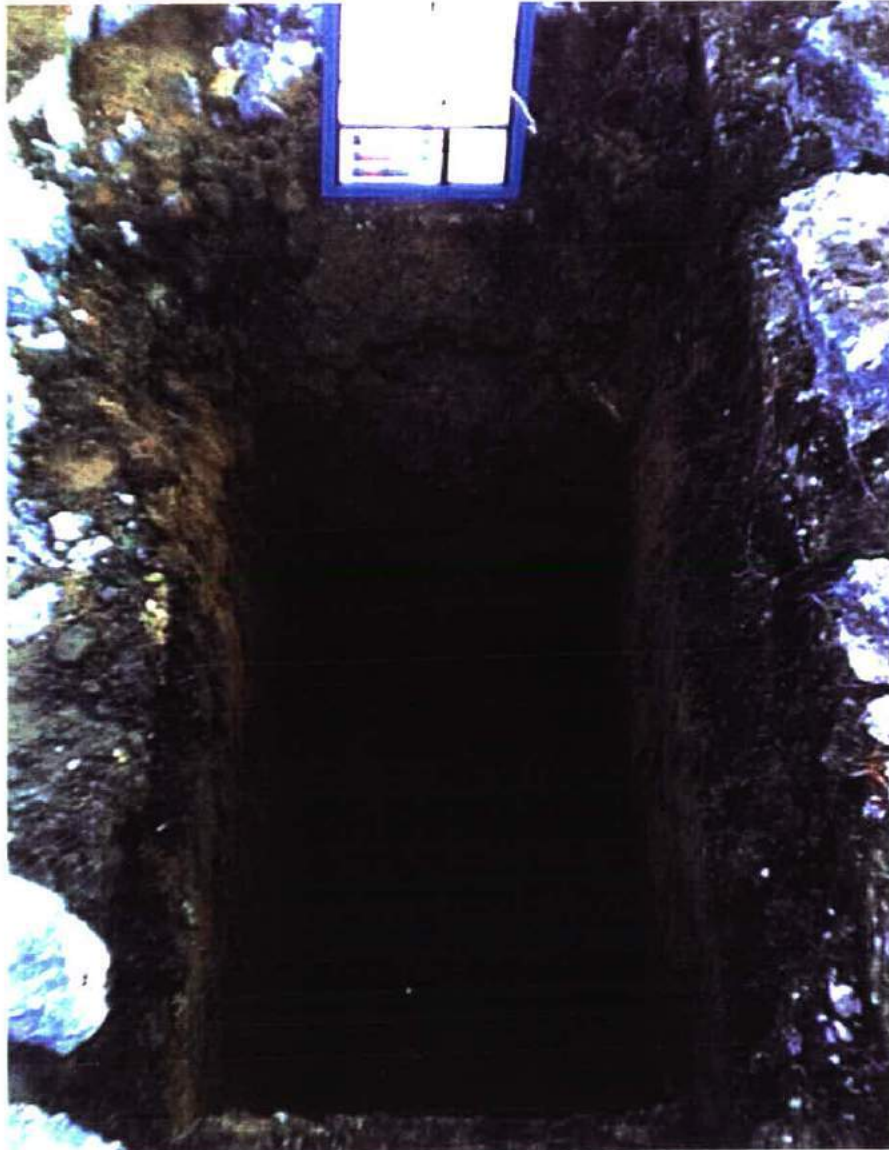
Photo 2a

Sevenoaks Holder Station – Trial Pit TP2 – View South

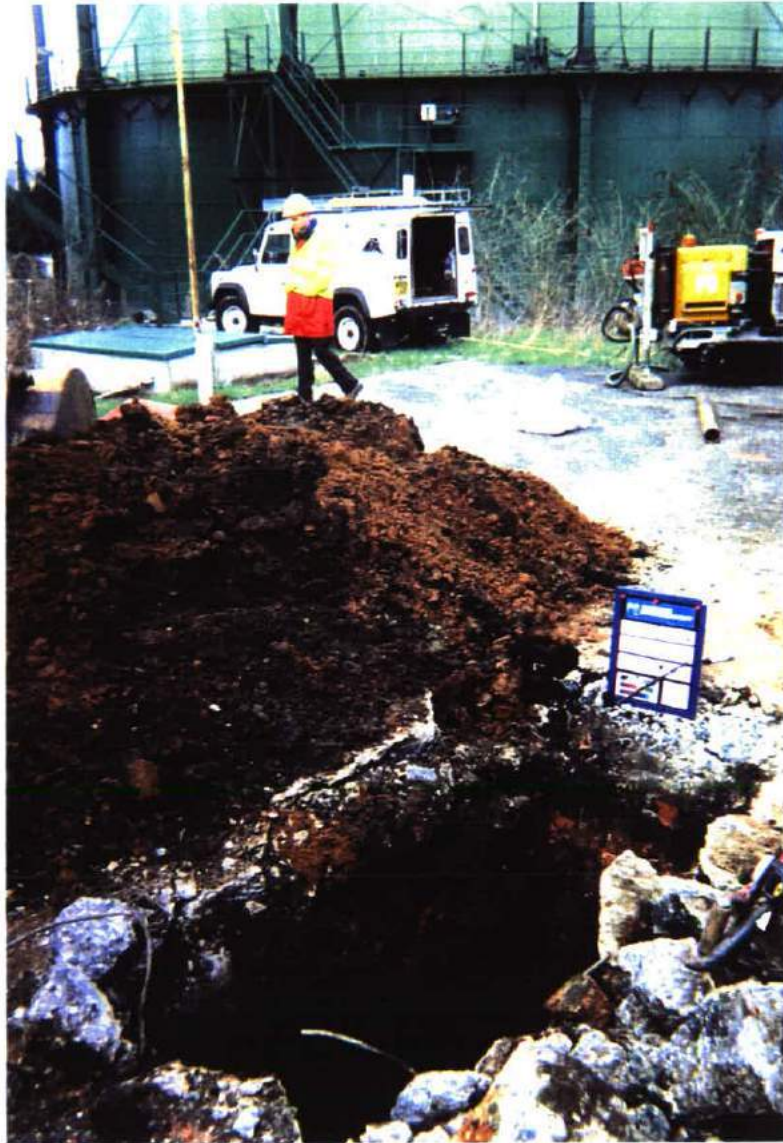
Photo 2b

Sevenoaks Holder Station – Trial Pit TP2 – View ENE of trial pit

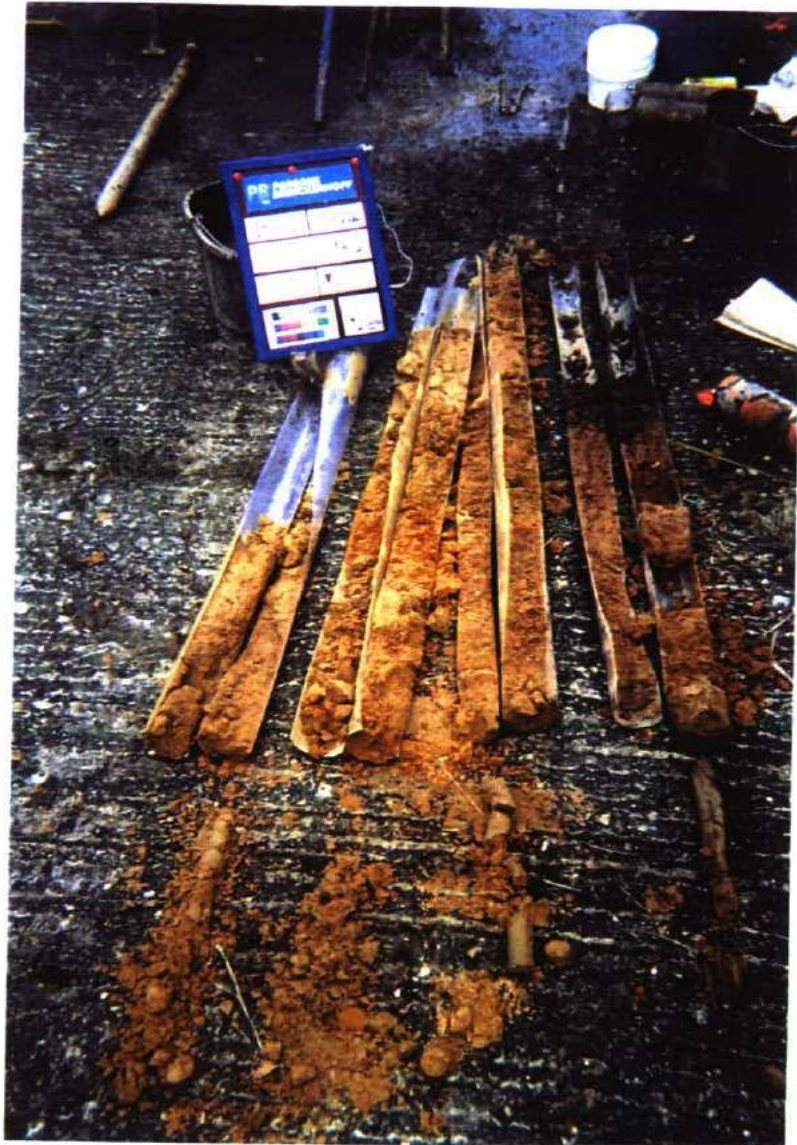
Photo 3a

- Within BH1 broken roofing material and brick fragments were encountered at 0.45m – 0.7m bgl. In addition, a bituminous odour was detected within this material.
- Within all excavations, characteristic blue colouration associated with spent oxide was noted, and a related odour was noted in BH1 and TP1.
- Within TP2, between 0.65m and 1.1m bgl, a strong tar/bituminous odour was noted.

Sevenoaks Holder Station – Bore Hole BH1 – Borehole Arisings

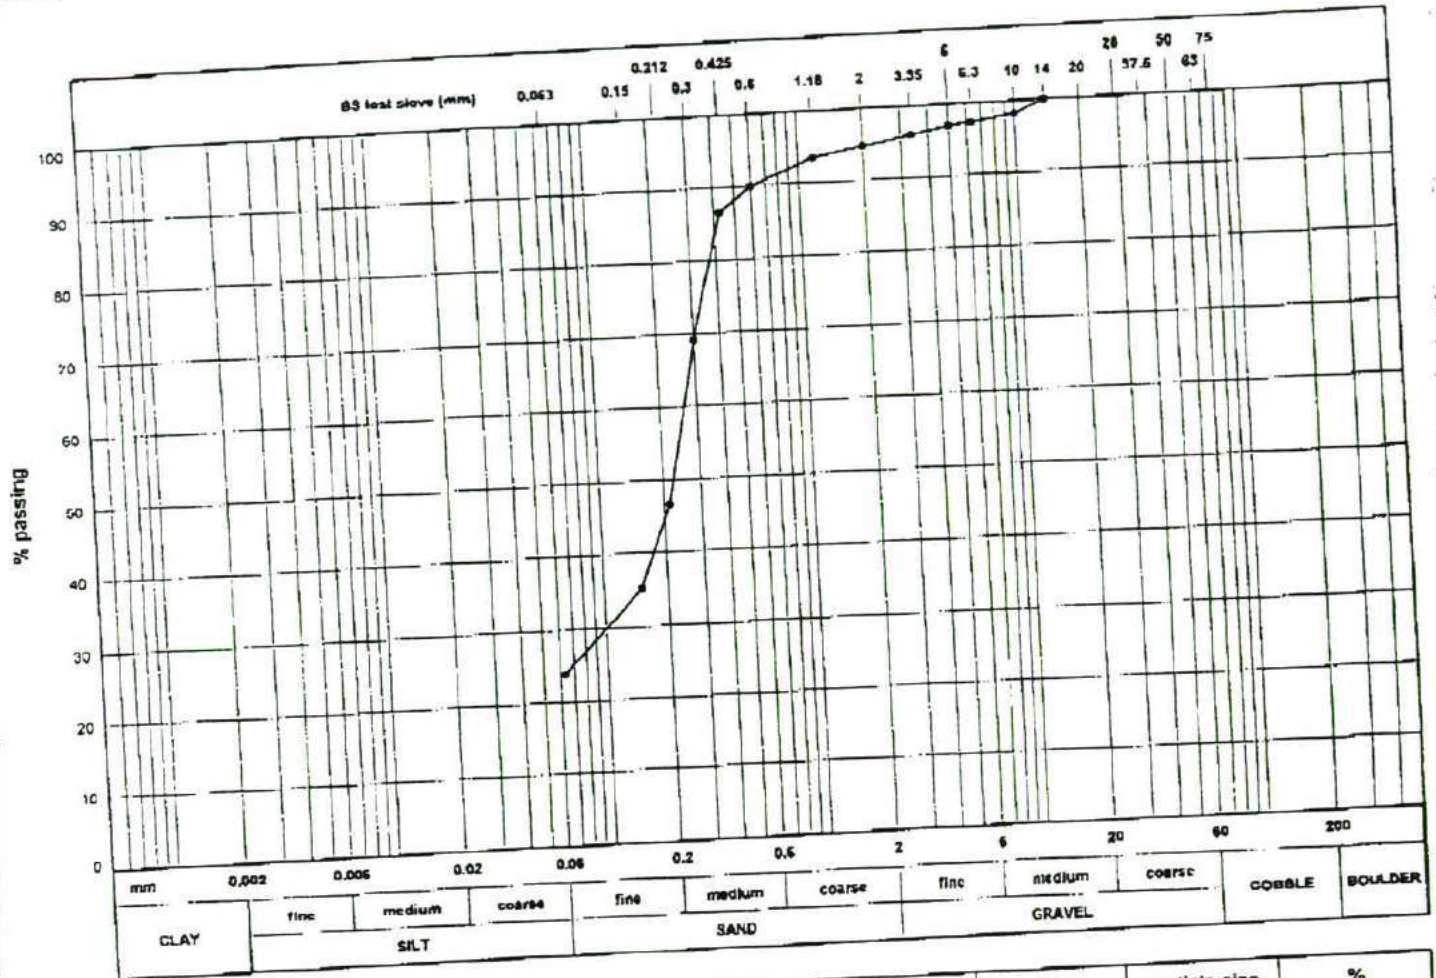
BH/TP No. BH01
SAMPLE No./TYPE B
SAMPLE DEPTH (m) 2.80
SPECIMEN DEPTH (m) 2.80

DESCRIPTION Yellow-brown very clayey SAND with a little f-m gravel.

soil type	% fraction	BS test sieve (mm)	% passing	BS test sieve (mm)	% passing	particle size (µm)	% finer
SILT & CLAY	24	75		3.35	96	20	
SAND	71	63		2	95	6	
GRAVEL	5	50		1.18	93	2	
COBBLE & BOULDER		37.5		0.6	90		
test method(s)	9.2	28		0.425	87		
test method:		20		0.3	69		
9.2 - wet sieving		14	100	0.212	47		
9.3 - dry sieving		10	98	0.15	35		
9.4 - sedimentation by pipette		6.3	97	0.063	24		
9.5 - sedimentation by hydrometer		5	97				
remarks:
