PHASE 1 DESK STUDY REPORT

6-12 LONDON ROAD, LIPHOOK, HAMPSHIRE, GU30 7AN

METIS HOMES LIMITED C/O MAPLEDEAN PROJECTS LIMITED

Report Reference: GWPR3874/DS/November 2020		Status: FINAL
Issue:	Prepared By:	Verified By:
V1.01 November 2020	[REDACTED]	
	Alec Ovens MSci RSoBRA FGS Senior Engineer	Francis Williams MGeol (Hons) FGS CGeol CEnv AGS Director
File Reference: Ground and Water/Project Files/ GWPR3874 6-12 London Road, Liphook, Hampshire, GU30 7AN.

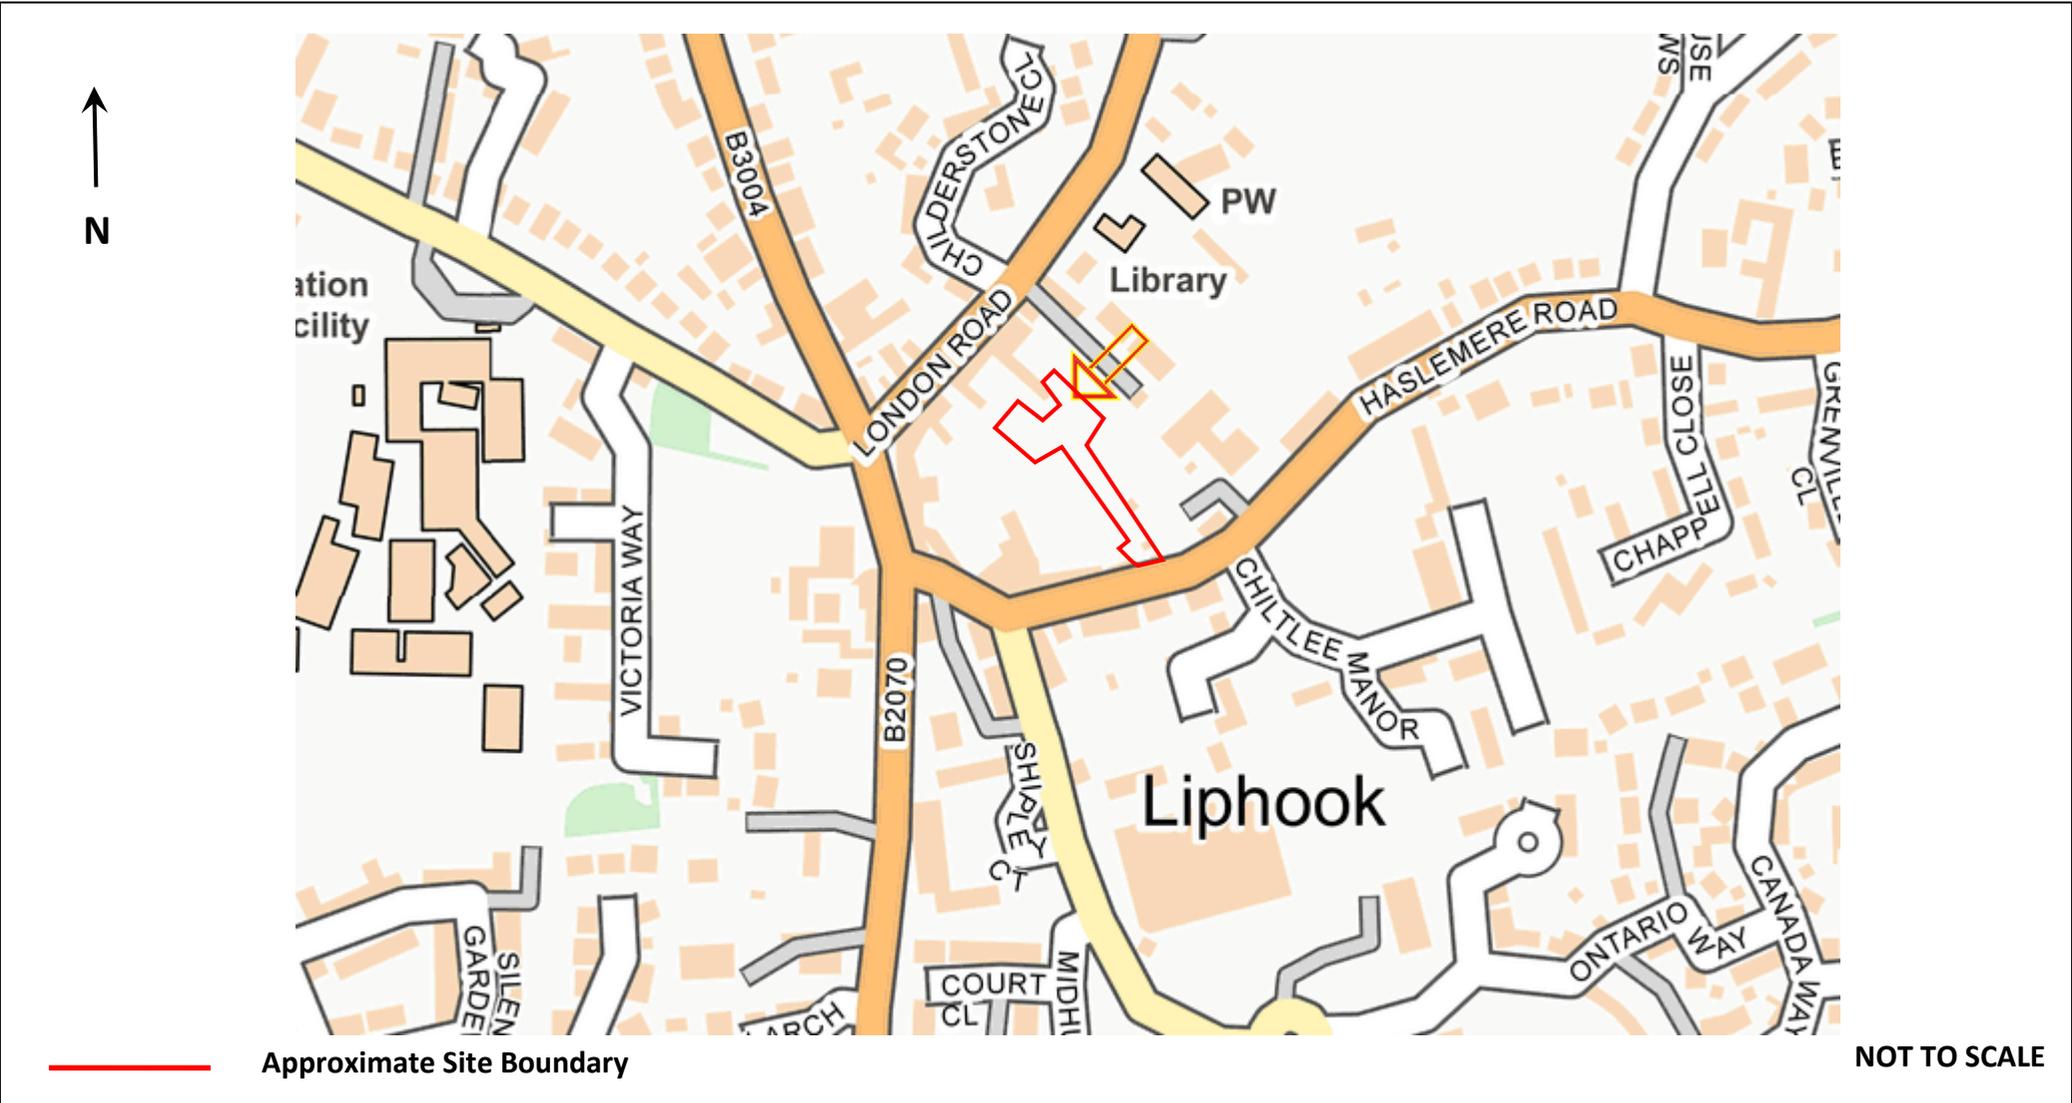
Figure 1

Project: 6 – 12 London Road, Liphook, Hampshire, GU30 7AN.	
Client: Metis Homes Limited c/o Mapledean Projects Limited	Date: November 2020
Site Location Plan	Ref: GWPR3874

The site comprised an ~4054m² irregular-shaped plot of land largely associated with the area of and to the south of 4 – 12 London Road. The site was located on the central plot of land to the south of London Road (B2131) and to the north of Haslemere Road within the central portion of the village of Liphook, within east Hampshire. The approximate O.S National Grid reference for the site was SU 84039 31592. A site location plan is given within Figure 1. A plan showing the site development area is given within Figure 2.

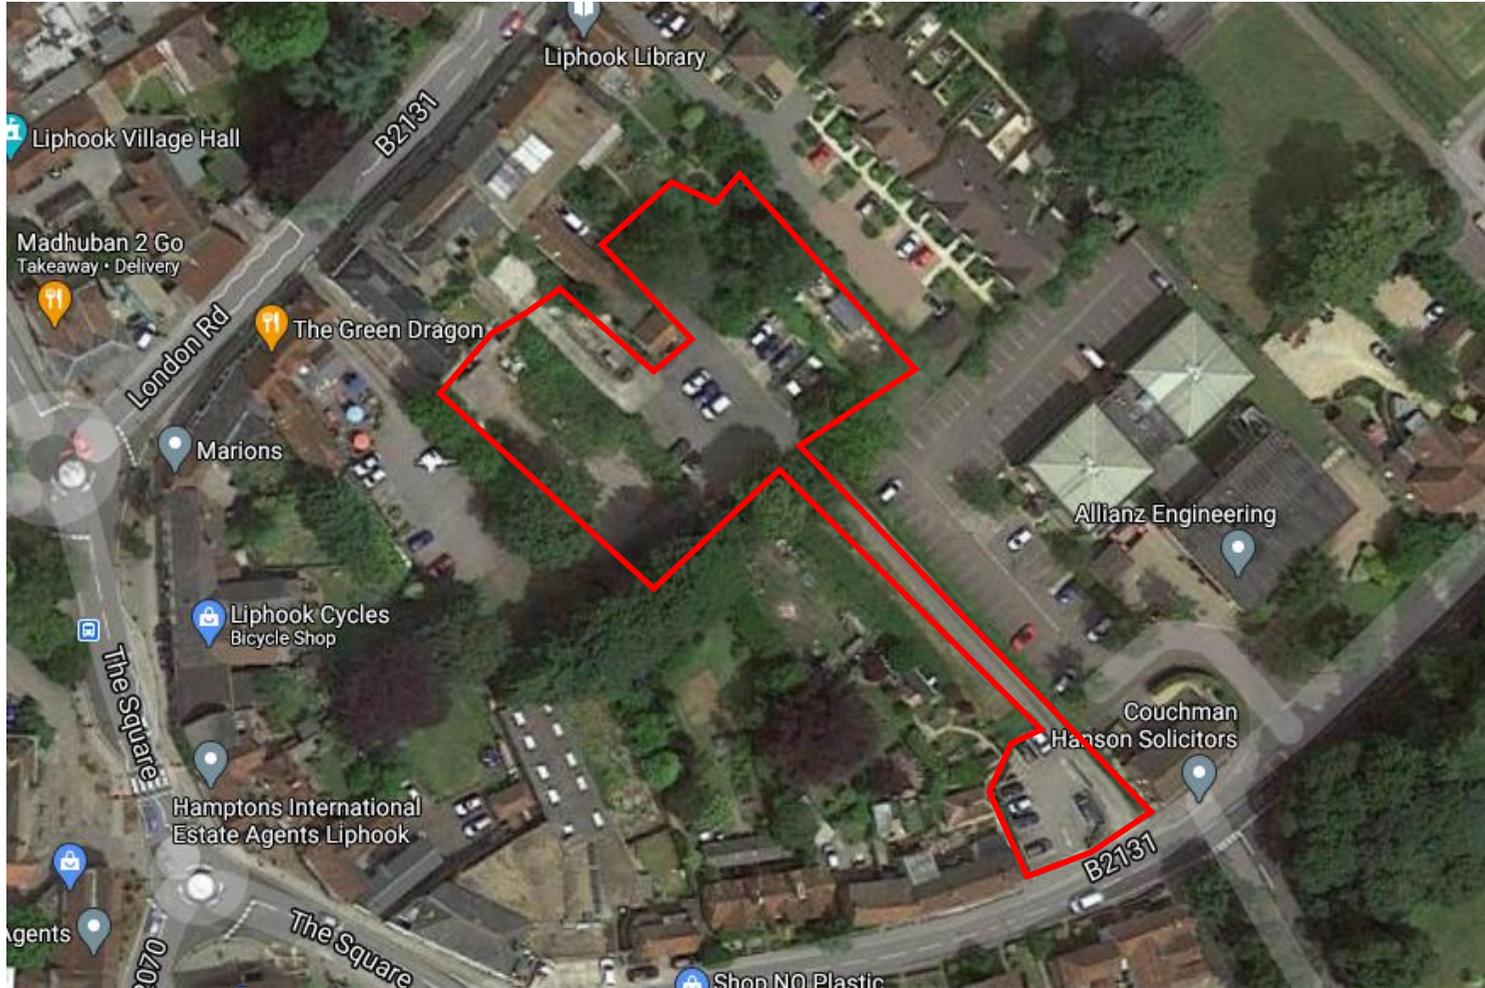
Figure 3

Approximate Site Boundary

A site walkover was undertaken by a representative of Ground and Water Limited on the 28th September 2020. A description of the site, as noted during the site walkover, is tabulated below. An aerial view of the site showing an approximate site boundary is given within Figure 3.

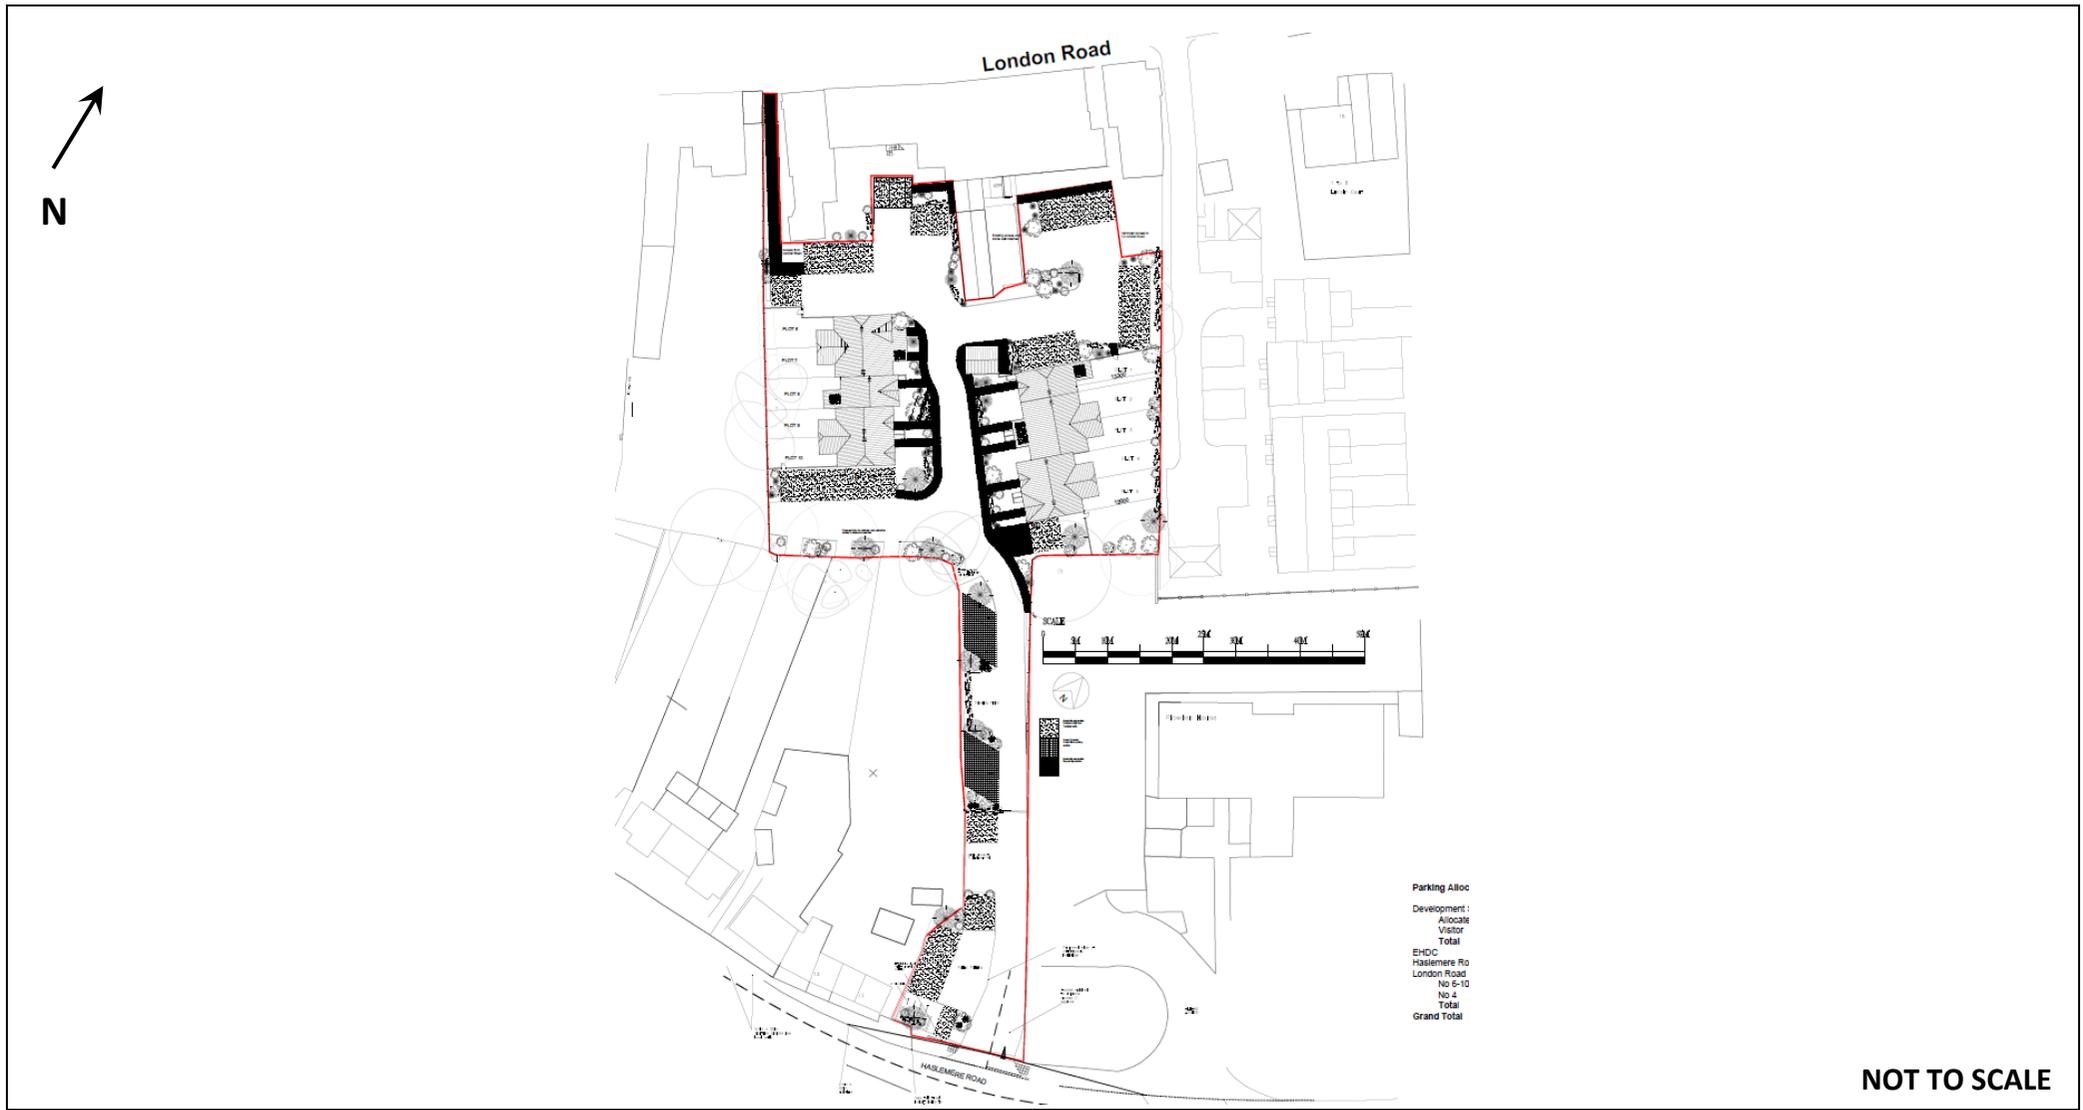
Project:		6 – 12 London Road, Liphook, Hampshire, GU30 7AN.	
Client:	Metis Homes Limited c/o Mapledean Projects Limited	Date:	November 2020
Proposed Development – Plan View		Ref:	GWPR3874

At the time of reporting, November 2020, the proposed development was understood to comprise the demolition of on-site structures and construction of 10No. low-rise two-storey residential dwellings with associated private garden areas, car parking and communal planting spaces. The

development would include additional guest and public parking areas to the south of the site. Vehicle access to the development would be gained via Haslemere Road to the south with additional a footpath granting access via London Road to the north. The proposed development plan – plan view can be viewed in Figure 4.
