## Bat Survey: Polvellan Manor, Looe

Project No: J000155

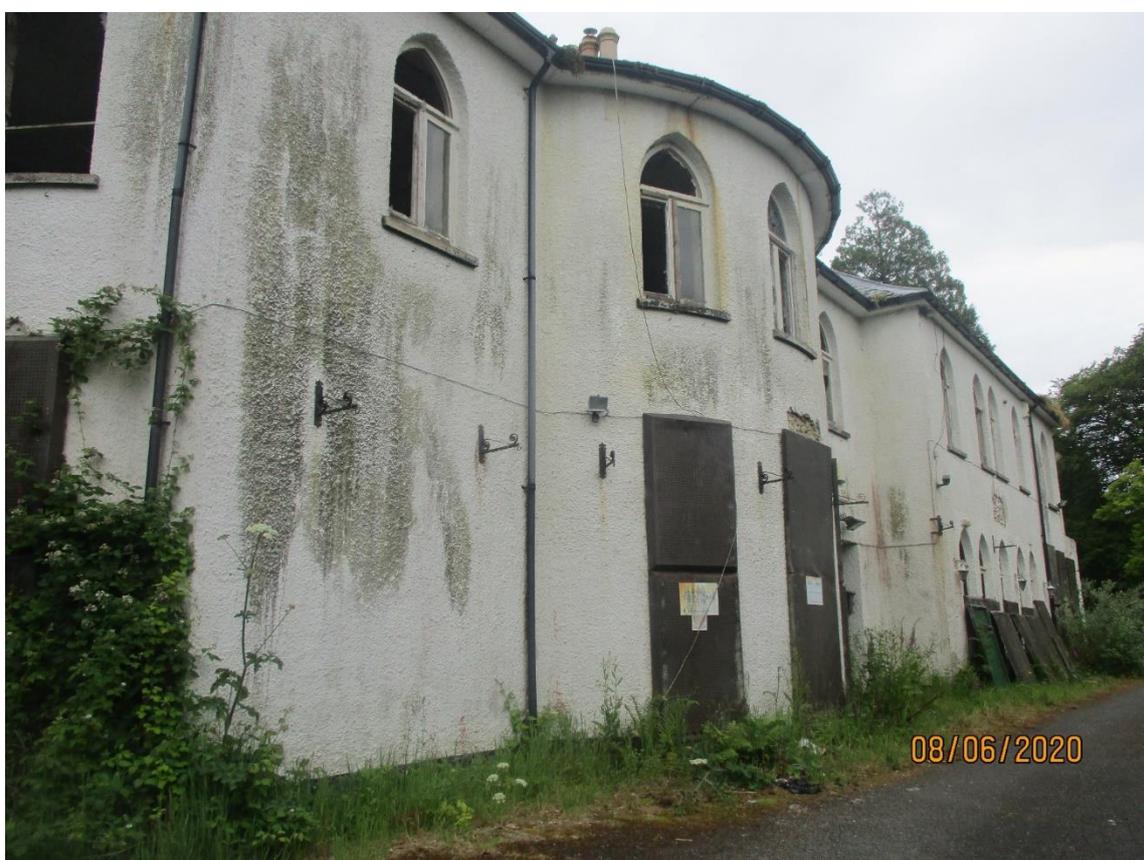
Figure 1: Polvellan Manor (front, north elevation)

The main house (figure 1) has been derelict for some years, with access for bats available via broken windows at first floor level (figure 2). The building includes two separate loft areas, where bats have previously been recorded (figure 3). The woodlands also contain some mature trees with a range of potential roost features (figure 4).

3. The removal of fascias and key features of the roof shall be dismantled by hand under the watching brief of the licensed ecologist.
4. The roosting features beneath the fascias of the eastern elevation (as shown in Fig 1) shall be retained/re-created.

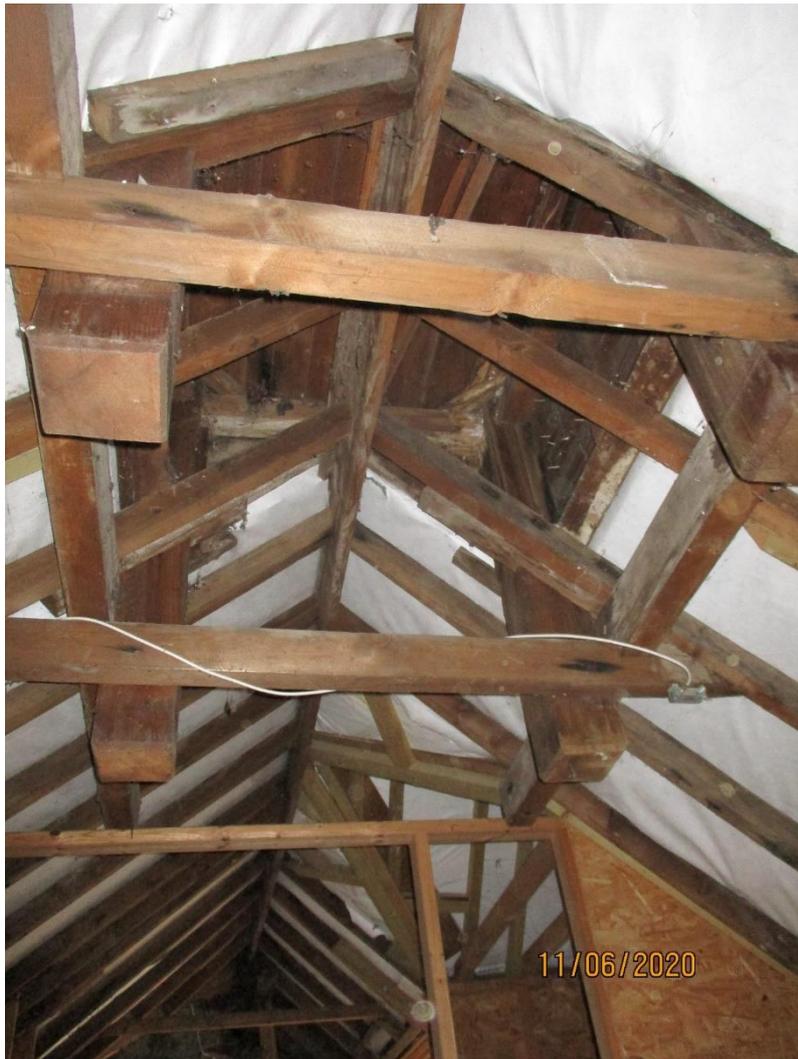
Figure 3: Attic (western end)

A building inspection was carried out on 11 June 2020. Many of the window panes of the house have been broken and the windows now provide multiple permanently open apertures. Some disturbance to the loft voids has occurred through trespass. Bat droppings were identified within the westerly loft space, below a section of torn roofing felt. Occasional bat droppings were identified at various locations within the building, conducive with bats in flight.

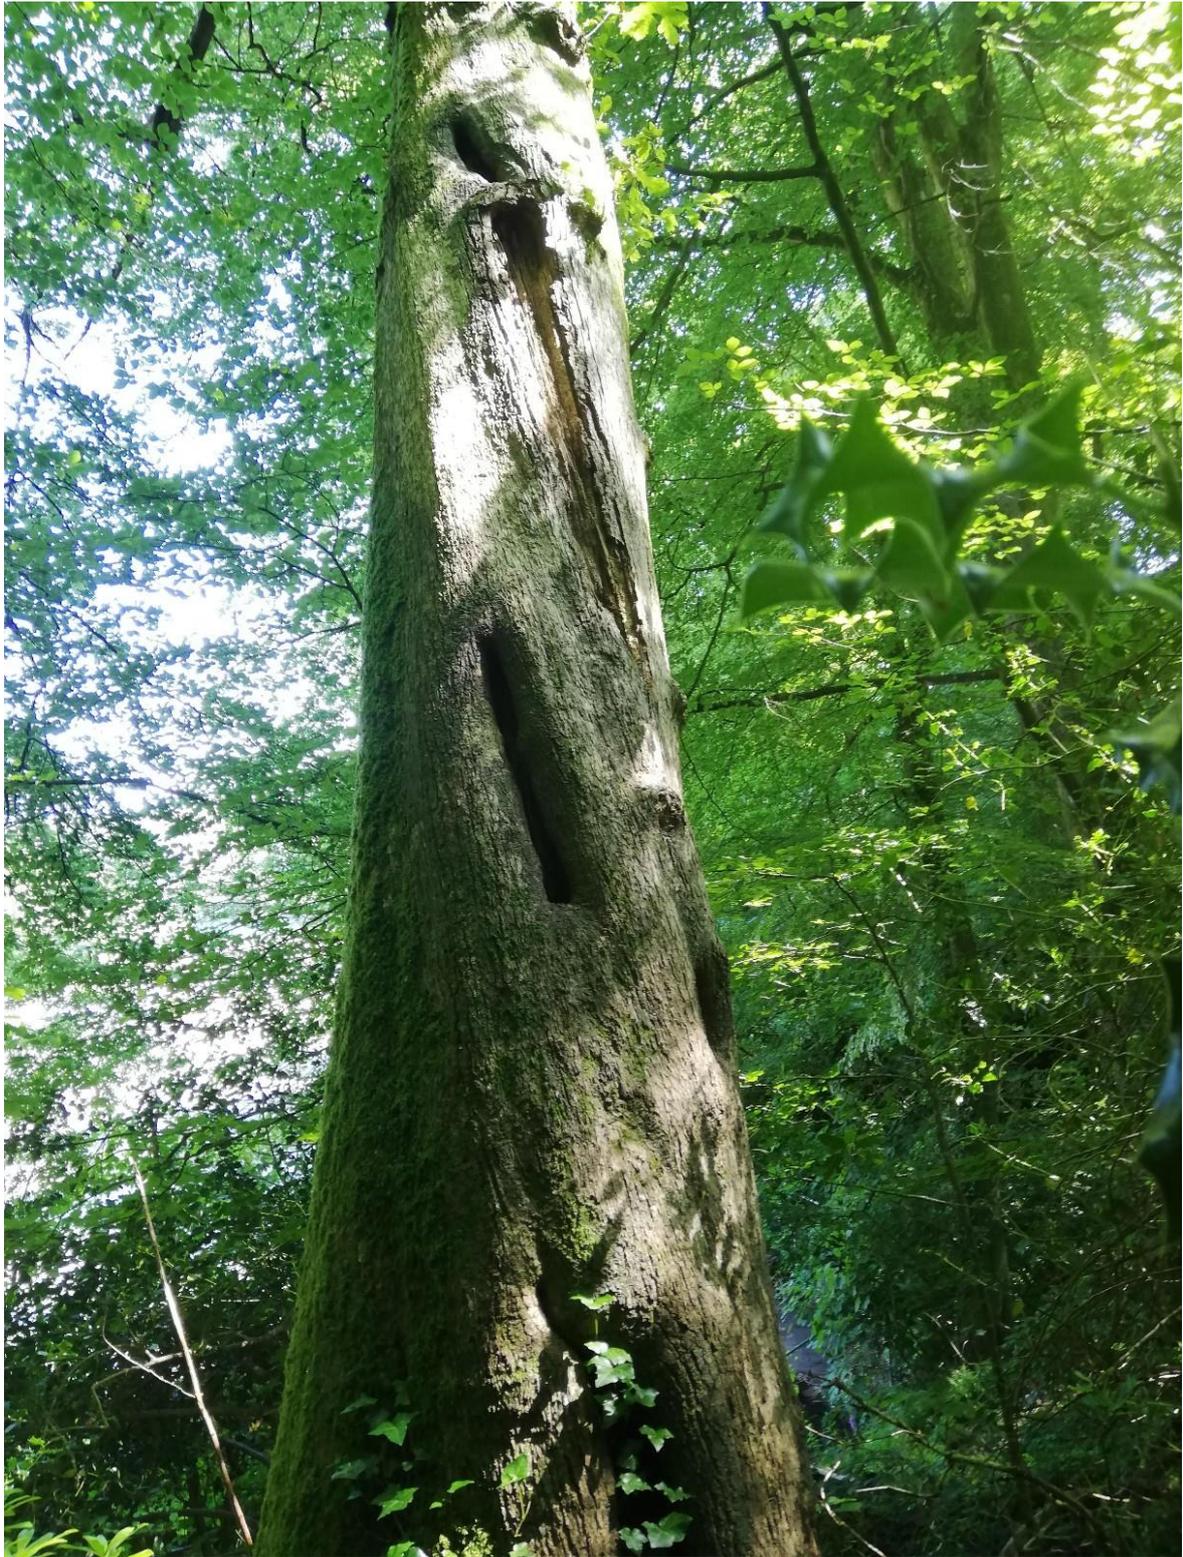
**Figure 4: Potential Roost Features in mature oak - hollows within main trunk.**

1. A hung up dead ash tree, not recorded in the BS5837 arboricultural survey
2. A large sycamore with major limb damage following the fall of an adjacent nature sweet chestnut, recorded as tree 118 in the BS5837 arboricultural survey
3. A mature oak, with hollows on the main trunk, recorded as tree 2010 in the BS5837 arboricultural survey; see also figure 4.

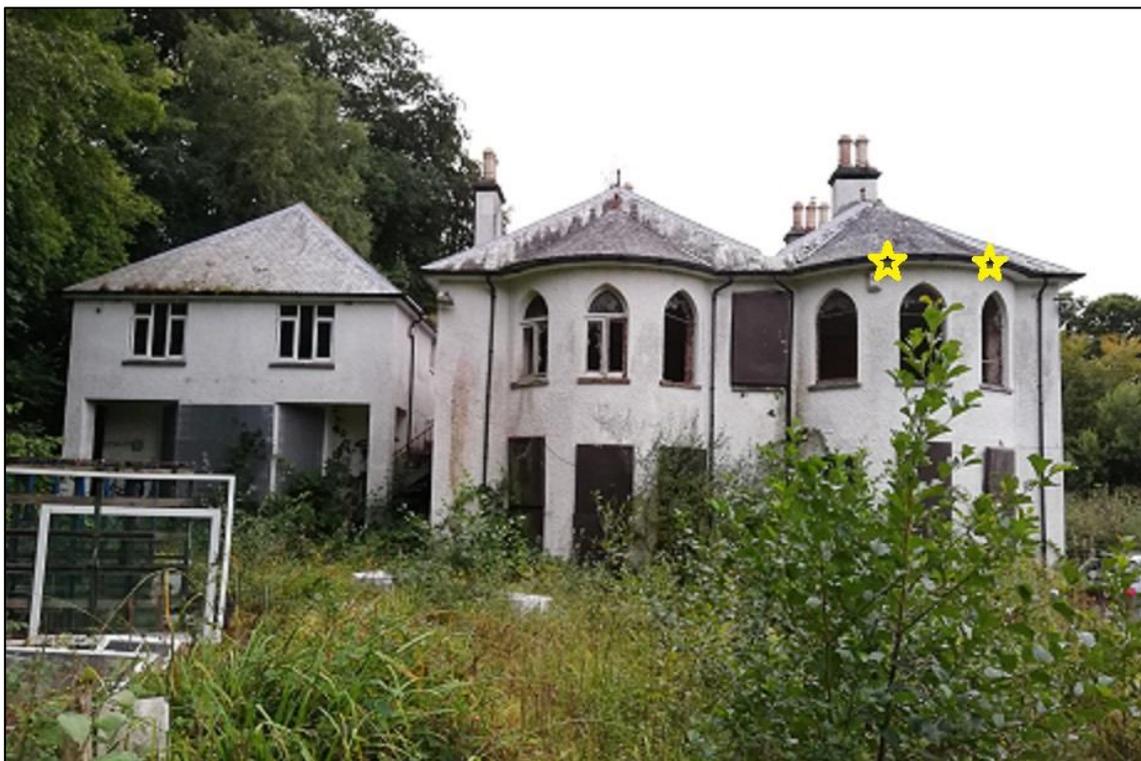
**Figure 5: Common Pipistrelle emergence points.**

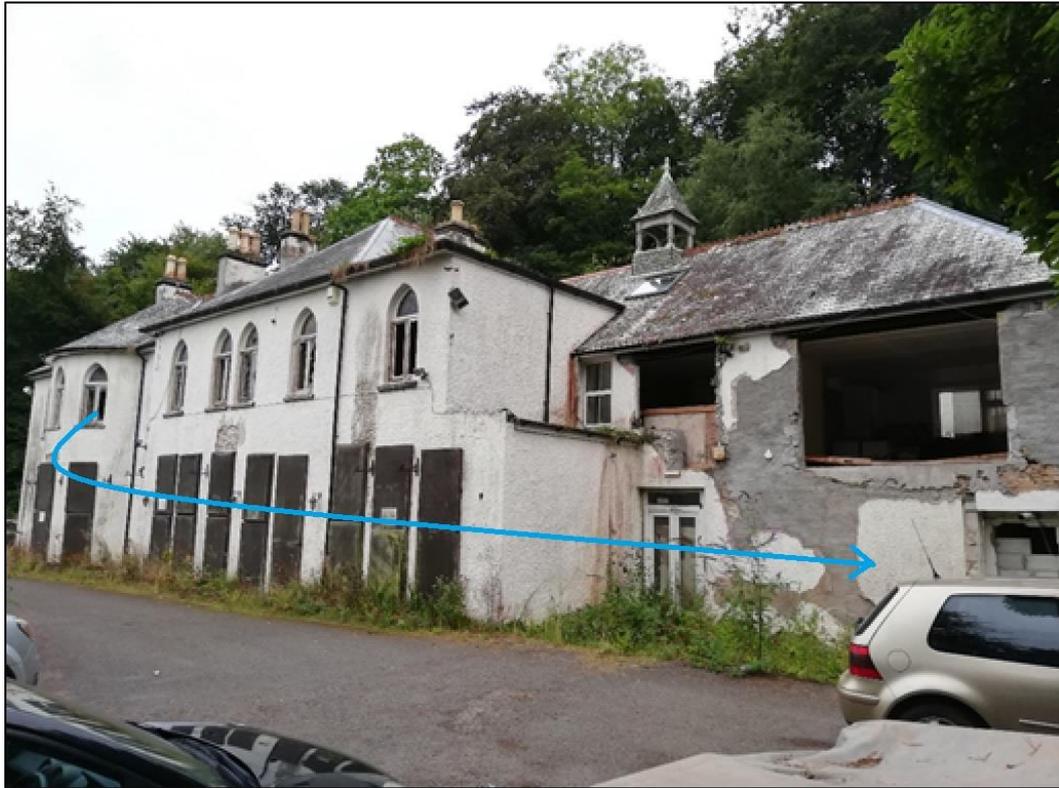
Figure 6: Lesser Horseshoe emergence point.

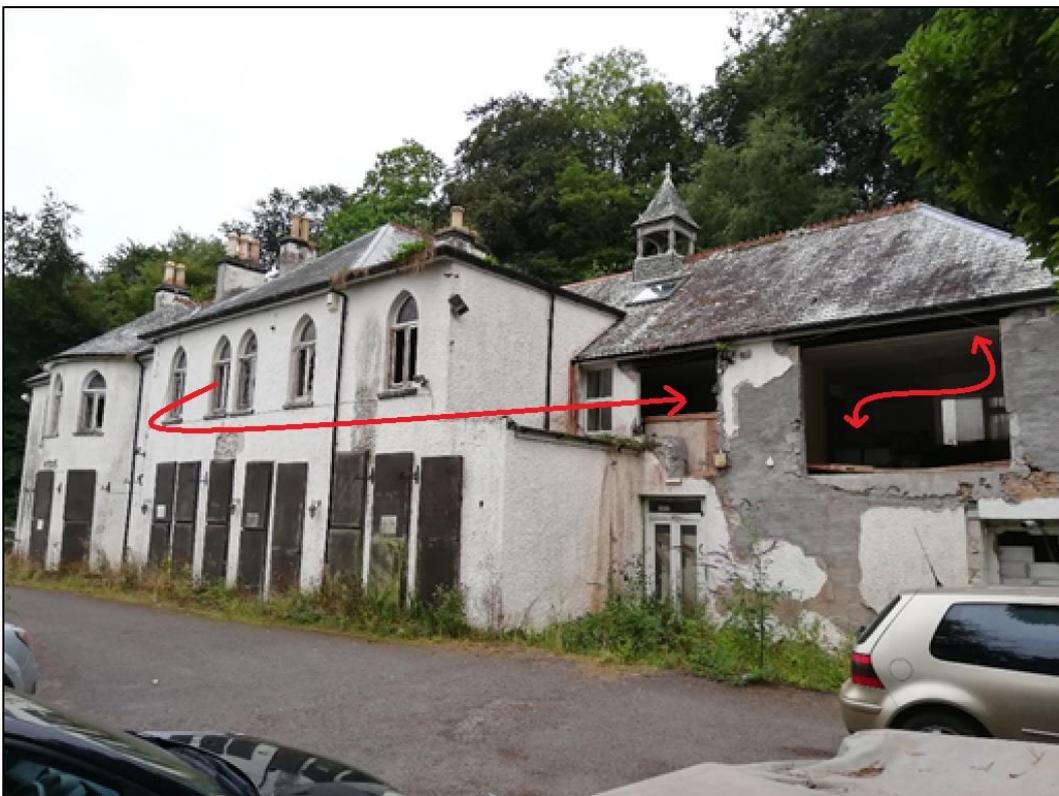
Figure 7: Greater Horseshoe emergence point, and pre-emergence flight behaviour in unfinished extension.

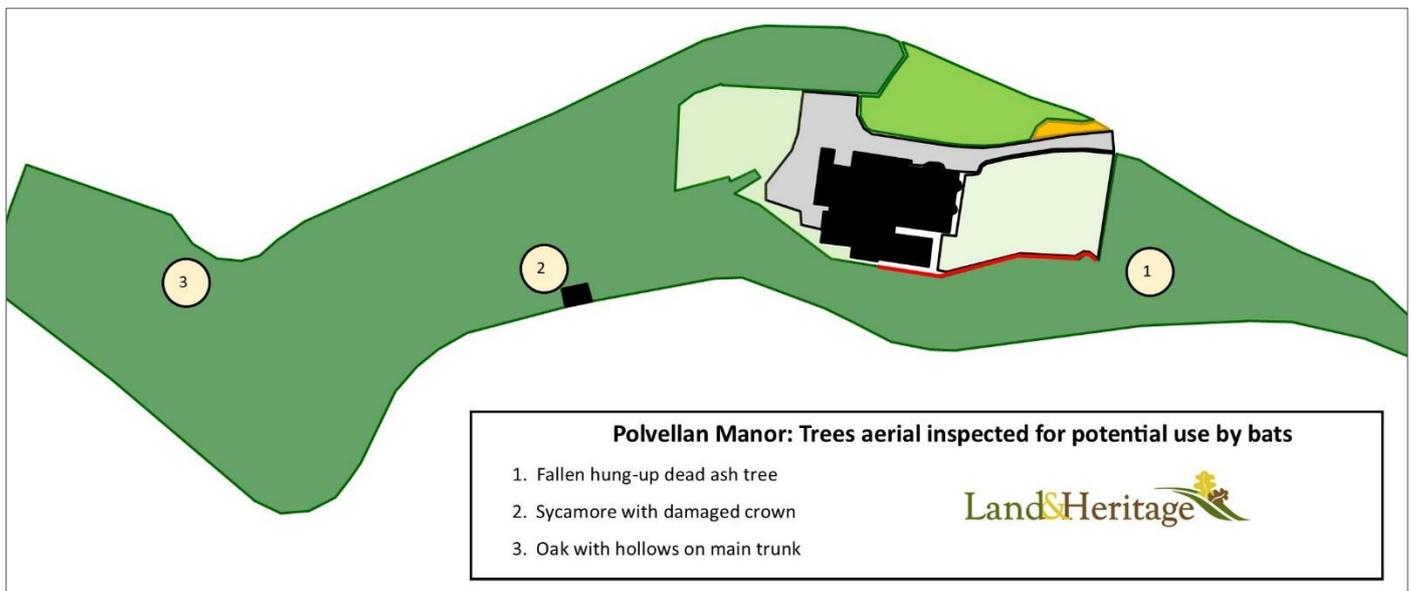
**Figure 8: Location of trees aerially inspected**

The tree locations are shown in figure 8 below.

No evidence of roosting bats was found in any of the surveyed trees.
