HERITAGE STATEMENT

3. EXISTING CONDITION OF THE RIGHT HAND GATE PIER

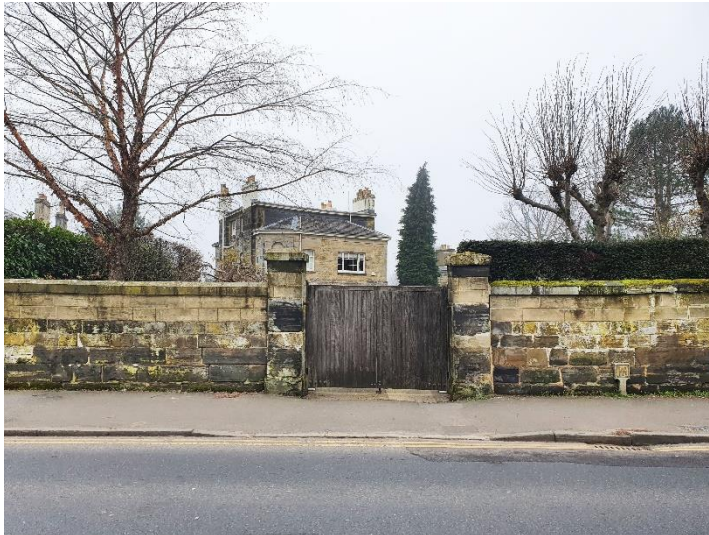
Most of the houses have a gated secondary access onto Prospect Road, the length of which is bounded by a high wall built in local sandstone. The photo shows the existing access to no.14 Calverley Park.

The wall is likely to have been built at the time of the houses in the Park and the gate piers are now leaning. The lean to the one on the right of the photograph is steadily increasing its lean and consent is sought to take it down and rebuild it

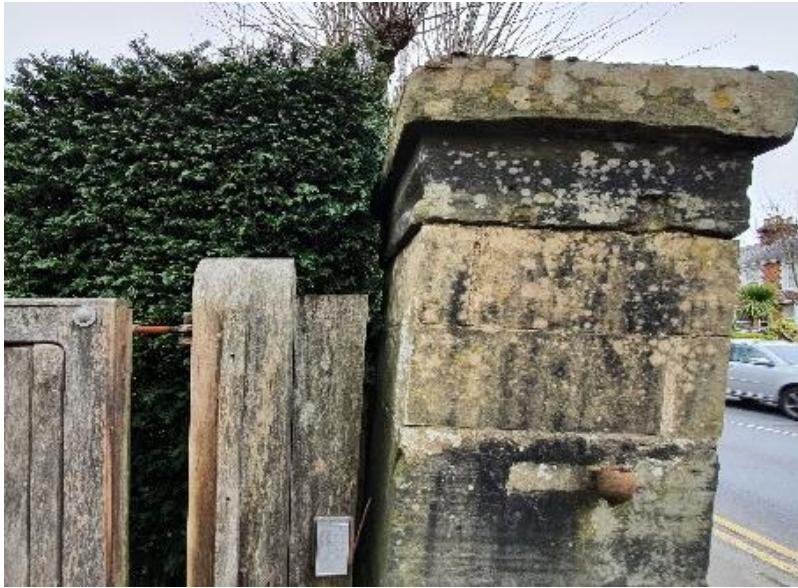
At the top the stone pier leans out 240mm towards the road from the timber gate post

The stone originally carried the entrance gates and the knuckles that carried them are still in place set into to the stone

The right hand pier has a pronounced lean in two directions. Shown here is the lean outwards the road. The lean has shown a steady increase and will in time collapse

It is proposed to take down the pier and carefully set the stone aside.

Excavate and install a concrete footing and reinstate the stone pier

The original cast iron knuckles will be retained in the stone

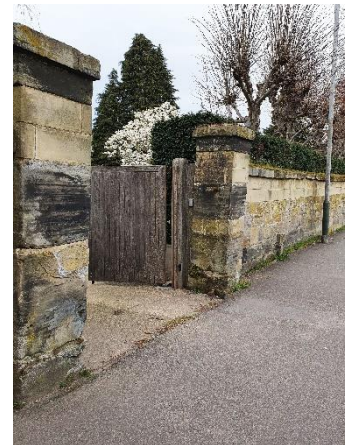
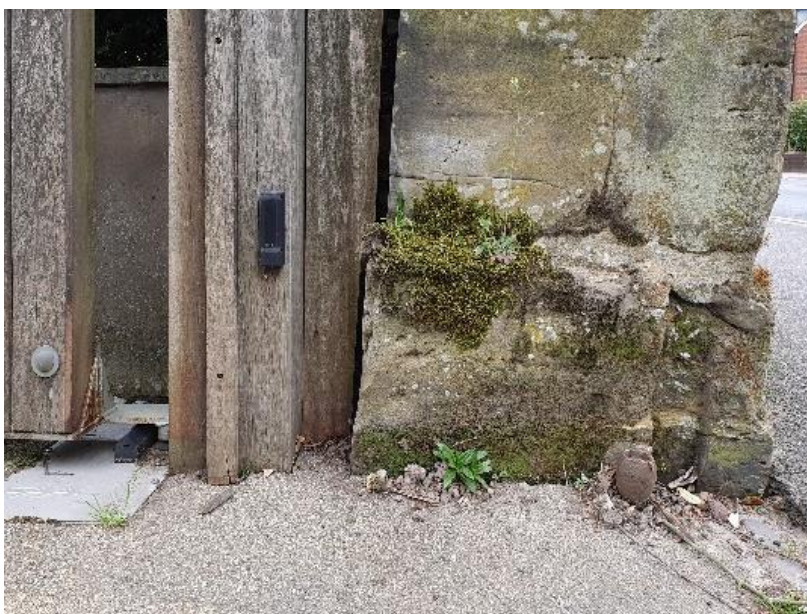
At the base (measured from the top of the plinth), the post is set back 155mm from the stone pier

This shows a lean of 85mm at the top

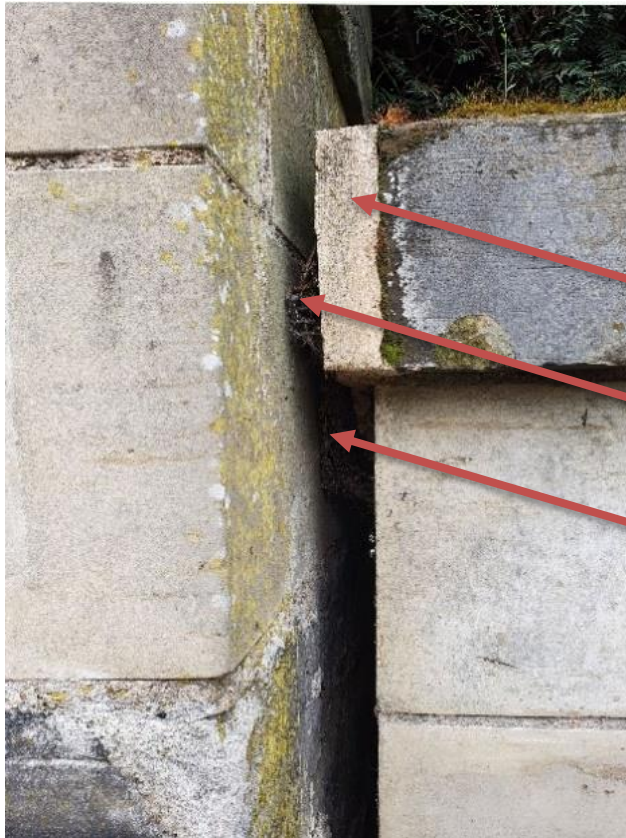
Gap filled with mortar at the time the new stone was installed.

The photograph shows that the pier has continued to move away from the wall

The lean in towards the left hand gate pier is clearly seen from Prospect Road. Both the pier and the wall were repaired using smooth cut stone more than ten years ago and the gap shows that the pier is not bonded to the wall. A small repair was carried out after the new stone repair

Present gap approximately 50mm
Wall and pier to be securely tied in together
Method to be agreed on site once pier dismantled

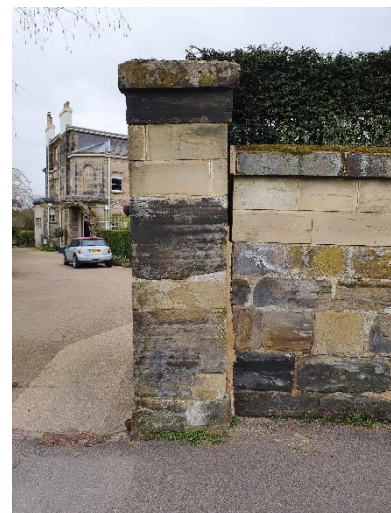
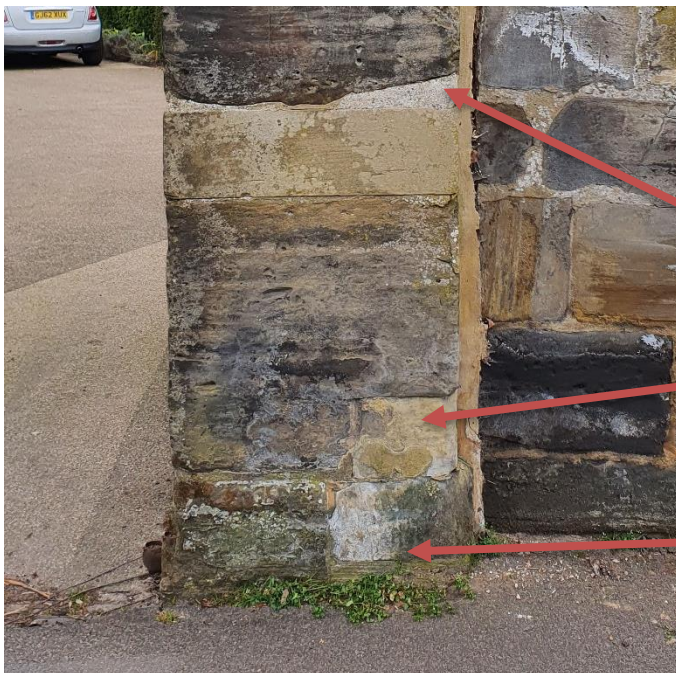
Previous repairs carried out to make up gaps using cement mortar

Damage to original stone repaired by cutting a new piece into the original

Stone at base of wall needs to be replaced as it will be damaged when moved

It is likely that some of the stone will break when the pier is being dismantled and will need to be replaced. Stone is no longer available from the original source in Quarry Road and the repairs will be carried out using natural sandstone from the nearest available quarry at West Hoathley, Sussex do not cause any significant harm to the setting of the Listed buildings. At the same time the cement patching of the damaged joints will be repaired and will be re-set using lime mortar.
