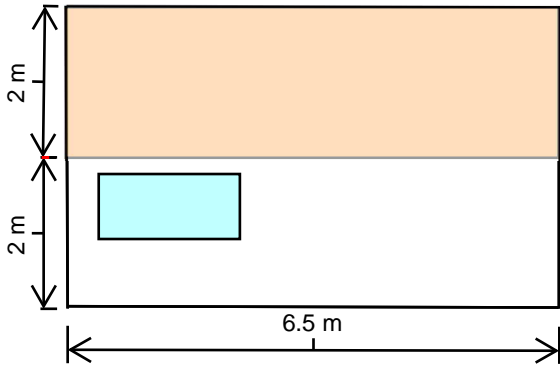
Rear Elevation

Brick work with pan tile roof.
Rear wall is falling back from side walls with two large cracks)

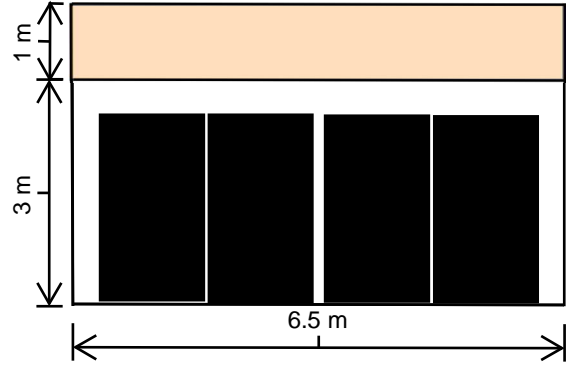
Front Elevation

Brick walls with four timber doors with rhs permanently sealed shut.

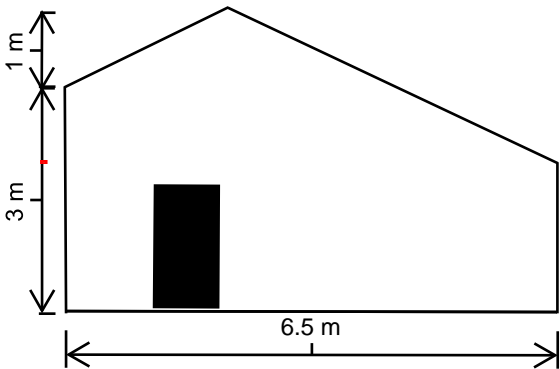
Right hand Elevation

LHS and RHS brick work elevation with cracking around windows and door with rear wall coming away from side walls.

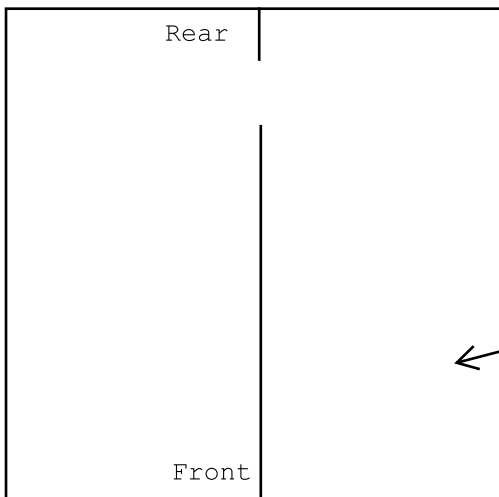
Floor Plan

Existing floor timber batten on right and concrete on the left.
Internal wall is a timber stud insert to 2m high.
