WESTCOUNTRY MINES  
& PROPERTY SURVEYS

A Report on a Site Investigation  
Carried out at:

Sarnia,  
Two Burrows,  
Blackwater,  
Truro.  
TR4 8HN.

Ref: 64244A

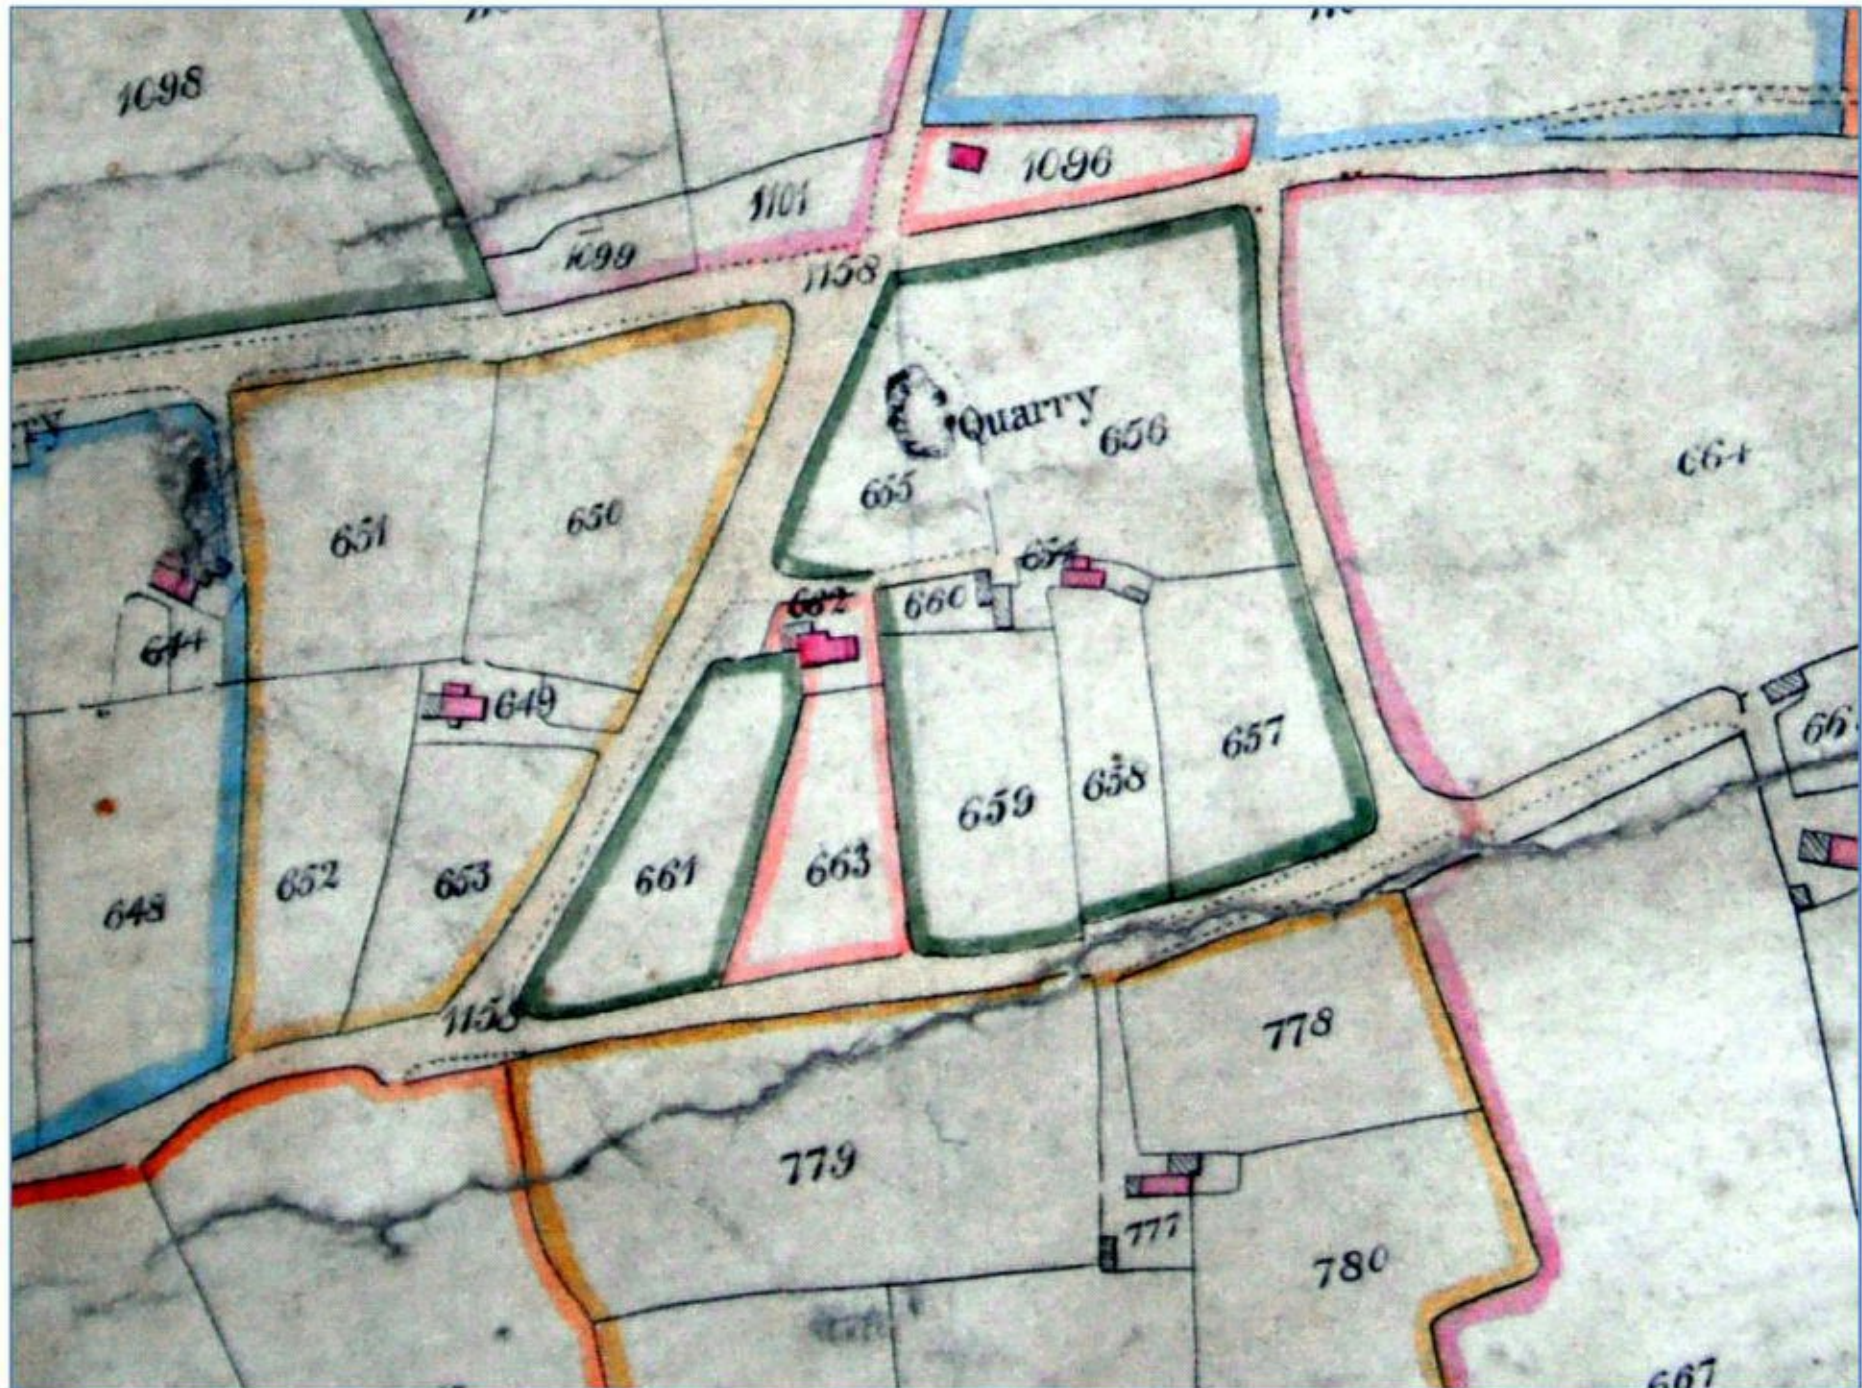
Extract from Map of Manor of Goonearl 1866, showing property (edged in green) and quarry within area annotated as 655.
