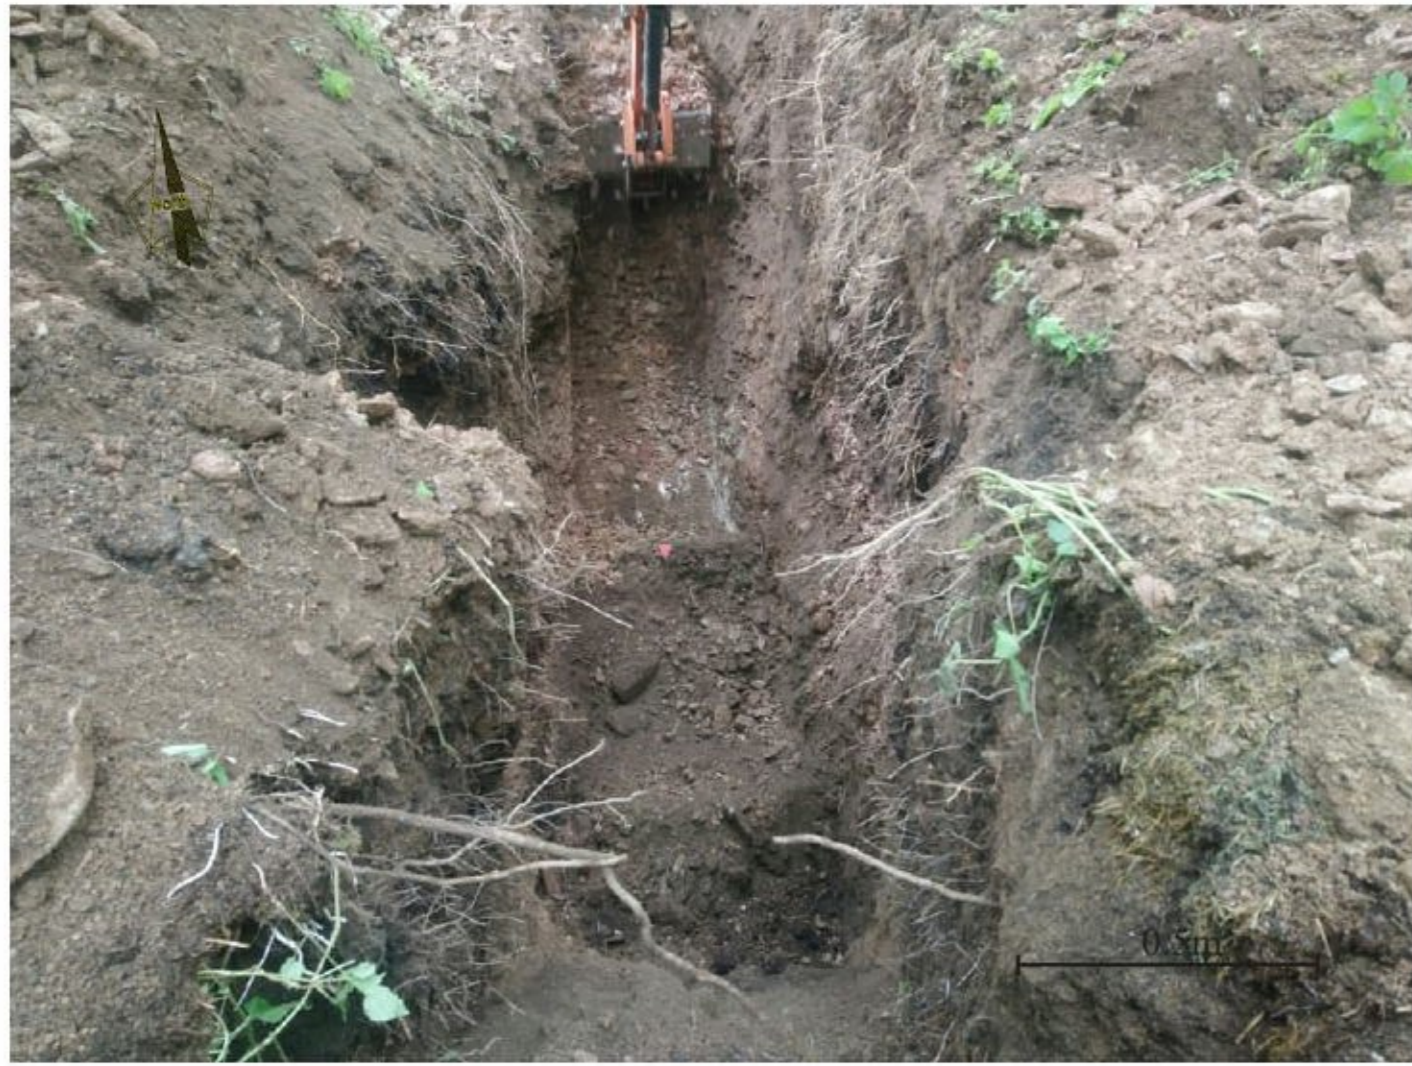
Photograph 1. In-situ weathered and fresher rock, overlain by stony clay and soil horizons, inferred to indicate northern limits of quarry.

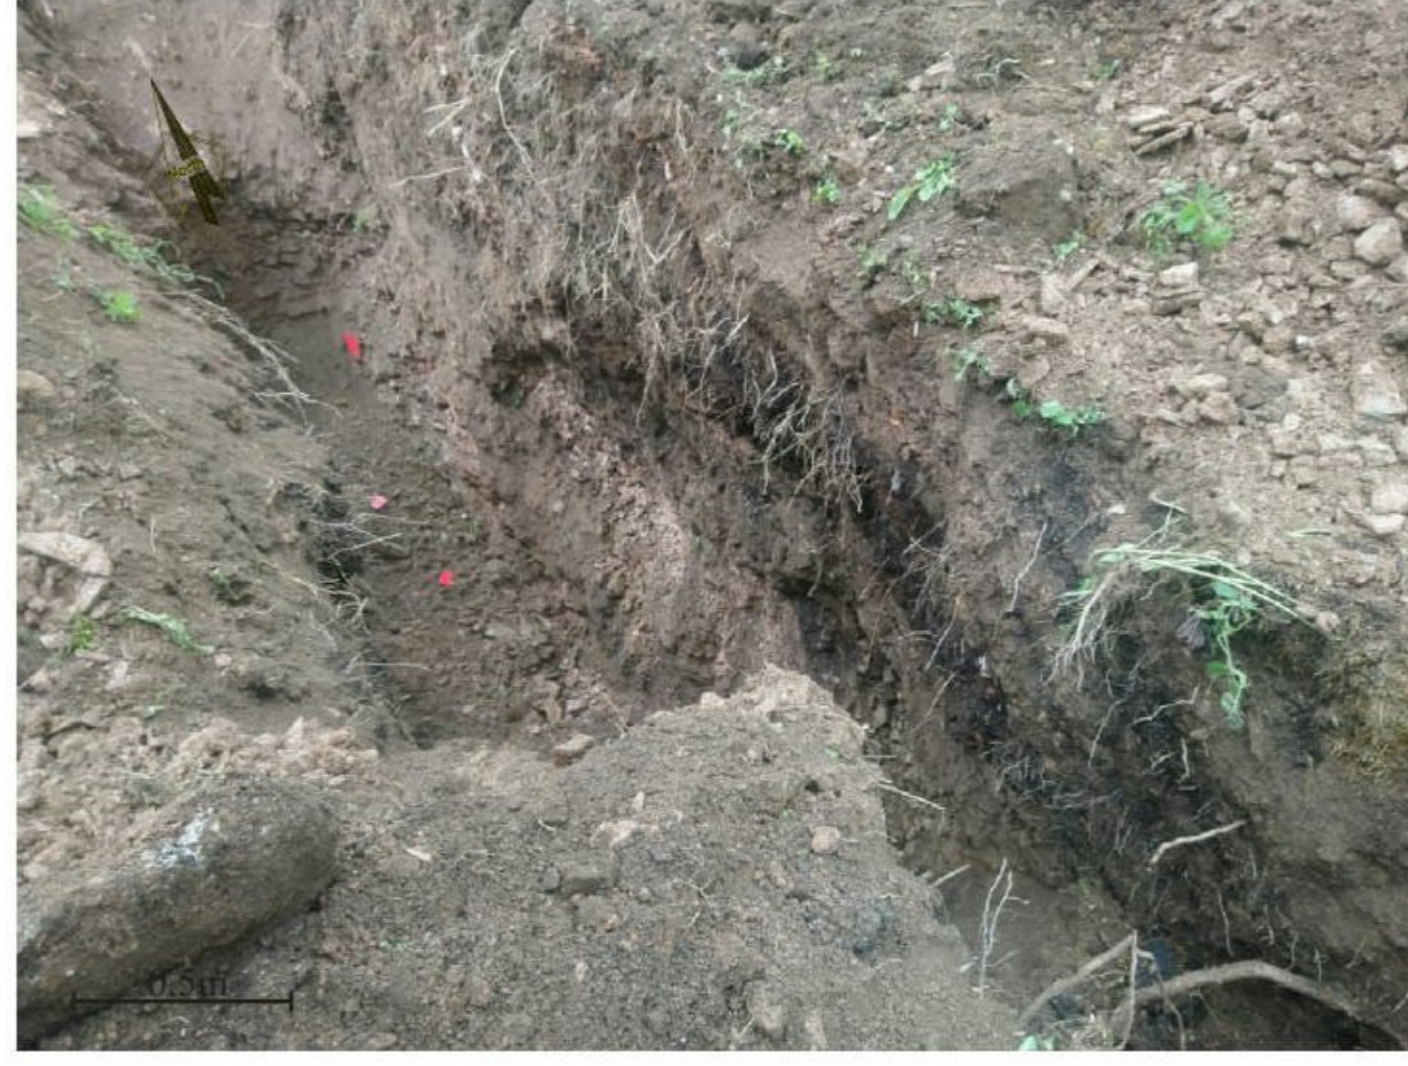
Photograph 2. Detail of the fill layered horizons encountered on northern side of quarry overlain by darker organic-rich soil, with roots. Base of quarry confirmed at 4.0m beneath the present surface.

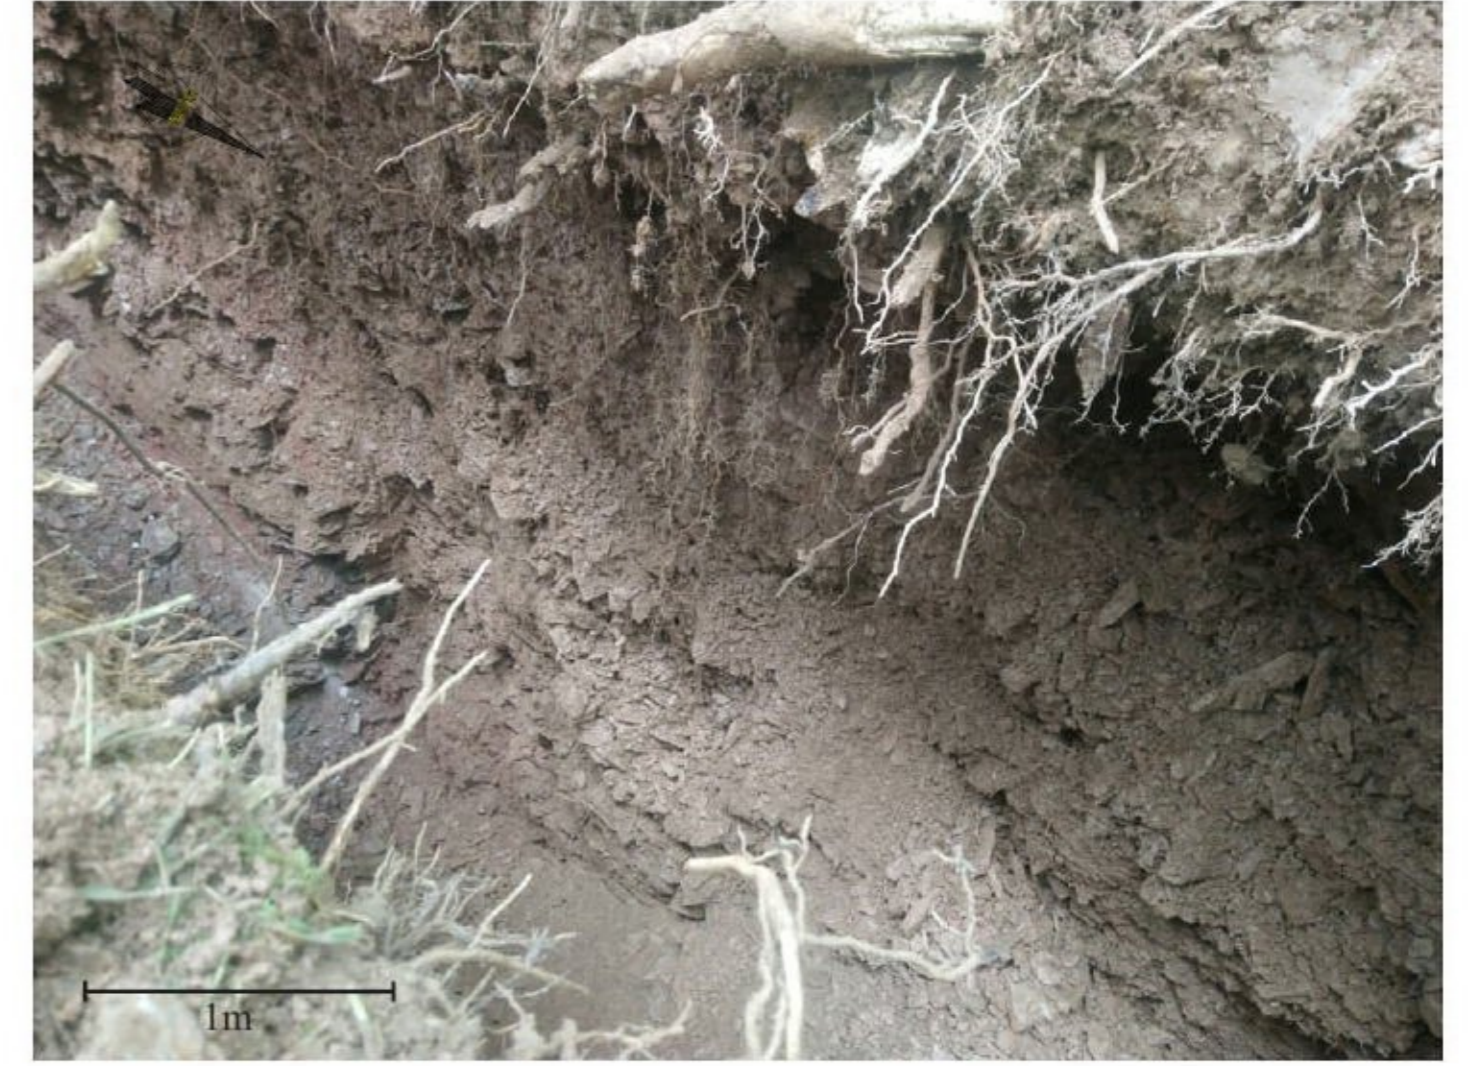
Photograph 3. Southern edge of quarry marked by shelf of intact weathered metamorphic bedrock at 2.5m beneath present surface level. Note uniform stony fill to north, confirmed to extend to approximately 4.5m beneath surface levels.

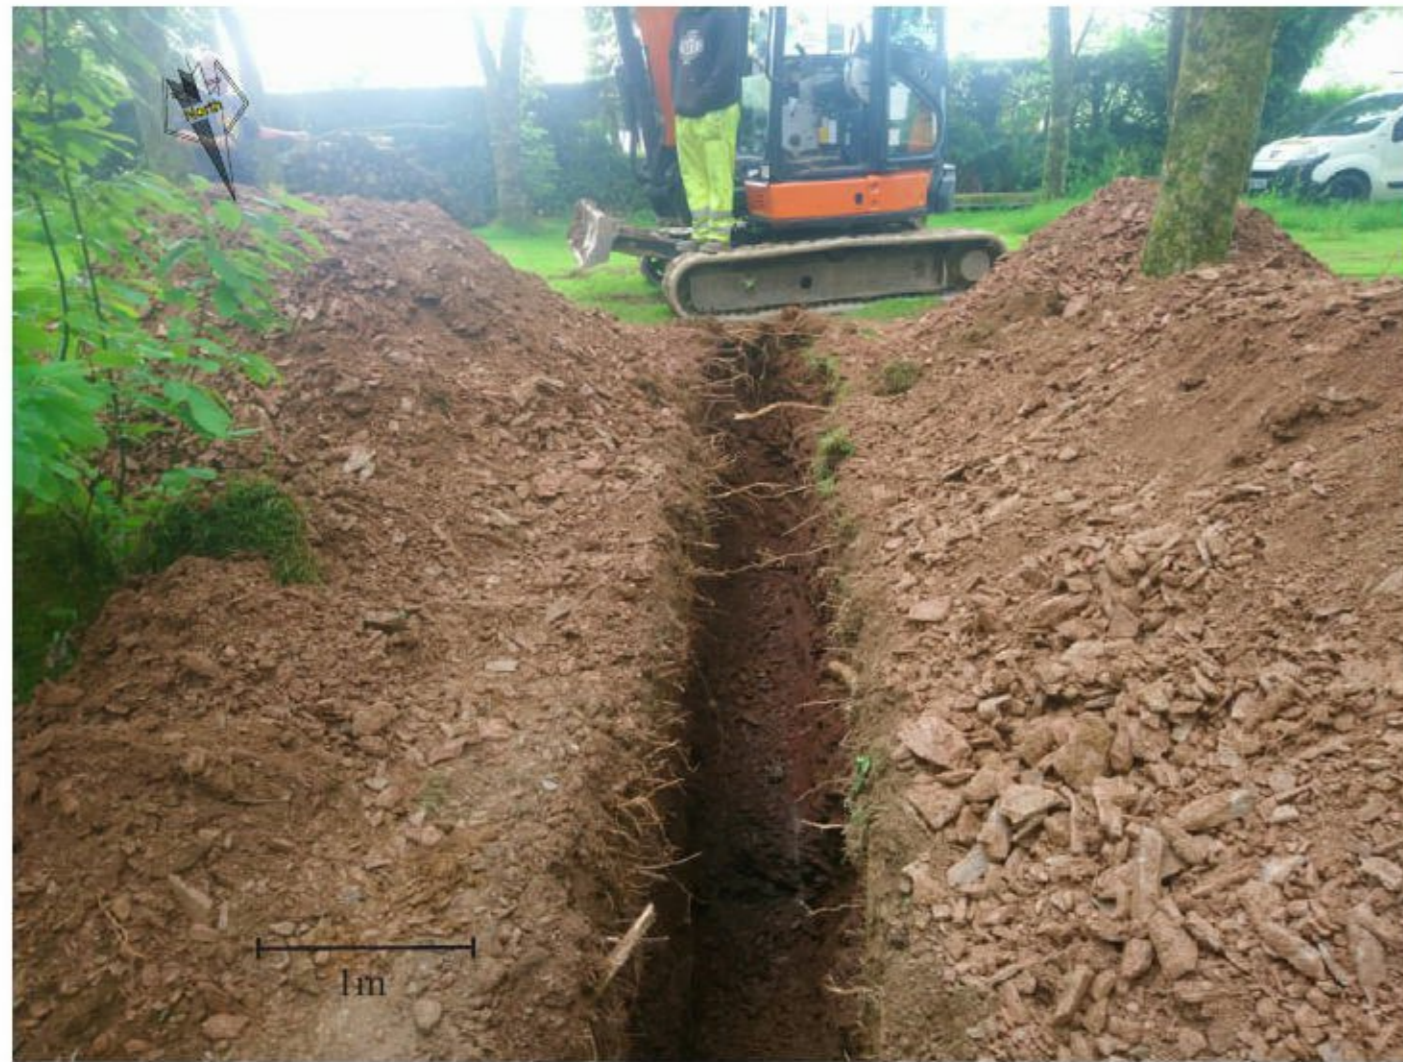
Photograph 4 View looking south along central trench showing consistency of encountered fill horizons comprising angular cobbles of metasediments with interstitial pink/buff clays.

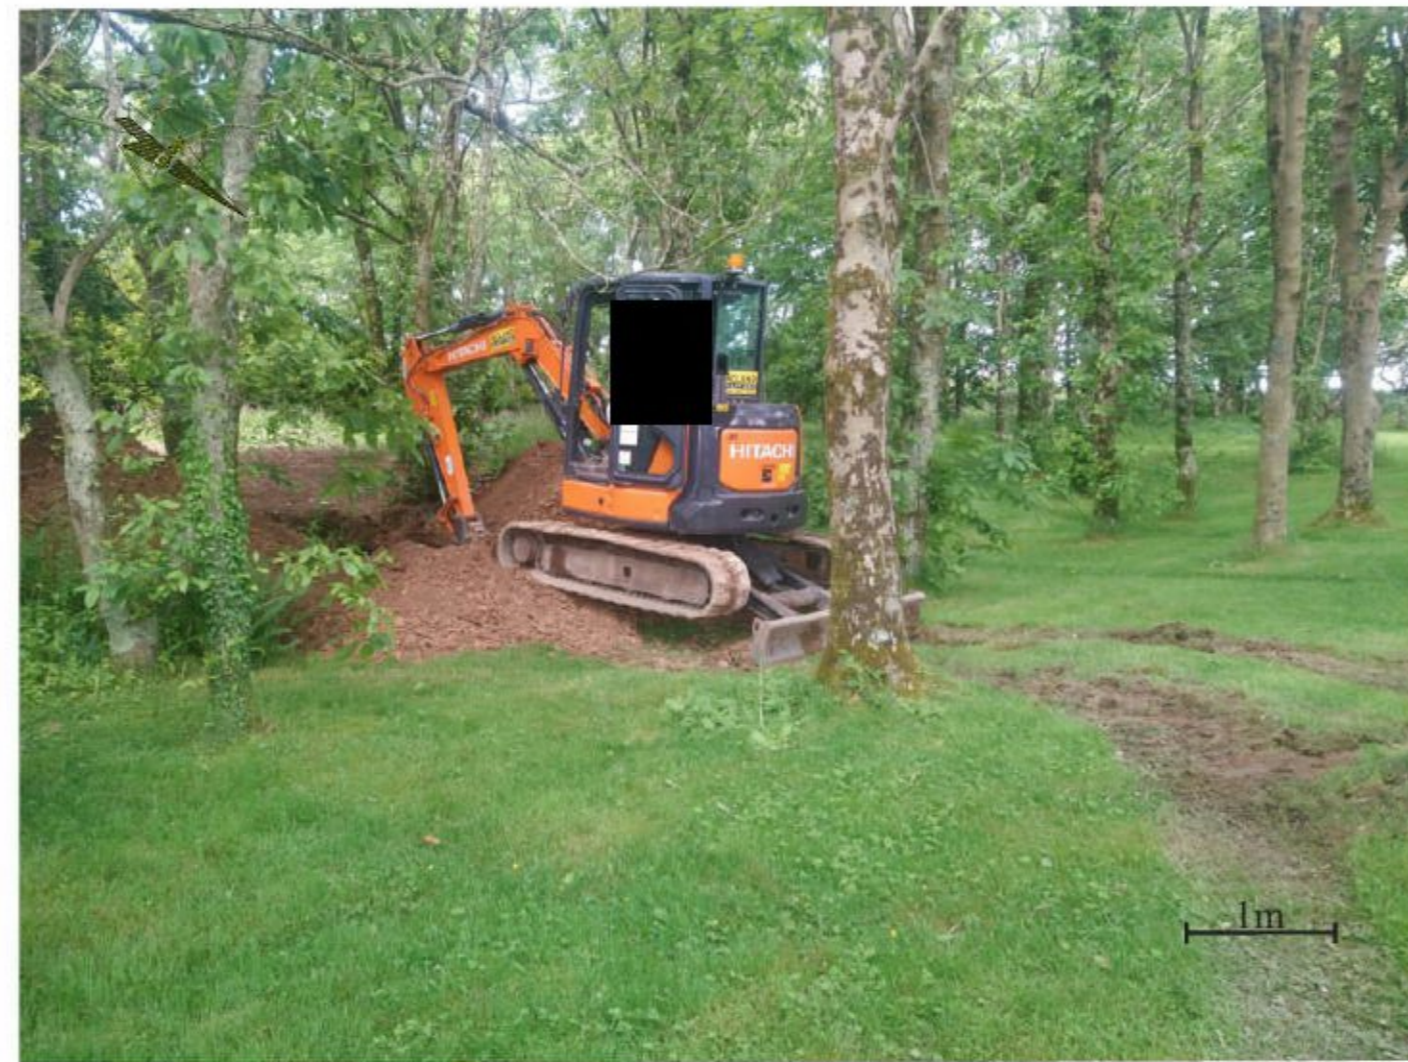
Photograph 5. View of quarry area showing depression indicating quarry area approximately marked by extent of mature trees.

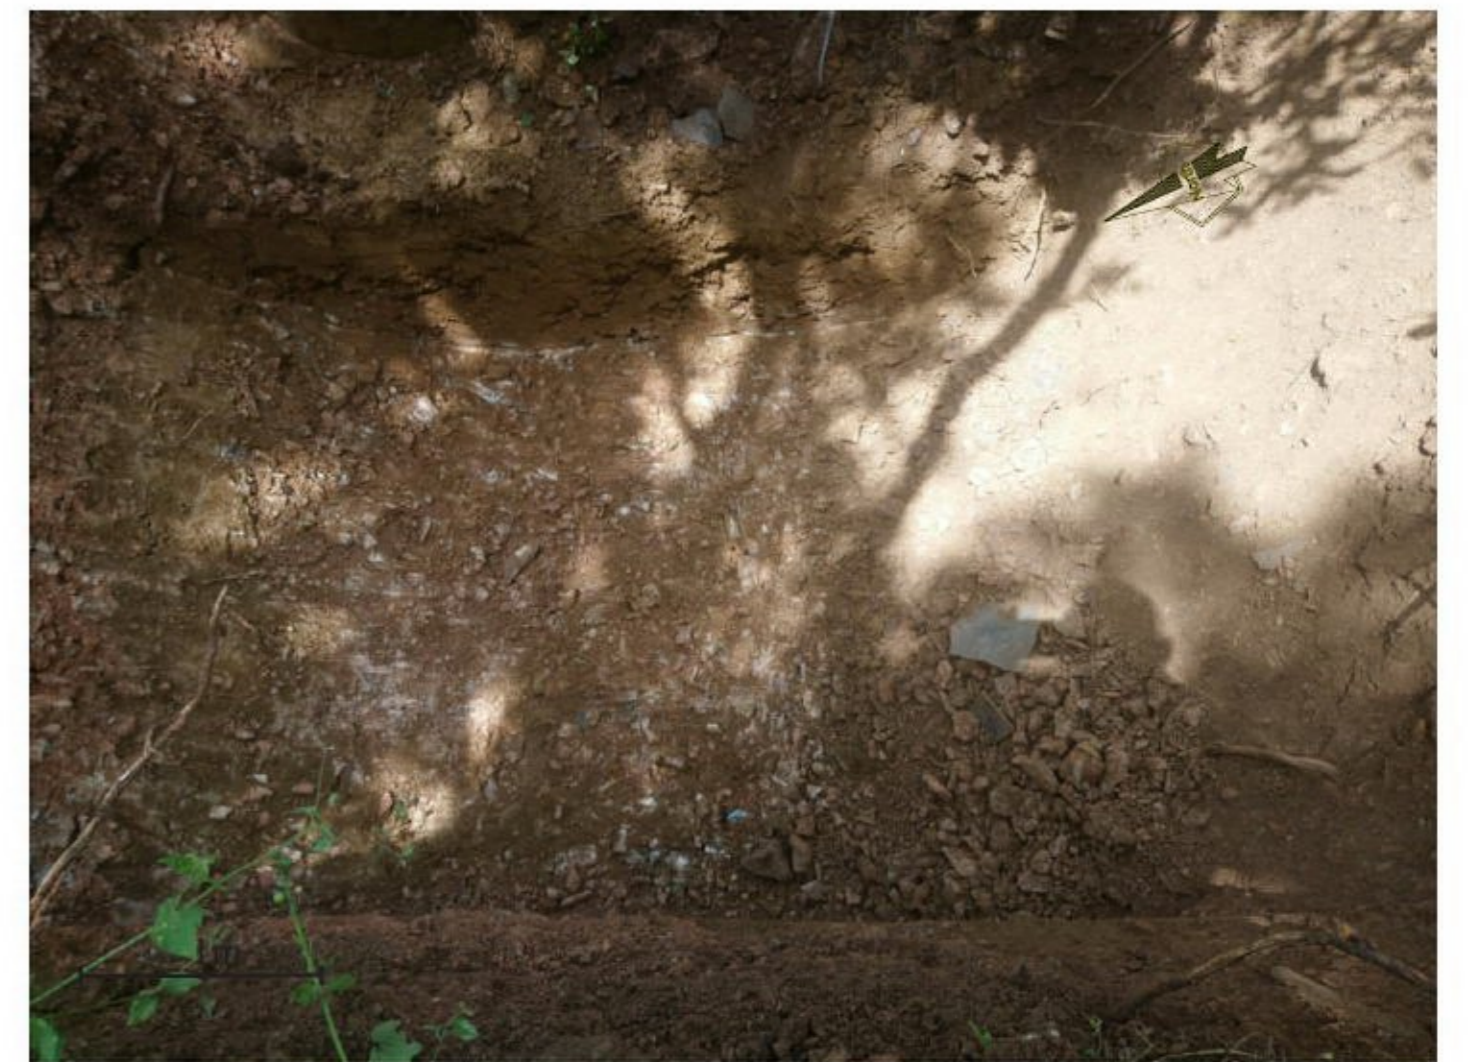
Photograph 6. In-situ stony clay encountered in position of suspected shaft, adjacent to northwestern.
