## **Bodynfoel, Llanfechain, Powys**

### Heritage Impact Assessment

Report No . 1924

October 2020

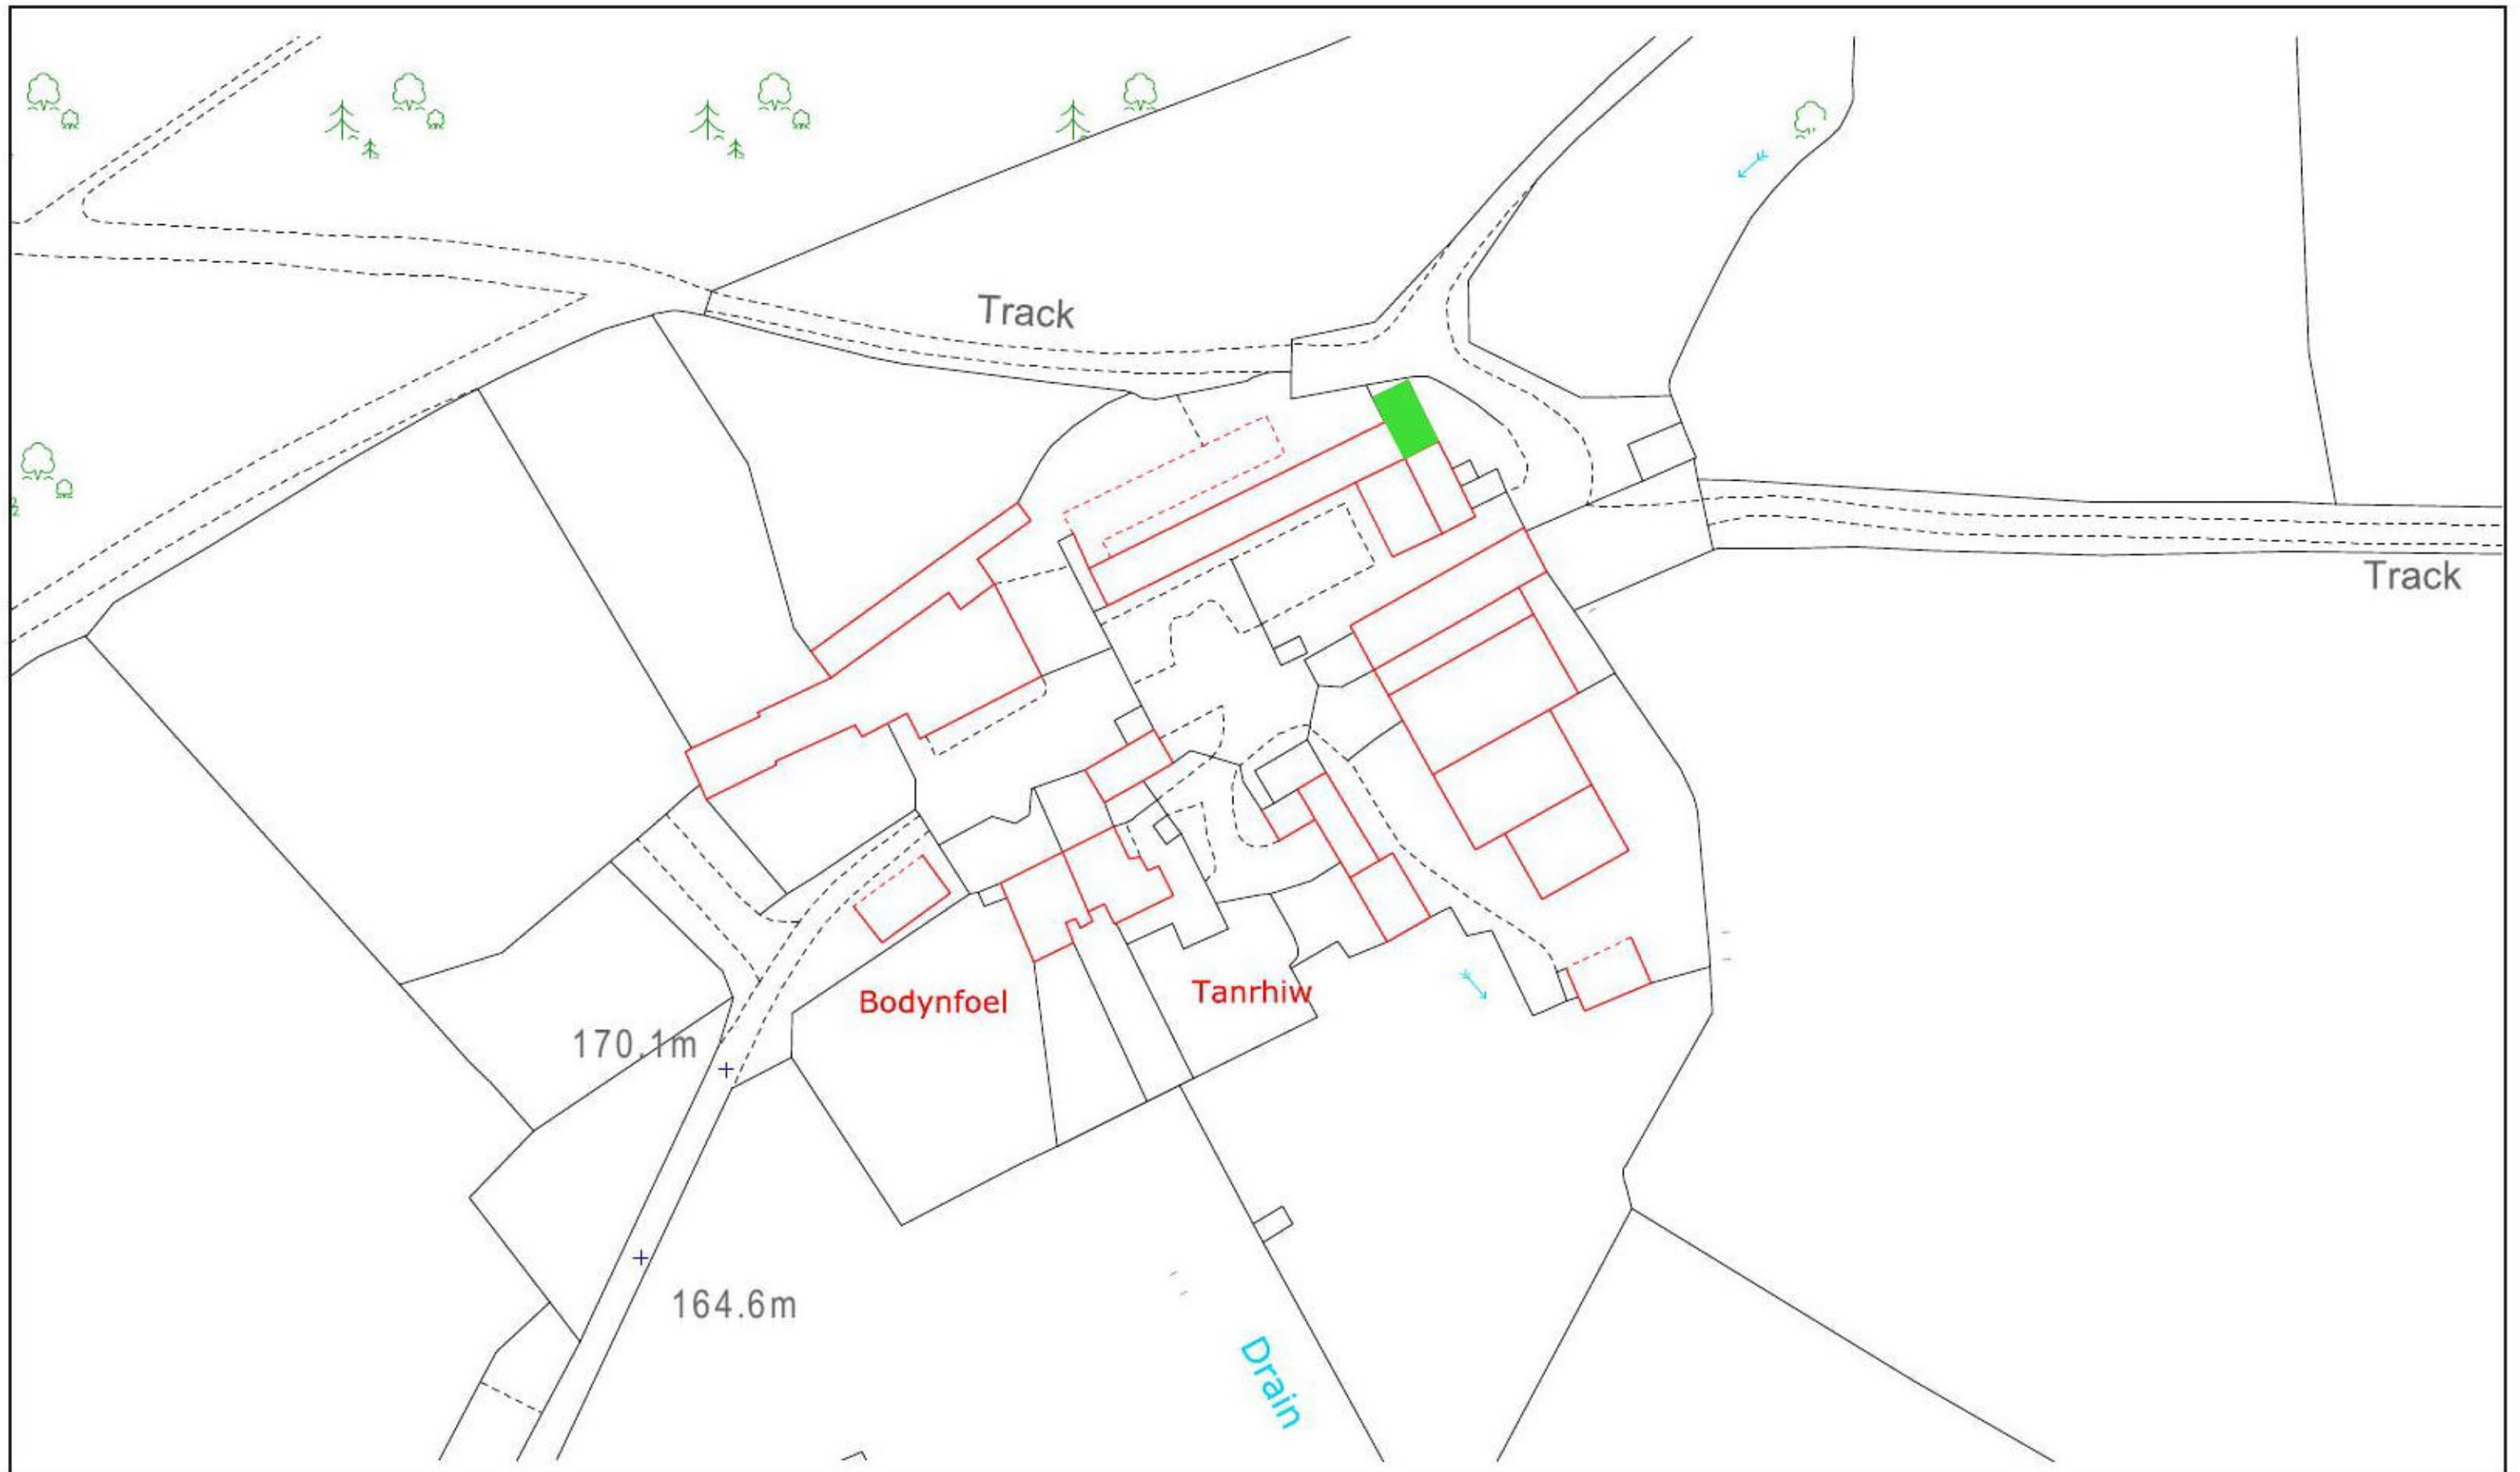
Figure 1. Site Location (green).

The listed structure is located toward the northernmost area of Bodynfoel farm complex, 1.2km NNW of Llanfechain. The complex is bounded to the north and west by Bodynfoel Wood and to the east and south by open fields (Figure 1).

Development proposals foresee the demolition of a building related to the Grade II Bodynfoel Farm (LB 7627; PRN 32648; NPRN 21256) (see Figure 1 – green). The building is in advance state of disrepair.

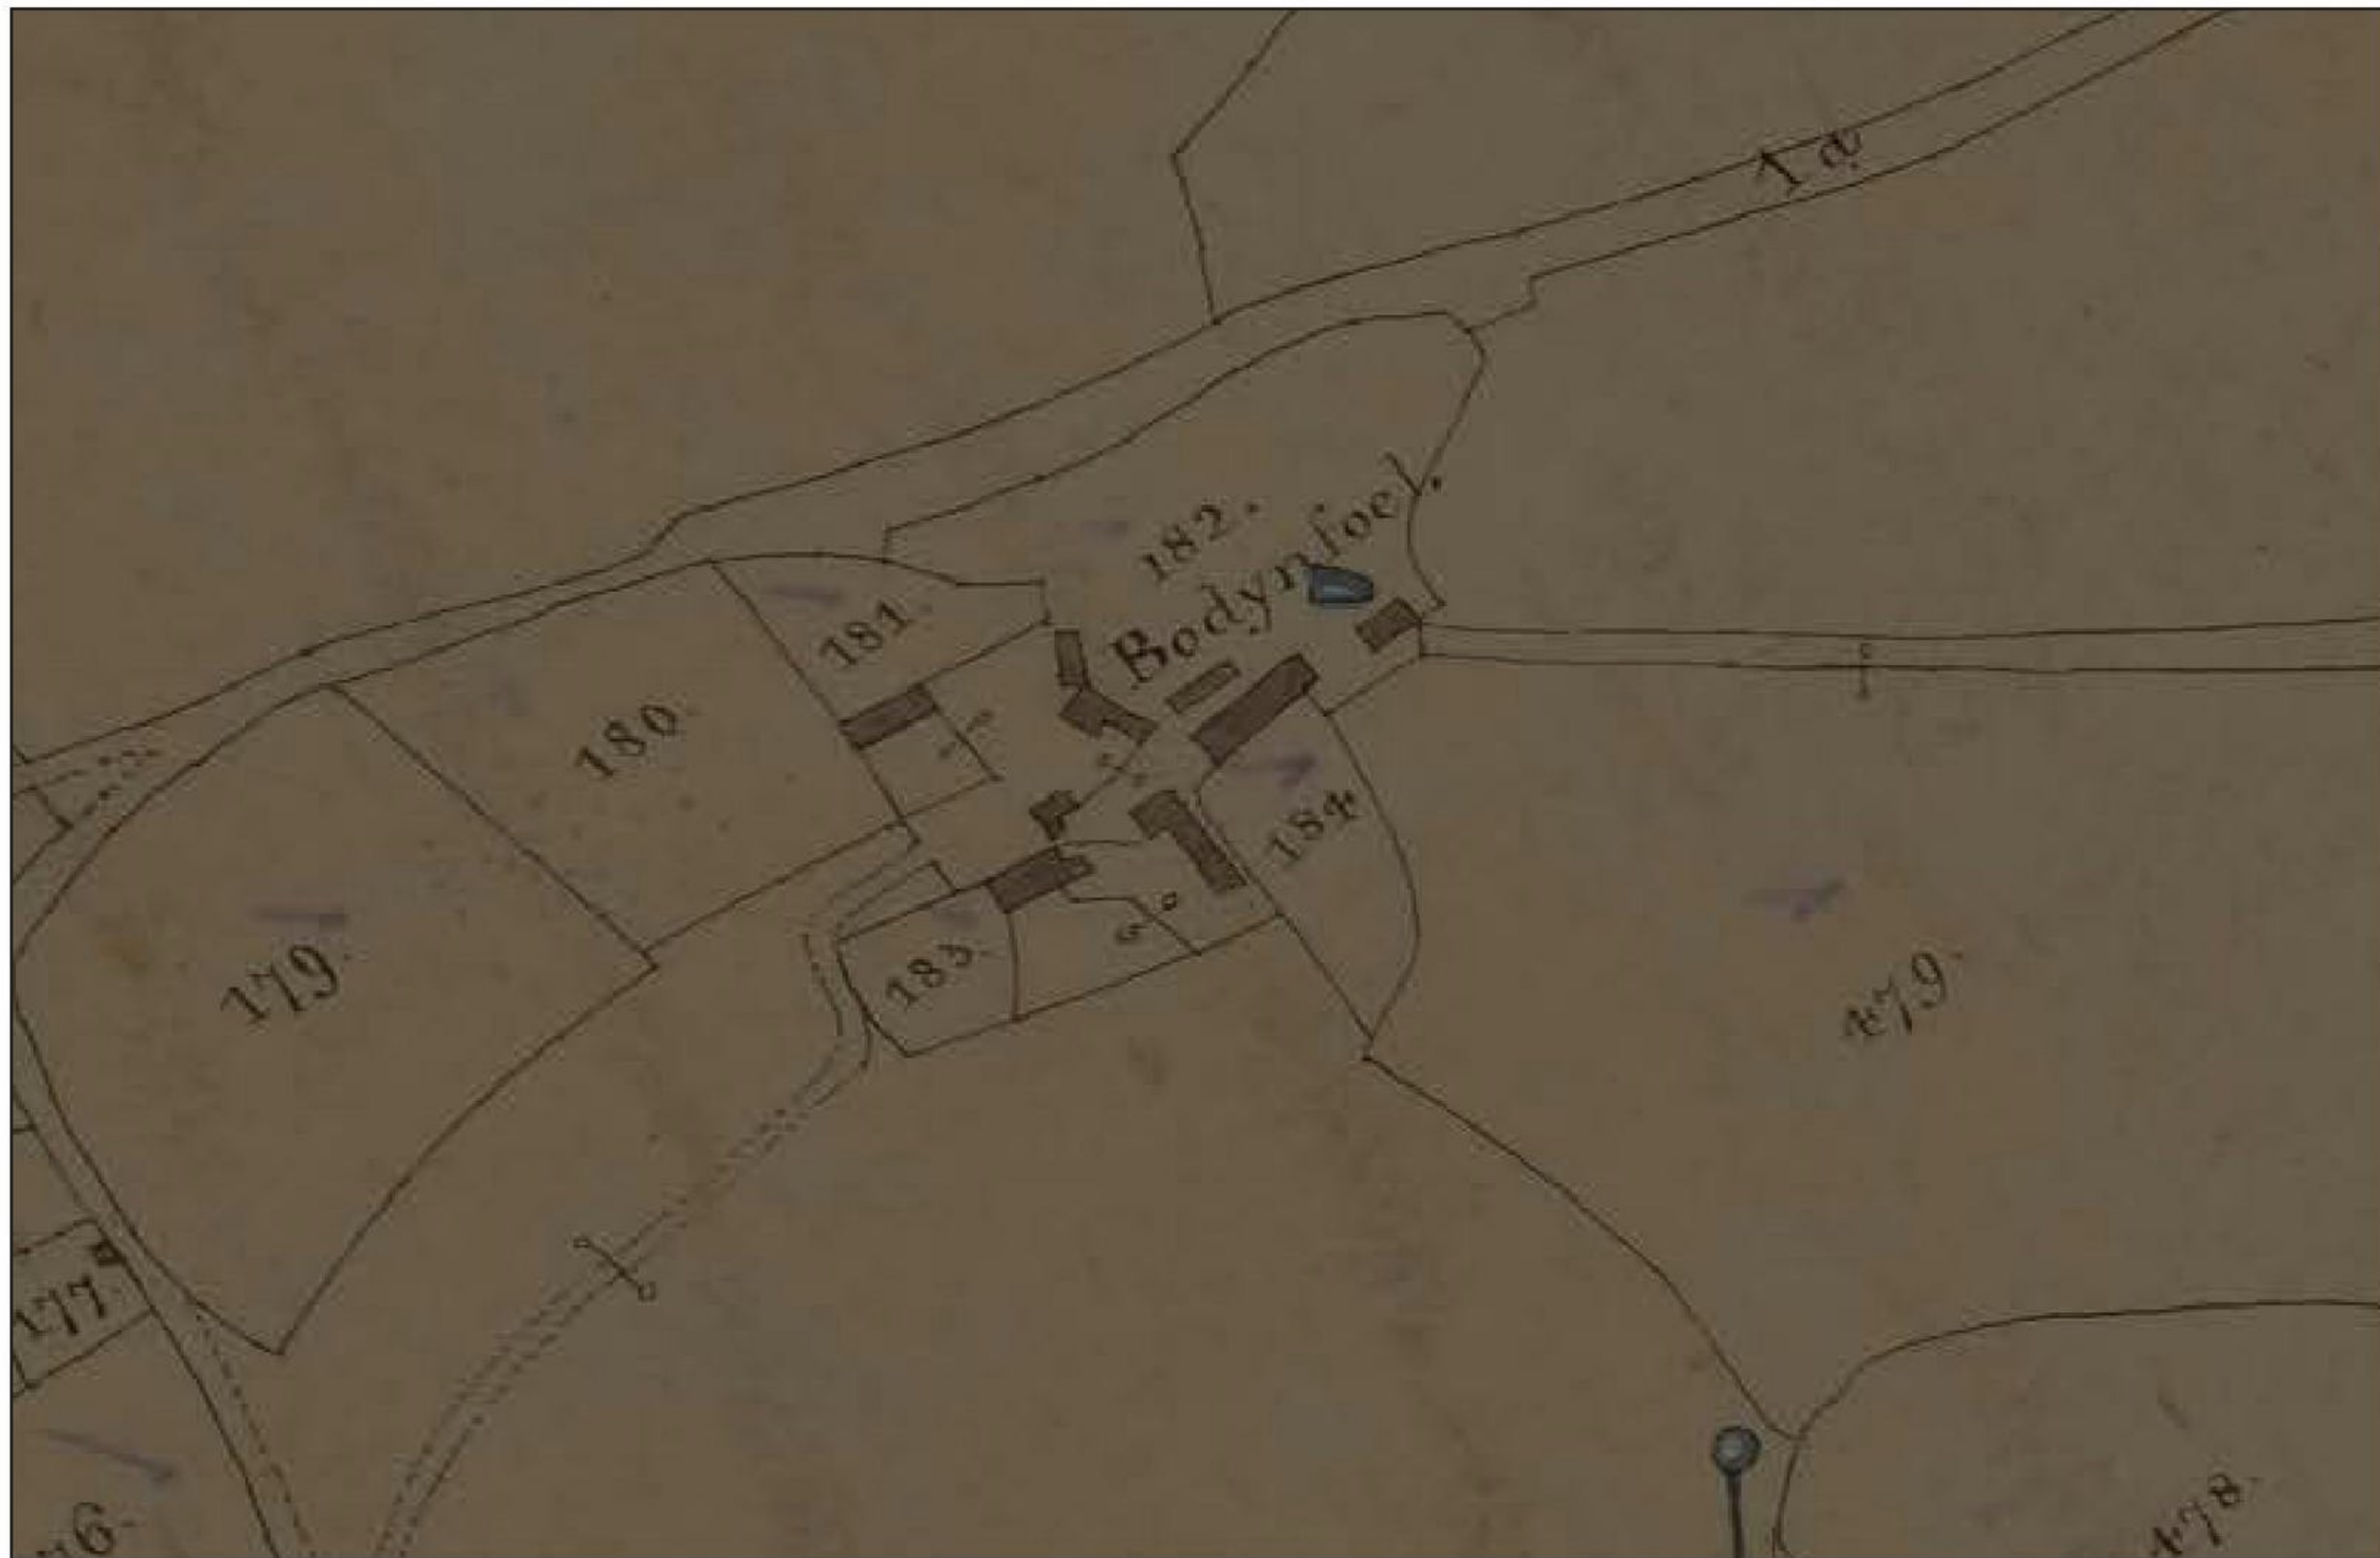
Figure 8. Map of the parish of Llanvechan in the County of Montgomery 1839.

The 1839 Tithe map documents the farm complex within plots 181 to 184. Plot 182 (the plot where the examined building lies nowadays), is defined as Ty Issa Mill and land. When observing the map, it is possible to suggest the existence of a small water powered mill indicated by the existence of a mill pond, as well as a fold and other buildings. Plot 181 and 184 are documented in the apportionment records as the stack yard and land use, while 183 documents Bodynfoel House and Gardens. Buildings which are still standing corresponding to this period have been highlighted in Figure 12 in blue.

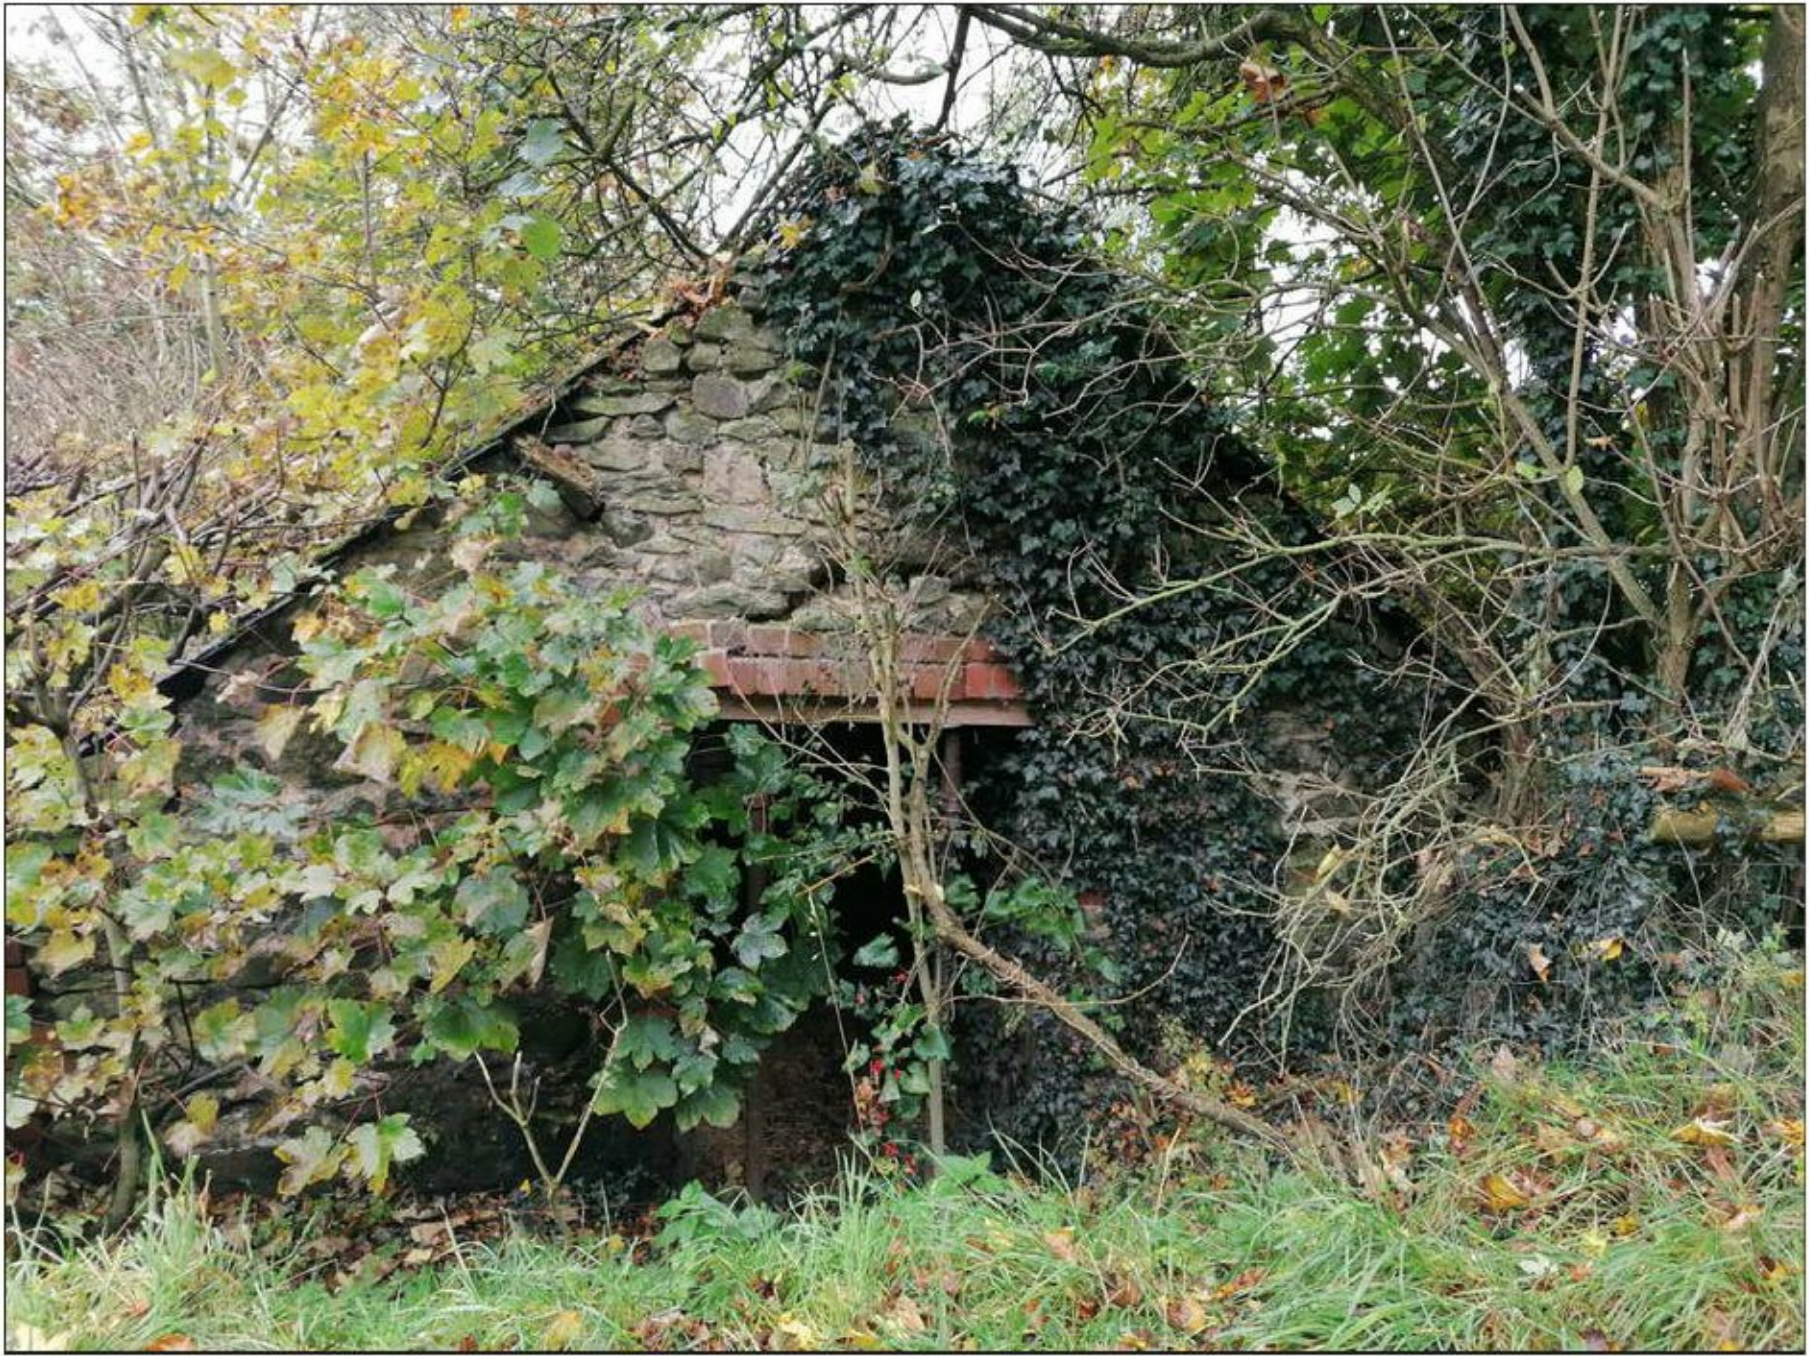
The NE elevation is partly obscured by overgrown vegetation and ivy, yet it remains one of the most visible regions of the building. This elevation contains a rectangular door opening capped with a brick lintel which is evidently not original but an alteration probably contemporary with the brick work observed in the opposed elevation. A wooden truss protrudes from the interior of the building.

Plate 1. NNE elevation.

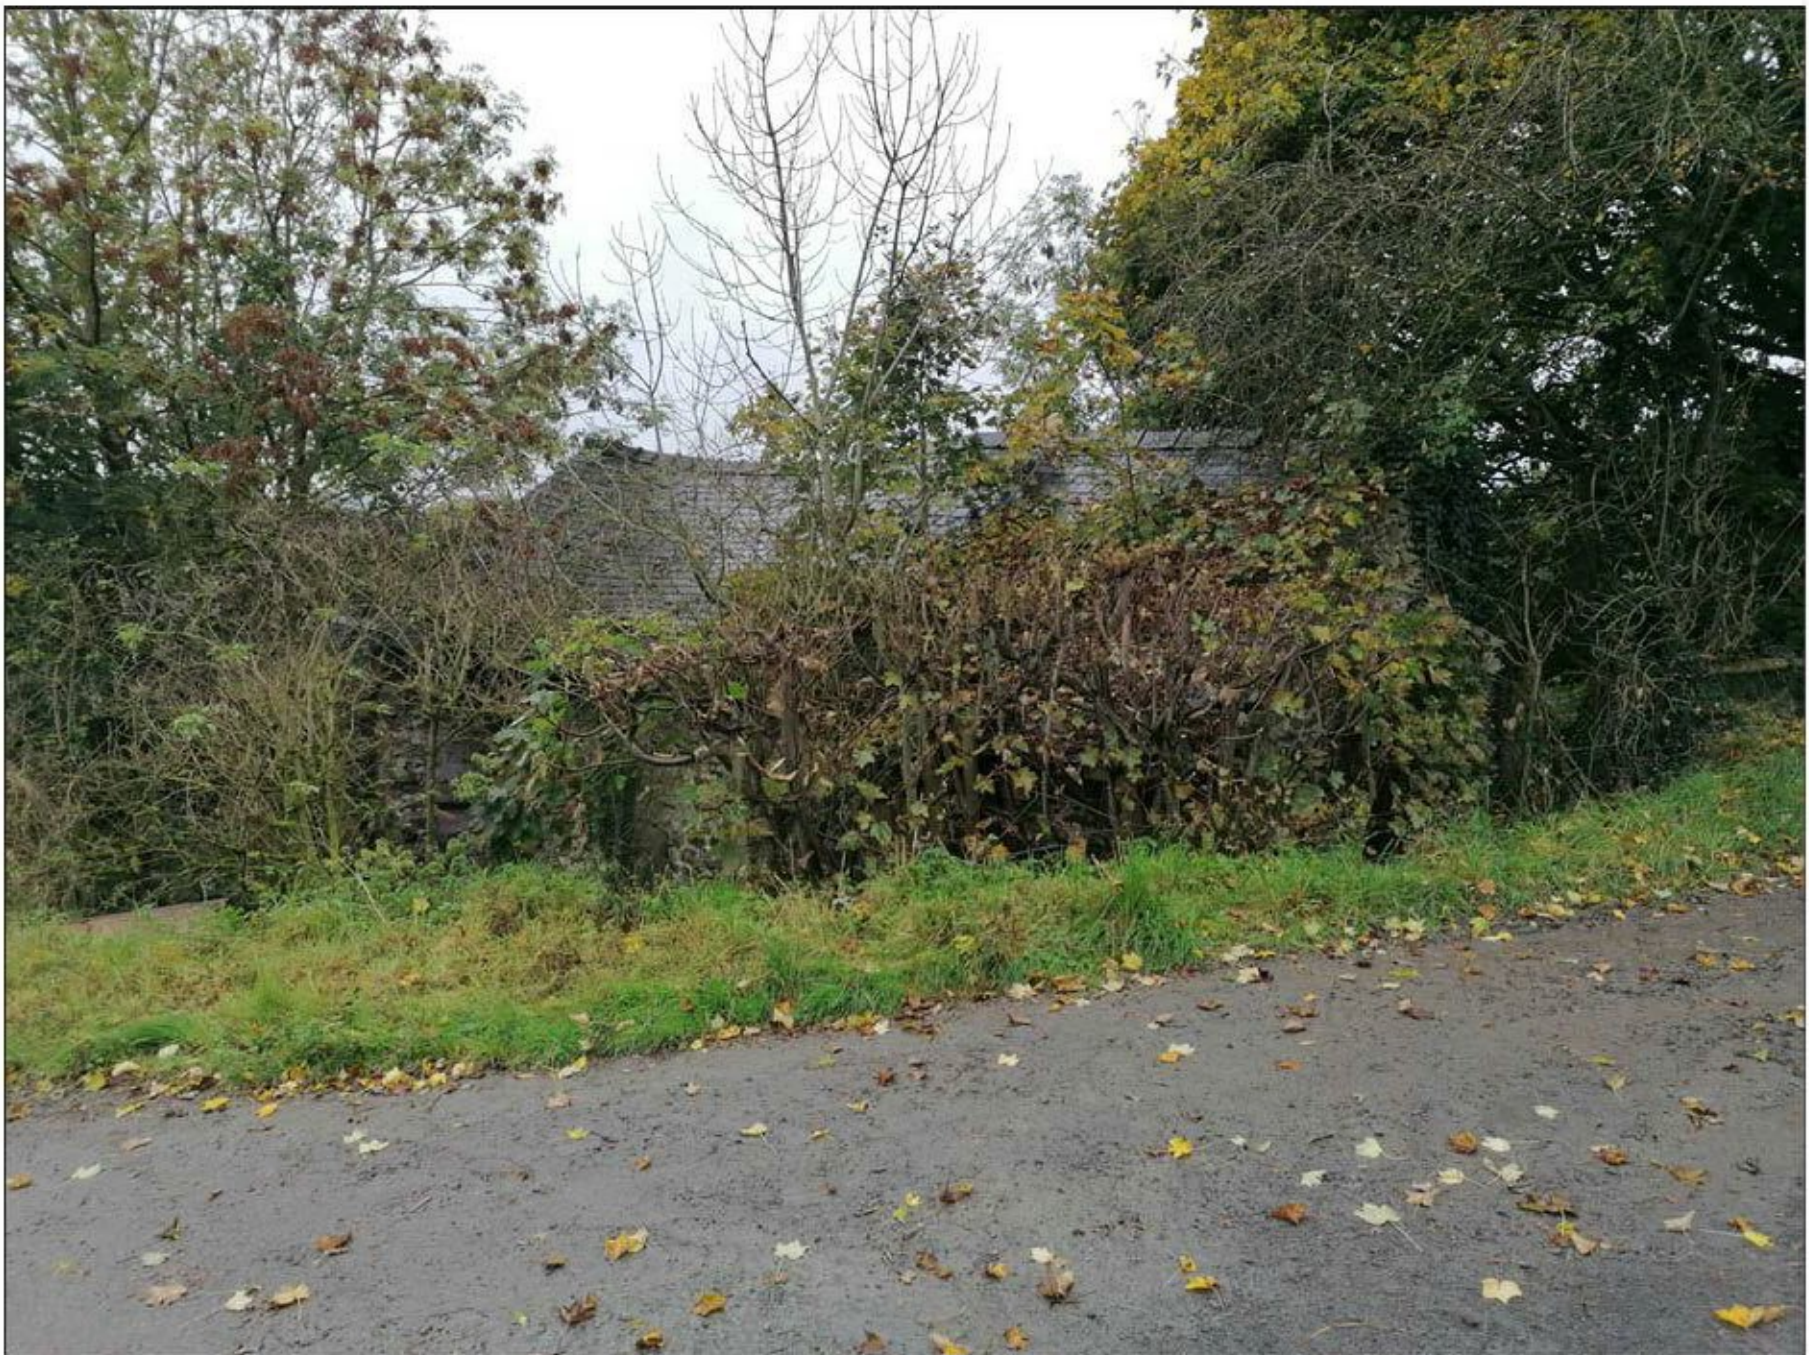
The SE elevation is mostly obscured by the abutting building. However, its upper region is still visible. This elevation is made of English Garden bond and, judging from the brick it dates to the mid-20<sup>th</sup> century. Only a small part of the SW elevation is visible and it is defined by a slate wall most probably not original.

Plate 2. SE elevation.

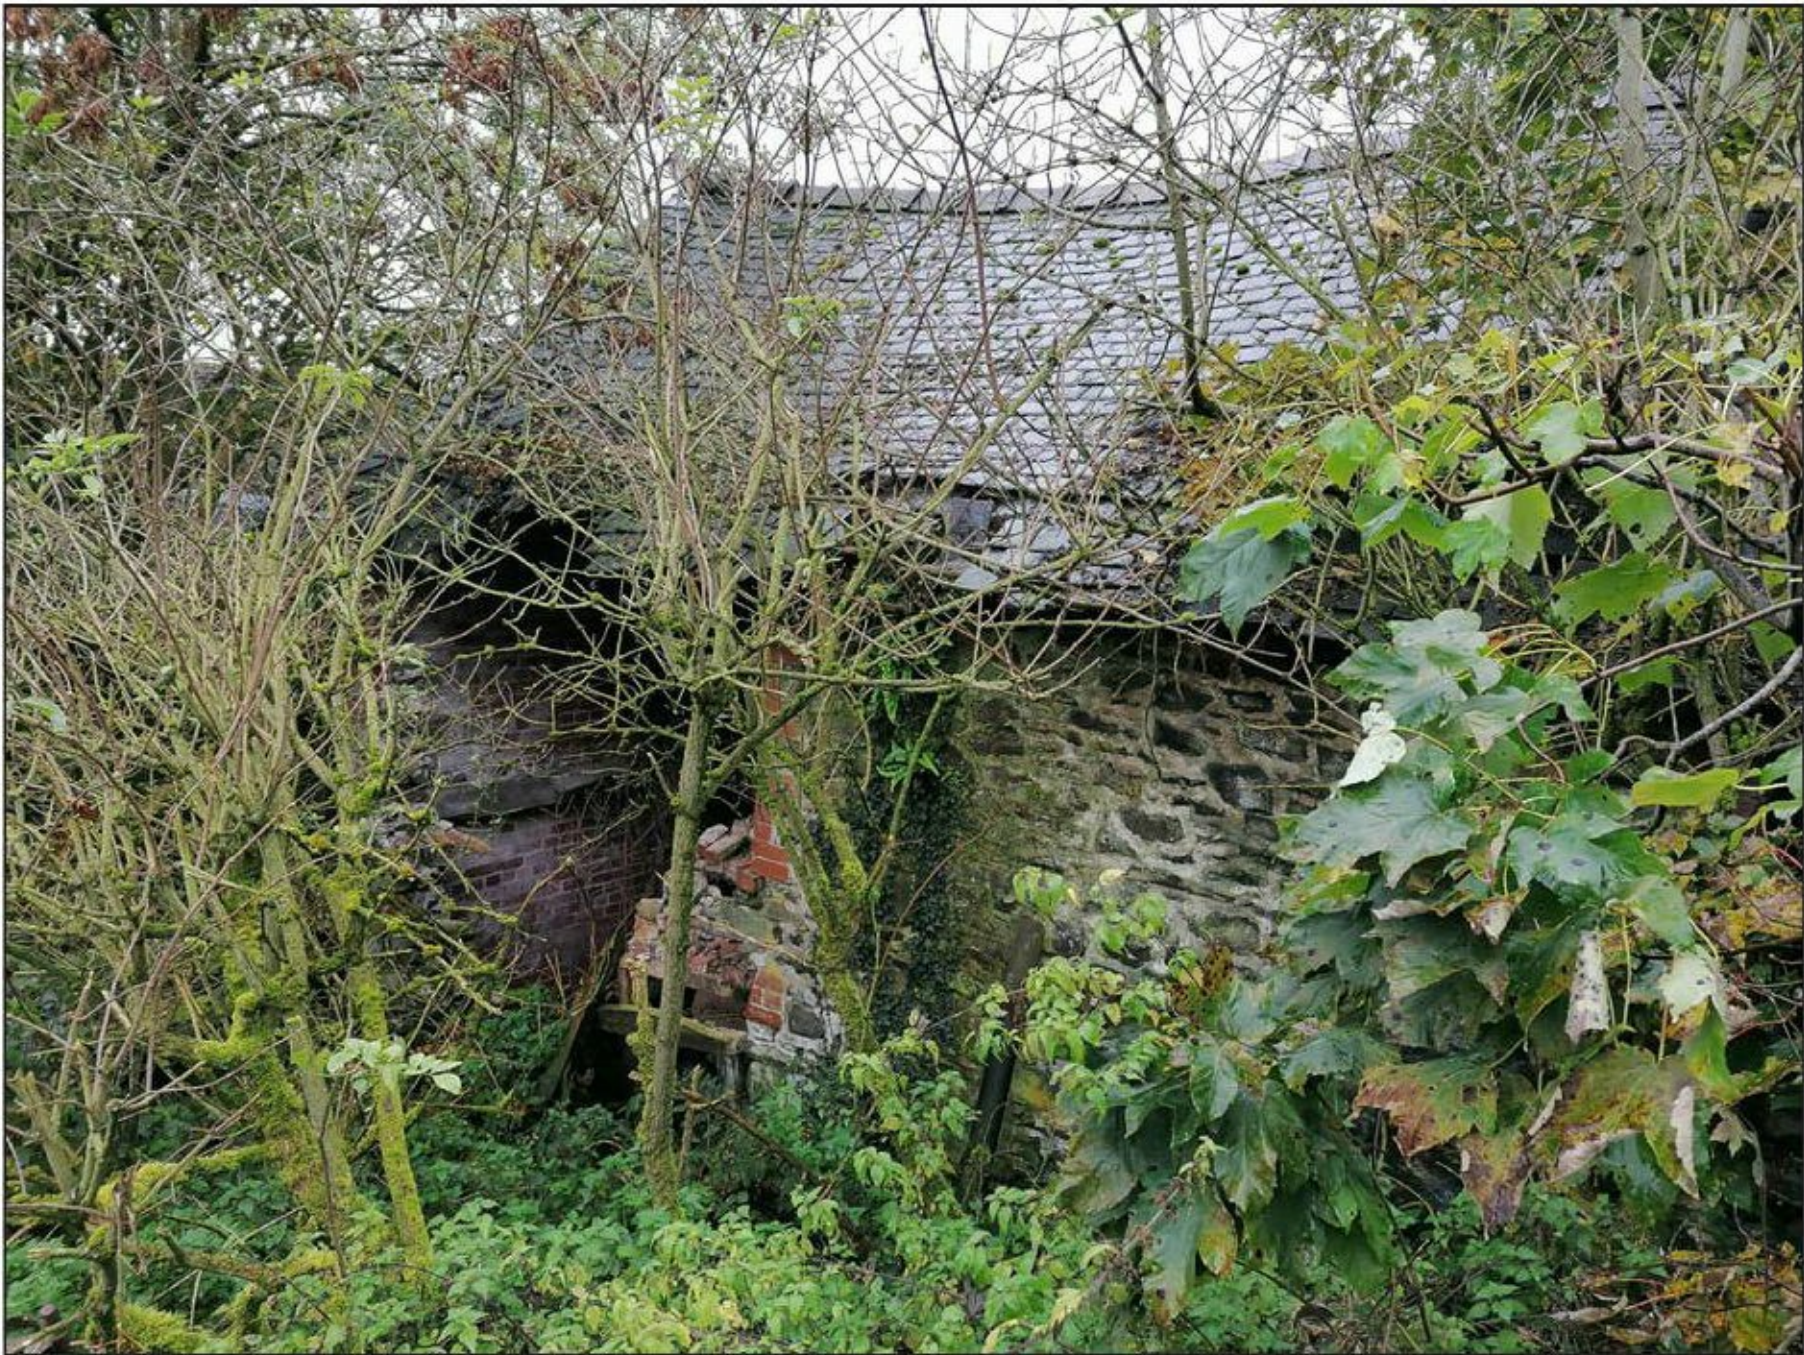
Plate 3. SE elevation - closeup.

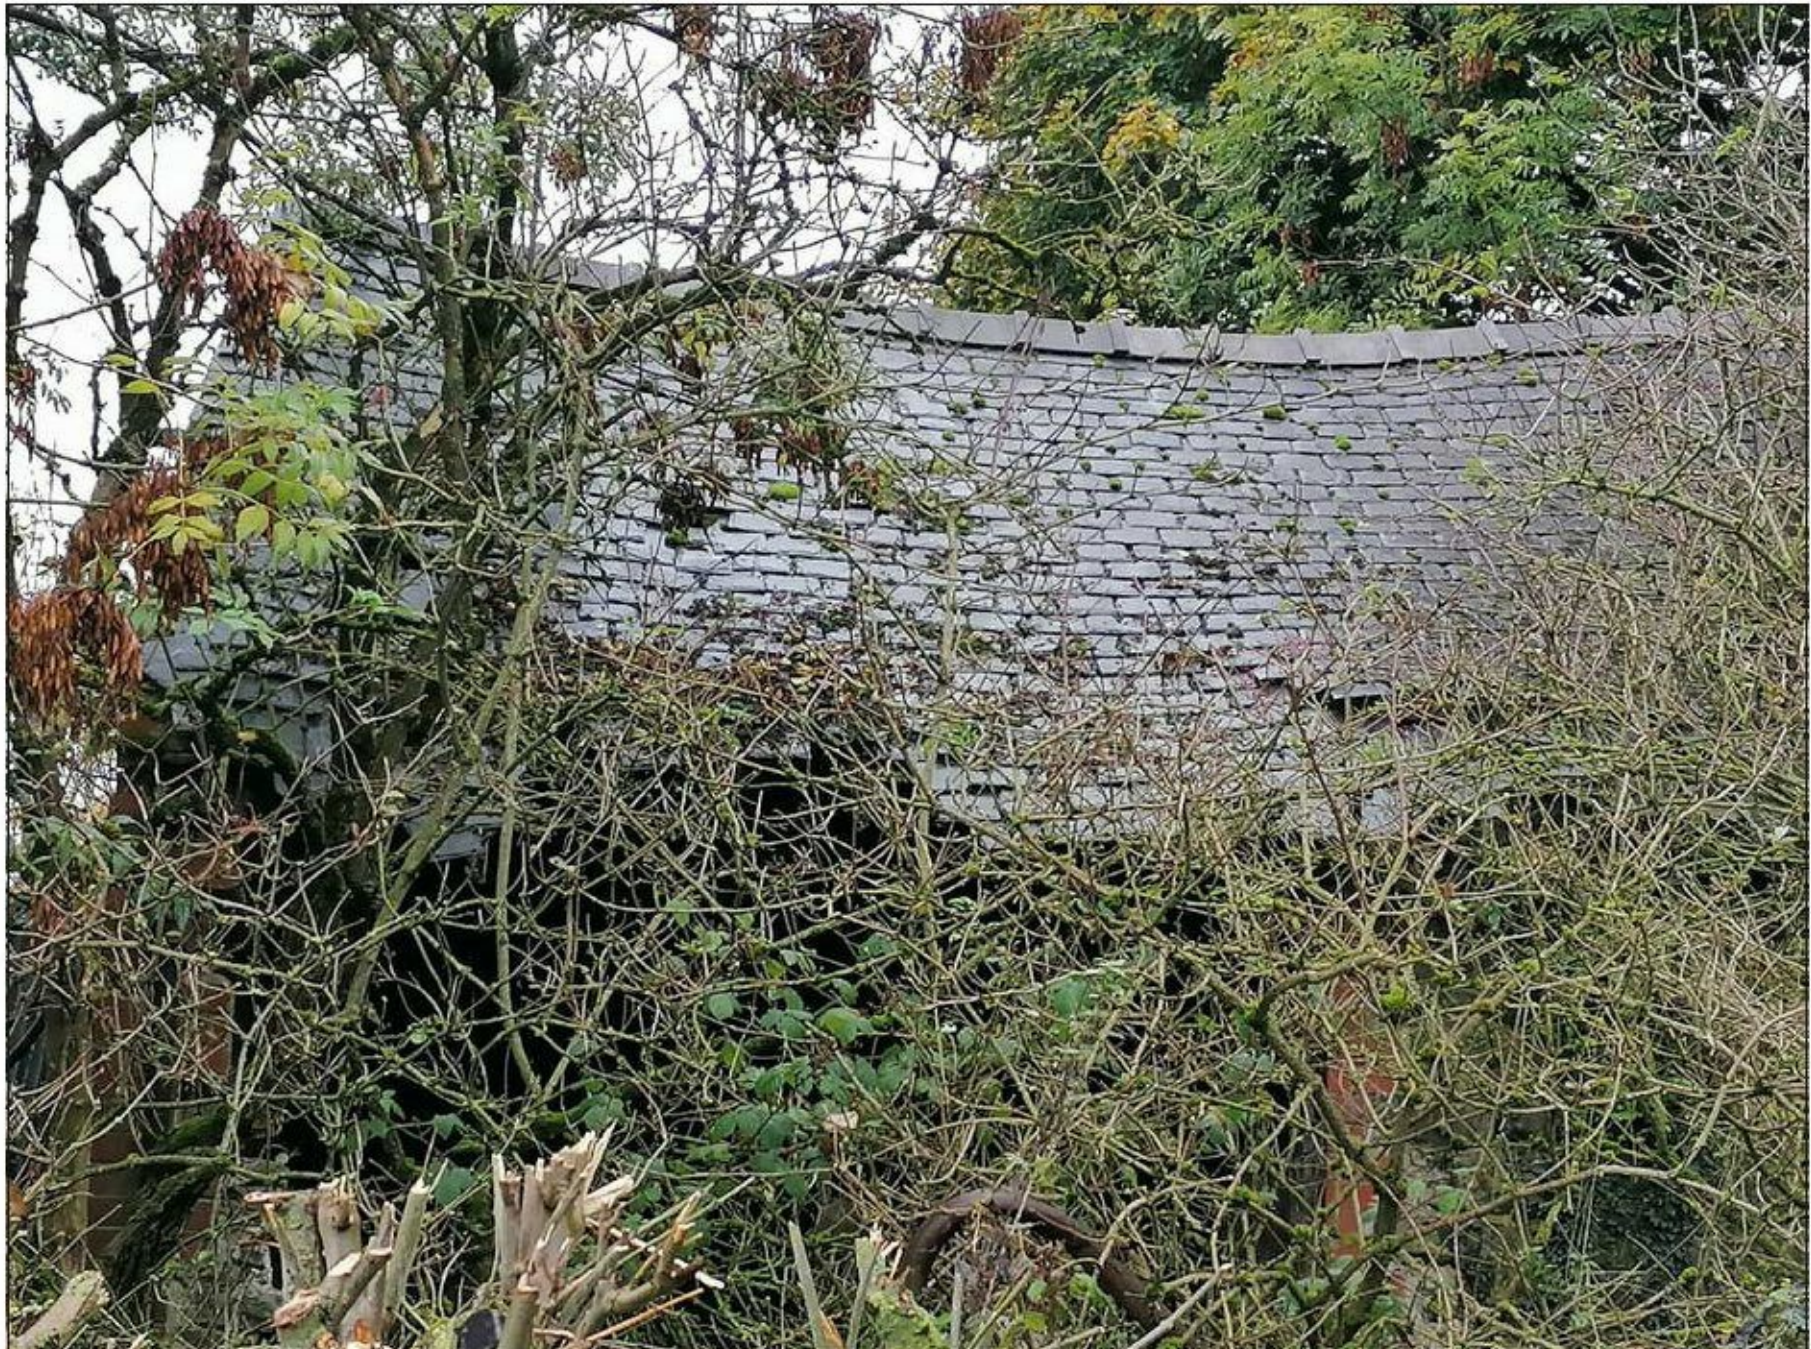
The building is defined as a rectangular gabled structure originally made of random local rubble bonded with lime mortar, and with multitude episodes of repair. The roof – also following the typical Welsh barn – is defined as a hang-down slate roof.

Plate 4. Details of slate roof.

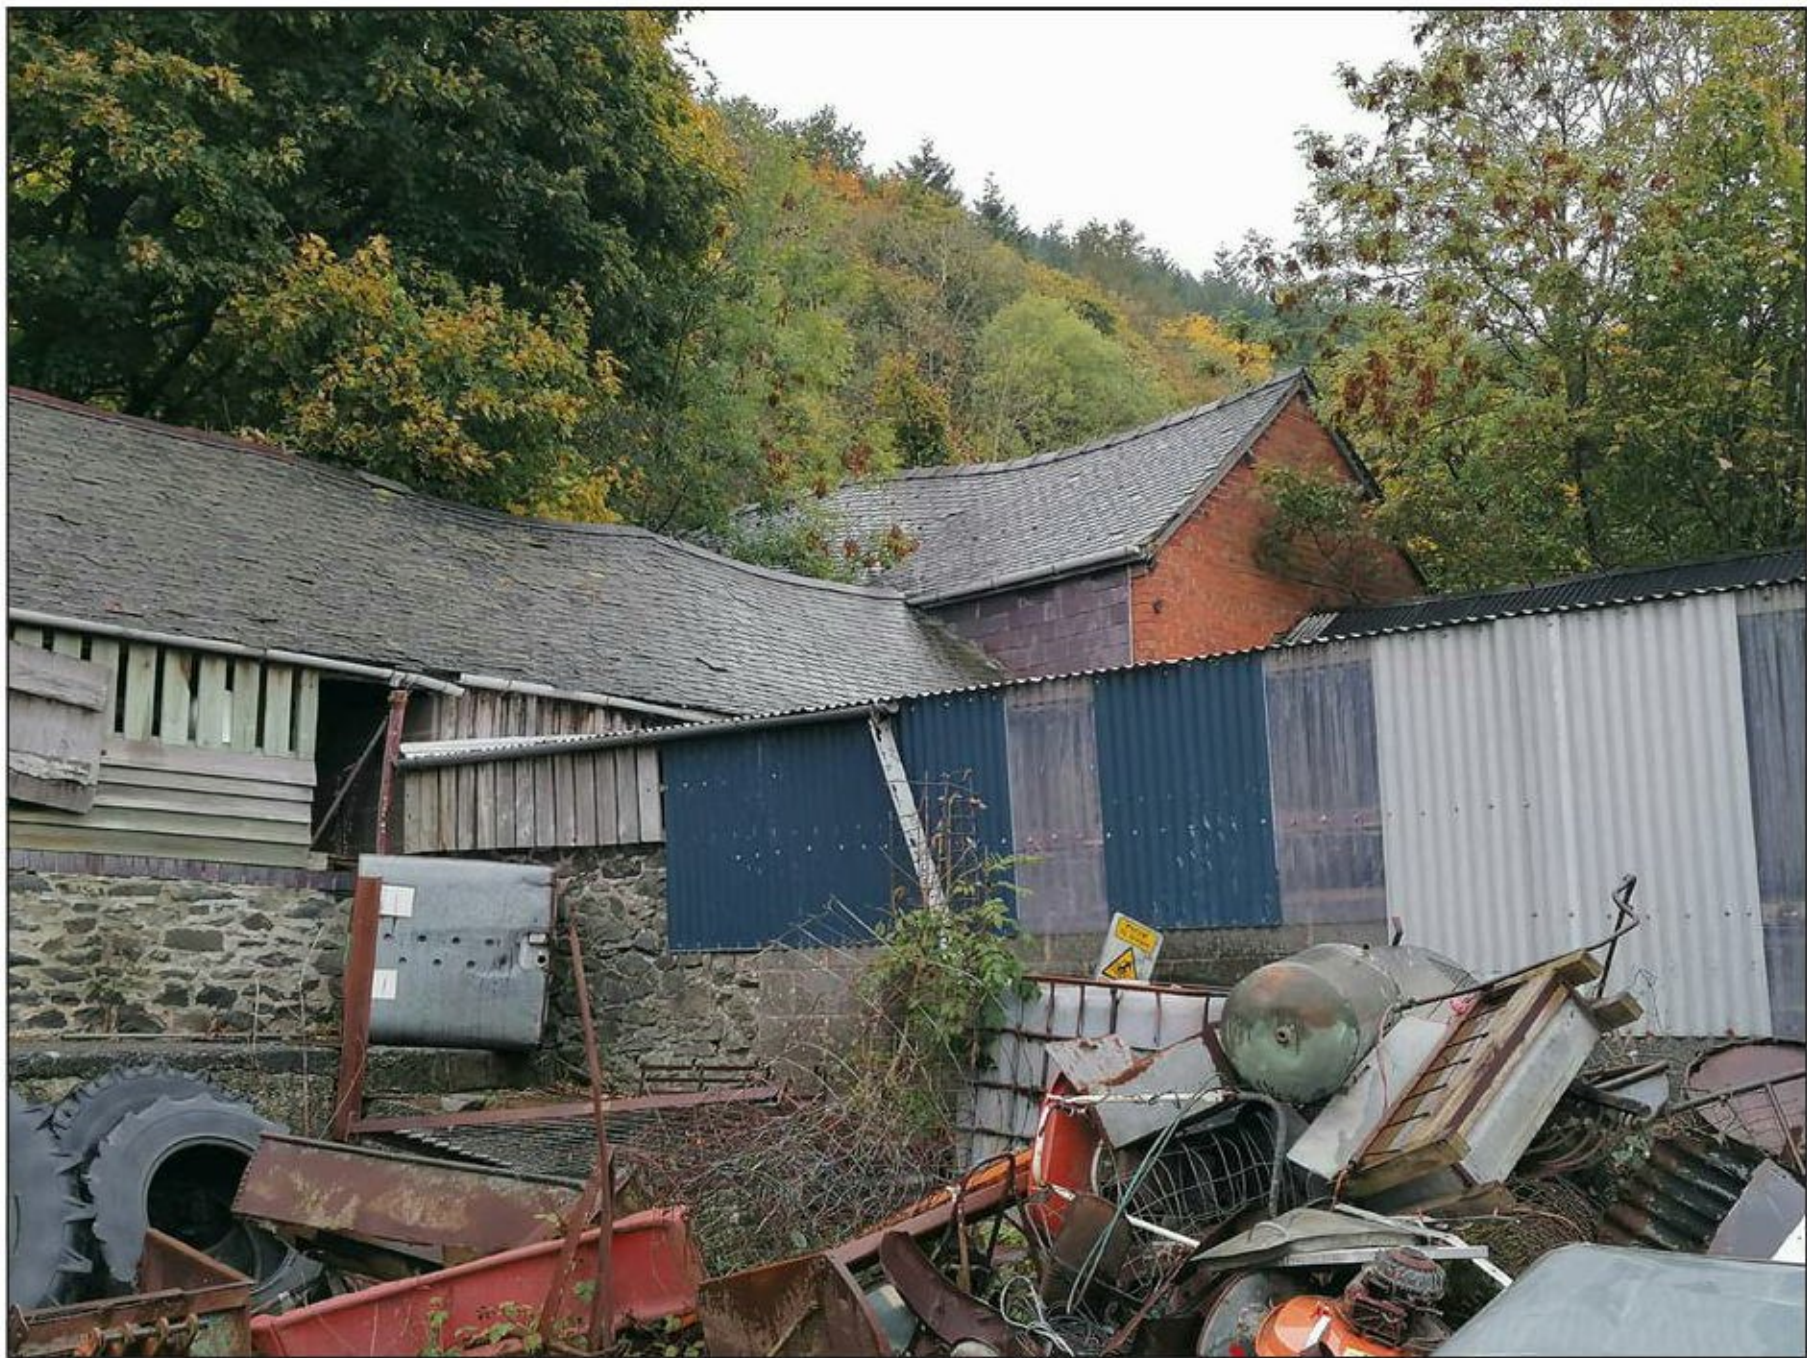
Plate 5. View of SE and SE elevations (back of image).

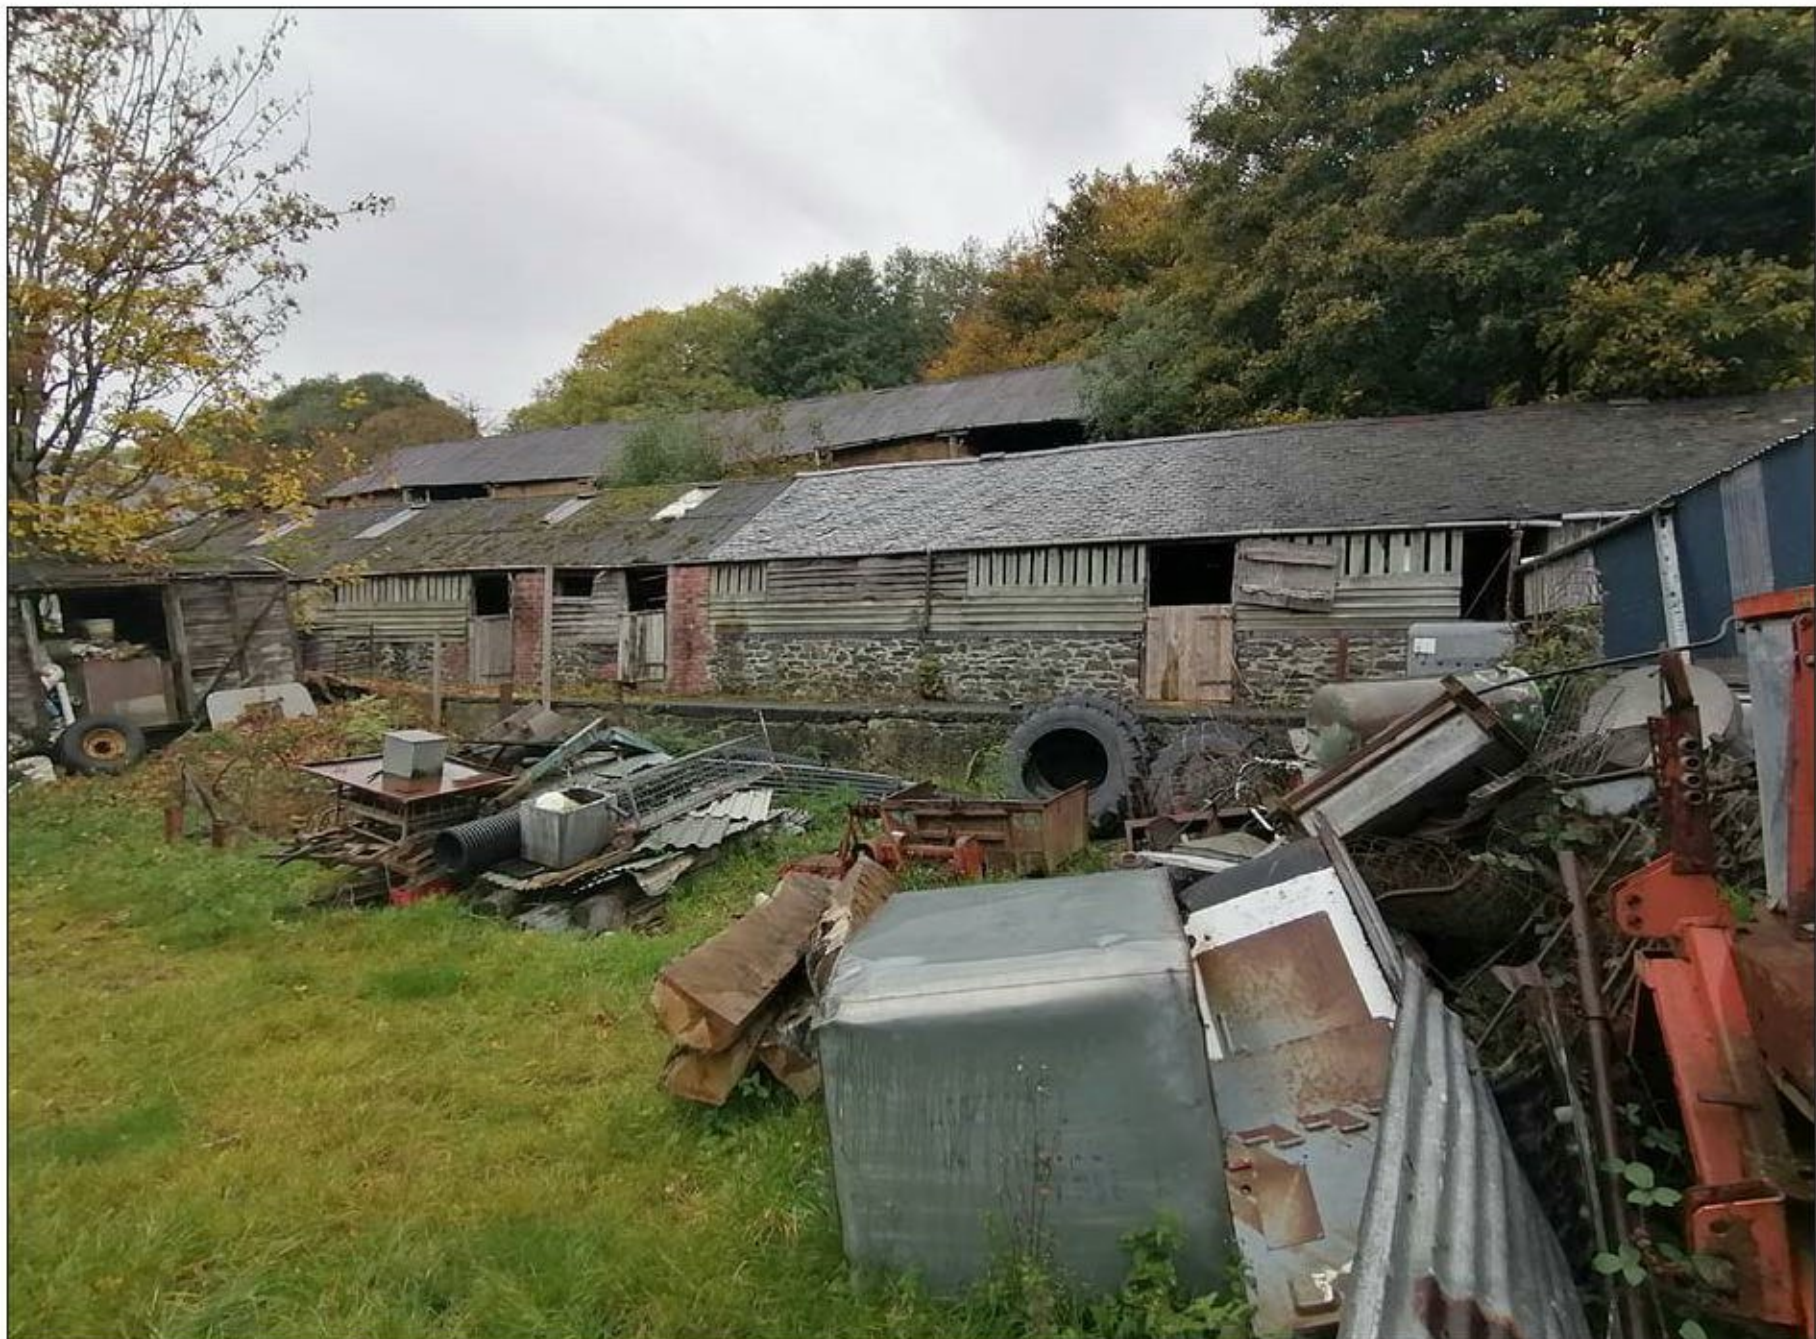
Plate 6. View of haystack barn adjacent to surveyed building.

In section 6, it has been noted that the structure under examination was built sometime during the late 1800s, once the Bodynfoel complex acted fully as a farm. At the time, the hay barn was already constructed suggesting that our building would have acted as an outshot or lean-to. Judging from aerial photographs, it has been able to suggest that the building was no longer used by the 1990s, triggering its gradual decay.
