## **Bodynfoel, Llanfechain, Powys**

### Heritage Impact Assessment

Report No . 1924

October 2020

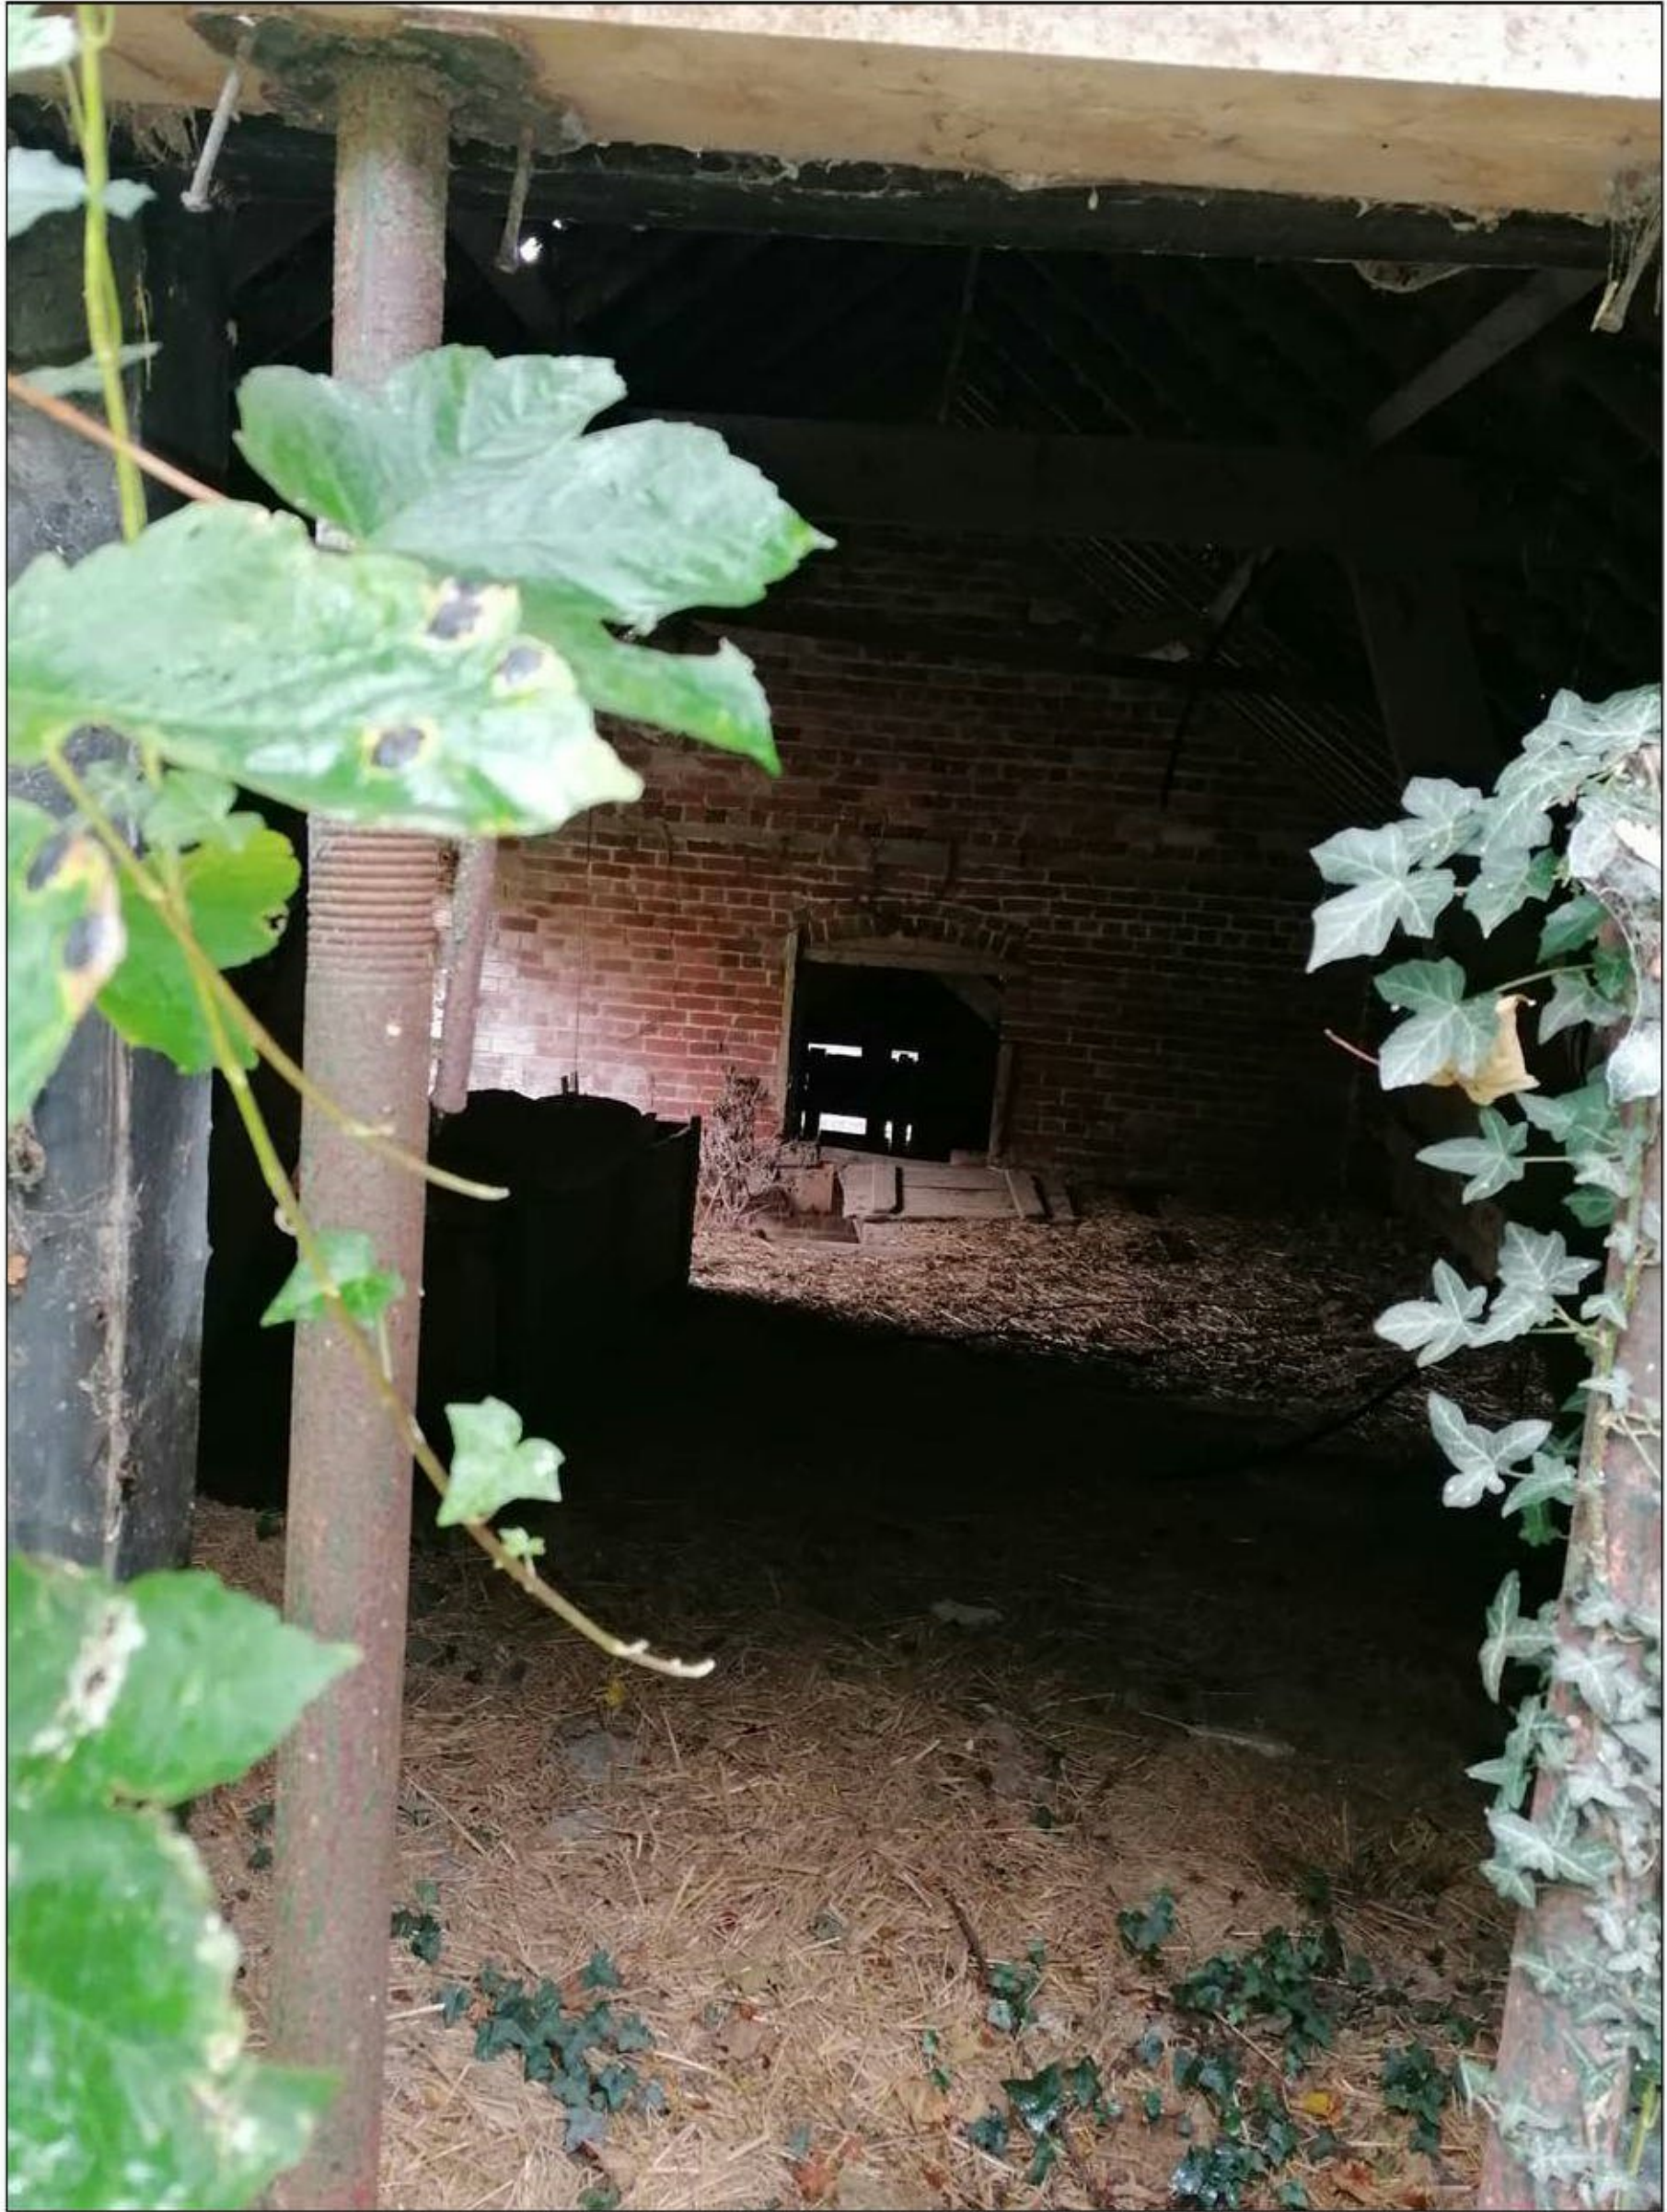
The interior of the barn was not fully examined due to concerns over the structural integrity of the building. However, looking into the barn from the exterior, it was possible to discern the presence of a common timber truss. Furthermore, it was noted that the SE elevation was made of brick, with an opening to the abutting structure. The opening documents

that the structure examined is in much higher topographic position. The interior flooring was not discerned given the amount of hay present in the structure.

Plate 8. View inside of building.

Considering the results produced in this report, it is recommended that permission is granted for its demolition. However, it is recommended that a quick photographic survey of its interior is carried out during the demolition stage to gather sufficient information to create a consistent record of this heritage asset.

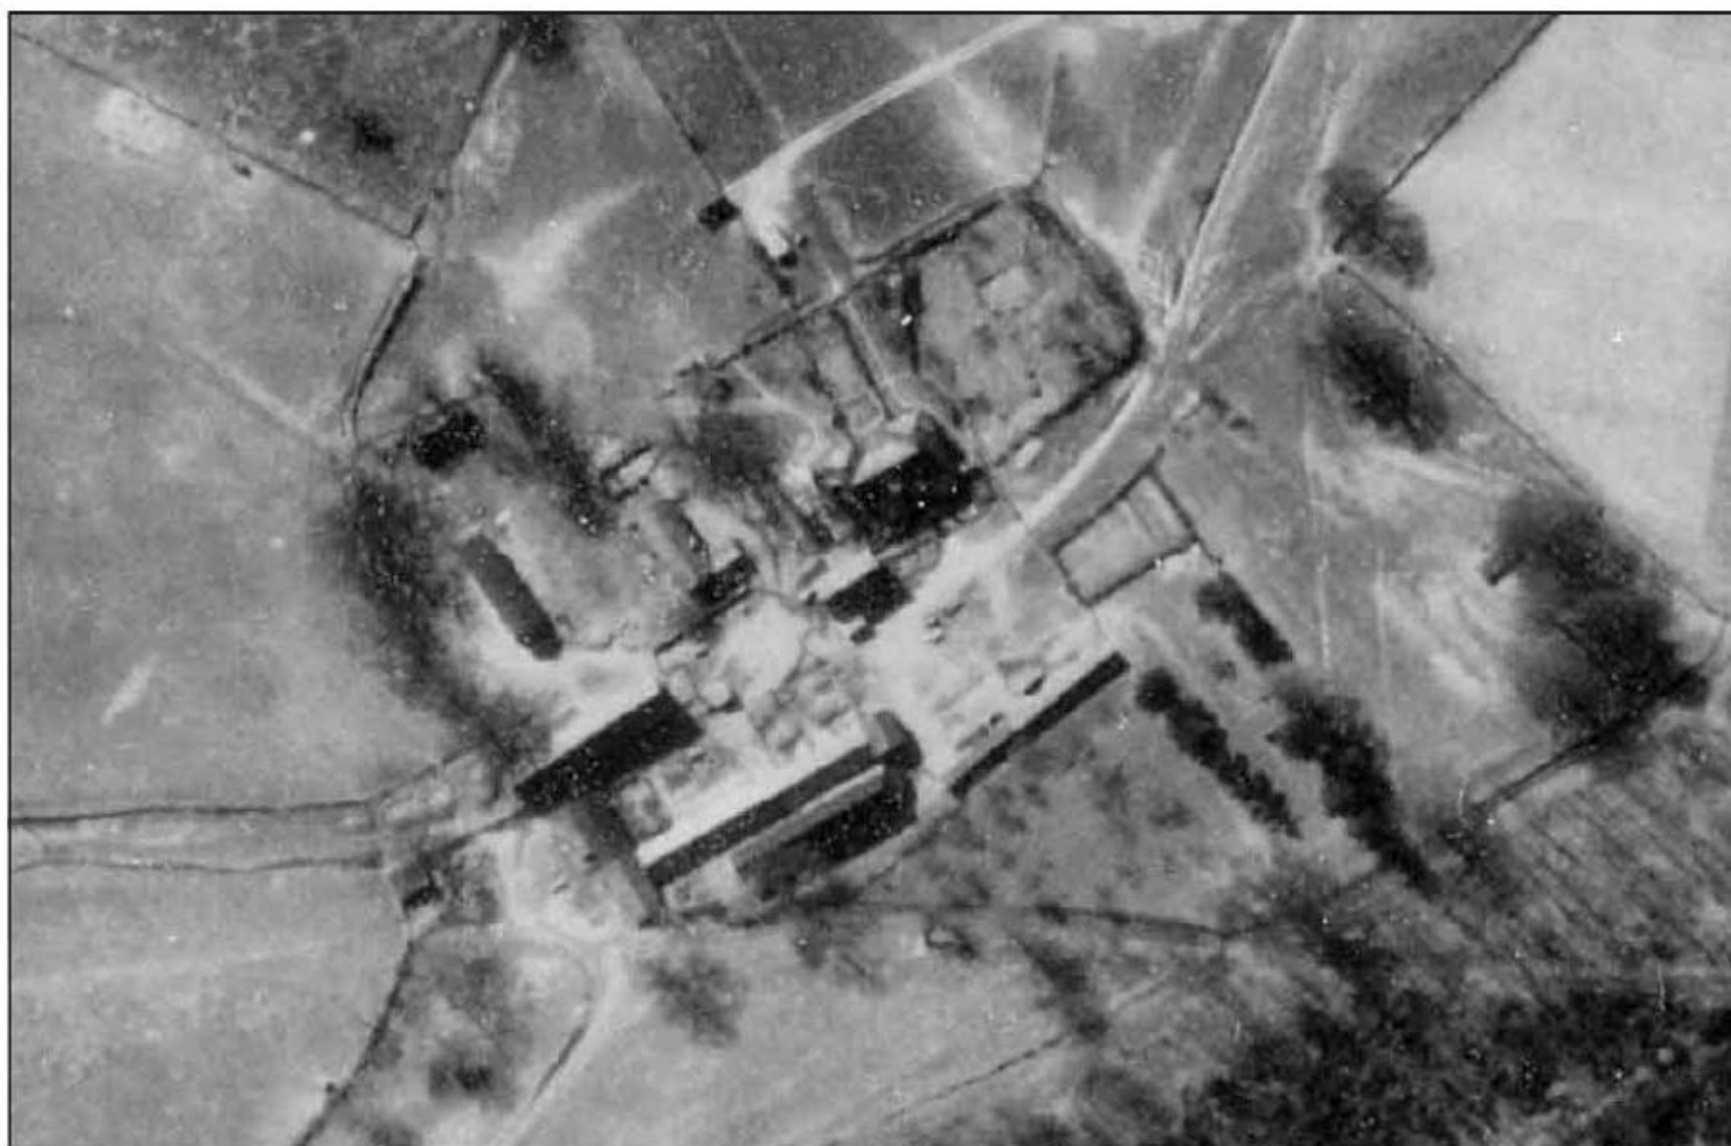
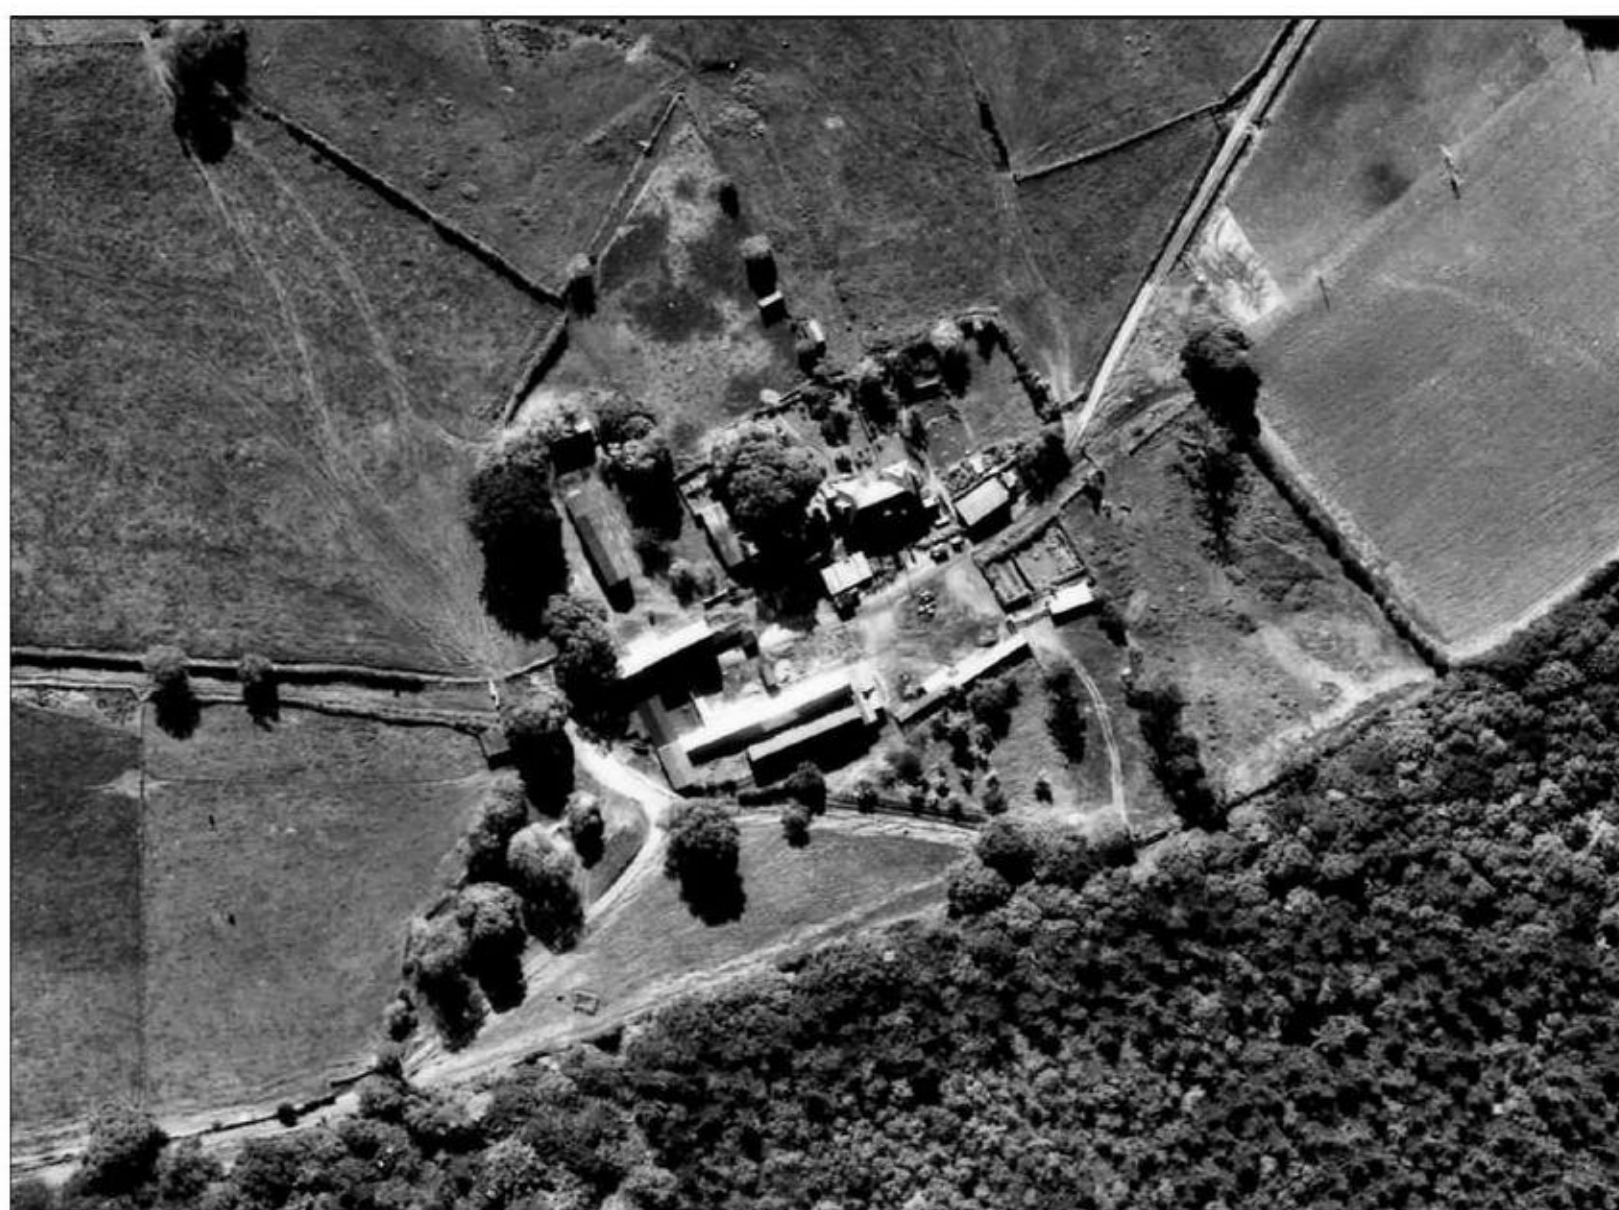
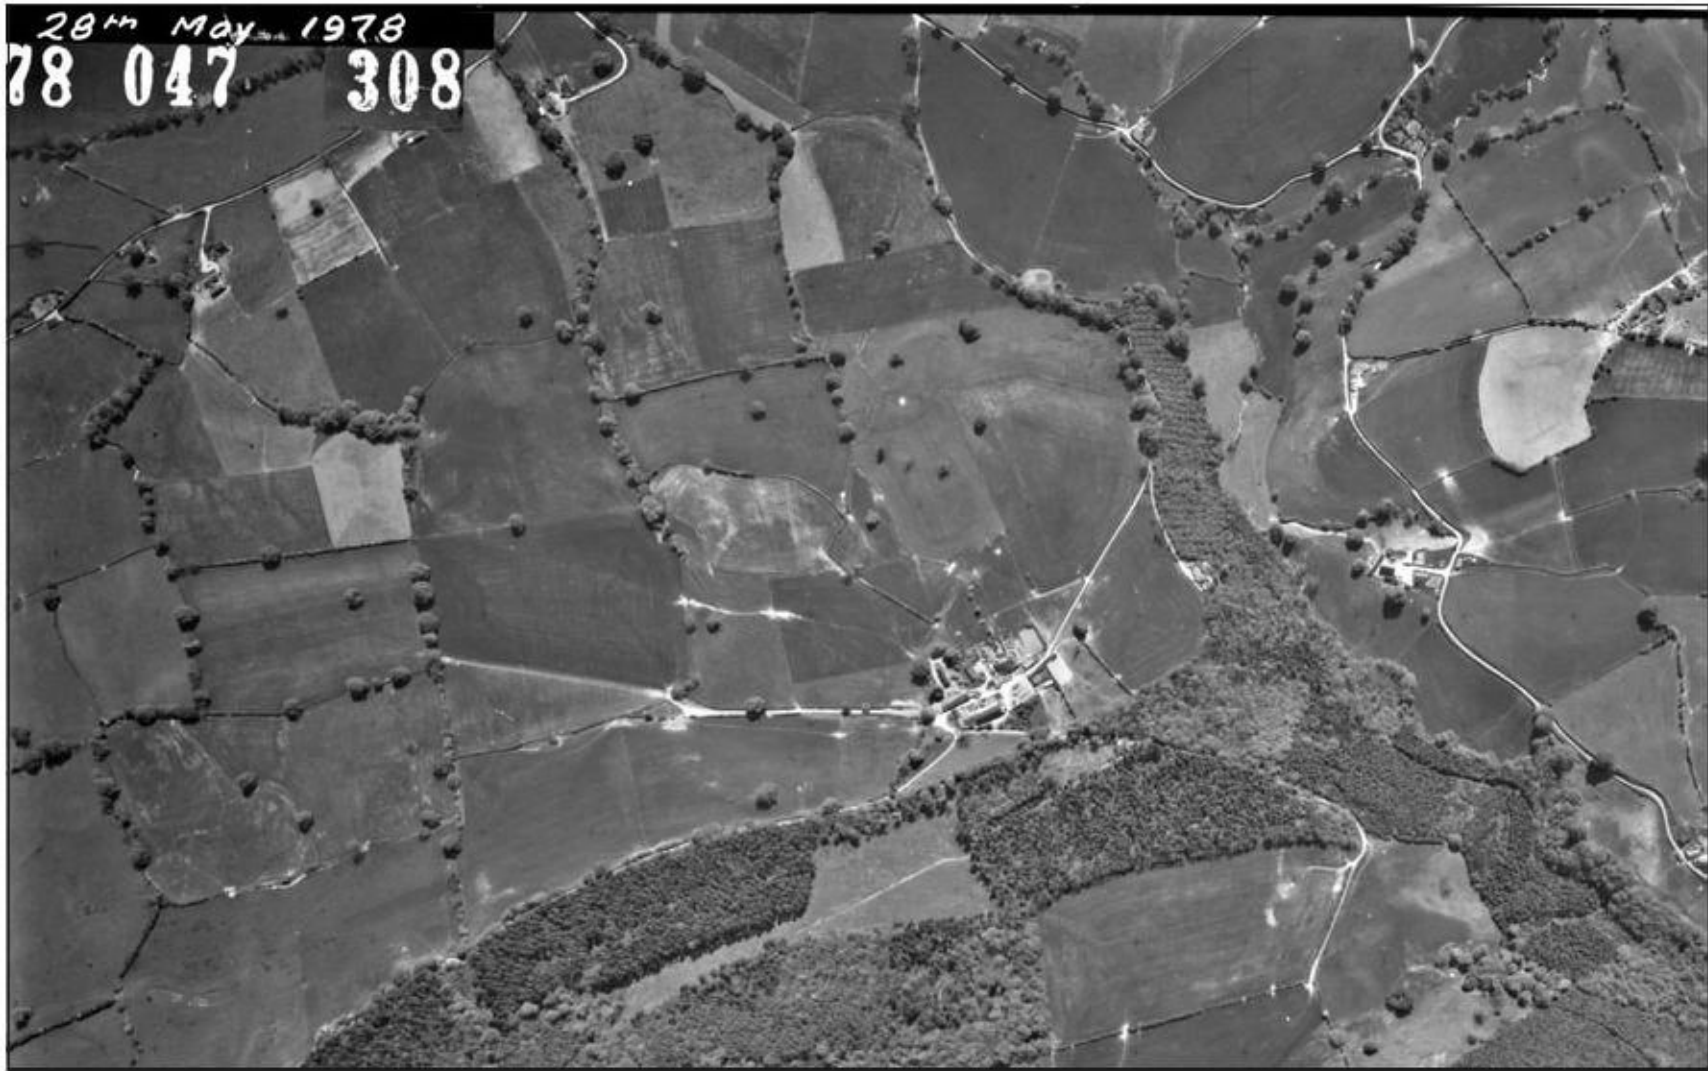
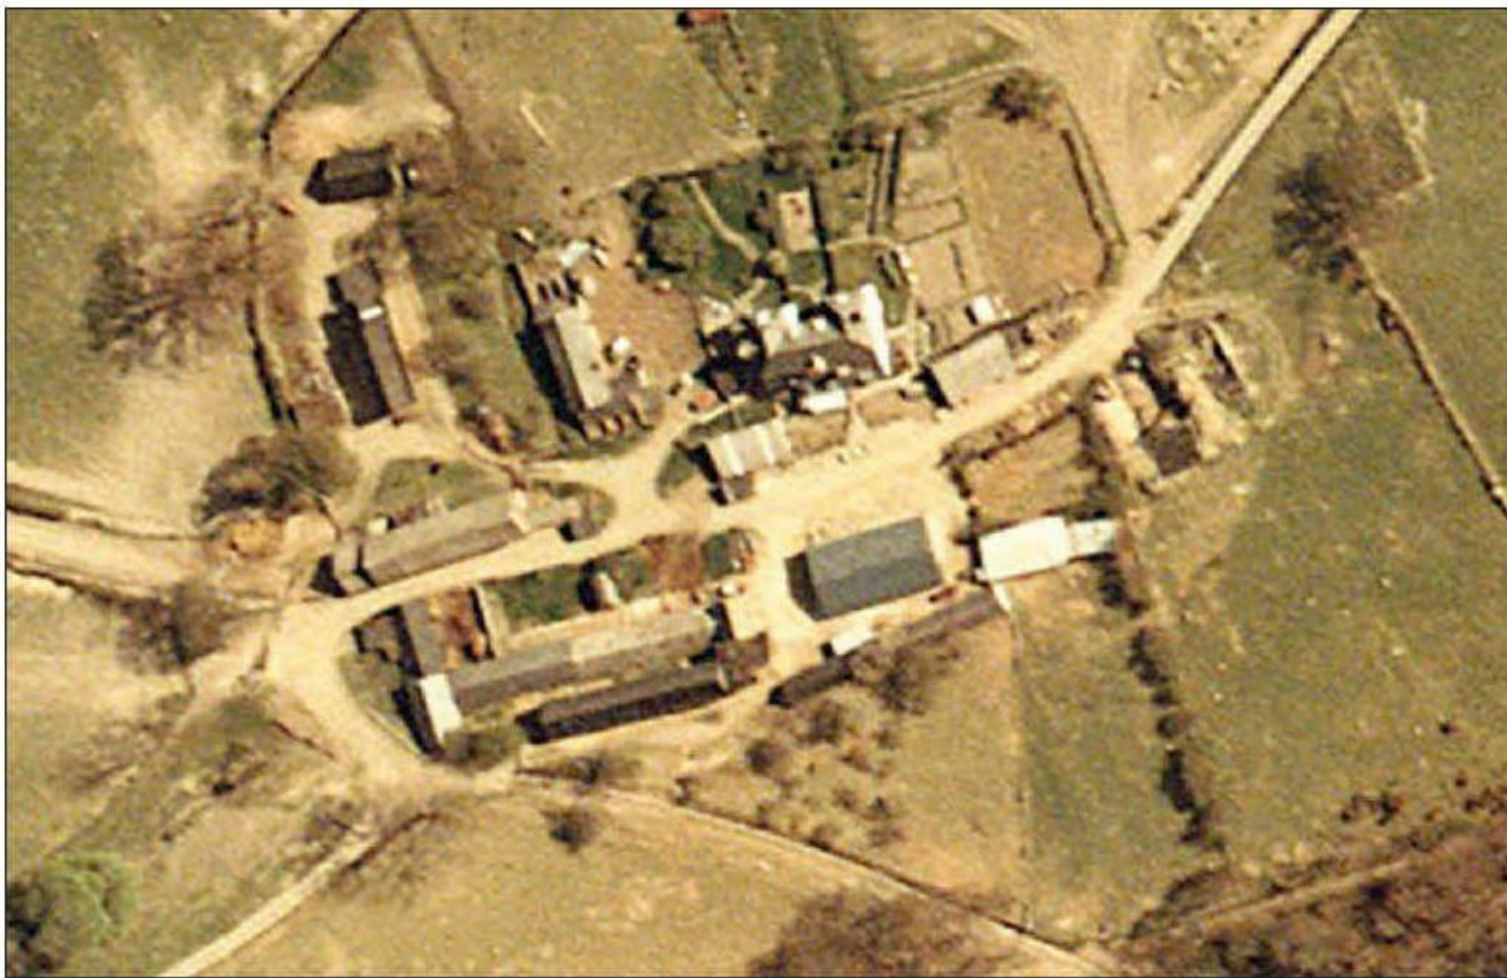
Further developments are best observed in the aerial photography collection consulted during the production of this report. Phasing dating to the 20<sup>th</sup> century is also documented in Figure 14. These photographs evidence that the decay of the building may have commenced sometime during the 1990s (Plates 9-12).
