## DESK STUDY REPORT

Site: CGT Properties Site, Coombe Valley Road, Dover, Kent CT17 0EX

Prepared for: CGT Properties

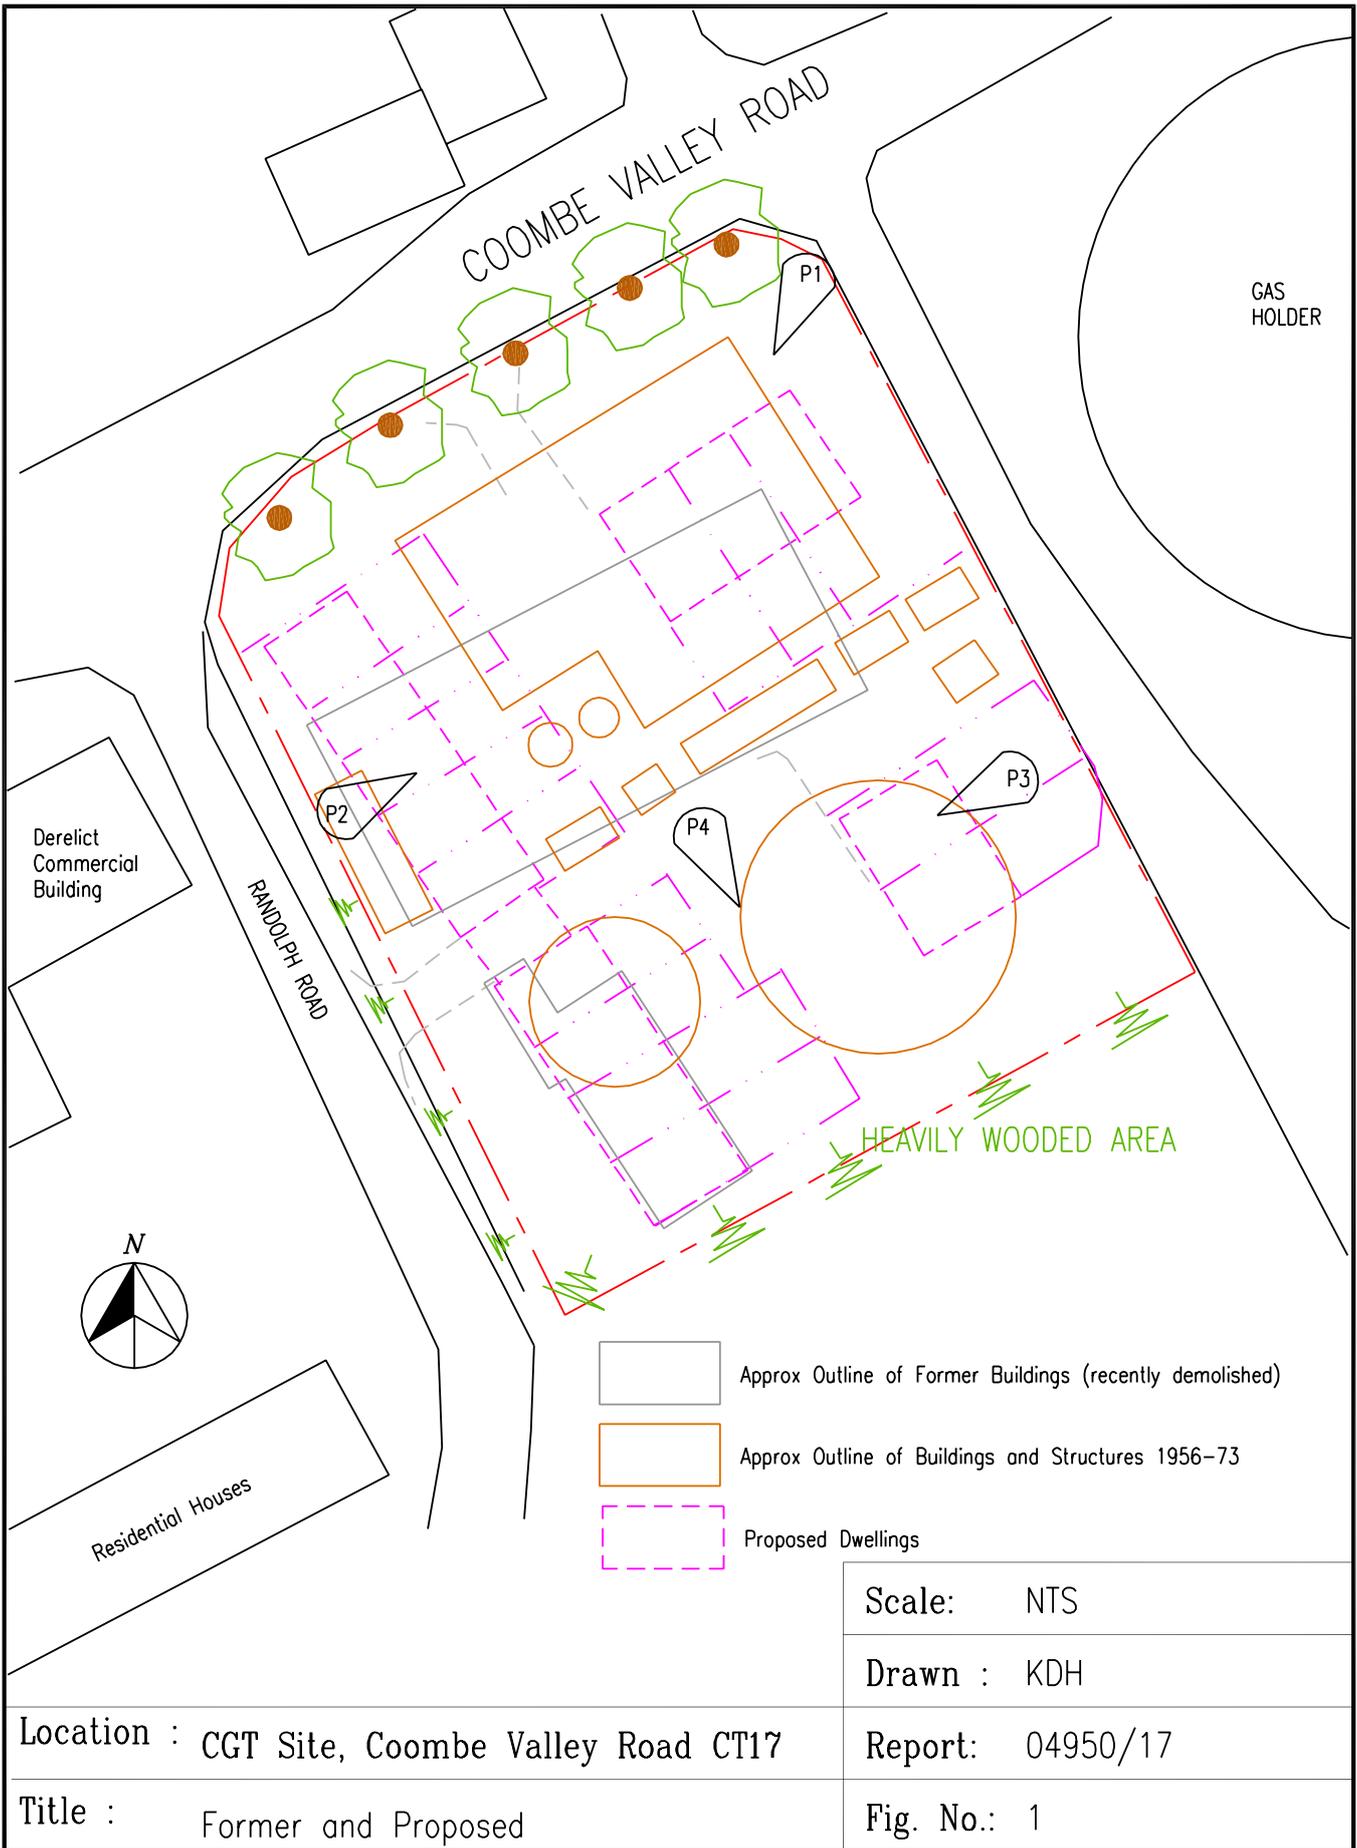
A site plan showing the former and proposed site layout and the immediate surrounding areas is shown in appendix 1 (p3). Also shown on this site plan are the locations and view direction of the photographs of the site that were taken during the walkover survey. The site photographs are shown in appendix 3.

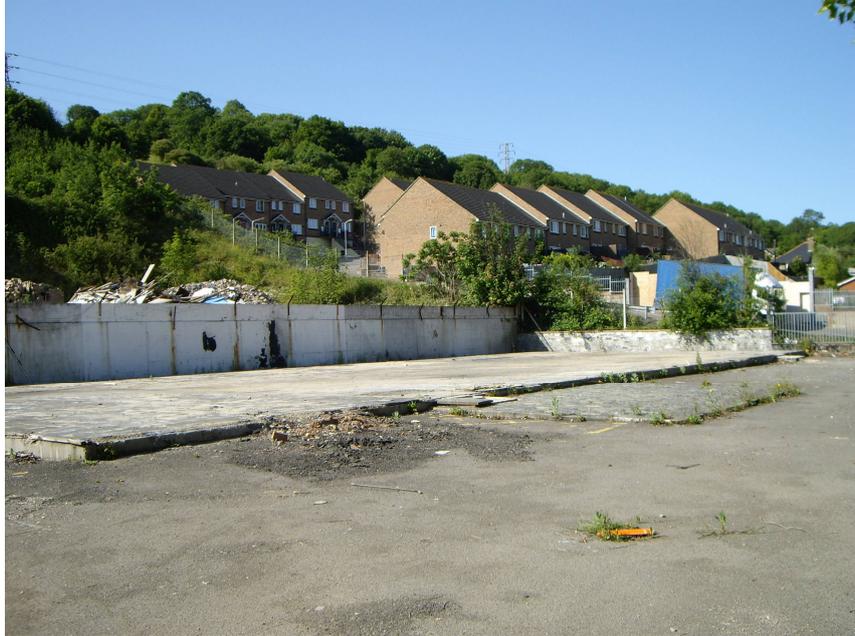
## PHOTOGRAPH 1

Looking southwest across the north area of the site showing the former building floor slab and retaining wall between the north and south areas of the site. The adjacent residential houses in Randolph Road are in the background.

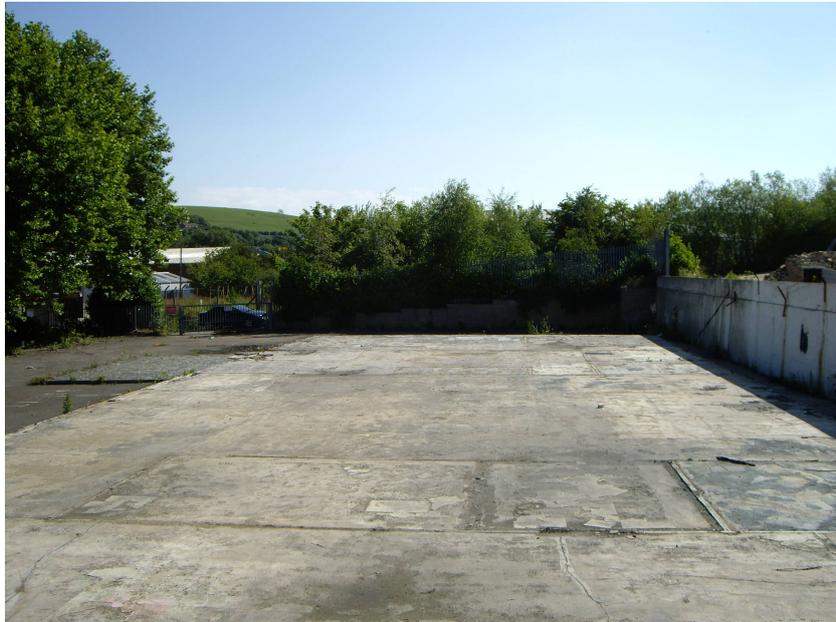
## PHOTOGRAPH 2

Looking northeast across the north area of the site. The gasholder on the adjacent Transco site is immediately beyond the trees in the background.

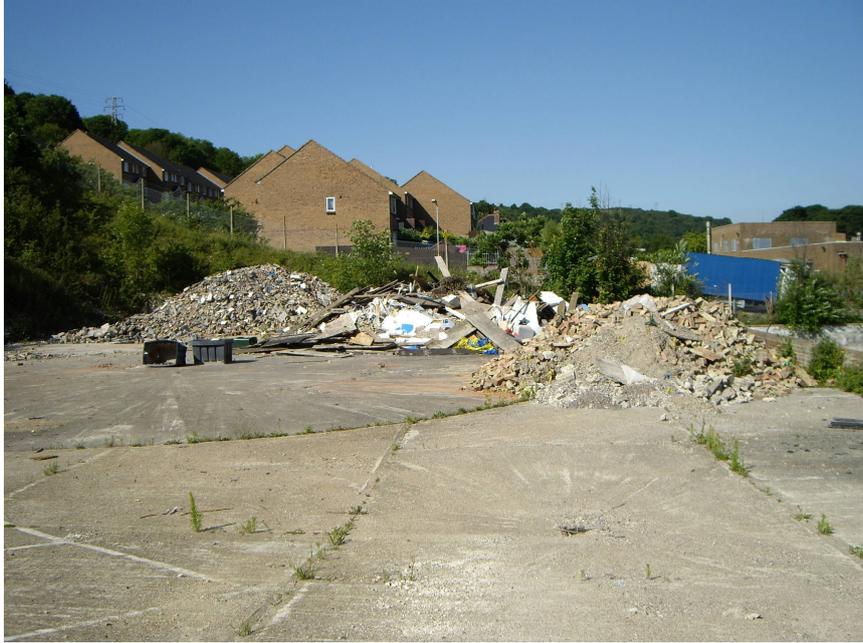
### PHOTOGRAPH 3

Looking southwest across the south area of the site showing the outline of one of the former tanks that was in this area and the stockpiled brick/block rubble. The adjacent residential houses in Randolph Road are in the background.

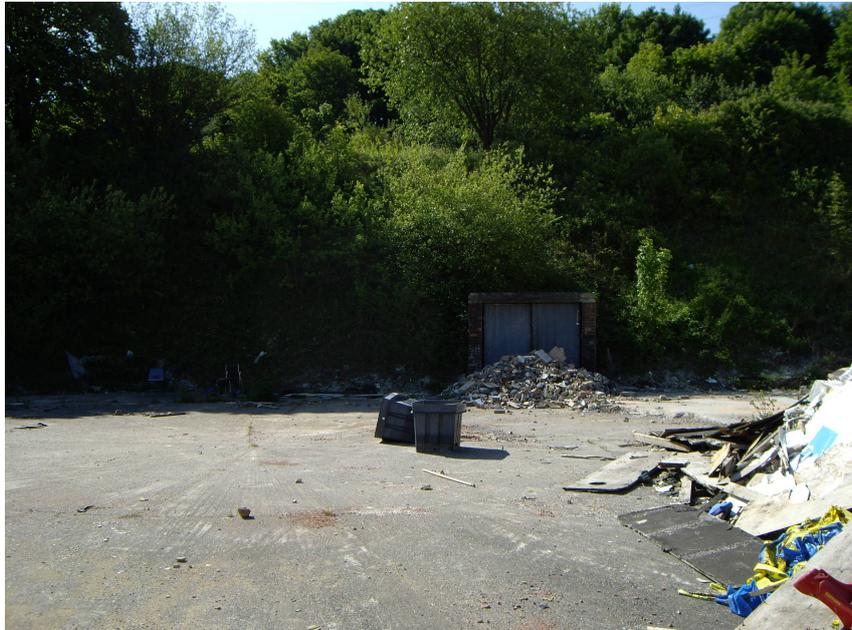
### PHOTOGRAPH 4

Looking southeast across the south area of the site showing the small brick shed that remains and the steep heavily overgrown embankment that bounds the site.
