**15/16 THE SQUARE, BLANCHLAND, PROPOSED DEVELOPMENT  
BAT AND BARN OWL REPORT– SEPTEMBER 2019**

**SECTION 1 BACKGROUND AND SUPPORTING INFORMATION**

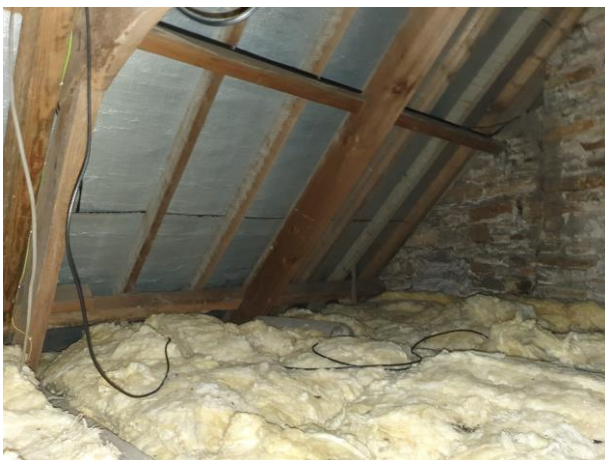
The buildings are two storey cottages constructed of stone with a pitched stone slate roofs. The stone work is well sealed however crevices were present at the eaves. The loft space has clean fibreglass insulation and a metallic backed bitumen sarking. Rat droppings (small quantity) were noted on the insulation. In the north loft cobwebs were present across the void.

**Rat droppings in the loft.**

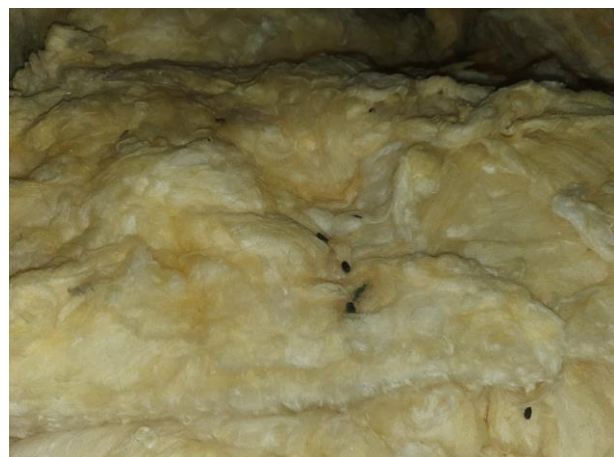
**Interior of the loft.**

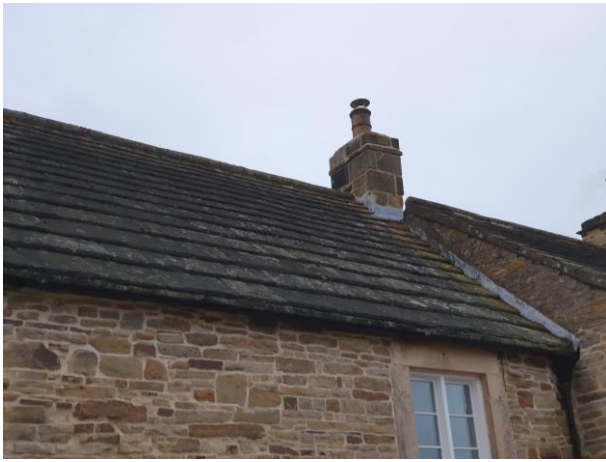
Well-sealed sound roof, ridge and flashing.

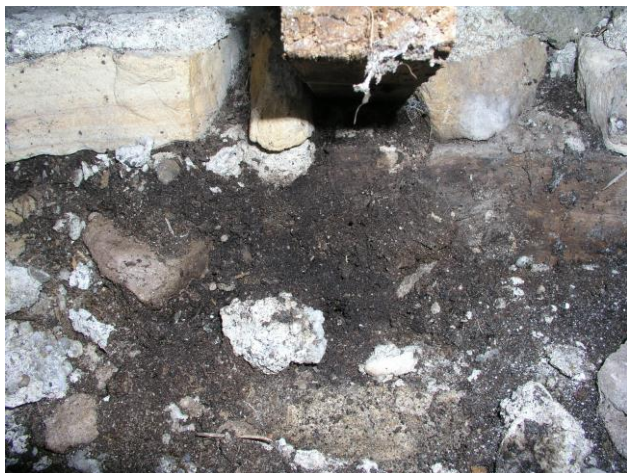
**Photo showing disintegrated bat droppings beneath coping stones. If examined carefully, in the black dust exoskeletons of insects can be seen shining.**
