Report prepared for: The Wadenhoe Trust

For the Site of: Barn & Cart Lodge, Part of Mill Farm Yard, Chruch Street, Wadenhoe
Peterborough, PE8 5SU

Preliminary Roost Assessment (PRA)

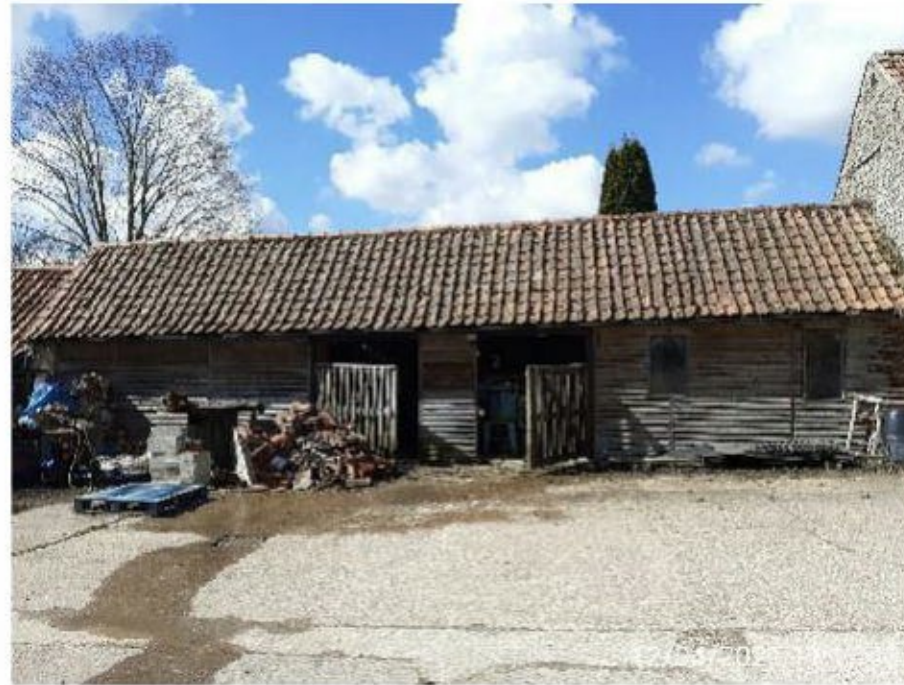
Figure 2: Front elevation B1

B1 is a former cart lodge, with an open gable roof structure. The building is brick built with timber cladding on the front elevation. There are clay, pan roof tiles and the building has timber, stable style doors.

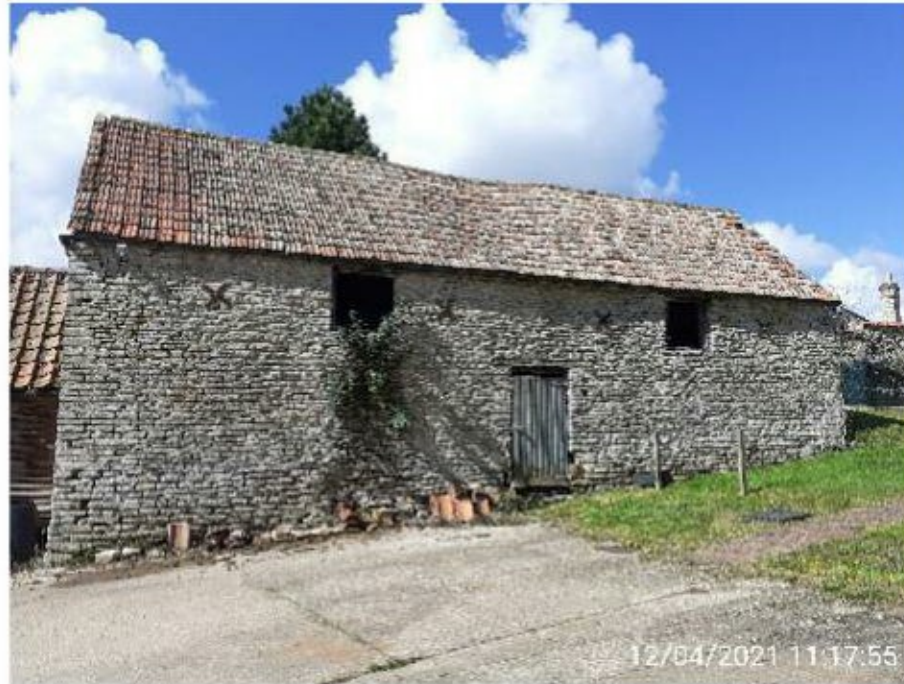
Figure 4: Front elevation of B2

B2 is a large barn with an open gable roof structure. The barn is made from stone with interlocking, clay roof tiles and timber doors.

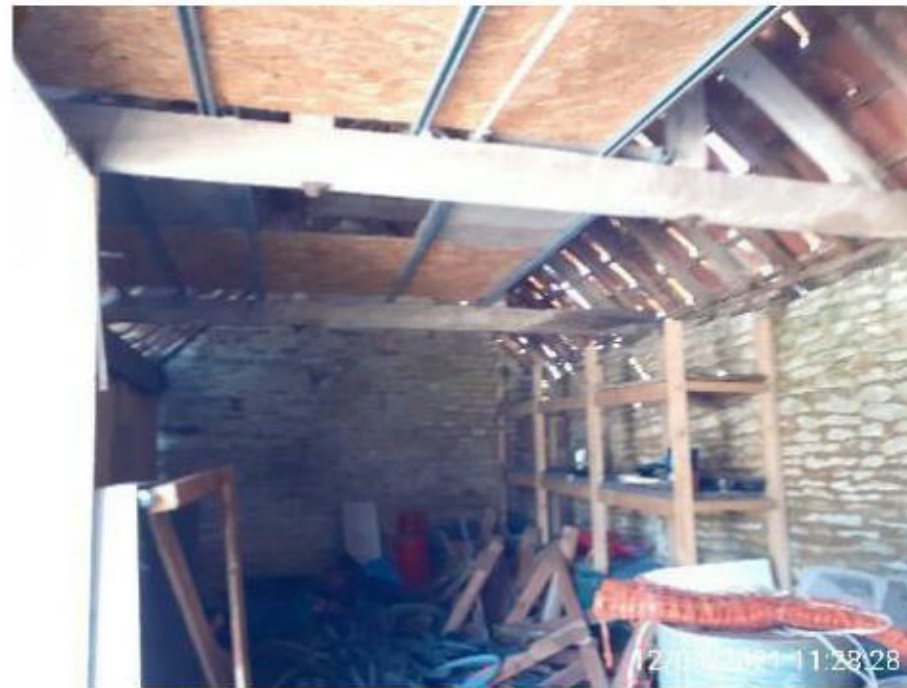
B1 has no internal loft void, with a vaulted ceiling and a queen post, roof beam structure, there is no internal roof lining. The building is currently used for storage.

Figure 7: Internal space within B1 (southern end)

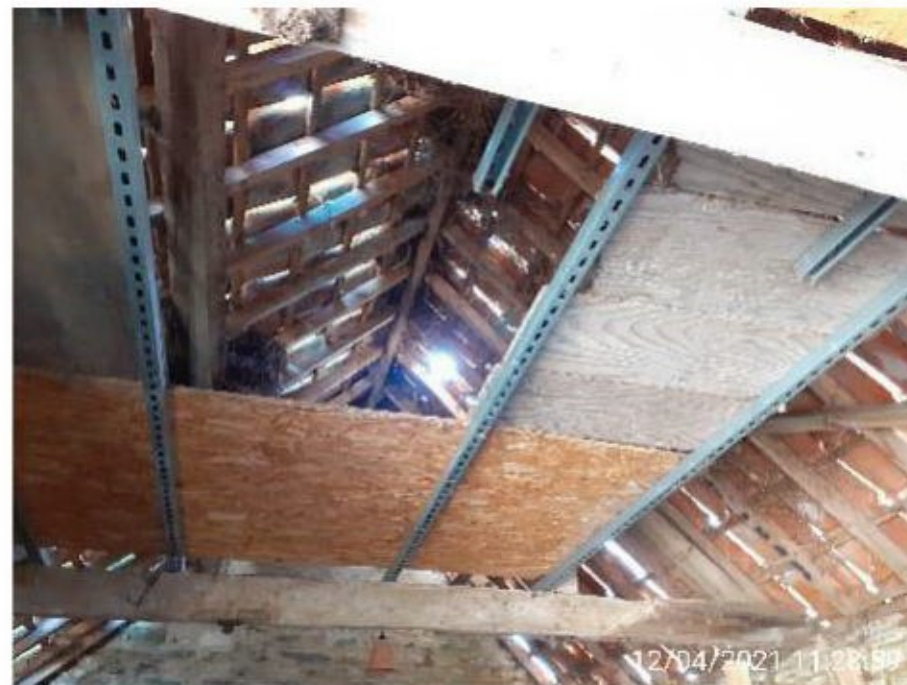
Figure 8: Internal loft space in B1

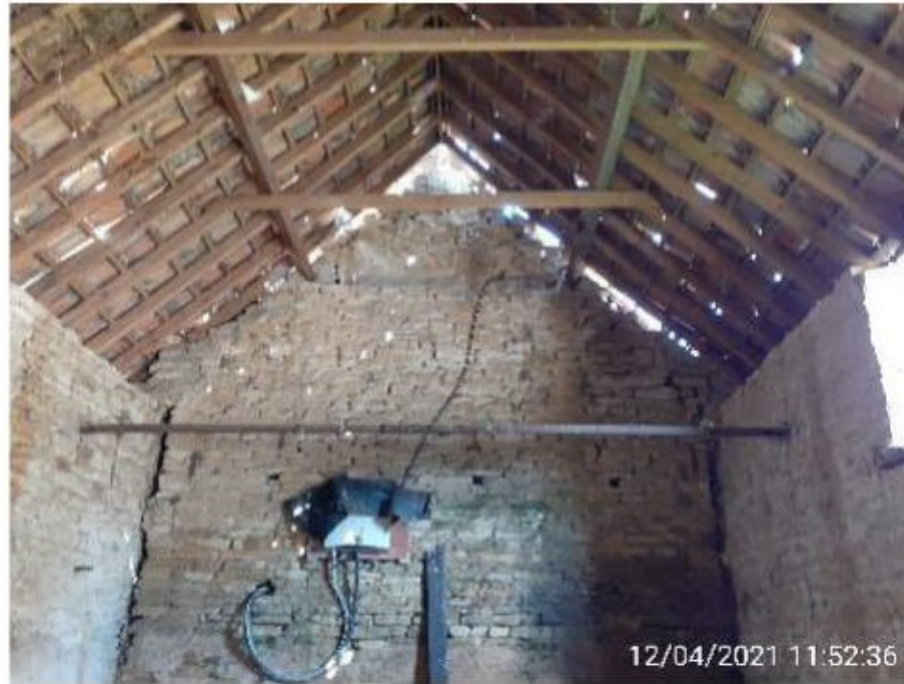
B2 has no internal void, with a vaulted ceiling and queen post, roof beam structure and no internal roof lining. The building is currently used for storage.

Figure 9: Internal space in B2 (northern end)

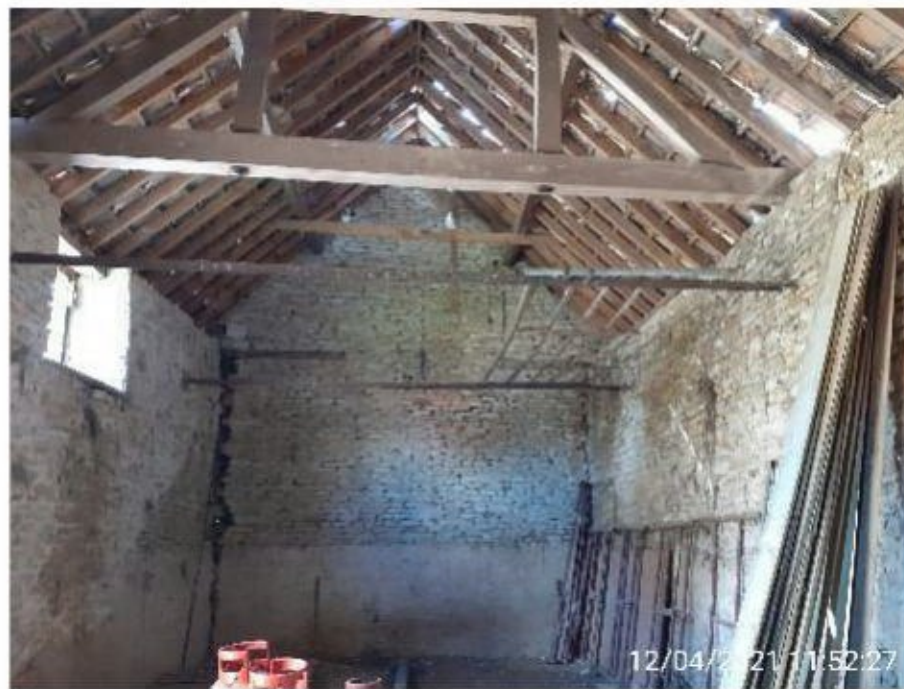
Figure 10: Internal space in B2 (southern end)

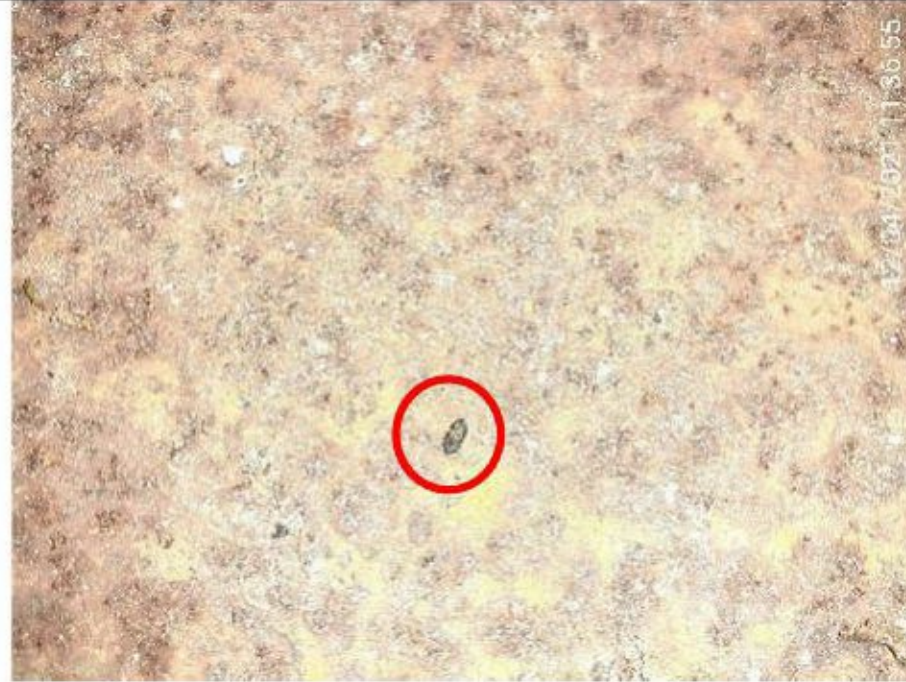
Bats found	No bats were found at the time of the survey.
Evidence of bat use	B1 - Evidence in the form of approx. 5 droppings and 2 butterfly wings were found at the time of the survey (see figures 11-15). B2 - No evidence of bats was found at the time of the survey.

Figure 11: Example of dropping found in B1

B1 - **Full roost characterisation surveys** will be required to determine species, population and the entry/exit points used (three surveys, a minimum of two weeks apart).

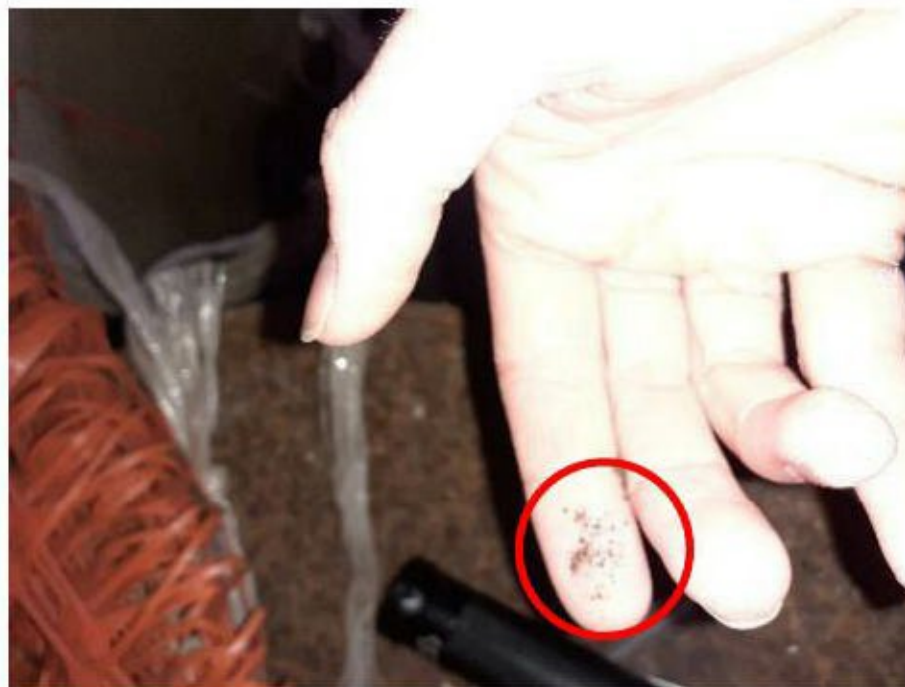
Figure 12: Example of dropping in Fig 11 crushed

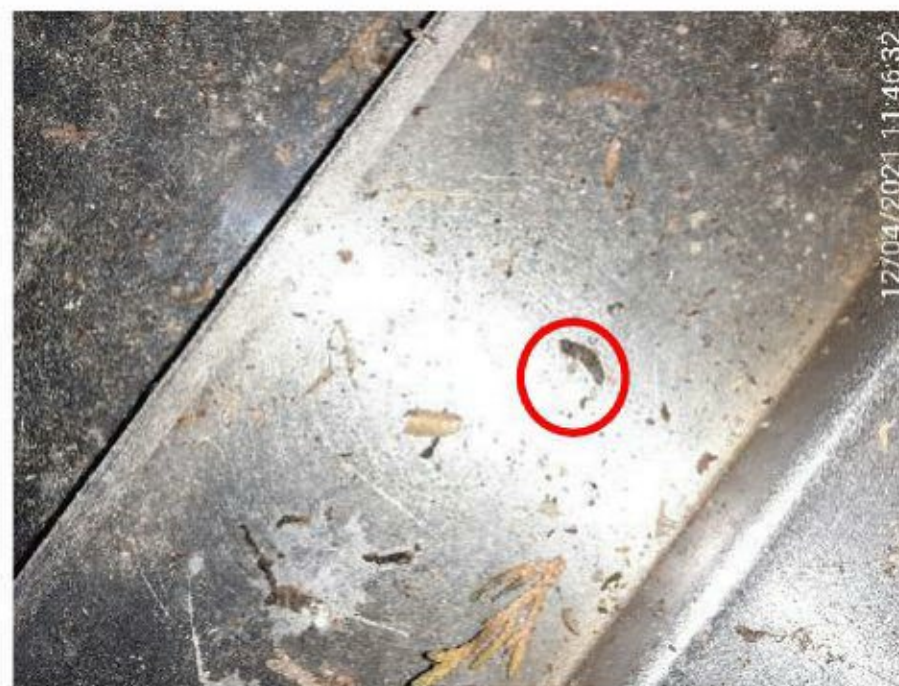
Figure 13: Further example of dropping found in B1

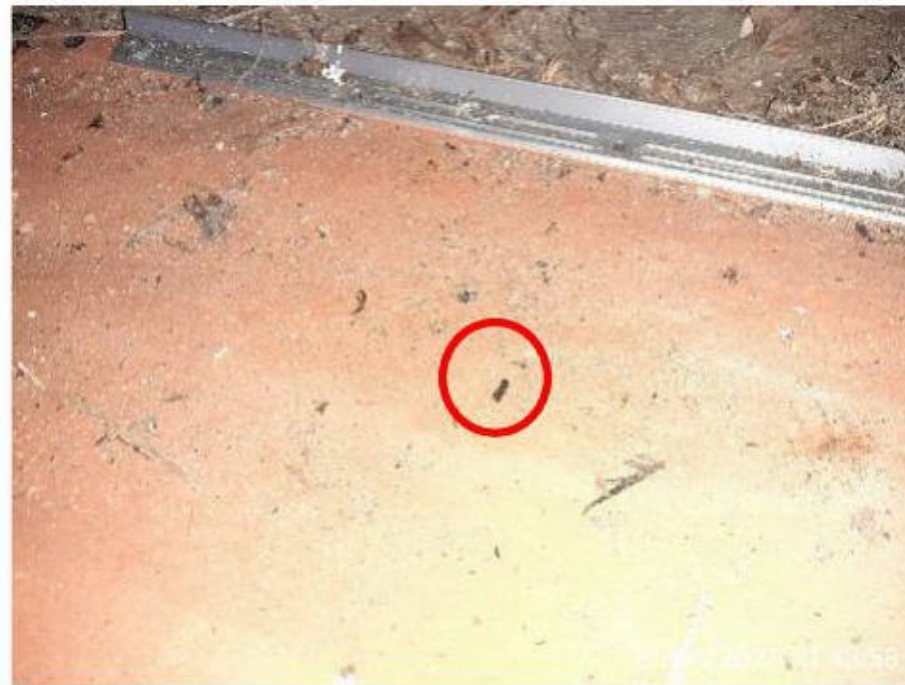
Figure 14: Further example of dropping found in B1

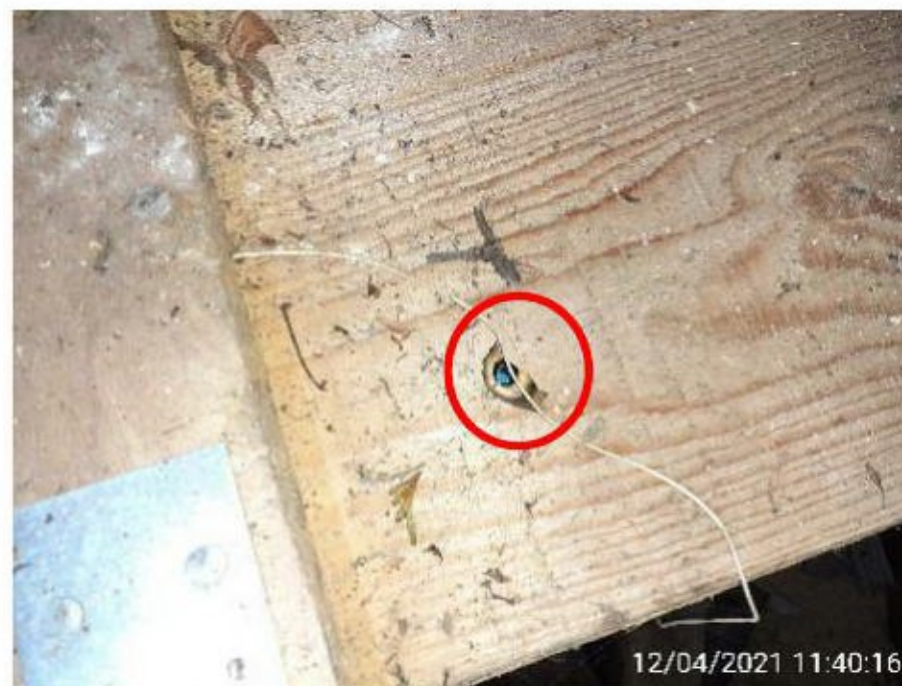
Figure 15: Example of butterfly wing found in B1

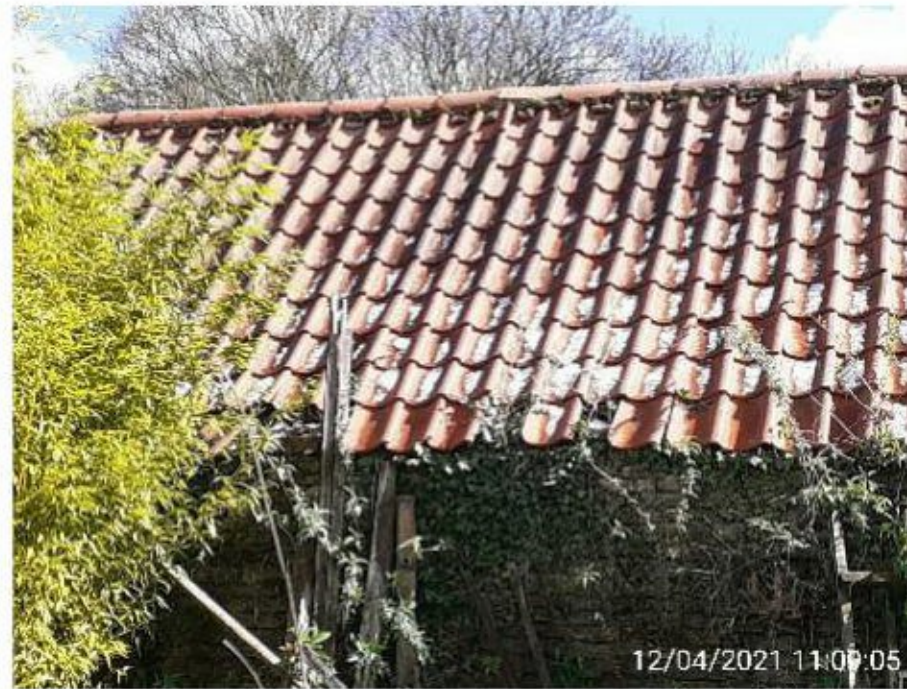
<p>Potential for bat use</p>	<p>Level of likelihood of presence - B1 - Confirmed. B2 - High.</p> <p>B1 - The presence of a roost was confirmed through approx. 5 droppings scattered across the floor and on objects within B1. The building has ample opportunity for access through the stable style doors and missing roof tiles. The beam structure also provides internal roosting opportunity (see figures 16-17).</p>
------------------------------	---

Figure 16: Example of missing roof tiles

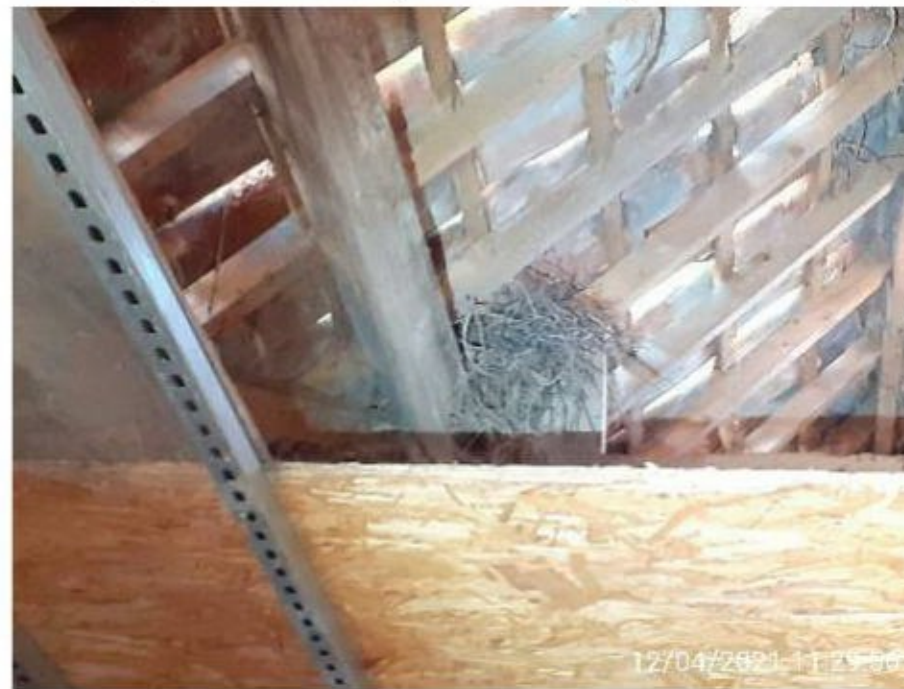
Figure 17: Example of numerous gaps in roof and bird nest in B1

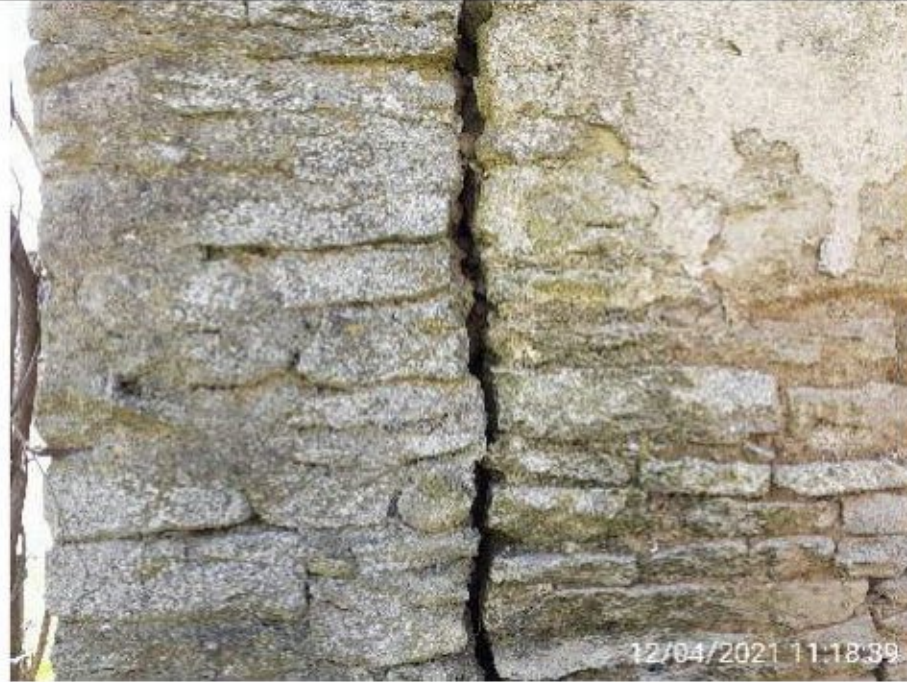
B2 - B2 provides high potential for roosting bats due to the numerous access points across the building such as loose and missing roof tiles, and open windows. There were also numerous holes within the stonework on the external of the building which could provide roosting opportunity for crevice dwelling species. Internally there is also roosting features present including along the beam structure and in internal holes in walls (see figures 18-2).

Figure 18: Example of large cracks/ crevices in stonework in B2

B2 - **Presence/Likely Absence surveys** will be required (three surveys, a minimum of two weeks apart).

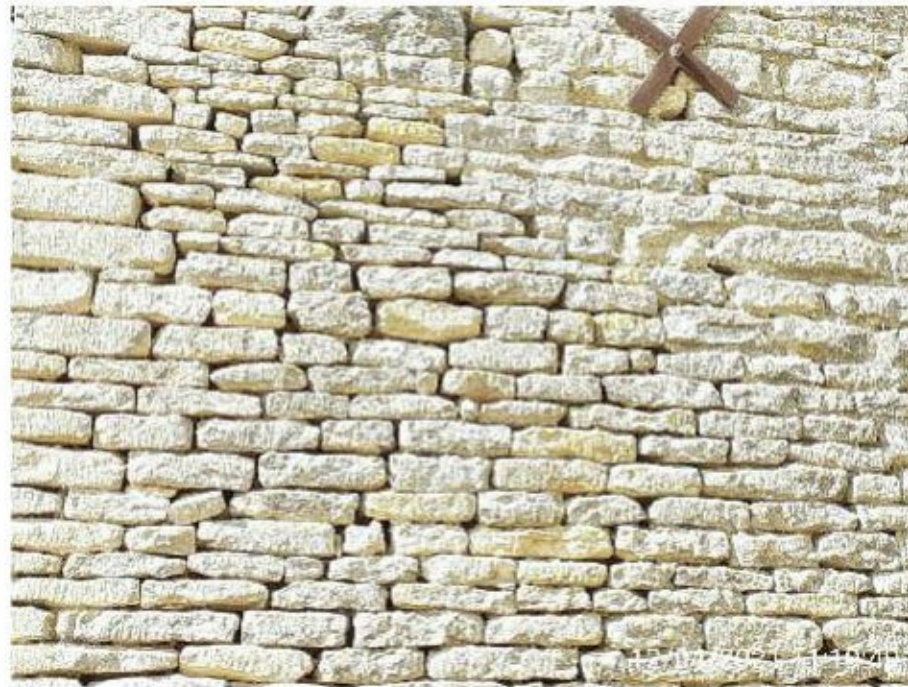
Figure 19: Further example of holes in wall of B2

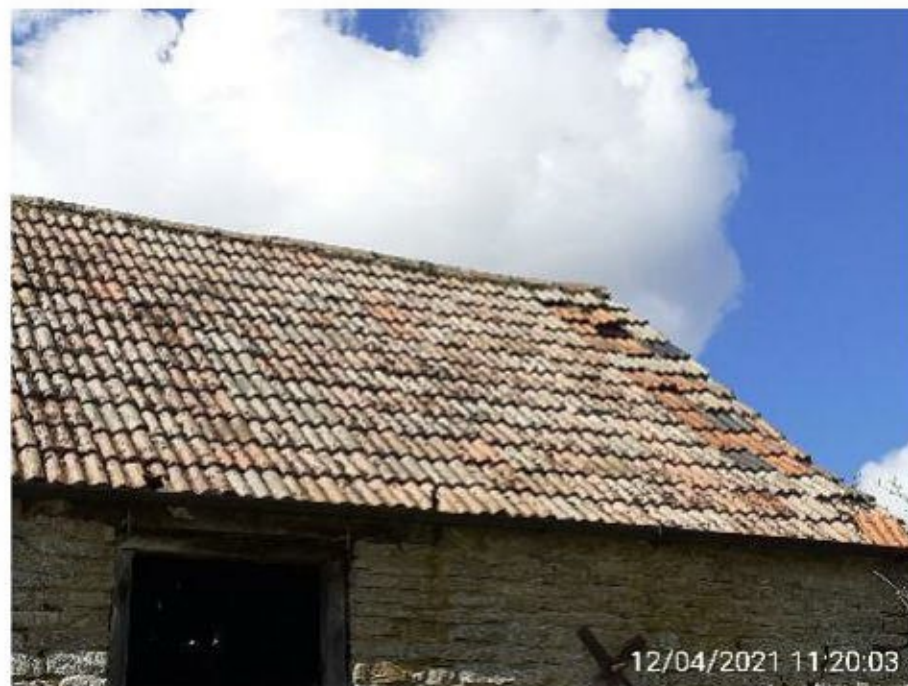
Figure 20: Example of loose/missing roof tiles on B2

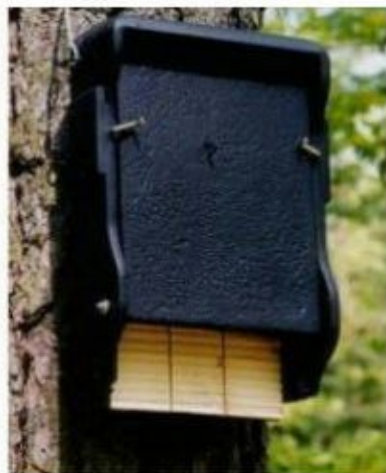
<p>Mitigation</p>	<p>Based on Mitchell - Jones, (2004), <u><i>subject to change following surveys.</i></u></p> <p>Under licence, demolition of suitable bat roosting features e.g. internal beams, stonework etc. will require the supervision of a bat licensed ecologist.</p> <p>The suitable bat roosting features e.g. stone work, internal beams. will be stripped by hand only. All areas across the roof/wall tops/weather boarding etc. will be checked for bats i.e. endoscope (where possible) and via destructive search. If bats are found, these will be removed by hand (Ecologist only) and placed in bat boxes that will be in place before works begin.</p> <p>Bat boxes will be installed. These will be no less than 3m above ground level and away from any neighbouring ledge to prevent local cats predated on bats using the boxes.</p> <p>A minimum of two Schweglar 1FF or similar boxes (Figure 23) will be hung on the trees at a minimum of 3m from ground level and face south/southwesterly. These boxes are known to be used by crevice and void dwelling species.</p> <div data-bbox="1028 2024 1371 2450" data-label="Image">

</div> <p>Figure 23: Schweglar 1FF bat box</p>

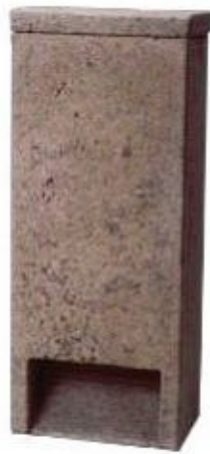
<p><i>A traditional bitumen felt (hessian backed only) is to be used it must be of the type 1F only.</i></p> <p>Bat tubes can also be built into the building (Figure 24). These require no maintenance, can be installed on a gable end, no less than 3m above ground level, face south or north and can be faced in any material to provide an aesthetic matching the reminding building.</p> <div data-bbox="1102 813 1288 1222" data-label="Image">

</div> <p>Figure 24: Example of bat tube</p> <p>Commuting bats maybe using the grounds and surrounds - therefore, any tree, hedges or linear feature should be retained were possible.</p>
<p>Lighting</p>	<p>Any lighting near or shining onto any trees, especially those with bat boxes in or commuting routes shown to be present at further survey stage, should be designed to minimise the impact it has on potential bat roosting and commuting.</p> <p>Lighting should be in line with the BCT lighting guidelines (Bats and Lighting in the UK (Bat Conservation Trust, 2018) https://www.theilp.org.uk/documents/guidance-note-8-bats-and-artificial-lighting/)</p> <p>This lighting should be of low level, be on downward deflectors and, ideally, be on PIR sensors. Using LED directional lighting can also be a way of minimizing the light spill affecting the habitat. No up-lighting should be used.</p> <p>This will ensure that the roosting and commuting resources that the bats are likely to be using is maintained.</p>
