Protected Species Survey  
Outbuilding at Rectory Farm  
Widmerpool Road  
Wysall  
Nottinghamshire  
NGR SK60605 27301

SAFETY SCHEMES IN PROCUREMENT	Report prepared by: C J Barker CEnv	Date Issued: 22 February 2021
	Reviewed by: KB	CBE Consulting, Highbank, 5 Grantham Road, Navenby, LN5 0JJ Tel: 01522 810086 Email: chris@cbeconsulting.co.uk
	Report ref: P2228 / 0221 - 01

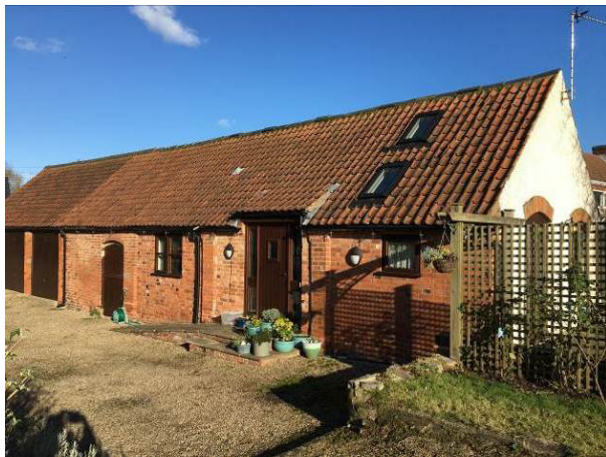
**Holiday Let** – situated at the southern end of the building the south gable has been pebble dashed and painted white with no cracks, bubbling or other cavities visible. The pitched roof was re-laid in 2007/8 when the holiday let was constructed and the main living area has no enclosed loft but is open to the roof apex. Internally the roof has been lined, boarded and painted and the roof edges are effectively sealed. Two velux style windows have been fitted.

Front of holiday let

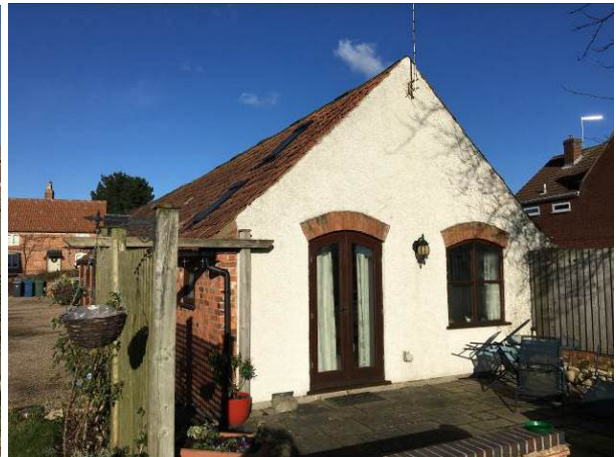
South gable of holiday let

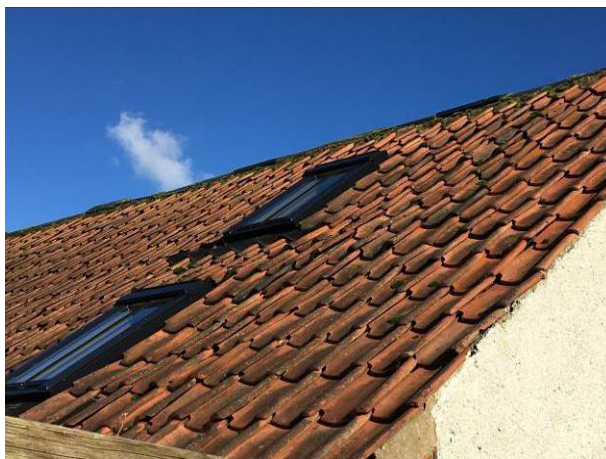
There is a sealed loft area over the bedroom of the holiday let which extend to the north over the small storeroom. The pitched roof has traditional pantiles throughout which have a number of gaps and since the roof is lined there may potentially be roosting places between the pantiles and the lining beneath. This part of the building does have a purpose-built loft roost space so ***the roost potential must be classed as high*** due to the presence of this loft area. However, ***no evidence of bat activity was found externally on any part of the building***. No evidence of nesting was found on any part of the building.

Roof of holiday let

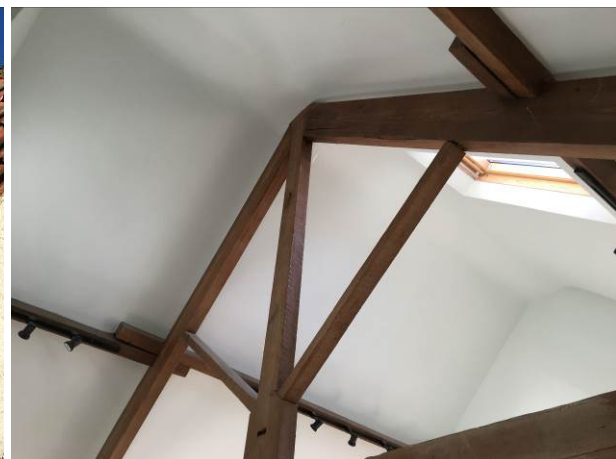
Internal open roof of holiday let

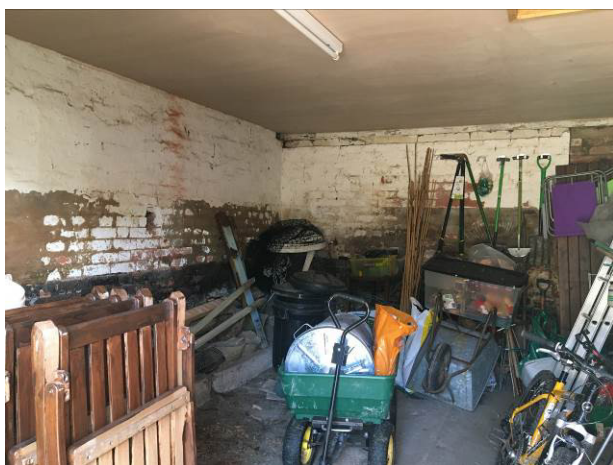
The ground floor room is painted white and has a concrete floor. There is a tightly fitting wooden door on the west side (front). No evidence of any bat or bird activity was found within this ground floor area. The loft area has been utilised to construct a purpose-built heated roosting area for the small colony of bats originally found within this building. This was quickly inspected and no fresh droppings were found anywhere within this and no bats were found using the roost space. The roost was inspected in 2018 by the Bat Conservation Trust Officer and a handful of old BLE droppings were found at that time. An activity survey carried out by BCT in August 2018 did not identify any bats leaving the building but for the purpose of assessment of the building this loft space should be considered to be an active roost even though it does not appear to be frequently used based on the lack of internal evidence. Access is via gaps in the pantiles and along the ridge directly above the storage room.

Storage area ground floor

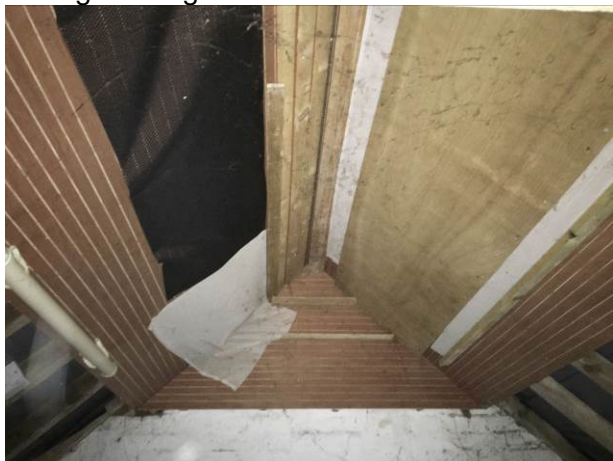
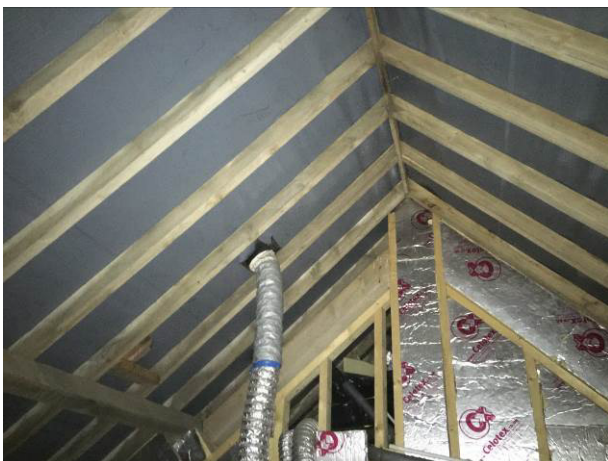
**Storage Area** – situated in the centre of the building this small single-room storage area has an enclosed loft space which is part of the purpose-built loft roost space. The pantiles extend across this section of the pitched roof and there are many gaps between these and rendering missing from the ridge.

Bat loft roost area

The proposal being considered is for the garage to be converted into a separate holiday let. This may include the ground floor of the storage room. It is unlikely that any conversion will have any impact of the existing bat loft area provided no velux windows are fitted too close to the sealed loft area. If the ground floor storage room is included within the holiday let building the loft access and ceiling to this room which forms the floor of the sealed loft must be carefully insulated to ensure that there is no way noise of heat can disturb the environment within the loft roost area.

The conversion of the garage should not require any further surveys to take place. However, as a precaution it might be prudent to consider undertaking any roof works to the garage to install windows outside of the bat activity season as such works may cause vibrations which could disturb bats in the adjacent loft roost area. Alternatively, the roost area could be inspected beforehand to determine if there are any bats present and the work supervised by a Licensed Bat Consultant to ensure it is carried out in a manner which does not cause any disturbance through noise or vibration.

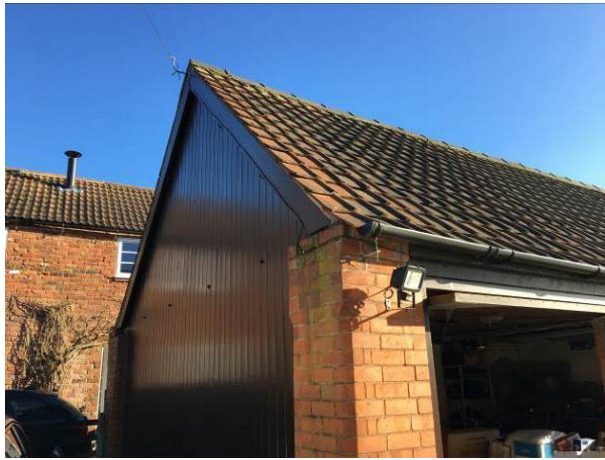
**Triple Garage** – the northern end of the building comprises an open triple garage area with three lifting steel doors on the west side. The interior of the garage is open and there is no enclosed loft area. The brickwork throughout both external and internal is exposed and in excellent condition. The north gable end is constructed from two layers of vertical cladding with internal insulation. This cladding is tightly fitted with no gaps or holes present.

North gable and roof

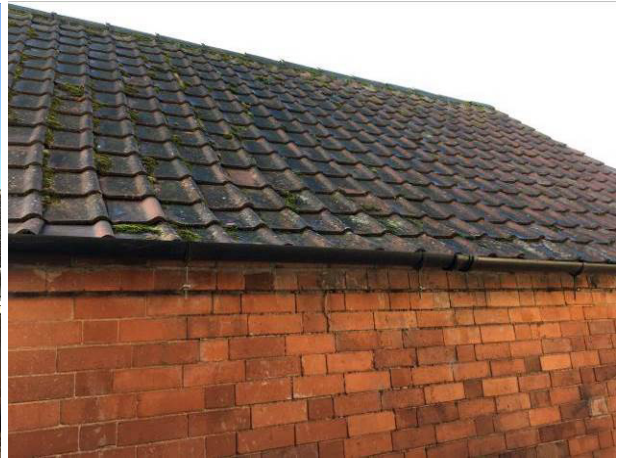
The pitched roof of this section of the building comprises concrete tiles with modern grey plastic sheet lining laid over prefabricated timber beams. There are no gaps or holes present in the tiles, none appear lifted, slipped or broken and the roof edges appear tightly sealed. No evidence of

bat activity was found on any part of the building or anywhere within the garage interior and because of the condition of the roof, the lack of any gaps or entry points visible and presence of grey plastic lining, which is not particularly desirable to bats, this part of the building is considered to have **negligible roost potential**. No evidence of nesting birds was found within this part of the building.

Roof to rear of garage

- The tiled roof structure of the garage is unlikely to be disturbed unless velux windows are to be fitted or a chimney is installed near the north gable end. If any works are required to the roof or roof edges ideally such work should be completed outside of the bat activity season (i.e. not between May – August). Any tiles or roof timbers should be carefully dismantled by hand at the start of the work and all tiles should be lifted rather than slid to enable the underside of these to be inspected in accordance with accepted good practice.

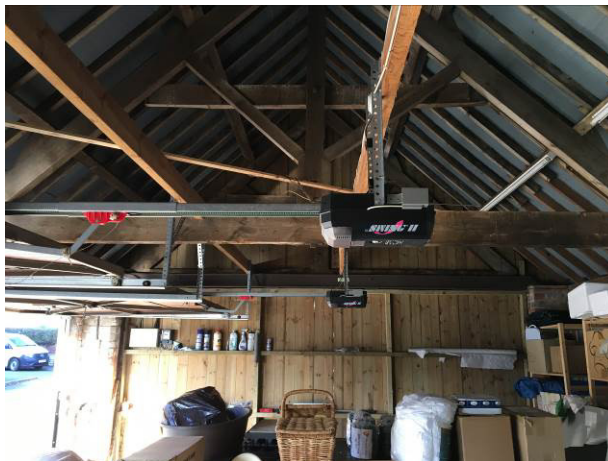
Garage interior looking north

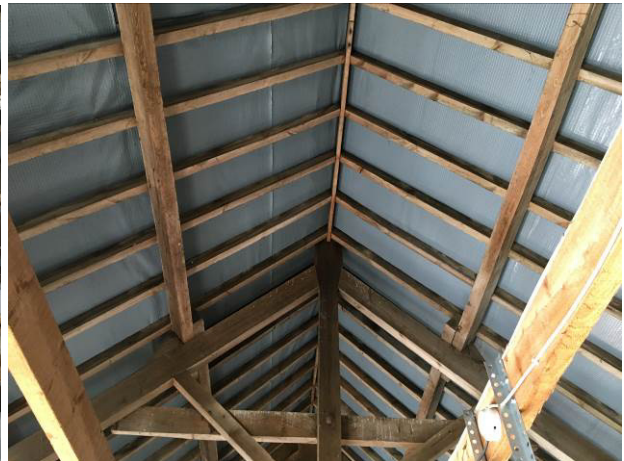
Interior of garage roof
