BAT SURVEY 2020
BARNS AT HOME FARMHOUSE
BAGENDON, GLOUCESTERSHIRE

CTM WILDLIFE**BAT SURVEY 2020****BARNS AT HOME FARMHOUSE
BAGENDON, GLOUCESTERSHIRE**

<u>Version</u>	<u>Purpose</u>	<u>Date</u>
V1.0	Conversion of barns for residential use	6 th December 2020
V2.0	Typographic corrections	11 th December 2020

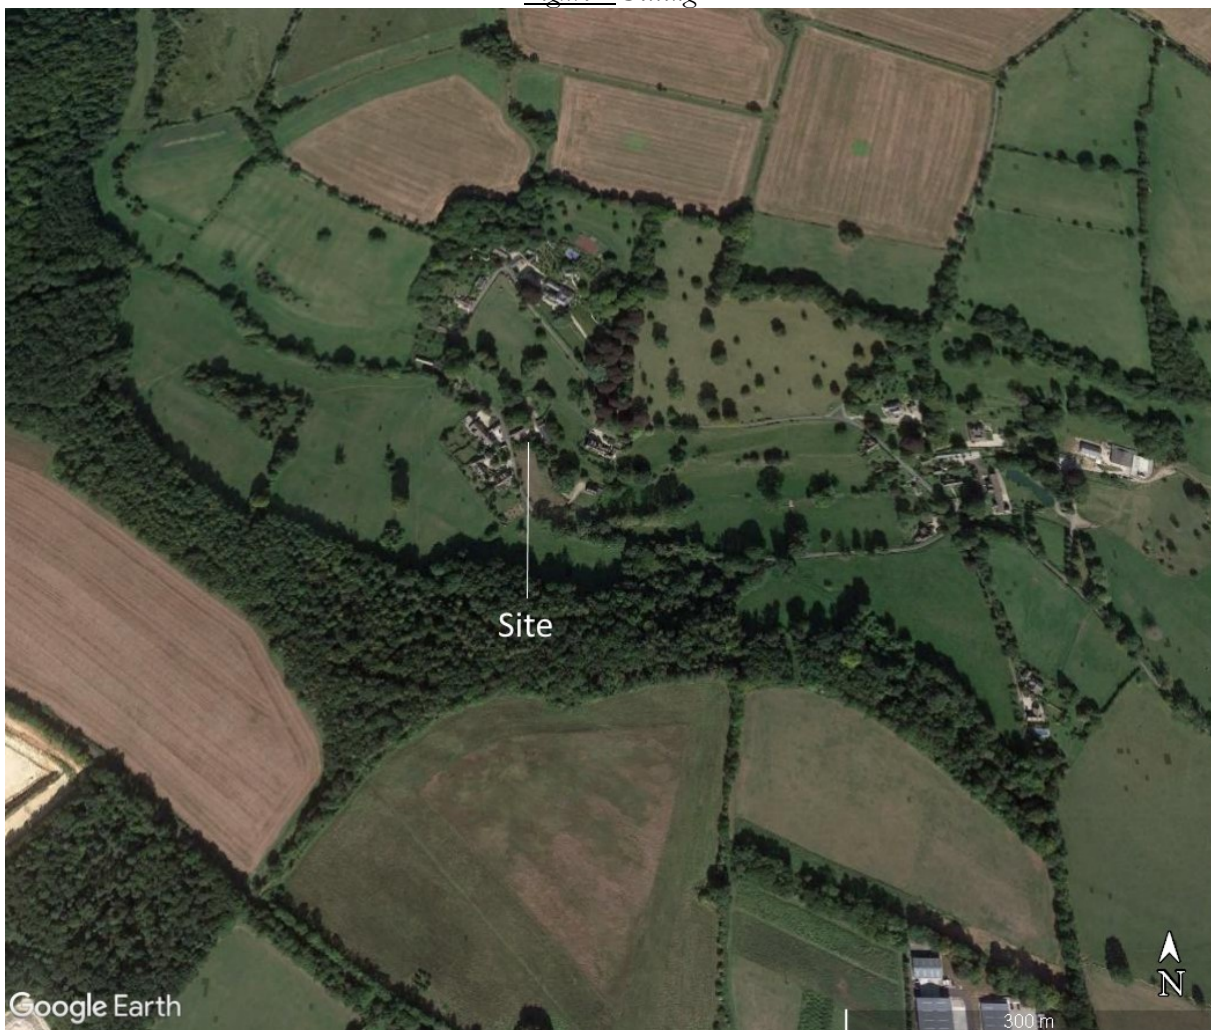
Figure 2 Setting

Bagendon consists of dispersed dwellings on the slopes and bottom of a small valley within the Cotswolds. The habitat is dominated by horse paddocks, parkland and a small stream along the valley bottom, and further afield arable farmland. There is woodland close-by to the south. It is an unlit village. The surveyed outbuildings are on the valley bottom next to the stream.

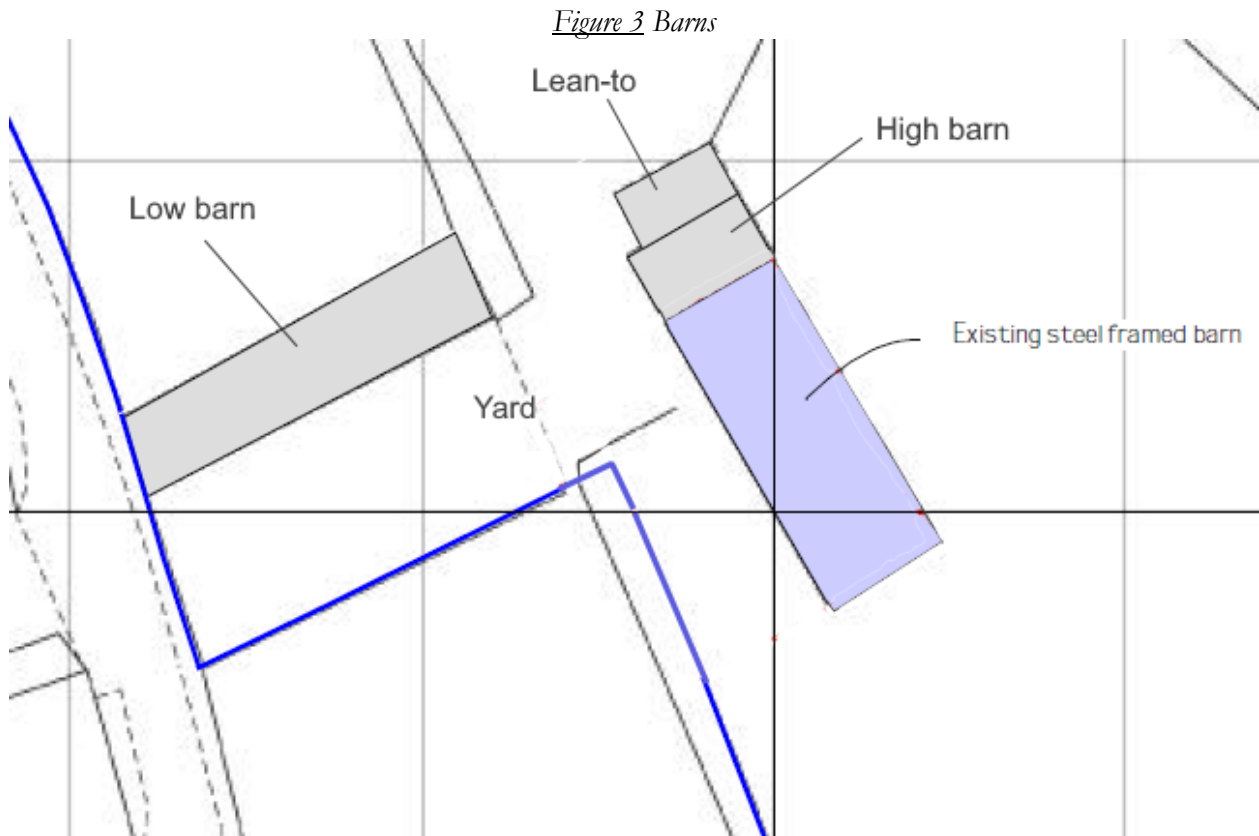
The existing steel-framed barn is not part of the scheme.

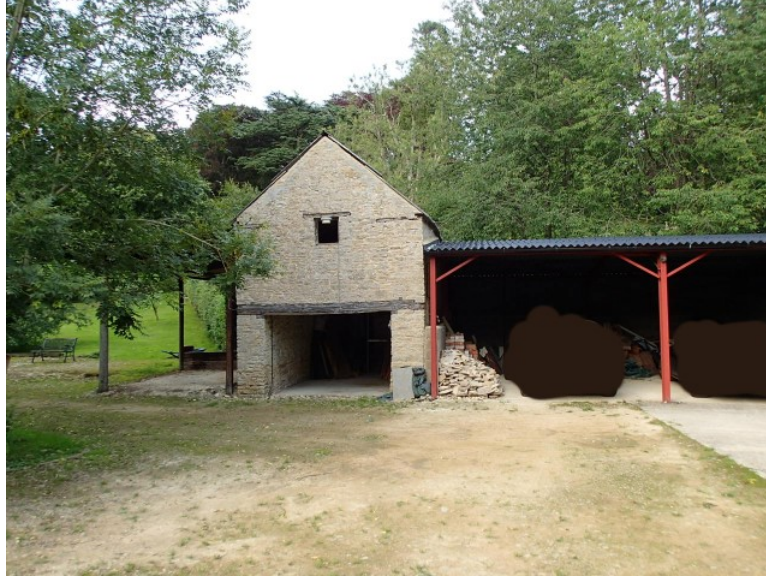
Photo 1 High barn

This is an open-fronted Cotswolds stone building that looks to have been a former cart shed with a hay loft above. The loft floor is missing and the building is now a single open space inside from floor to roof. The walls are mortared Cotswolds stone and in good condition. There is an open cart entrance, open window above and open loft door on the side. There are timber lintels above these openings. It is light and airy in the building. The roof is corrugated sheets sitting on old sawn purlins on what looks to be older original main rafters. The roof frame joints were tight. The roof is loose-fitting at the verges and eaves. To the side is an open lean-to with a corrugated sheet roof. There is an exterior light.

Potential bat roosting places are (1) gaps at the roof underside between parallel timbers along the ridge and (2) gaps at the timber lintels. It is too light and airy for daytime use by perching or free-hanging bats in the open.

There was a small aggregation of half a dozen bat droppings on items stored on the ground below the roof ridge at the rear of the barn where the parallel ridge timbers are close together forming a small cavity above. The droppings were this season's and DNA analysis identified them to be **common pipistrelle droppings**. The droppings were swept away and checked for during subsequent visits during the night-time surveys; no new droppings were found.

It is understood that the original planning permission for the conversion of the barns was approved with the building-in of Schwegler N27 Bat Brick Boxes into the gable walls of the High barn and a bat/owl loft.

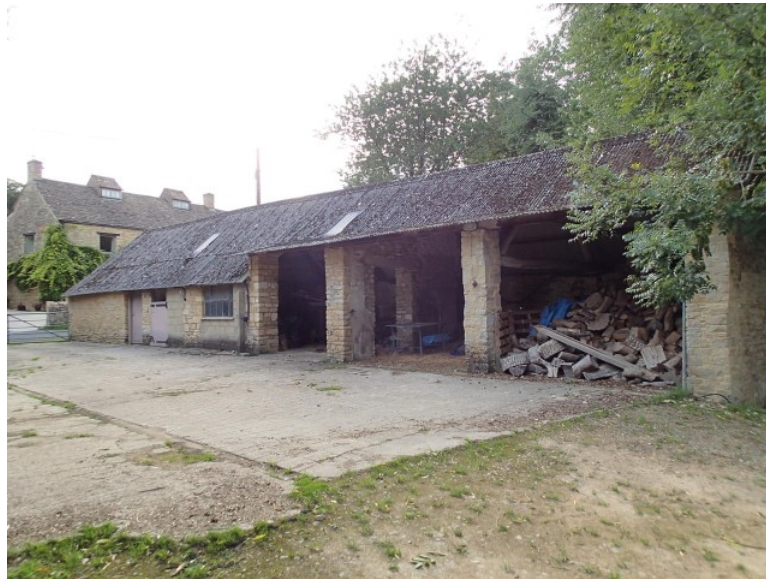
Photo 3 Low barn

The Low barn is built with Cotswolds stone. It consists of four parts: (1) at the north-eastern end a couple of open-fronted bays, (2) a central open-fronted bay continuous inside to the side into a room with a glazed window, (3) a stall with stable door open at the top and (4) a closed tack room with a glazed window at the other end. It is light and airy in the building. The north-eastern open-fronted part is open from the floor to the roof. The remainder has a low roof void under the ridge behind a soft board ceiling and soft boards fitted on the roof slope between main rafters. The soft board was loose and hanging in places making the spaces behind partly open and visible (and cobwebby). A doorway in the rear of central room had a fence panel fixed over it. The roof is corrugated sheets and clear plastic sheets as roof lights sitting on a timber frame with a mix of old and new sawn timbers. There are electric lights in the building. There were trees overhanging the rear of the barn.

Potential bat roosting places are not obvious, but could be (1) a few gaps at the stone walls, (2) between the roof and verge wall tops and (3) unseen places in the partly clad roof space. It is too light and airy for daytime use by perching or free-hanging bats in the open.

There was one bat dropping on an item stored in the open-fronted part of the barn. DNA analysis identified it to be a **Brandt's bat dropping**.

- (1) Build the bat loft in the Low barn to accommodate its long-eared bats and at least one bat brick/tube/box in the exterior walls and (2) build-in at least two bat bricks/tubes/boxes in the exterior walls at the High barn. There is the risk that if circumstances change in the future that a bat loft might also be required for the High barn.
