Date: 21 May 2021

**DC/21/02140 Grove Farm Stonham Aspal - Proposed demolition of existing dwelling - Ecological Appraisal assessment**

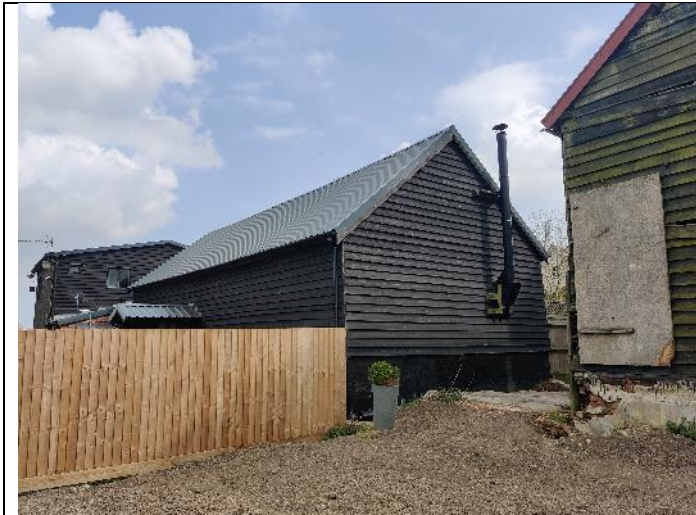
Photo 1 North and west elevation of barn proposed for demolition

**Bats:** The existing dwelling (Photos 1 to 4) was only converted in the past 5 to 10 years with timber cladding and tin roof in a very good condition with no obvious access points for bats with no evidence recorded on site.

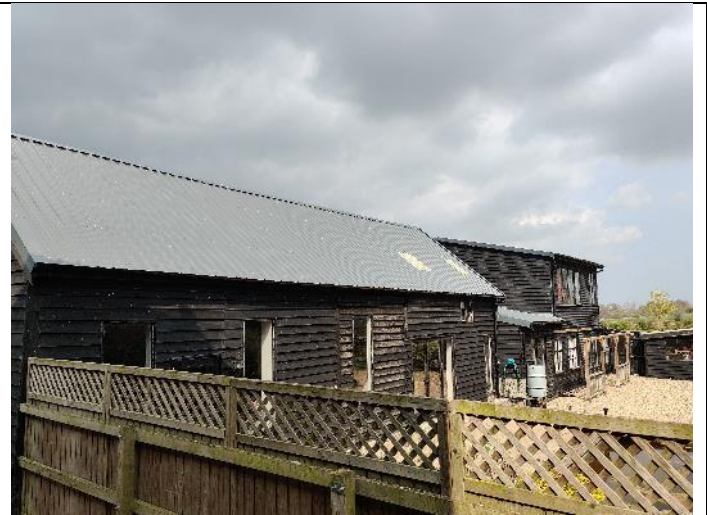
Photo 2 South elevation of barn and hard standing in garden

**S.41 List habitats and species:** No habitats present and the hard standing dominated gardens are considered unsuitable for small mammals such as hedgehog (*Erinaceus europaeus*) with close board fencing preventing access.

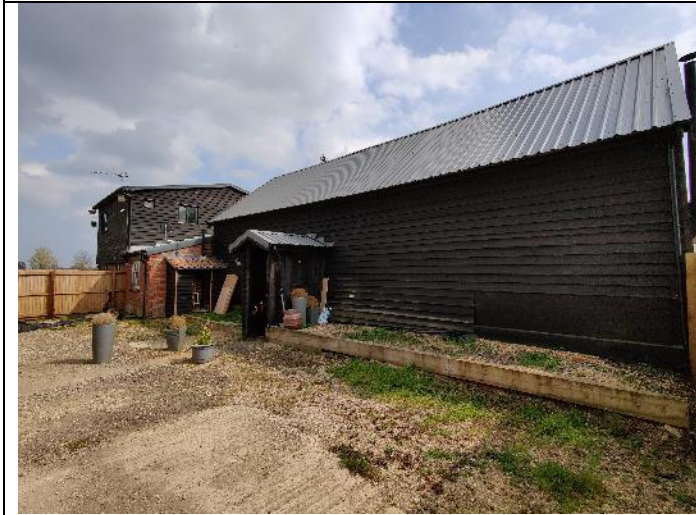
Photo 3 North elevation of barn

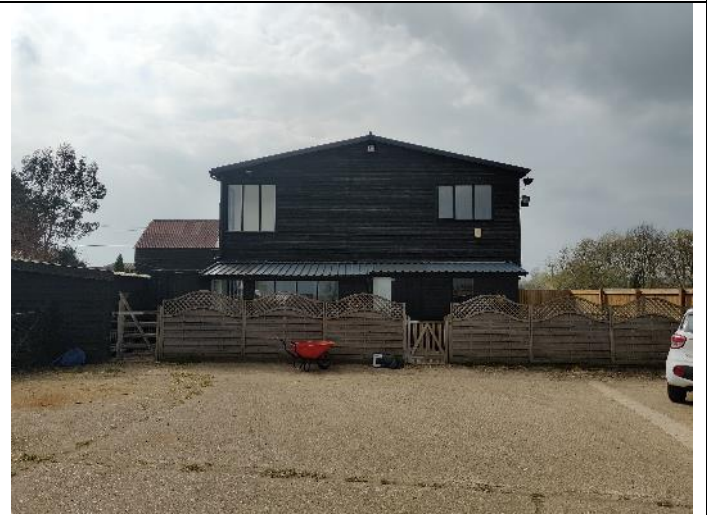
Photo 4 East elevation

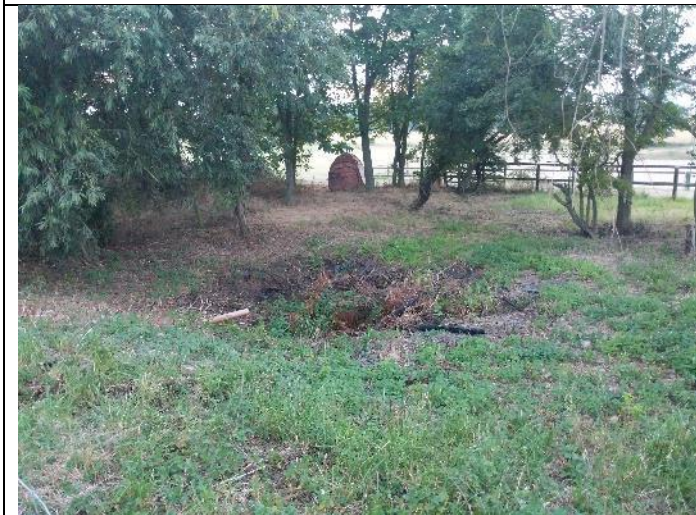
**Amphibians:** Two ponds P1 and P2 are located within 250m of the site and one of them is dry (Figure 1; Photo 5) and overgrown with trees and ruderal vegetation, whilst pond P2 (Figure 1; Photo 6) was very shallow (<10cm deep), heavily choked with common bulrush and was assessed as being unsuitable for supporting GCNs or any significant populations of common amphibians. The hard standing that surrounds the existing dwelling and short mown lawn are unsuitable as refuge habitat; the lawn may provide foraging habitat at night during heavy rainfall but the garden is fenced off with close board fencing and is unlikely to support any significant amphibian or reptile populations.

Photo 5 Pond P1

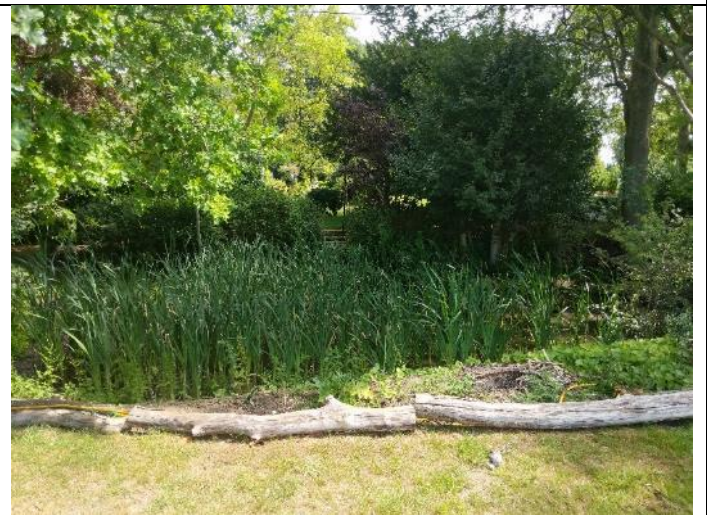
Photo 6 Pond P2
