**Preliminary Bat Roost Assessment and Bird  
Survey for,  
Bickford Builders Solihull.  
Buildings adjacent to,  
The Paddocks,  
Honiley Road,  
BEAUSALE,  
Warwickshire,  
CV35 7NX.**

**Map Ref SP 2405 7136  
17<sup>th</sup> February 2021.**

**S. Christopher Smith MRICS MSc CEnv.  
The Hayloft,  
Farm Lane,  
Grendon,  
ATHERSTONE,  
Warwickshire.  
CV9 3DR**

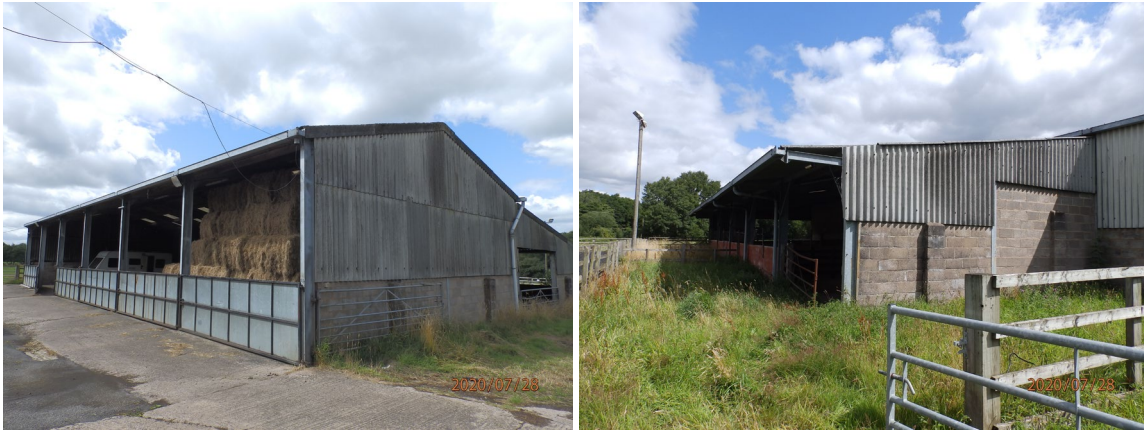
**Barn A.**

This is a galvanised steel portal framed building with some low level blockwork.

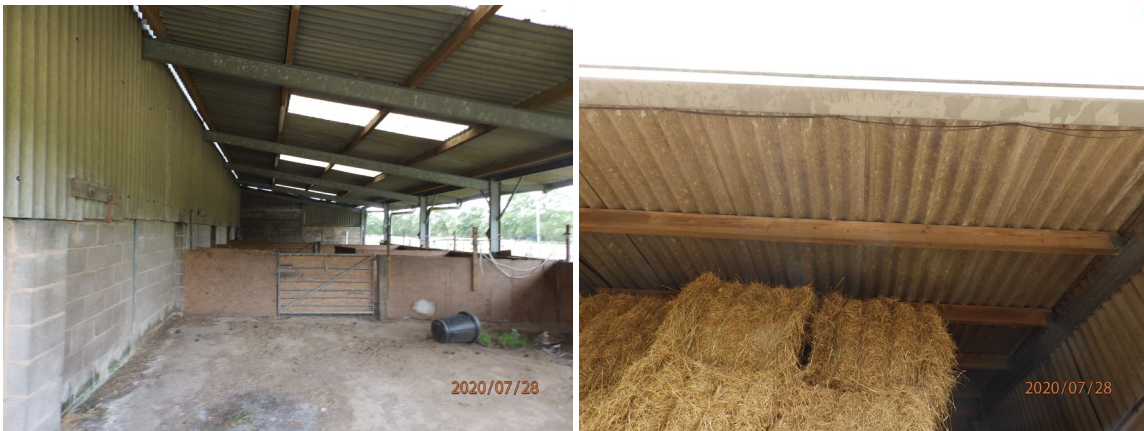
There is fibre cement vertical and roof cladding fixed to timber sheeting rails.

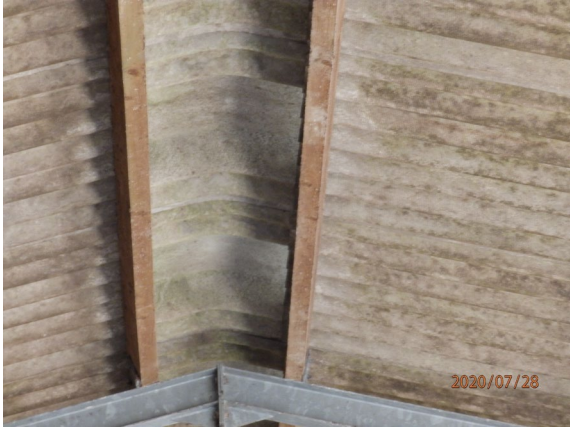
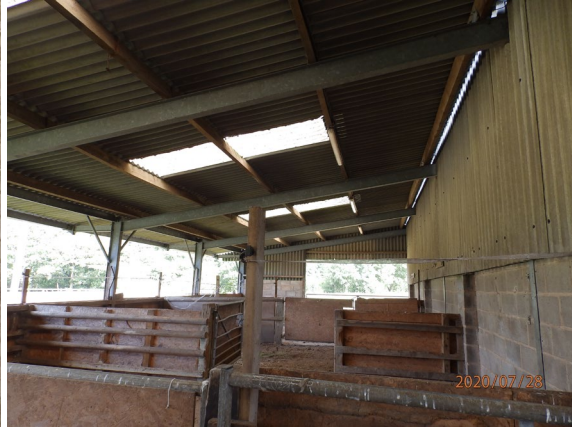
There is a very poor place of shelter for individual bats in the gap between the rear of the corrugated roof sheets and the timber sheeting rails. This gap would only provide shelter for individual bats but is open to natural illumination and weather penetration and the likelihood of bats using the space is exceptionally small and can be managed by contractors following the method of working set out below.

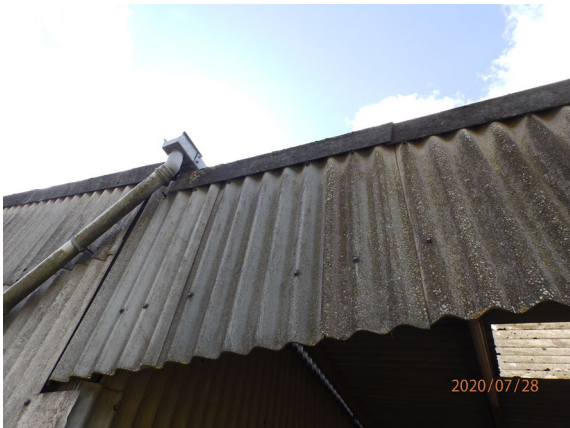
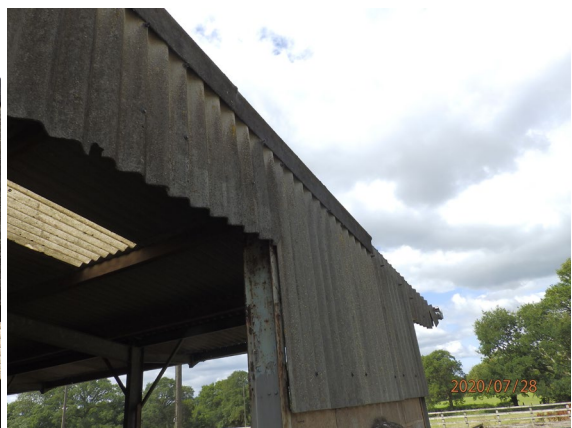
There are fibre cement verge flashings with a gap between the rear of the flashing and the roof sheets that could provide a temporary place of shelter for bats. This gap would only provide shelter for individual bats but is open to natural illumination and weather penetration and the likelihood of bats using the space is exceptionally small and can be managed by contractors following the method of working set out below.

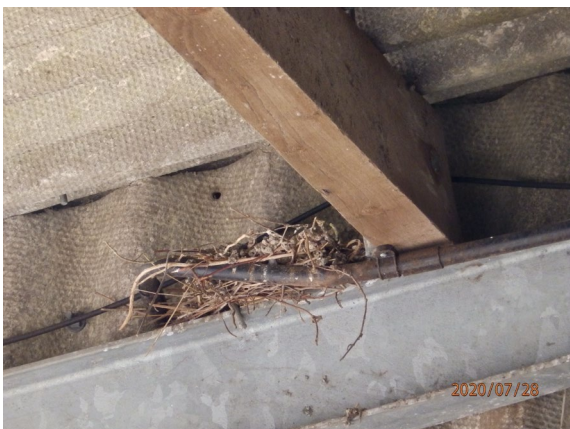
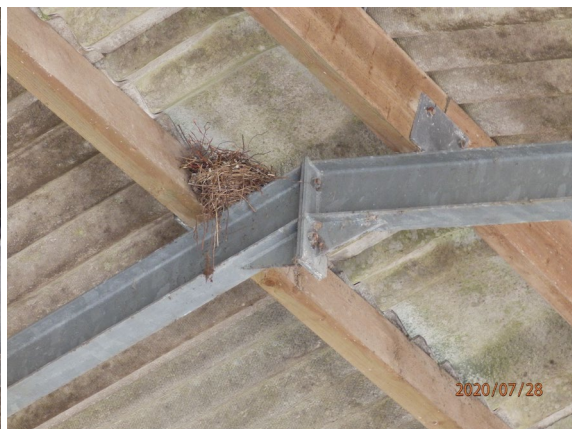
There are Pigeons and Jackdaws nesting in the building.

**Bird nesting opportunities; Definite.**

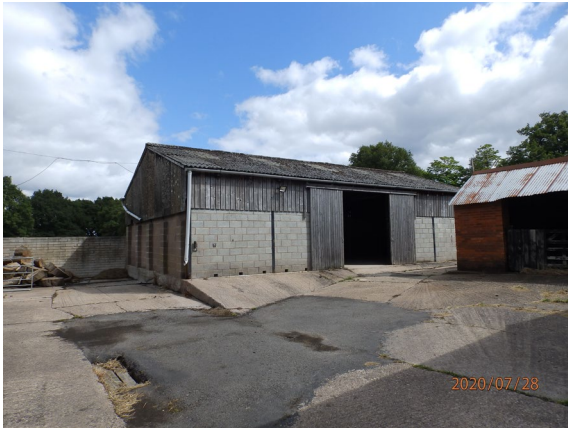
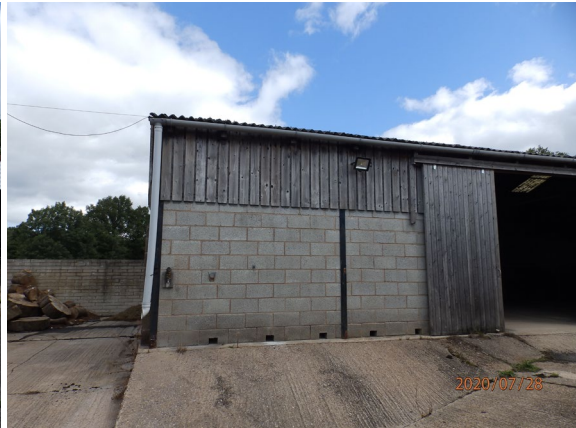
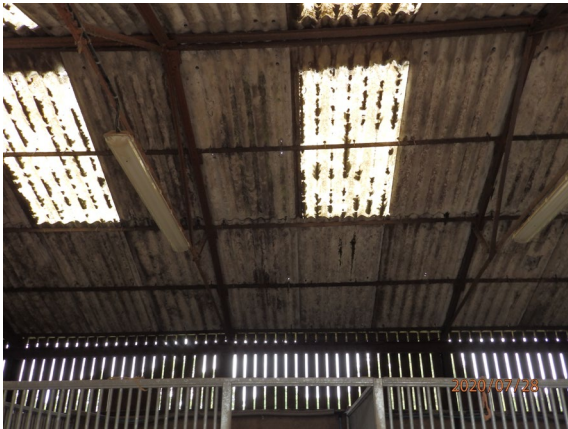
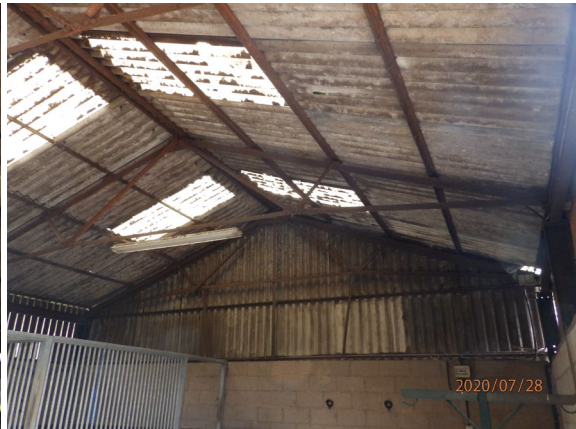
**Barn B.**

This is a steel angle iron framed building with some low level blockwork.

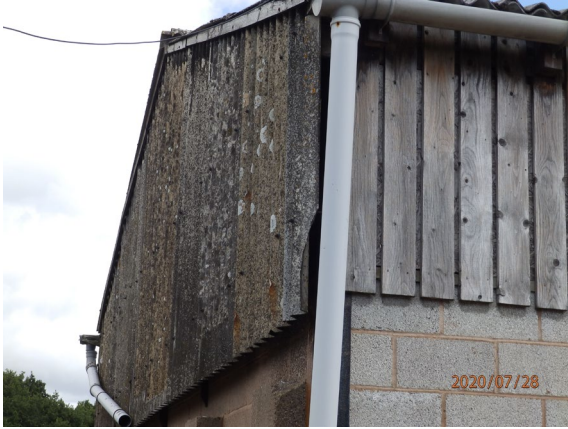
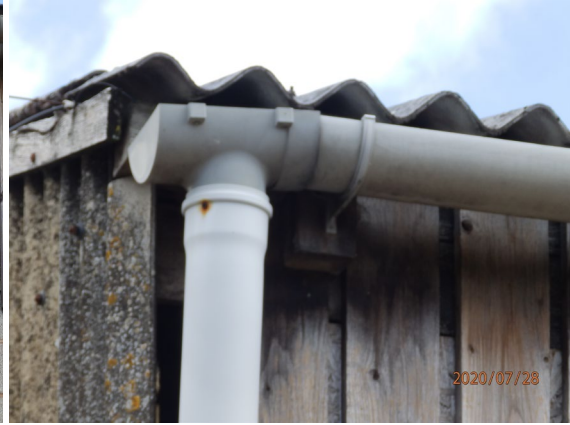
There is some fibre cement vertical cladding and some hit and miss timber cladding. The roof cladding is fixed to angle iron sheeting rails which offer no place of shelter for bats.

There are timber verge barge boards with a gap between the rear of the board and the vertical sheets that could provide a temporary place of shelter for bats. This gap would only provide shelter for individual bats but is open to natural illumination and weather penetration and the likelihood of bats using the space is exceptionally small and can be managed by contractors following the method of working set out below.

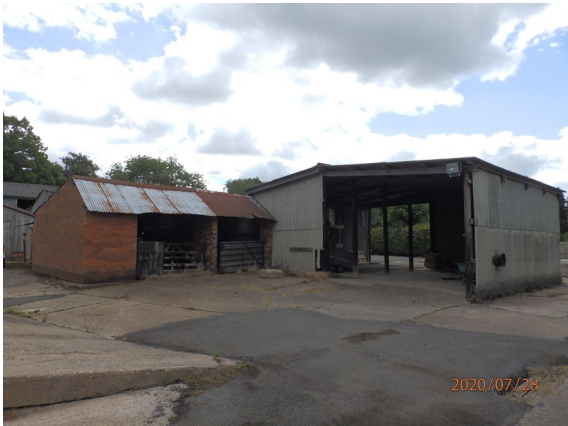
**Barn C.**

This is a timber pole framed building with some low level solid brickwork.

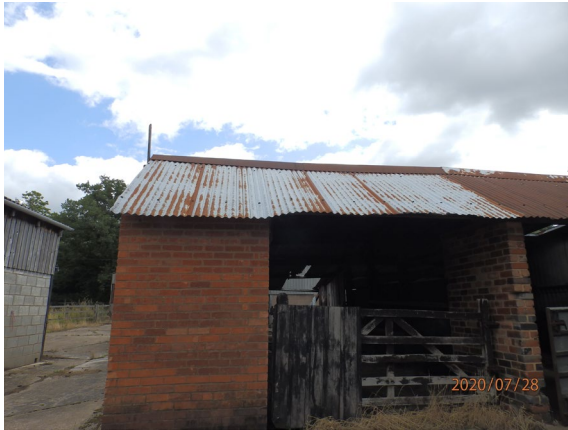
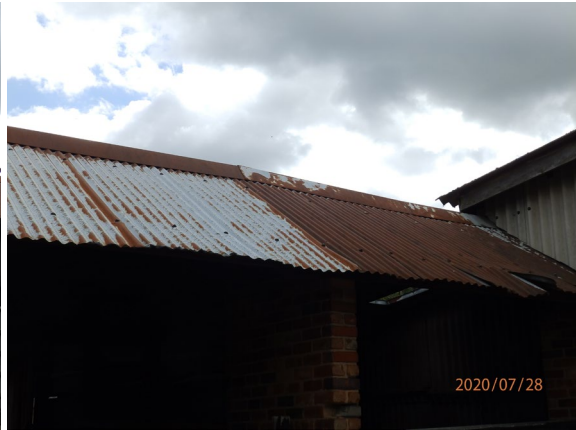
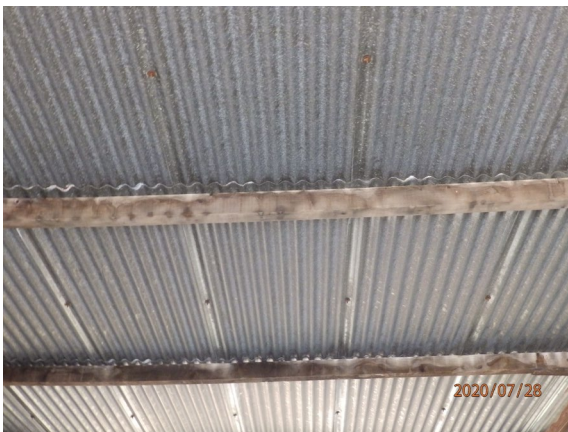
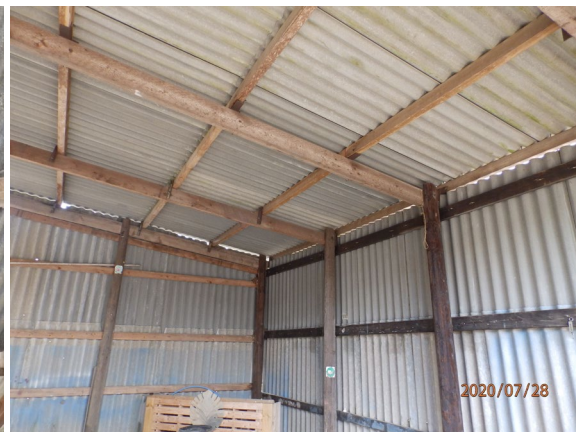
There is fibre cement vertical and roof cladding fixed to timber sheeting rails. The roof sheeting on the solid brick area is corrugated iron.

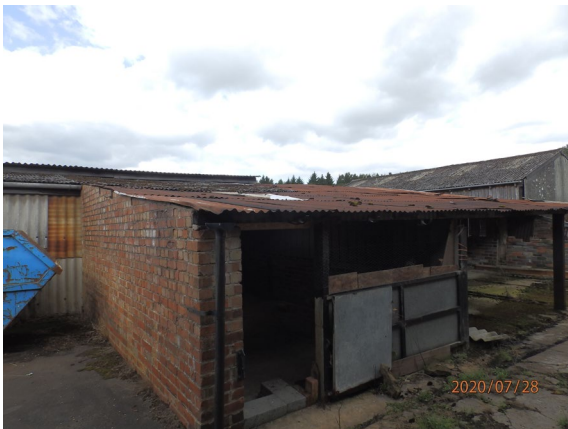
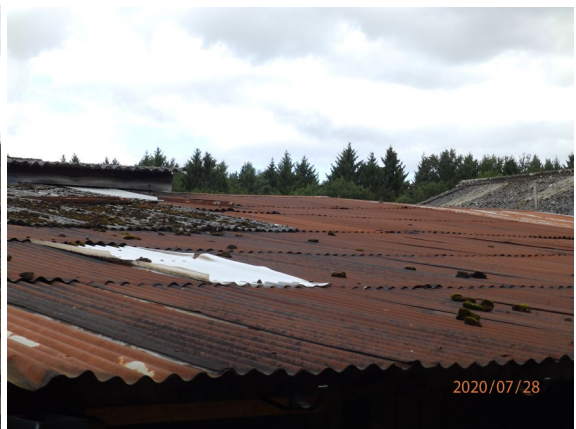
There is a very poor place of shelter for individual bats in the gap between the rear of the corrugated roof sheets and the timber sheeting rails. This gap would only provide shelter for individual bats but is open to natural illumination and weather penetration and the likelihood of bats using the space is exceptionally small and can be managed by contractors following the method of working set out below.

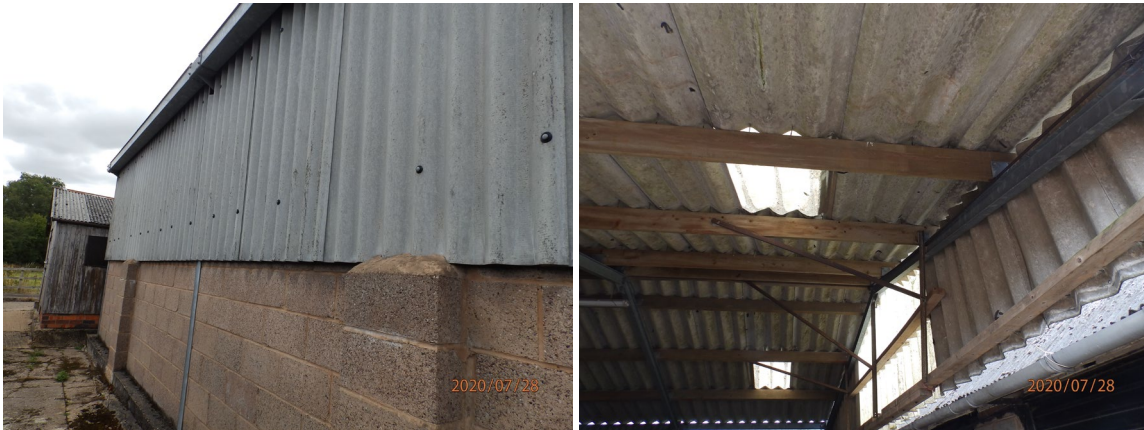
**Barn D.**

This is a steel portal framed building with some low level blockwork.

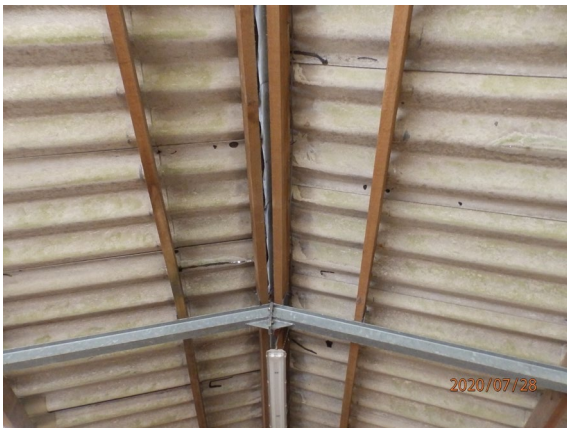
There is fibre cement vertical and roof cladding fixed to timber sheeting rails.

There is a very poor place of shelter for individual bats in the gap between the rear of the corrugated roof sheets and the timber sheeting rails. This gap would only provide shelter for individual bats but is open to natural illumination and weather penetration and the likelihood of bats using the space is exceptionally small and can be managed by contractors following the method of working set out below.

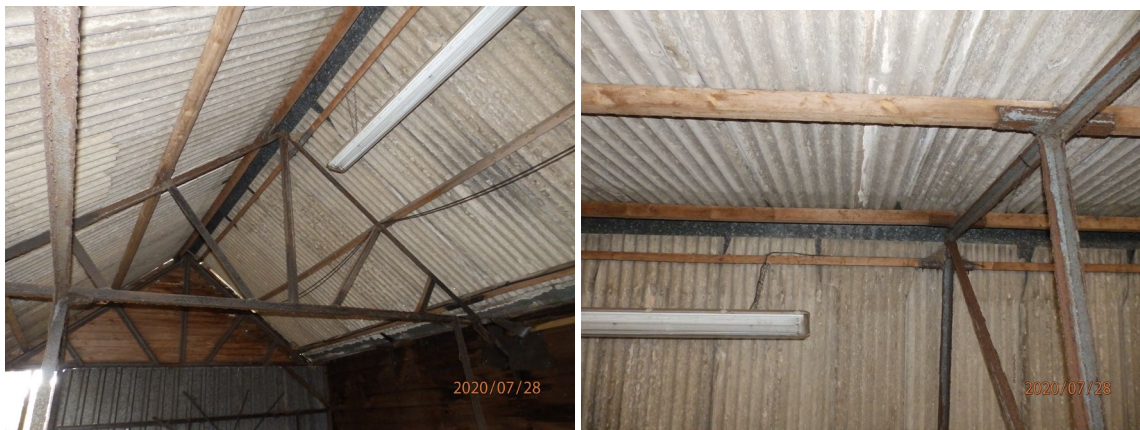
**Barn E.**

There is fibre cement vertical and roof cladding fixed to timber sheeting rails.

There is a very poor place of shelter for individual bats in the gap between the rear of the corrugated roof sheets and the timber sheeting rails. This gap would only provide shelter for individual bats but is open to natural illumination and weather penetration and the likelihood of bats using the space is exceptionally small and can be managed by contractors following the method of working set out below.

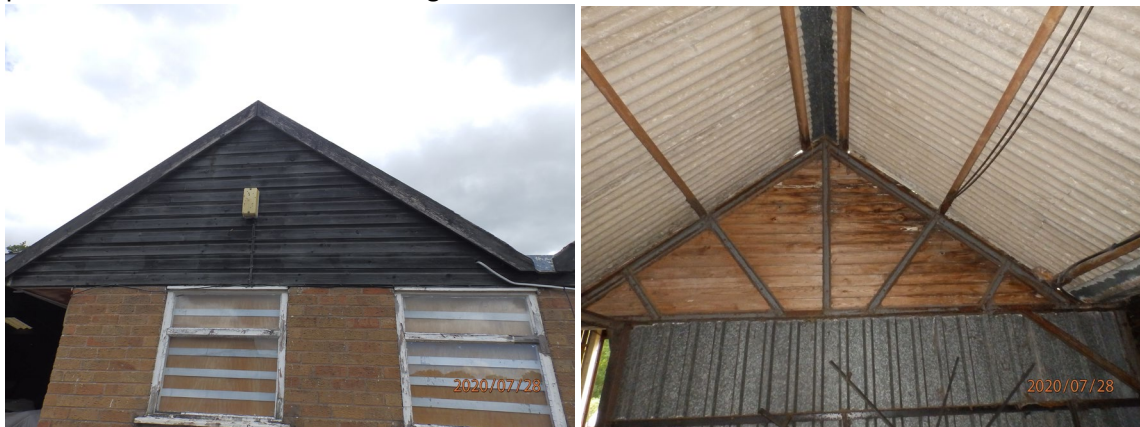
There is timber cladding at the gables but there is no liner board or sheet and therefore no places of shelter for crevice dwelling bats.

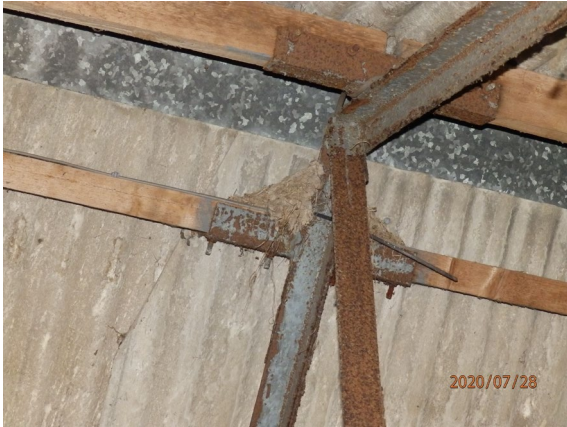
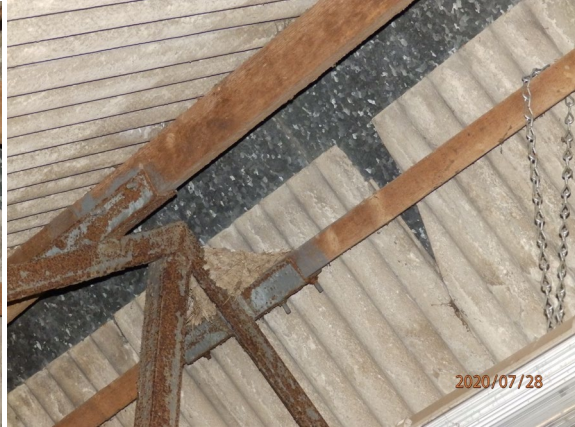
There are Swallows nesting in the building.

**Bird nesting opportunities; Definite.**

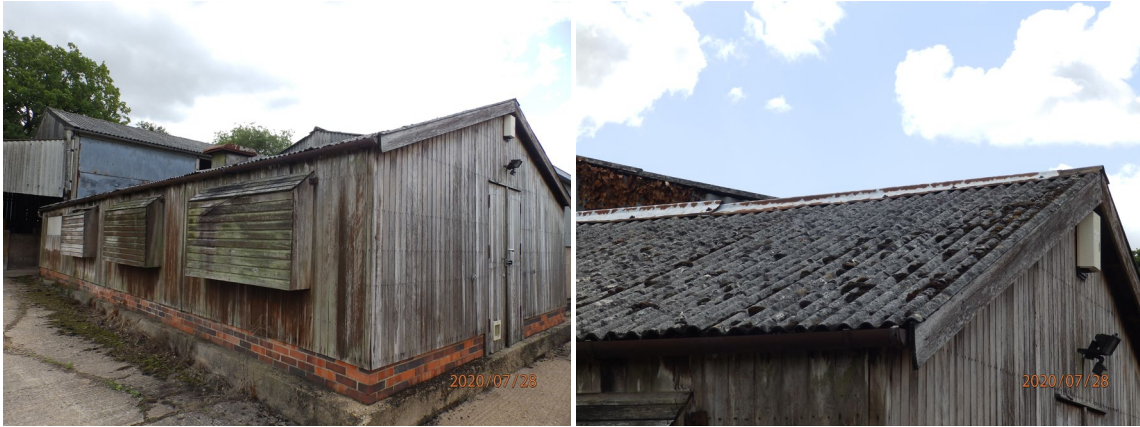
## Barn F.

This is a timber framed building with some low level blockwork.

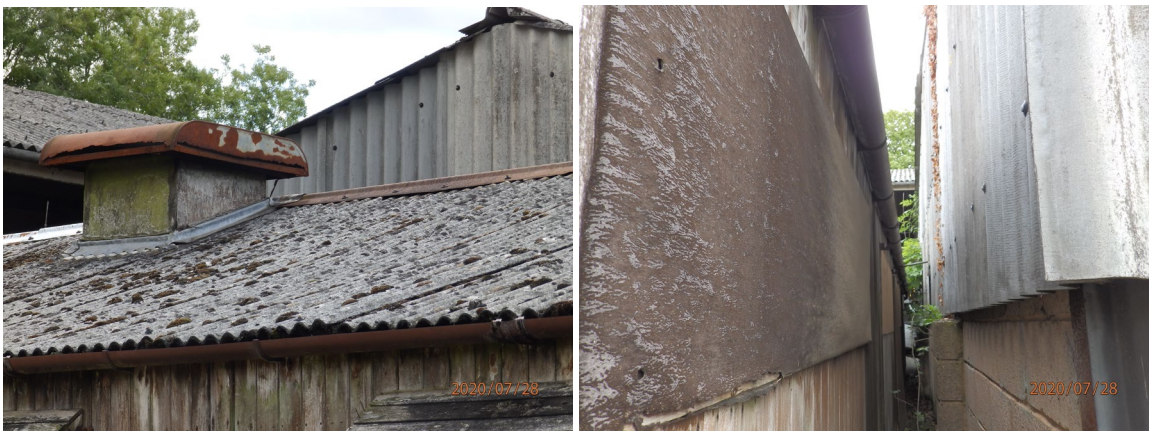
There is fibre cement vertical cladding fixed to timber sheeting rails.

There is a very poor place of shelter for individual bats in the gap between the rear of the corrugated roof sheets and the timber sheeting rails. This gap would only provide shelter for individual bats but is open to natural illumination and weather penetration and the likelihood of bats using the space is exceptionally small and can be managed by contractors following the method of working set out below.

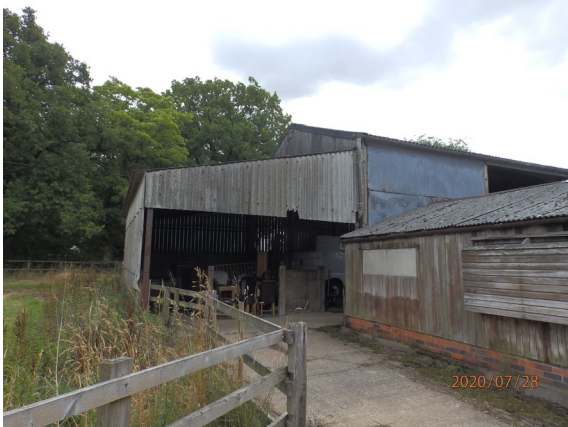
## Barn G.

This is a pre-cast concrete portal framed building with some low level blockwork. The building has been extended at each gable with a mono pitch steel frame.

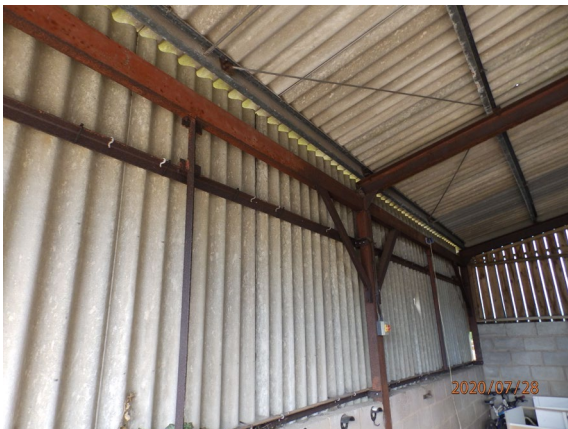
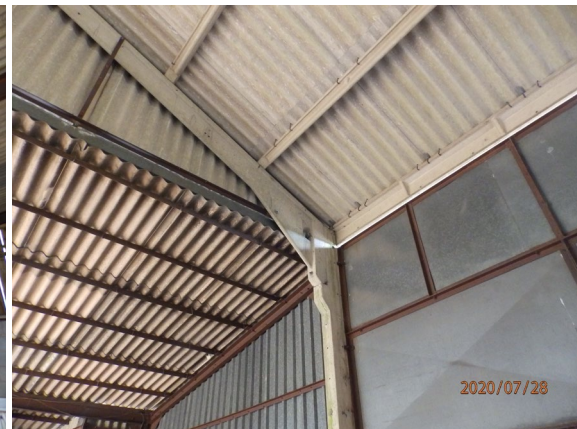
There is fibre roof cladding fixed to pre-cast concrete or galvanized Z purlin sheeting rails.

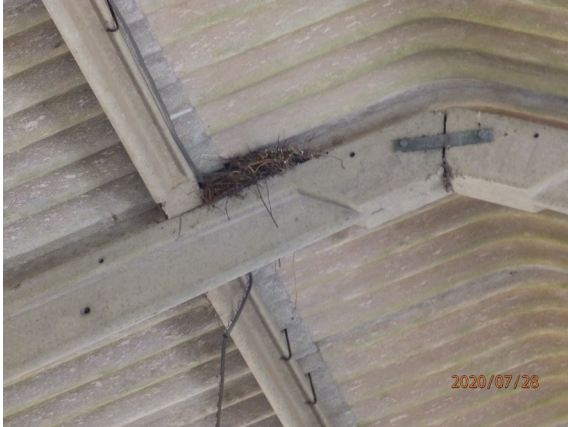
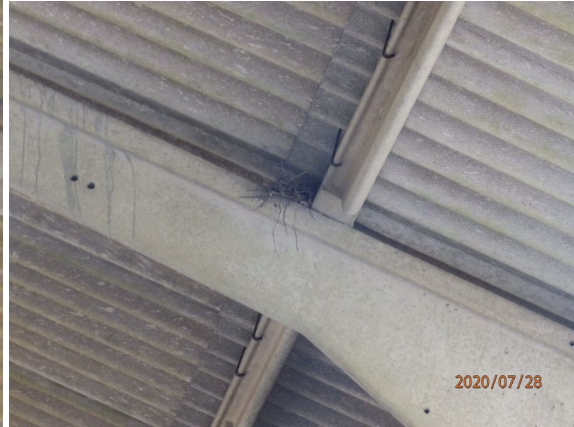
There are Pigeons or Jackdaws nesting in the building.

**Bird nesting opportunities; Definite.**

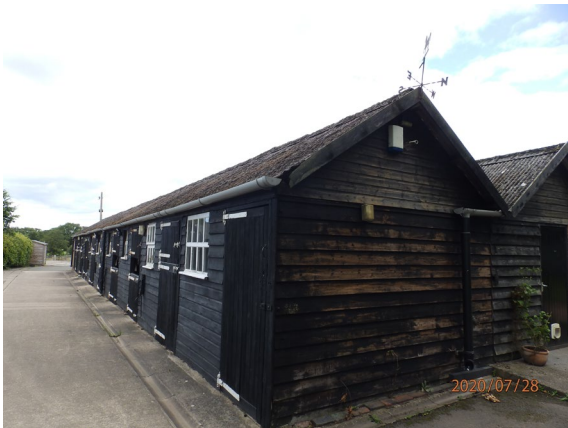
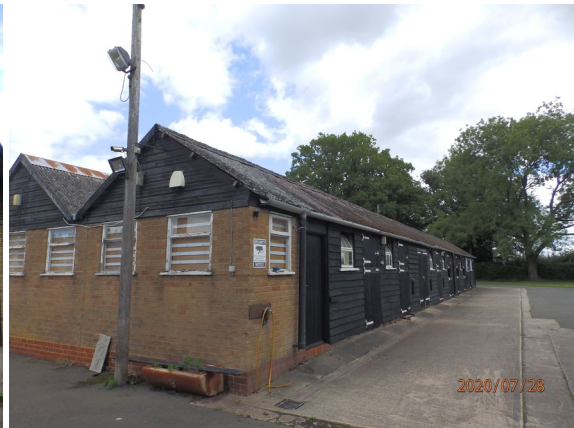
**Barn H.**

This is a timber framed stables building with some cavity brickwork.

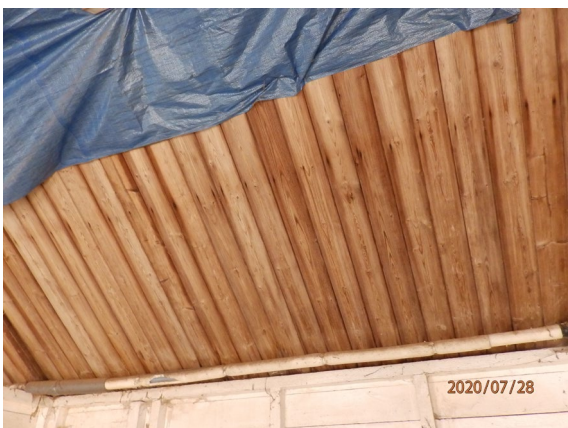
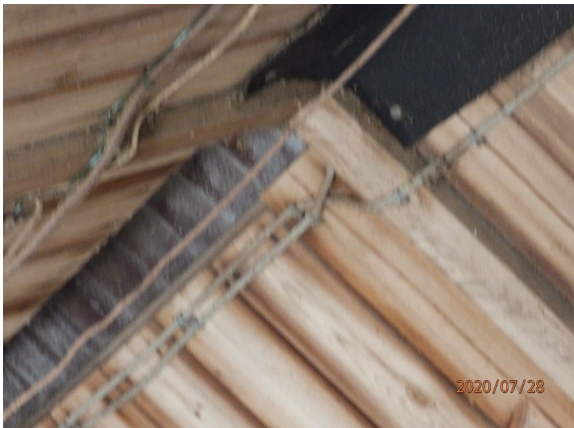
There is fibre cement roof cladding fixed to timber sarking boards.

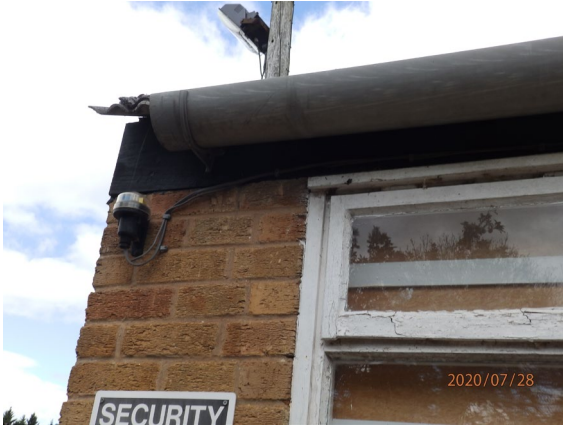
There is a very poor place of shelter for individual bats in the gap between the rear of the corrugated roof sheets and the timber sarking boards. This gap would only provide shelter for individual bats but is subject to rapid heating and cooling and weather penetration. The likelihood of bats using the space is exceptionally small and can be managed by contractors following the method of working set out below.

- When roof sheets are removed they should be lifted away from the roof and not slid or twisted to avoid injuring any bats roosting beneath the tiles.
- Ridge and verge flashings should be lifted without sliding so as to avoid injuring any bats roosting beneath them.

- If a bat is found under a roof sheet or ridge/verge flashing, the item should be carefully replaced and work in that area stopped until such time as a licensed bat worker can attend the site.

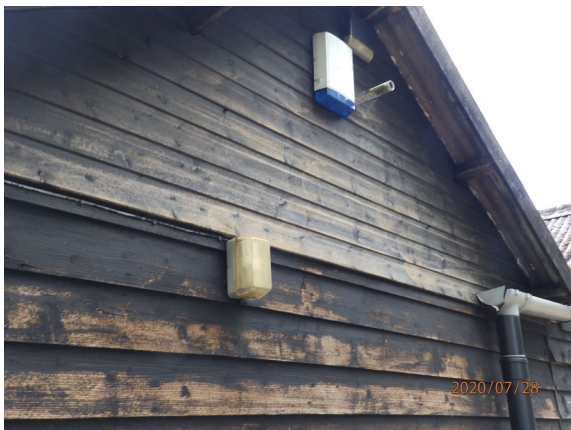
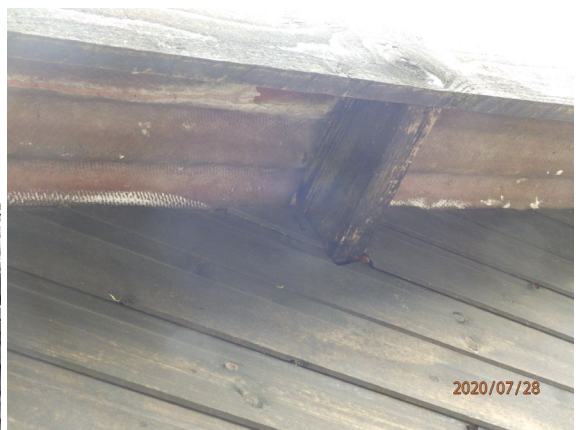
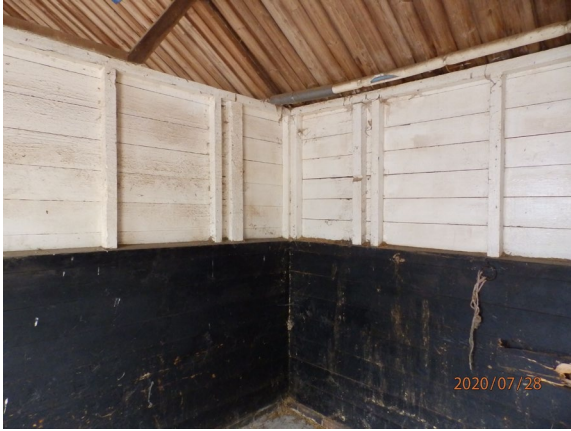
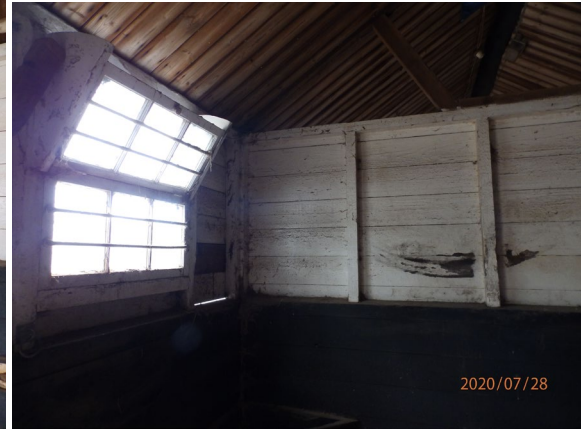
There is timber cladding on the walls with low level liner/kick boards in the stables. There is no access to the cavity between the timber cladding and the liner boards.

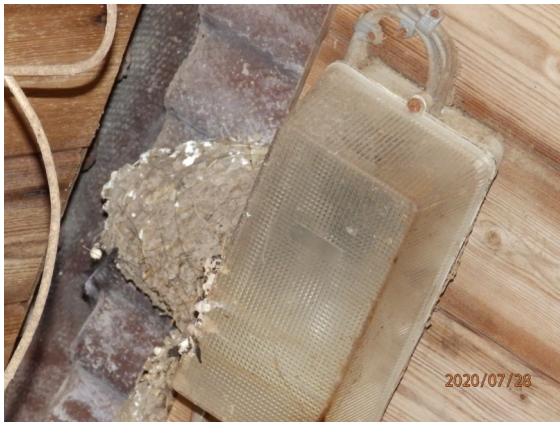
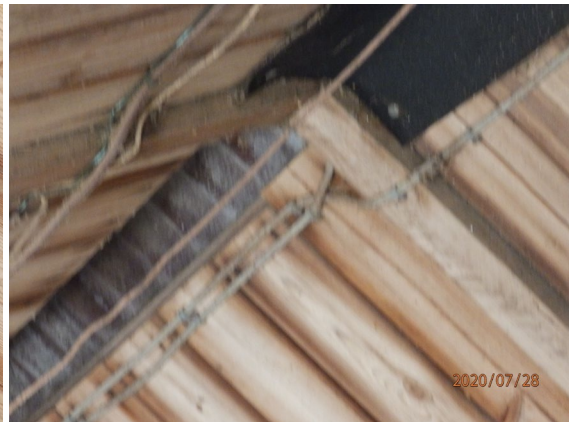
There are Swallows nesting in the building.

**Bird nesting opportunities; Definite.**

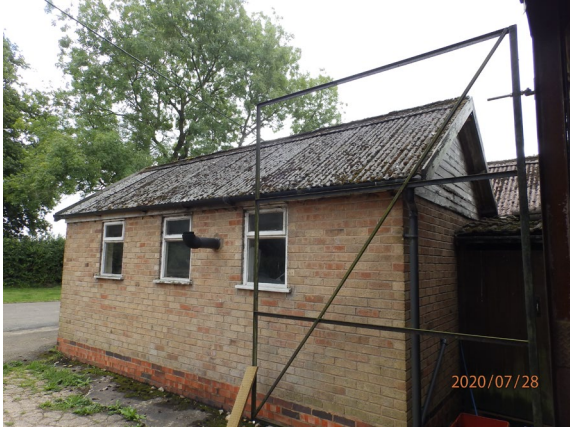
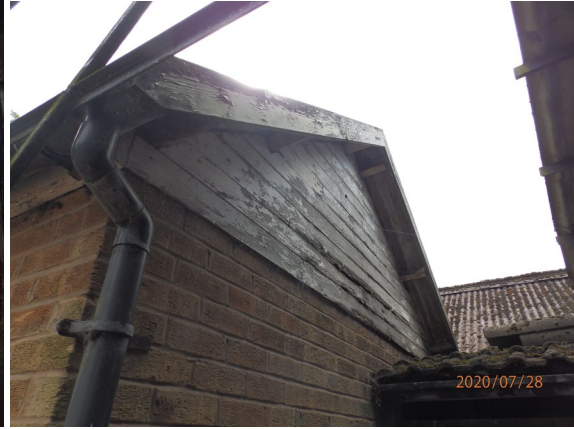
**Barn J.**

This is a cavity brick and block walled building with a pitched roof covered with fibre cement roof sheets.

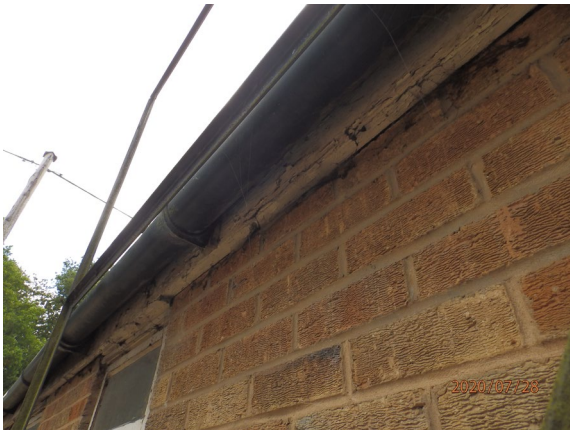
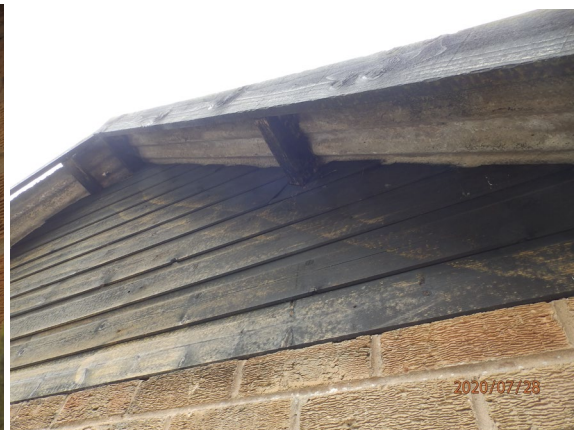
There are fibre cement roof sheets supported on timber sheeting rails but there is no access to the building for bats.

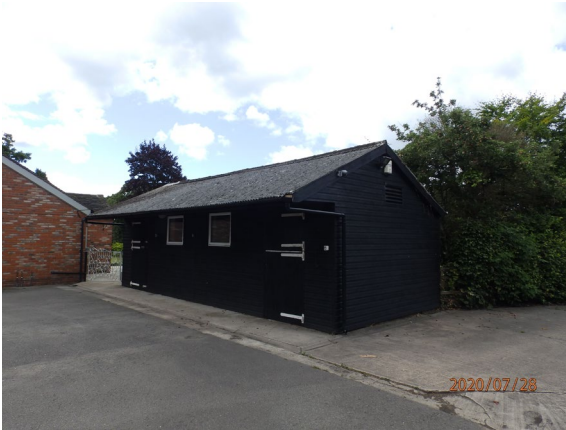
**Barn K.**

This is a timber framed building with a pitched roof.

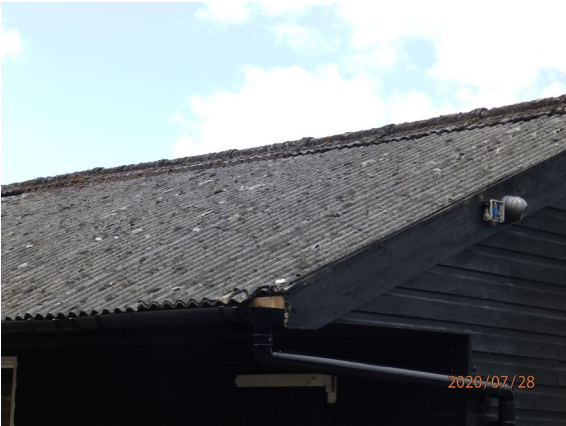
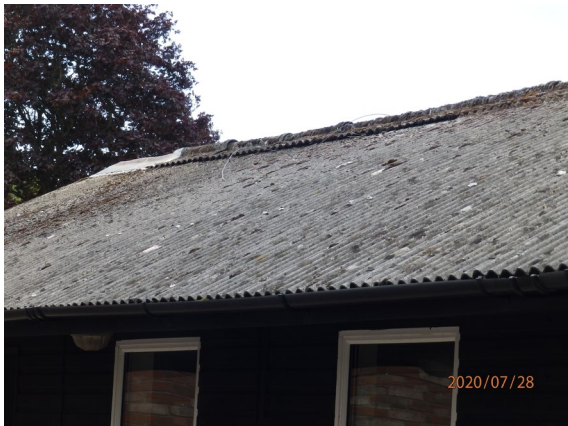
There is timber vertical cladding and fibre roof sheets fixed to timber sheeting rails.

The ridge flashing has lifted in places so that individual bats can shelter under the flashing but there is no access to the inside of the building. This area is open to weather penetration and would only provide exceptionally poor places of shelter during periods of warm and dry

weather. This small likelihood can be managed by contractors following the method of working set out below.

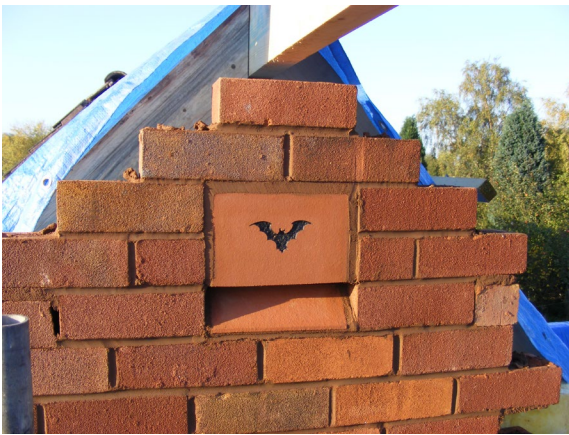
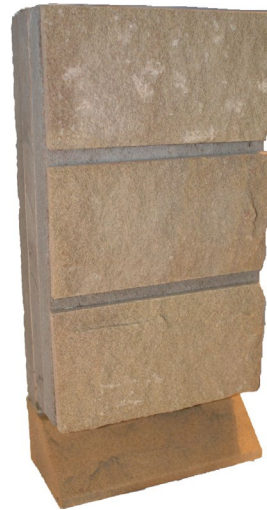
5 brick built bat boxes are to be installed at the gable apex of one elevation on the new dwellings, should planning permission be granted. These are constructed from brick or concrete blocks and are built into the outer leaf of brickwork. They can have facing bricks or be rendered. They provide no access to the cavity wall.
