#### DESK STUDY WITH WALKOVER SURVEY

AT FORMER POLICE STATION, MARKET PLACE, POULTON-LE-FYLDE, FY6 7AS

PREPARED FOR CHOICE HOTELS LIMITED

> REPORT NO. 6859 NOVERMBER 2019

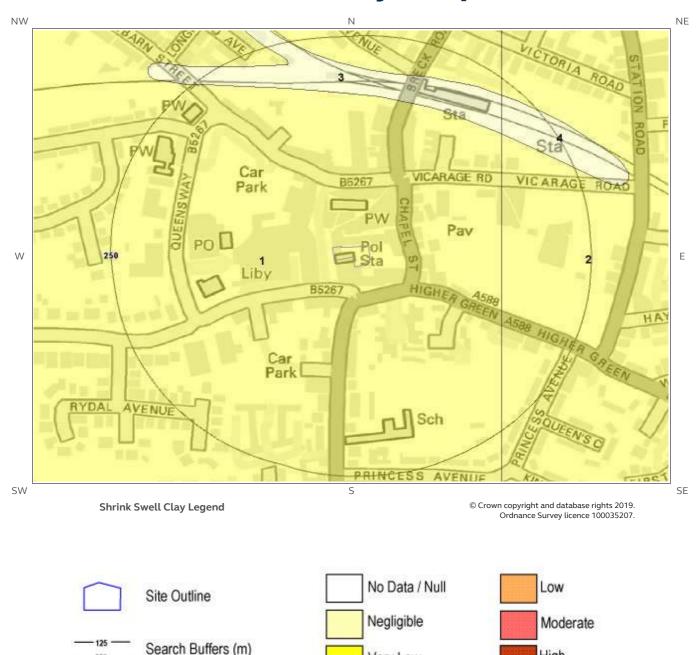
# 6 Natural Ground Subsidence 6.1 Shrink-Swell Clay map

ID	Distance (m)	Direction	Hazard Rating	Details
1	0.0	On Site	Very Low	Ground conditions predominantly low plasticity. No special actions required to avoid problems due to shrink-swell clays. No special ground investigation required, and increased construction costs or increased financial risks are unlikely due to potential problems with shrink-swell clays.

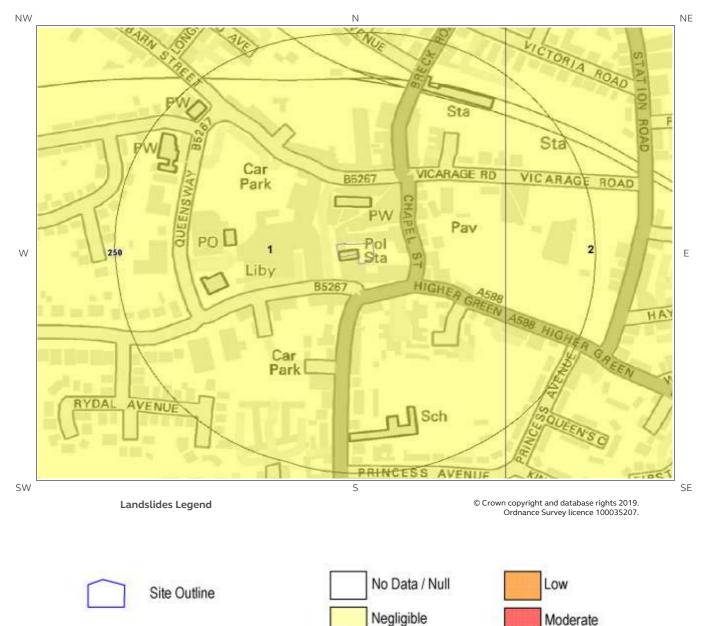
### 6.2 Landslides map

ID	Distance (m)	Direction	Hazard Rating	Details
1	0.0	On Site	Very Low	Slope instability problems are unlikely to be present. No special actions required to avoid problems due to landslides. No special ground investigation required, and increased construction costs or increased financial risks are unlikely due to potential problems with landslides.

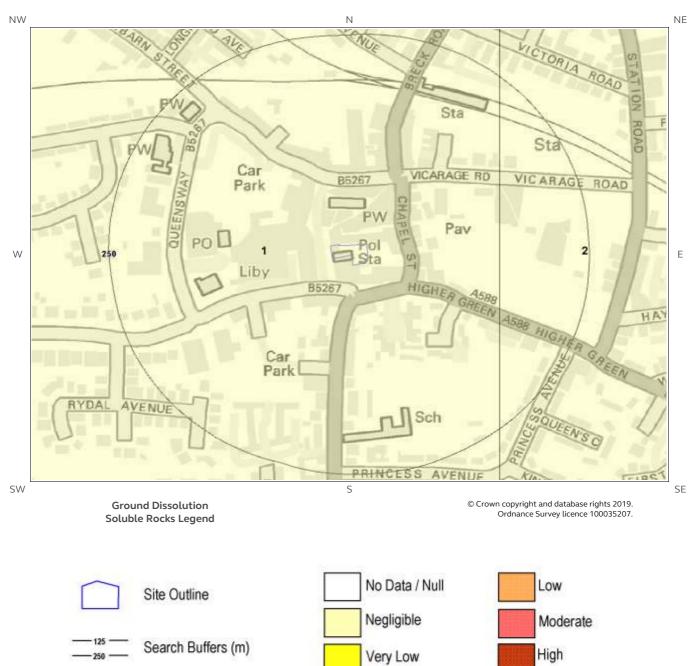
# 6.3 Ground Dissolution of Soluble Rocks map

ID	Distance (m)	Direction	Hazard Rating	Details
1	0.0	On Site	Negligible	Soluble rocks are present, but unlikely to cause problems except under exceptional conditions. No special actions required to avoid problems due to soluble rocks. No special ground investigation required, and increased construction costs or increased financial risks are unlikely due to potential problems with soluble rocks.

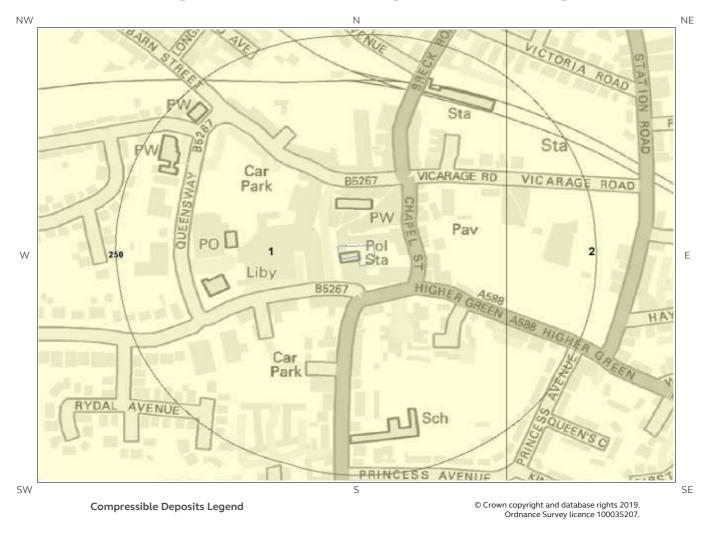
### 6.4 Compressible Deposits map

ID	Distance (m)	Direction	Hazard Rating	Details
1	0.0	On Site	Negligible	No indicators for compressible deposits identified. No special actions required to avoid problems due to compressible deposits. No special ground investigation required, and increased construction costs or increased financial risks are unlikely due to potential problems with compressible deposits.

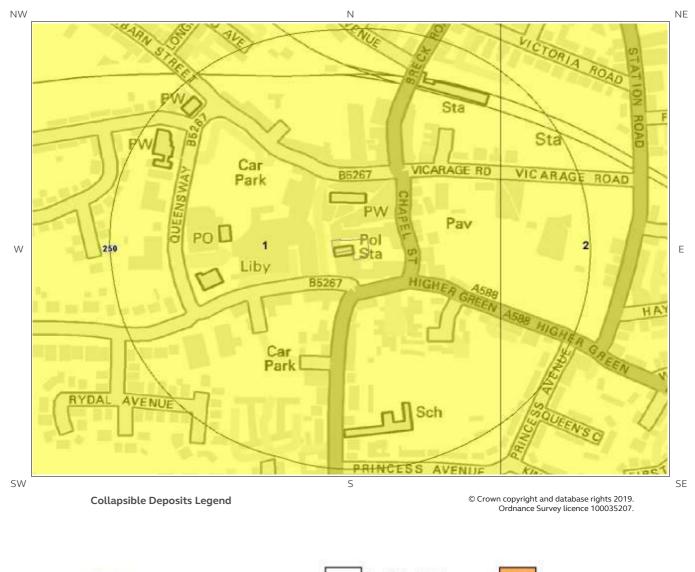
### 6.5 Collapsible Deposits map

ID	Distanc (m)	<sup>e</sup> Direction	Hazard Rating	Details
1	0.0	On Site	Very Low	Deposits with potential to collapse when loaded and saturated are unlikely to be present. No special ground investigation required or increased construction costs or increased financial risk due to potential problems with collapsible deposits.

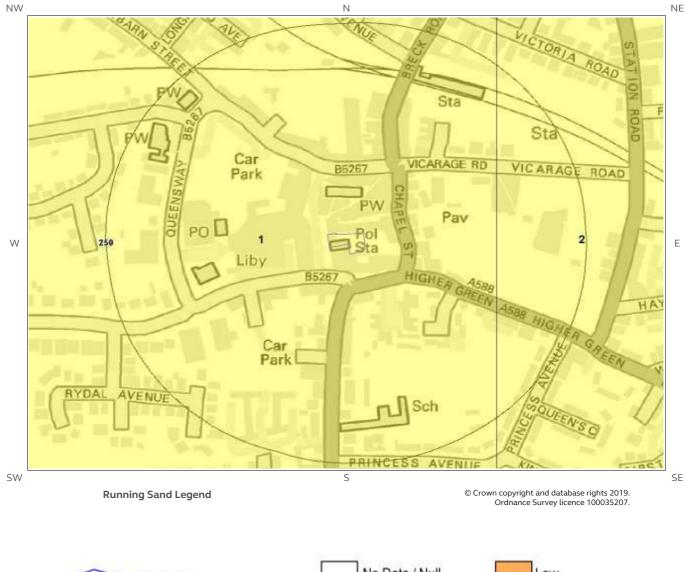
# 6.6 Running Sand map

ID	Distance (m)	Direction	Hazard Rating	Details
1	0.0	On Site	Very Low	Very low potential for running sand problems if water table rises or if sandy strata are exposed to water. No special actions required, to avoid problems due to running sand. No special ground investigation required, and increased construction costs or increased financial risks are unlikely due to potential problems with running sand.
