**The Hop Poles
2 Mount Pleasant Road,
Alton,
Hampshire
GU34 1NG**

Phase 1 Bat survey

MARCH 2021

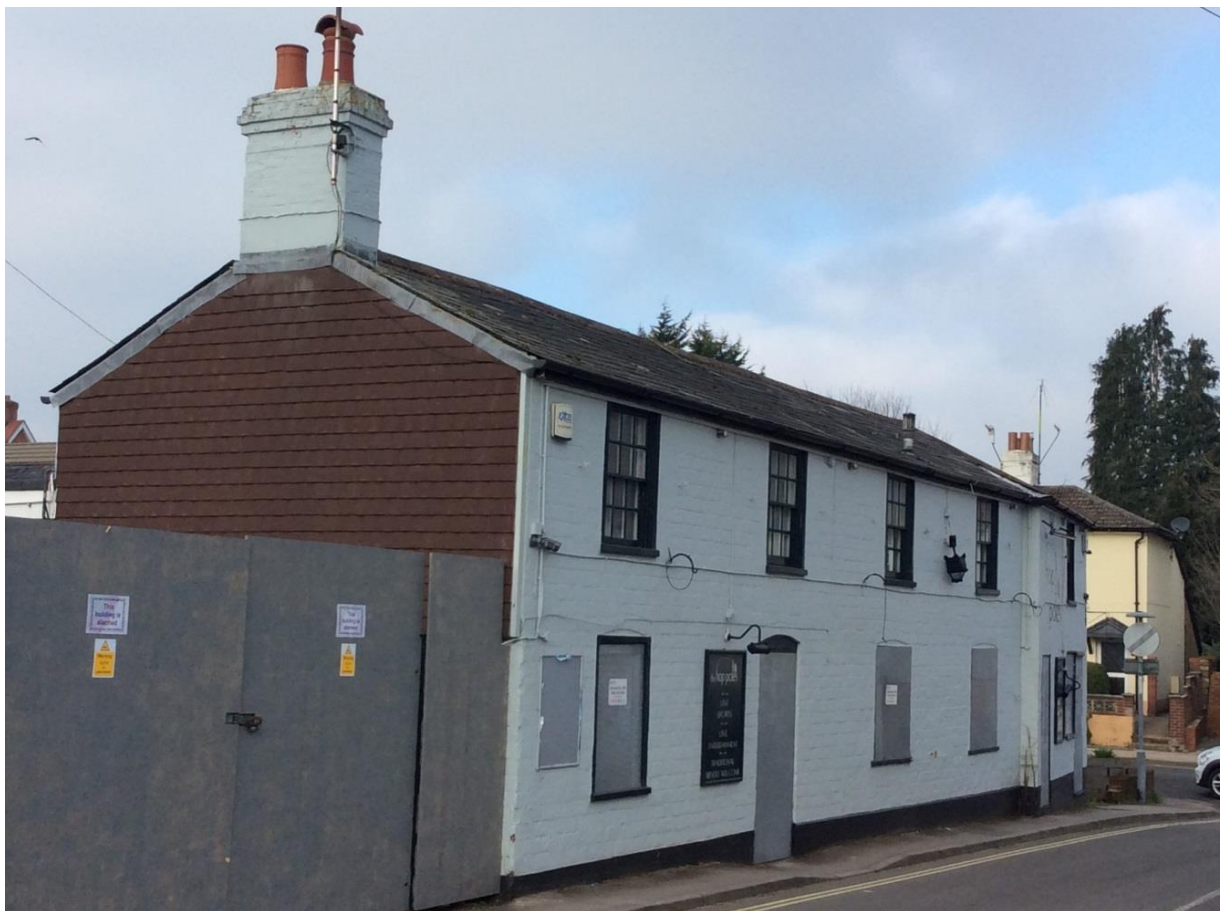
The south-east facing gable is covered in close fitting hang tiles which hare in excellent order and have no openings (see figure 1).

Fig. 1. Hope Poles public house: Looking North.

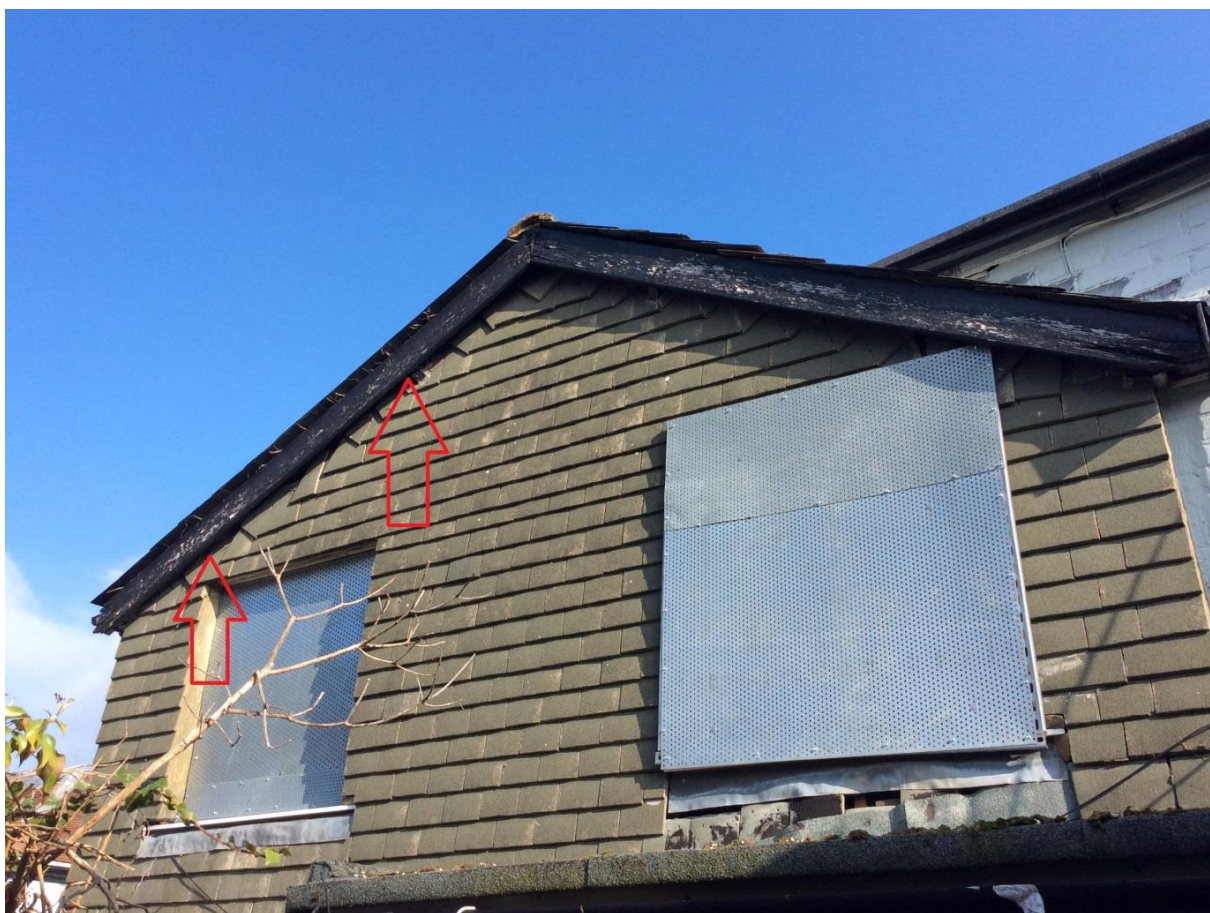
Fig 2. South-west gable looking North-east. Red arrows indicate potential access points for bats.

The south-west gable is covered in sand-coated cement hang-tiles which have been disturbed by encroaching ivy in the past. These have failed in places near the barge boarding and house sparrows were seen entering (see fig. 2).

There were no signs of hirundine nesting as there are no overhanging eaves. House sparrows were observed entering the under-eaves on the south-west elevation, and may well use it for nesting. Therefore the works should ideally be undertaken outside of the bird nesting season, which is typically 1st March to 31st August.

There was no evidence of any bat activity within the buildings, but there are some potential access points into the under-tile space on the south-west elevation. Therefore this has low potential and a phase 2 emergence survey is recommended.

A phase 2 (two viewers will be required in this instance) should be carried out in suitable weather between 1st May and the end of September.

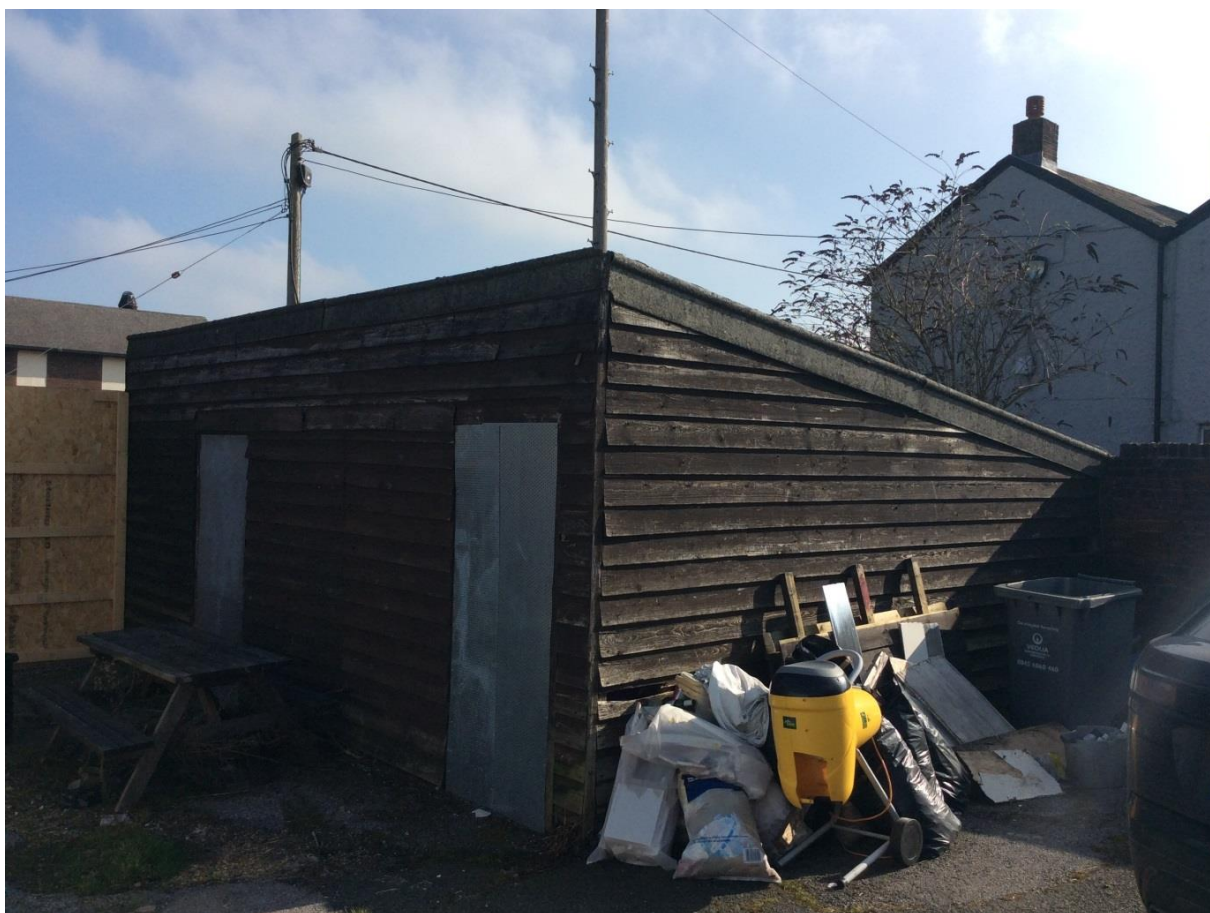
The shed is faced with ship-lap planking on a wooden frame with an a sloping corrugated cement sheet roof, which overlaps the vertical faces forming a tight seal..

The planking is unlined

Figure 5. storage shed
