THE ELMS
COLSTON BASSETT

Bat Survey Report

Report Reference:
RSE_3322_02_V2

Project: The Elms, Wash Pit Lane, Colston Bassett

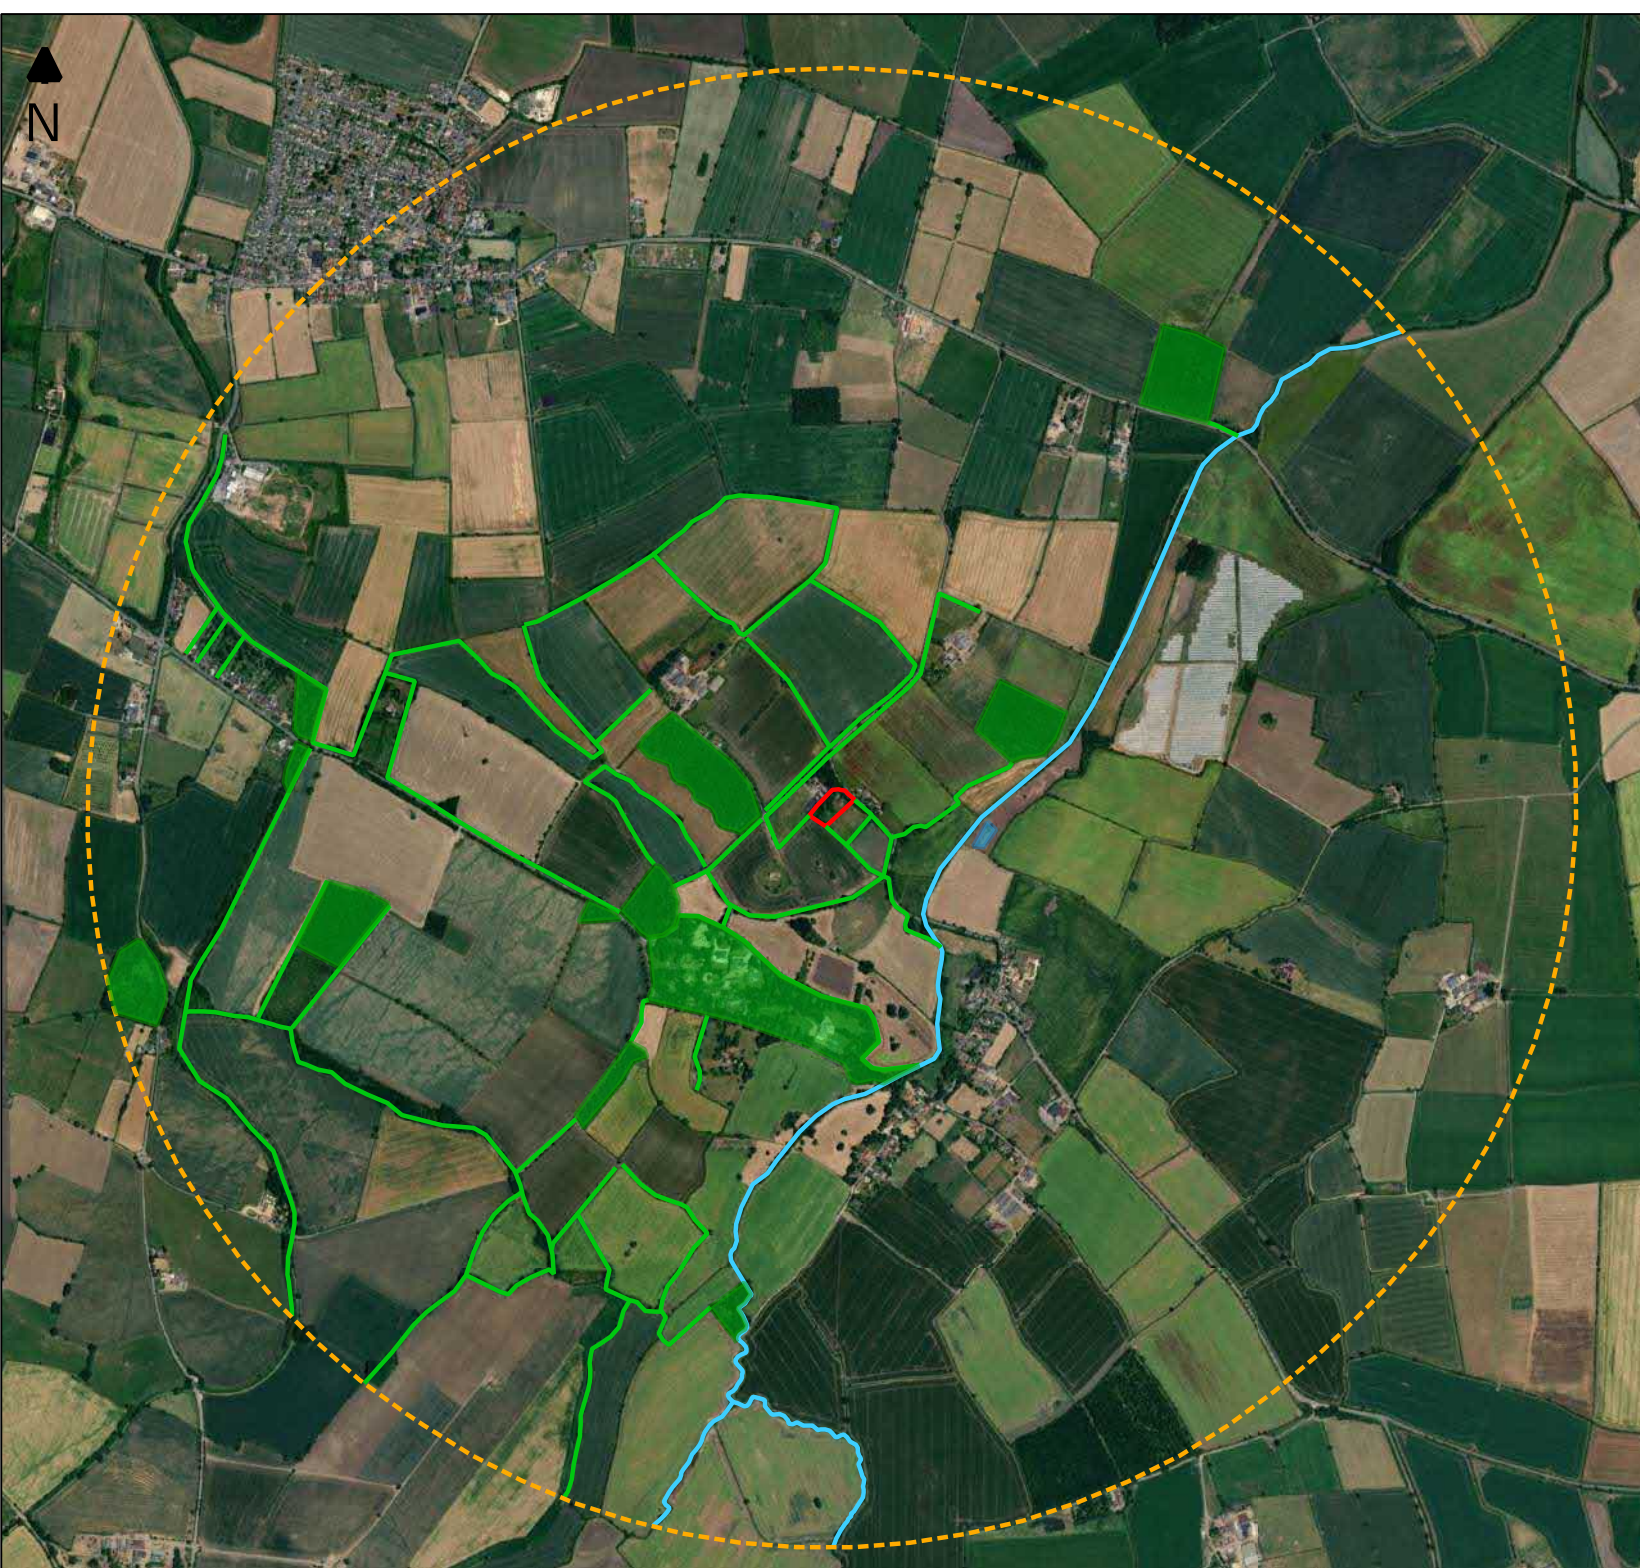
- I In assessing the site, a review of online resources and desk study data was undertaken to assess the site with respect to its connectivity to the wider environment, particularly along linear features (rivers, railways, canals etc.) and any designated or protected sites. The figure below highlights the site and any such habitat connectivity. This assessment enables the evaluation of a particular proposal in context of the wider environment with regard to the site itself and any species which may utilise the site. As figure below shows, the site is in a rural setting characterised by arable farmland with mature hedgerow connections linking it to the wider countryside.

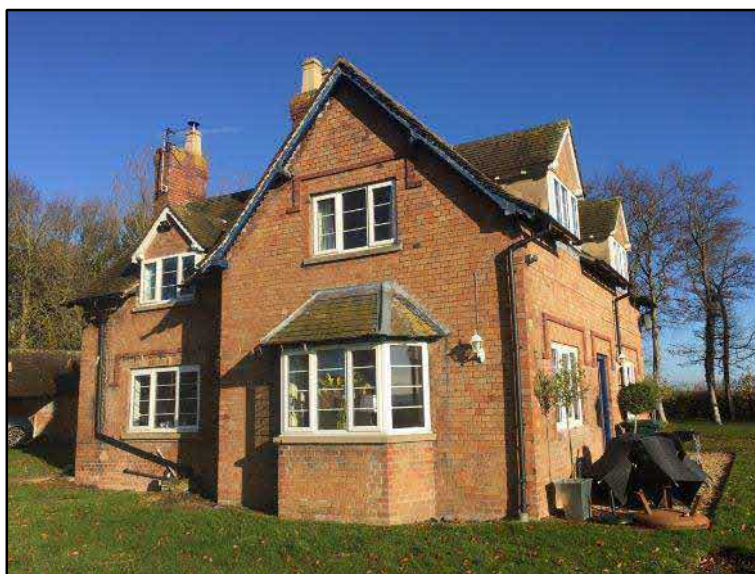
Figure 3: View of Residential Property

Bldg. ref	Description	Potential Access Points	Evidence	Grading	Photographs
House	<p>A solid skin red brick two storey structure with a pitched slate roof and UPVC doors and windows. The building was occupied and generally considered to be watertight. There was a small single storey section with a tiled pitched roof which also formed a small porch over the front door. There were a total of three dormer windows as well as a bay window with a pitched tiled roof, with timber barge boards at the gable ends.</p> <p>Internally the roof was found to be constructed of modern sawn timbers, with no roofing felt so that the underside of the tiles was visible. Although there was an accessible roof void, due to the roofs in part being located within the roof space the height of the roof void was reduced (approx. 1.5m) with narrow sections sloping down below the joists around the sides of the dormer windows.</p>	<p>Gaps were noted in the main roof as a result of slipped or missing tiles, with light ingress points recorded in the roof void. The roof extends beyond the wall in a number of places with gaps visible at the top of the wall plate. There was a section of lifted lead flashing below one of the dormer windows as well as, gaps at the apex of the gable ends where beams extend from the roof. It was also noted that the porch, dormer windows and bay window all had small accessible voids present either as a result of slipped or missing tiles or gaps at the eaves.</p>	<p>Droppings were scattered throughout the roof void which was roughly T shaped and orientated northwest to southeast and northeast to southwest, it was noted that the northeast southwest section had a higher proportion of droppings with a small collection identified at the gable end of the northeast southwest section of the roof. It was also noted that there were a number of conspicuously clear gaps above the ridge board. The droppings were characteristic of BLE and may account for the scattering of droppings throughout the roof void as individuals undertake pre-emergent flight within the roof void prior to emerging.</p>	Confirmed

- i This building was a two-storey detached residential dwelling which was confirmed as a roost during the daytime inspection. As per best practice guidelines three nocturnal surveys were carried out. A maximum count of three bats were recorded roosting in the house, with bats returning to two different locations during the surveys; the south eastern dormer window, and the south western bay window. All bats were common pipistrelle and as a result the two roosts can be classified as a summer daytime roost of low conservation significance. Common pipistrelle are common in a local and national context and so this site is not considered to represent a significant or locally important site. It must however be recognised that the roost site is legally protected and therefore an EPSL must be applied for before works commence.

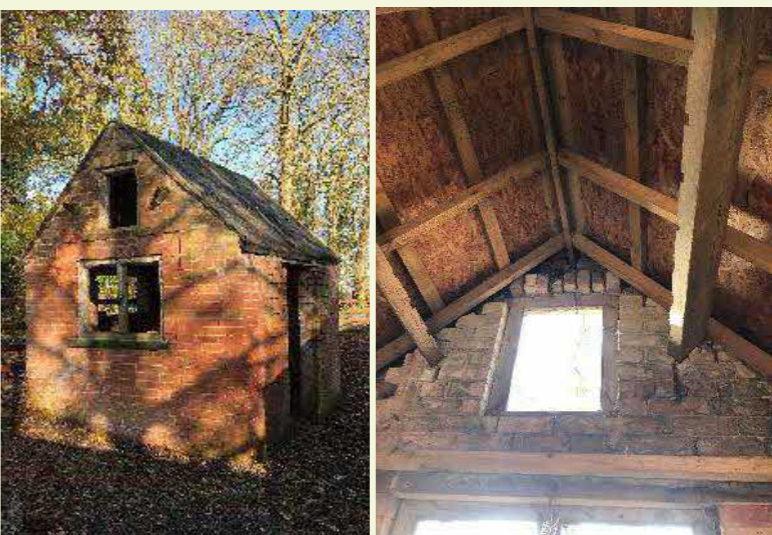
Bldg. ref	Description	Potential Access Points	Evidence	Grading	Photographs
B3	<p>A small single storey solid brick structure with a black felt apex roof. The building was in a dilapidated state with no doors or windows present. Internally the building looked to have been relatively recently re-roofed with modern sawn timbers and plywood boards between the beams and external roofing felt. There was a gap identified around one of the window frames as well as a large number of gaps internally as a result of missing bricks, structural cracks and at the wall plate in the gable ends.</p>	<p>The absence of glazing in the window frames and absence of a door provides free access into the building.</p>	<p>No evidence identified</p>	<p>Low</p>

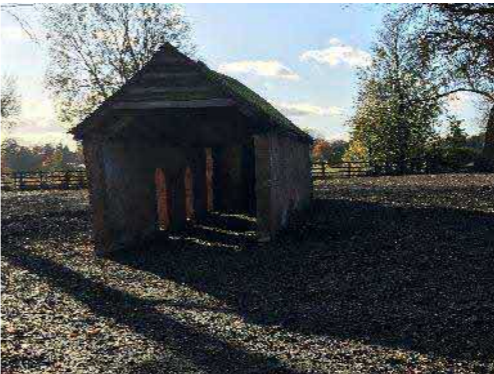
B4	<p>A small single storey solid brick structure with a clay tiled apex roof forming a single roof. The building was in a dilapidated state with one of the walls noticeably leaning out at the top. There was a small section of timber weather boarding at the north gable end which other than this was entirely absent. There were a number of doorways located along the south west aspect. Due to the potential for structural weakness owing to the bowed walls the building was not entered. Internally the roof was supported on modern sawn timbers with no roofing felt present on the underside of the tiles.</p>	<p>Open gable end, doorways and slipped a missing tiles on the roof.</p>	<p>No evidence but internal inspection was not carried out.</p>	<p>Low</p>

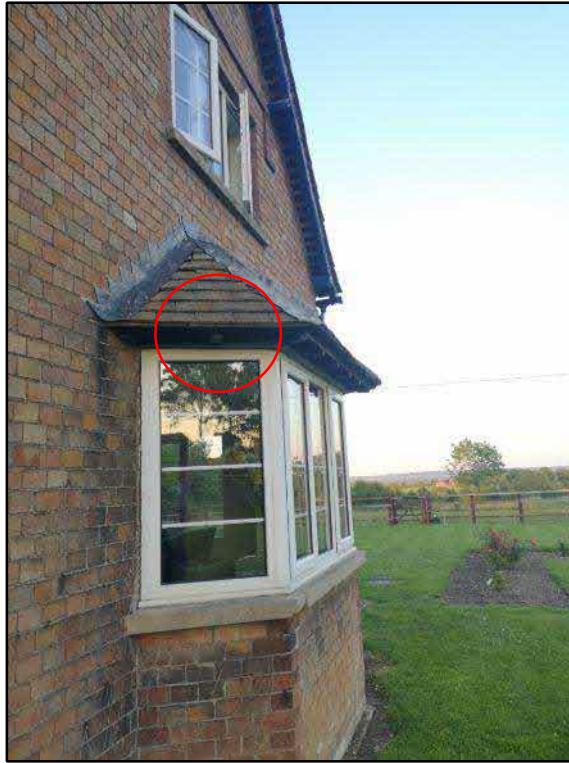
Figure 5: Bay window roost location

- v The Main House had a total of three emergences. The first emergence occurred at 21:42, with a common pipistrelle emerging from under the bay window on the south-western elevation of the house (Figure 5). A second common pipistrelle emerged from within the lead flashing on the right dormer window on the south eastern aspect of the house at 21:44 (Figure 6). This bat re-entered soon after emerging due to a short burst of rain the ceased almost immediately. Another common pipistrelle then emerged at 21:52 from the same aspect. It is possible that this was the same bat that re-entered earlier.

- ix The main house had a total of one emergence at 22:01 from a common pipistrelle emerging from under the bay window on the south-western elevation of the house; the same location as the previous survey (Figure 5).

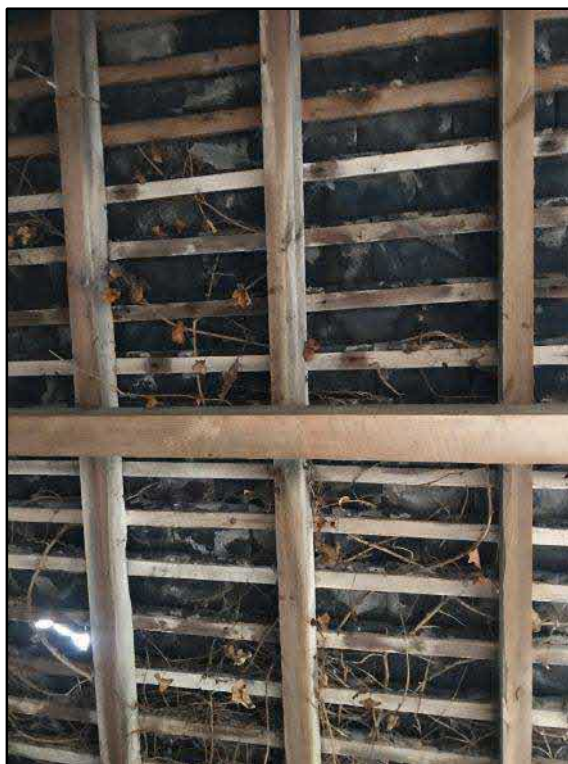
Figure 7: Likely roost area within building 4

- iv Building 4 had one emergence from a common pipistrelle which occurred at 22:07 from within the building. The exact emergence location cannot be confirmed, however it is likely to have been roosting within the wooden beams in the roof (Figure 7).

- v Building 4 was considered to offer low potential to roosting bats due to its open gable end, doorways and missing tiles on the roof. As per best practice guidelines one nocturnal surveys was carried out. However, an emergence was observed during this survey and as such a second and third survey was conducted to ascertain roost population dynamics including size and class. A maximum count of two bats were recorded roosting in B4, within the wooden beams inside the barn. As the previous roosts on site, all bats were common pipistrelle and this is also indicative of small numbers of bats only taking advantage of the roost features

available on this building. This building will also require an EPSL to legitimise its redevelopment and should be encompassed within the EPSL for the site to include both the house and Building 2.

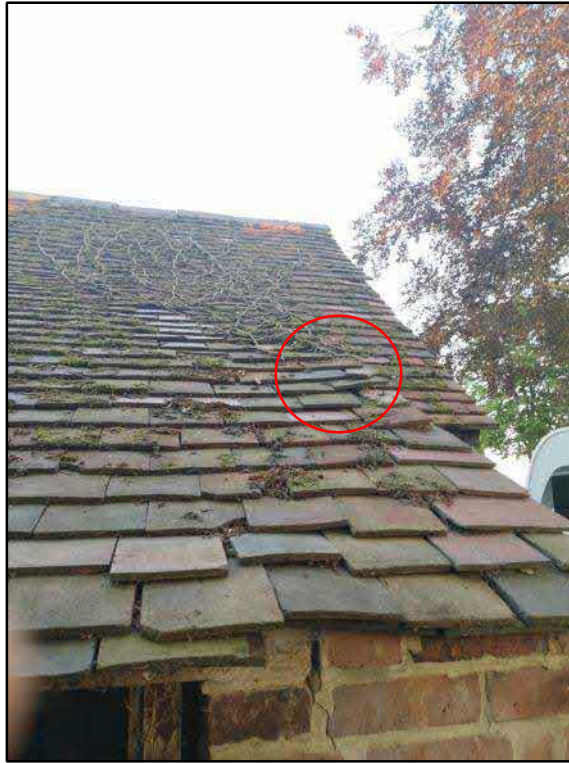
Figure 8: Lifted tiles as roost location

- x Building 2 had a total of two emergences. The second emergence was a common pipistrelle which occurred at 22:07, emerging from under the western aspect of B2 (see Figure 8). The third emergence occurred at 22:17 with a common pipistrelle emerging from the eaves of the western aspect of the south-western gable end (Figure 9).

- iii Building 2 was considered to offer moderate potential to roosting bats, this was mainly due to the free access to the eaves where a number of gaps were noted, and lifted tiles on the roof. As per best practice guidelines two nocturnal surveys were carried out. However, an emergence was observed during the second survey and as such a third survey was conducted to ascertain roost population dynamics including size and class. A maximum count of two bats were recorded roosting in B2, with bats returning to two different locations; the western aspect of B2 and the eaves of the south western gable. All bats were common pipistrelle and this is indicative of transitional individual bats only taking advantage of the roost features available on this building. This building will also require an EPSL to legitimise its redevelopment.

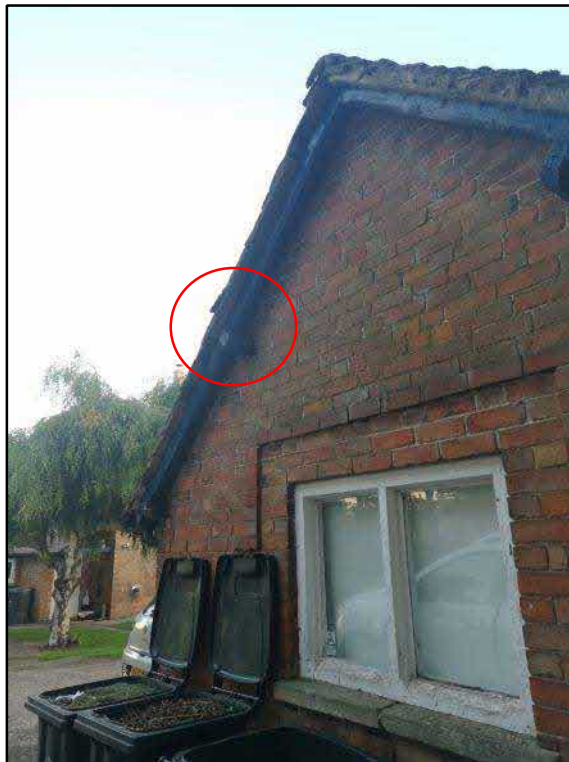
Figure 9: Eaves of south-western gable roosting location

- xiv Building 2 had one emergence at 22:19, with a common pipistrelle emerging from the eaves of the western aspect of the south-western gable as in the 3rd survey (Figure 9).

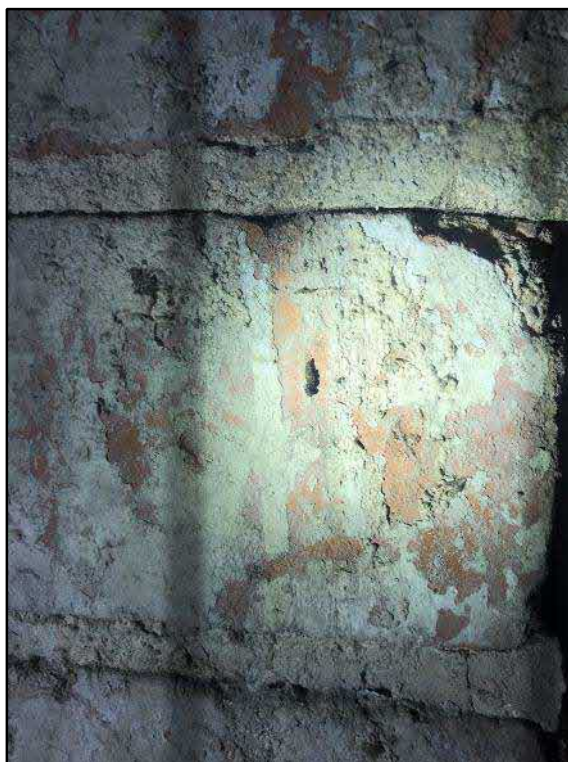
Figure 10: Bat droppings found withing B4.

- viii The first emergence was a common pipistrelle emerging from Building 4 at 22:11, following by a second emergence at 22:33 by another common pipistrelle. Evidence of bat droppings were found inside after the survey, suggesting the bats emerged from between the wooden panelling and the outer roof slates, similar to survey 2 (Figure 10).

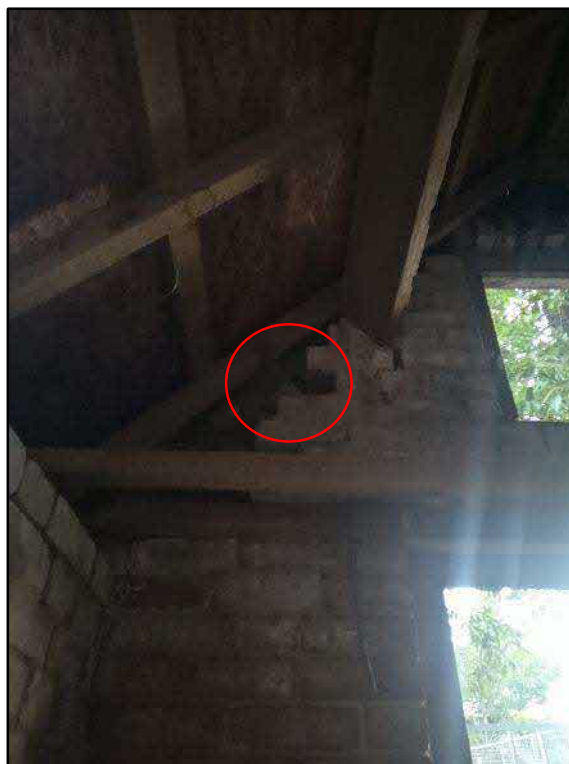
Figure 11 : Swallow nest within B3

- I A nesting swallow was observed entering through the open windows within B3 during the 4th survey. No other nesting birds or empty nests were noted in the other buildings during the surveys.

- i All species of bird, whilst nesting are protected under the Wildlife and Countryside Act (1981) as amended. Therefore, site demolition and clearance works should avoid the bird nesting season which runs from March to September inclusively. Works within this period should be preceded by an inspection for nesting birds by an ecologist. Where active nests are found, working restrictions would be put in place until follow up survey can demonstrate that all chicks have fledged. Based on this survey however, it is recommended that the site is cleared/prepared for redevelopment during the winter period outside the nesting season in line with bat recommendations (as detailed above) and as such numerous constraints would be put in place should clearance occur during the nesting period.

- ii Before building works commence within all buildings, any nests should be checked to ensure that all chicks have fledged.

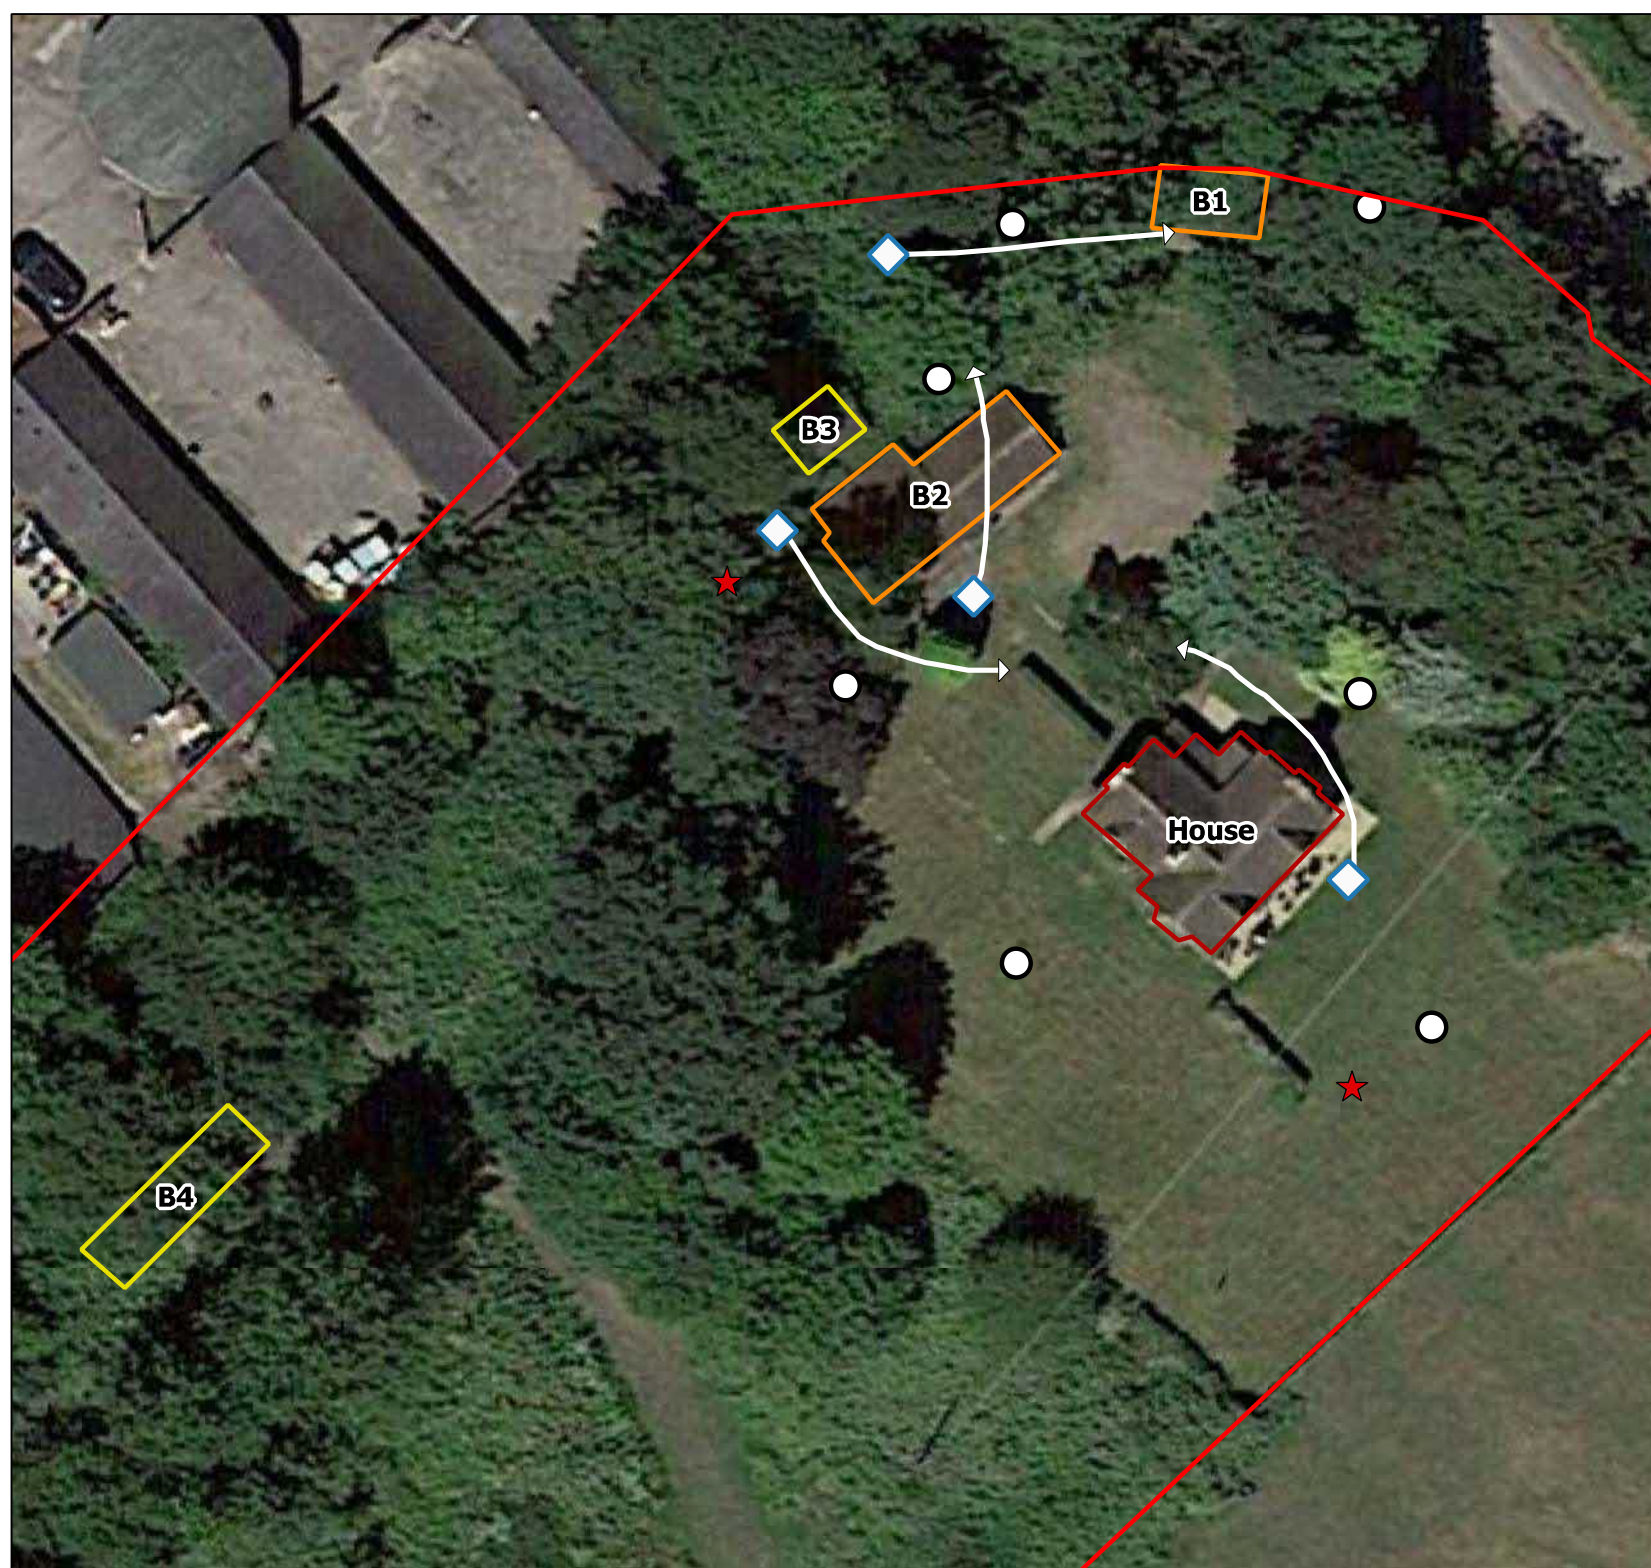
- ii Seven surveyors were optimally positioned to survey The Main house and Buildings 1, 2 and 3. Sunset was at 20:54, the survey began at 20:39 and ended at 22:25. The first recorded bat was at 21:13 which was a common pipistrelle (*Pipistrellus pipistrellus*). No emergences were recorded during this survey.
- iii General foraging behaviour was noted around B2, B3 and the nearby treeline throughout the survey with a max count of 2 common pipistrelle recorded. Noctule (*Nyctalus noctula*) and a myotis species were recorded but not seen, however these passes were a single pass each indicating commuting behaviour. The last recorded bat was a common pipistrelle which was heard but not seen.

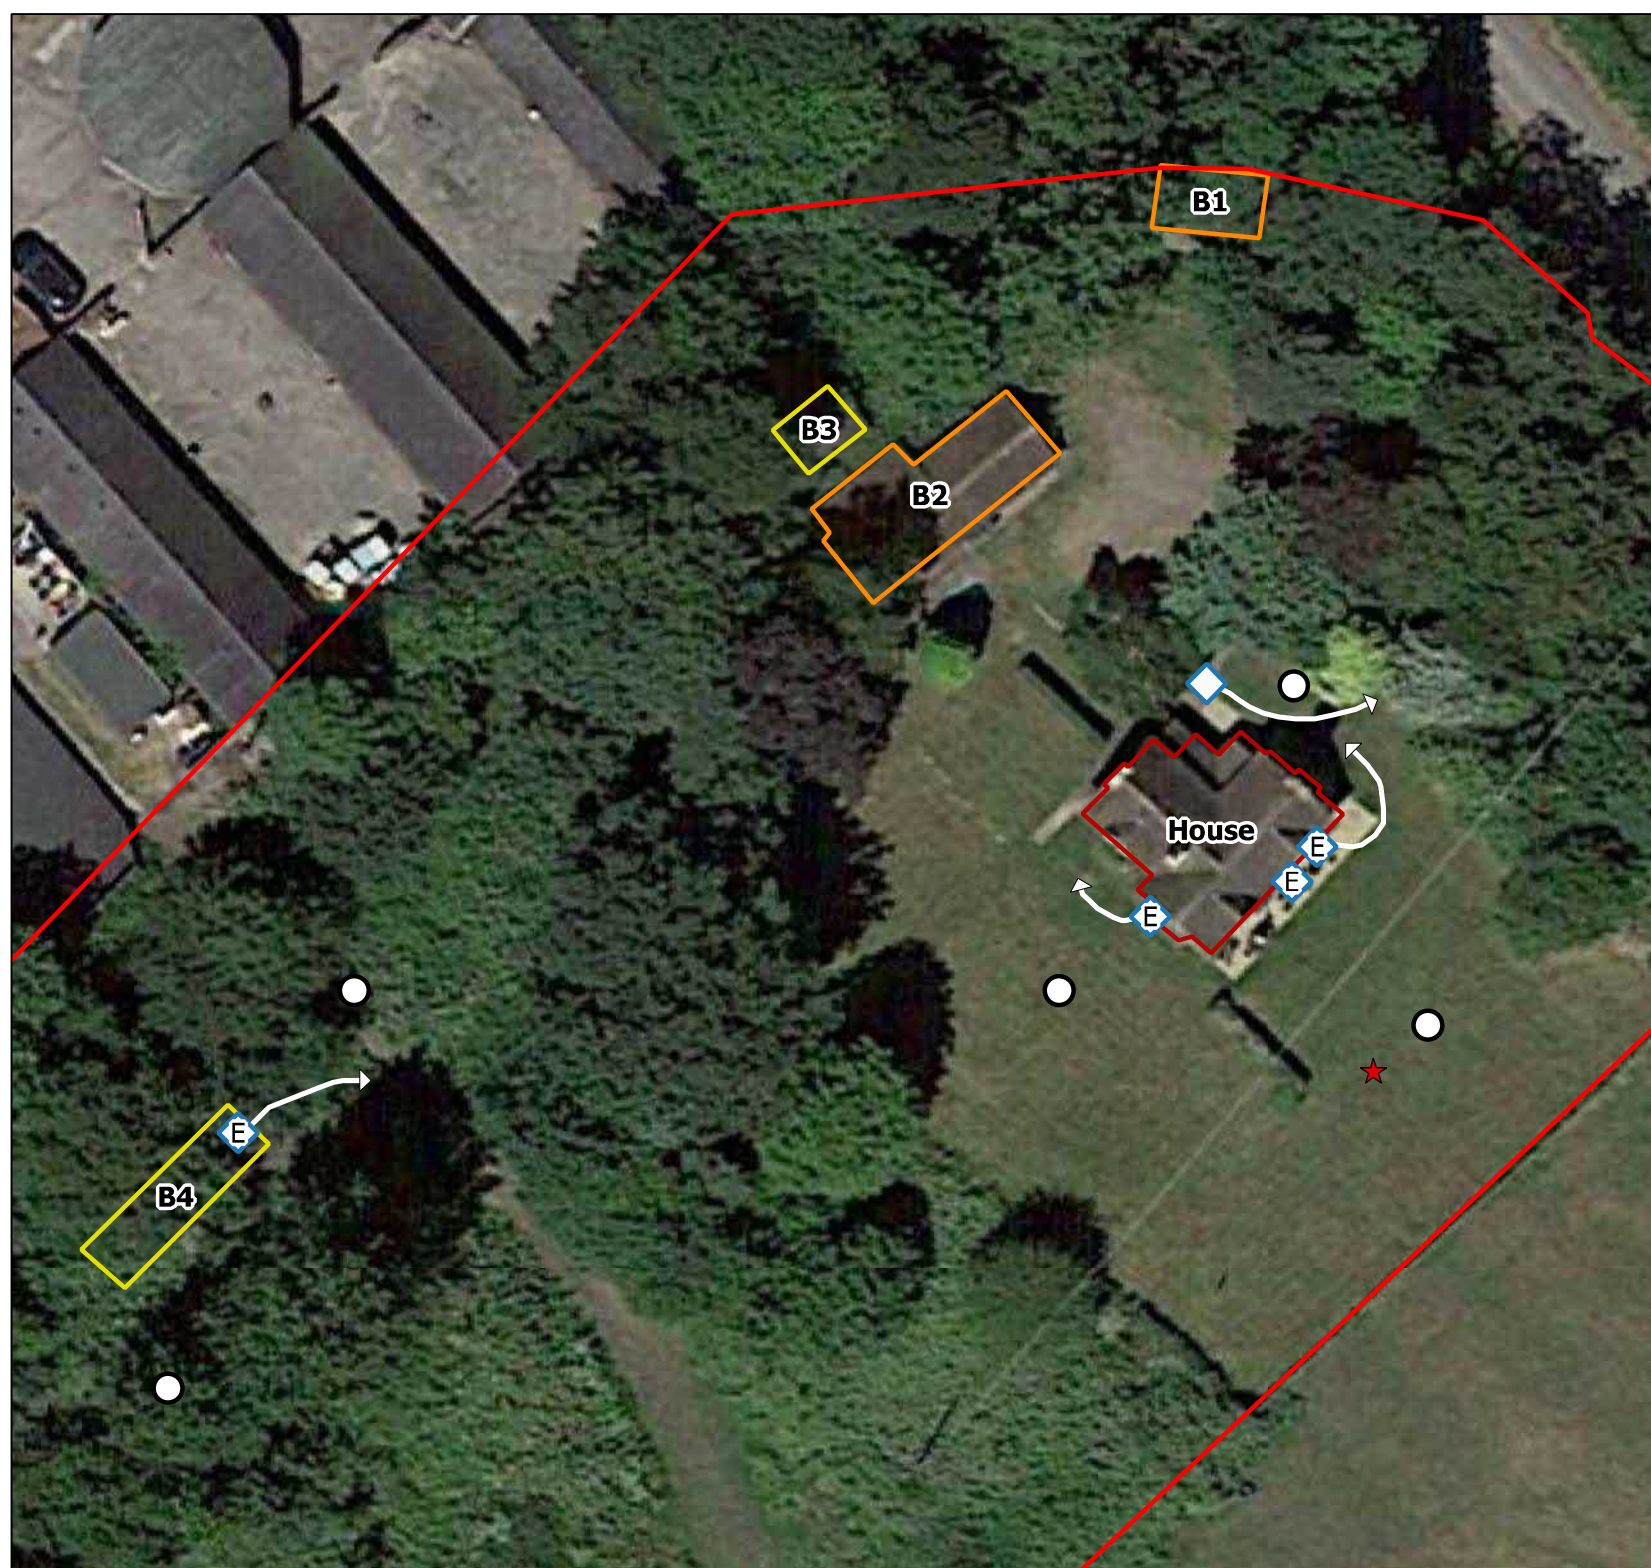
- iv Five surveyors were optimally positioned to survey the Main House and Building 4. Sunset was at 21:22, the survey began at 21:07 and ended at 22:52. The first recorded bat was at 21:42 and was a common pipistrelle. Four emergences were recorded during this survey.

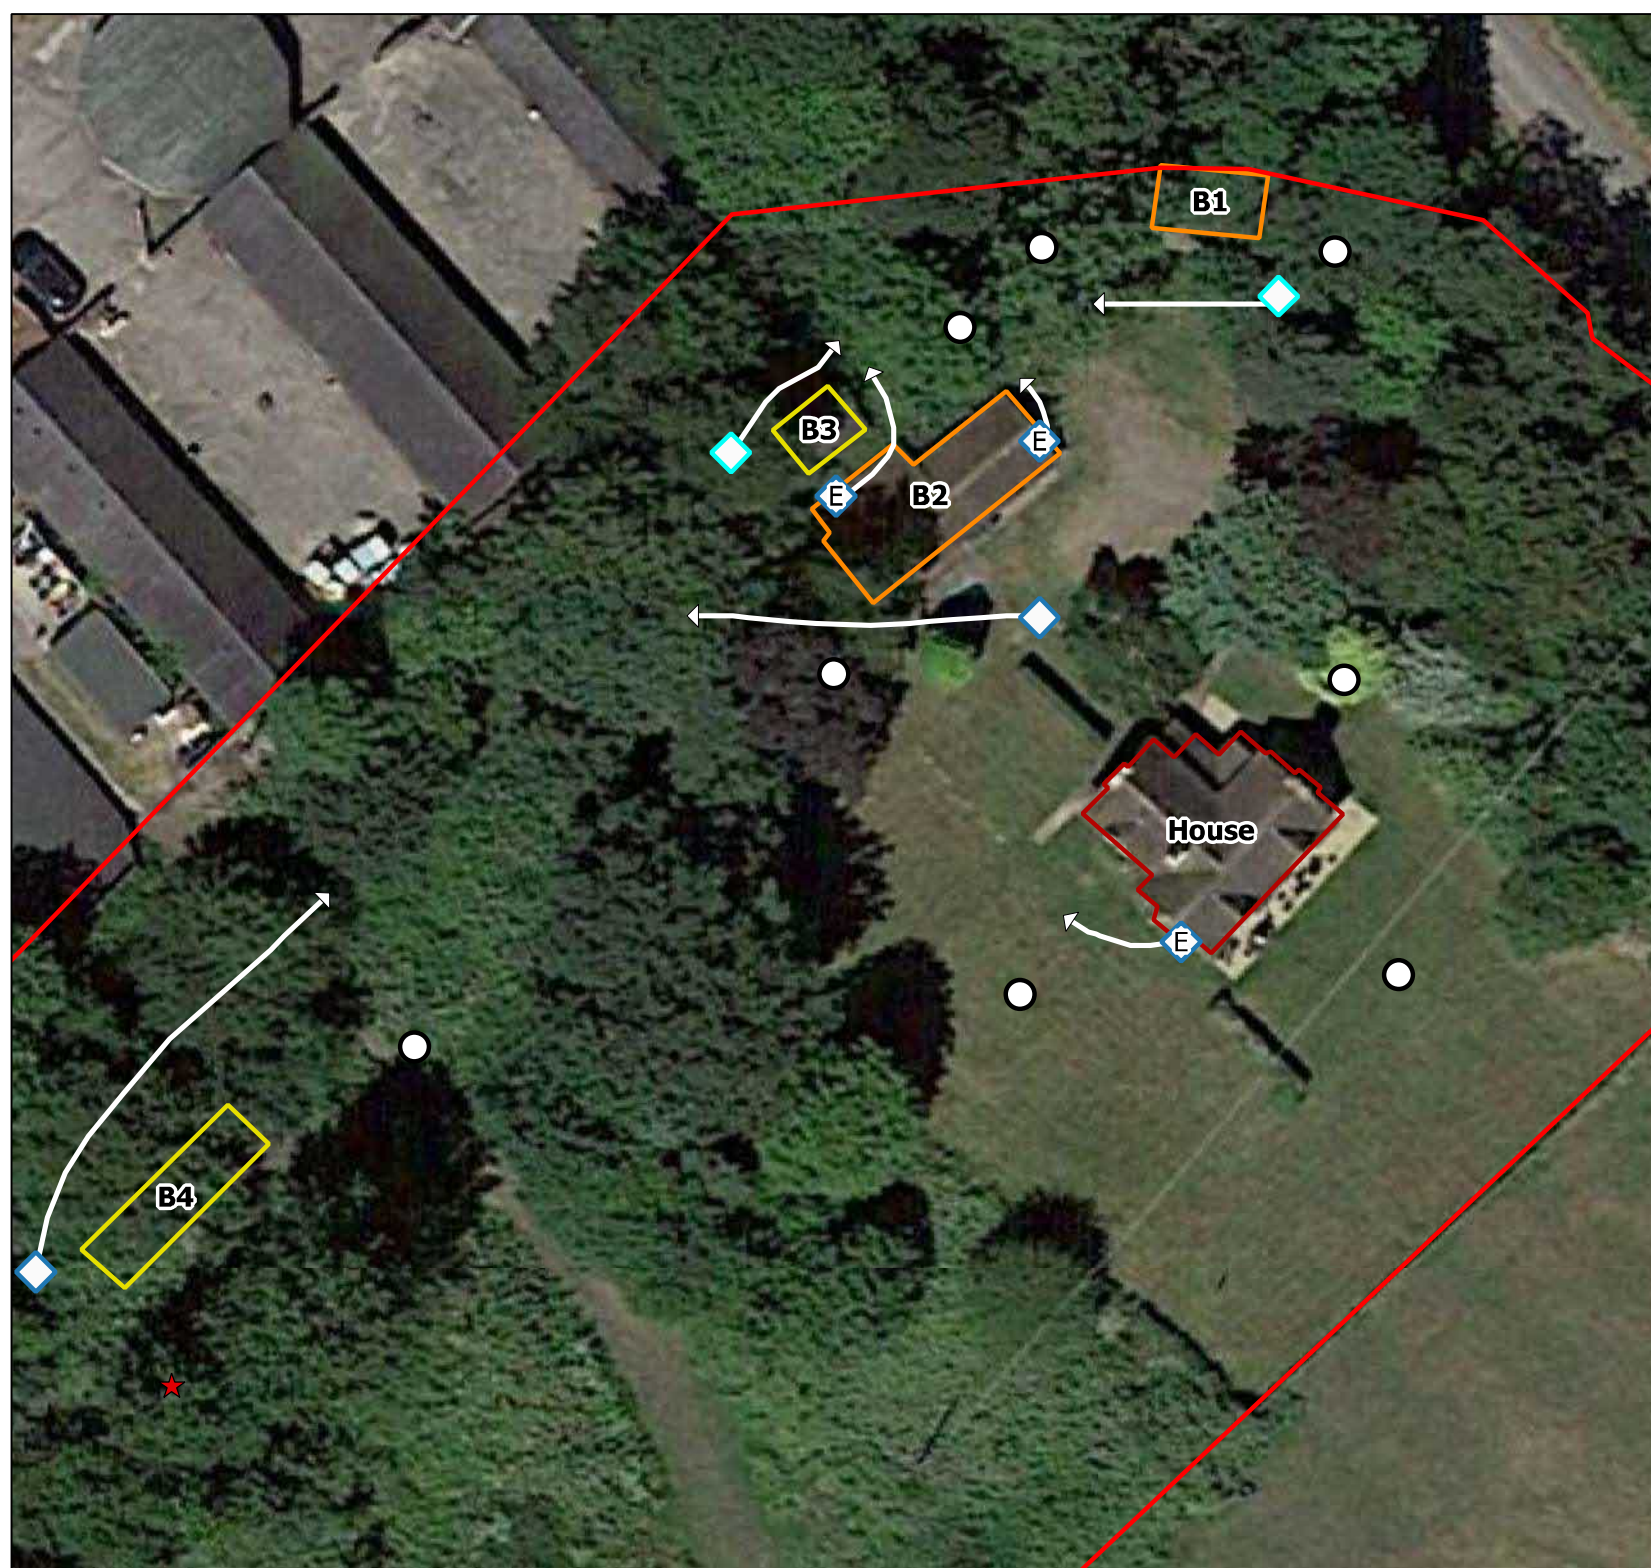
Drawing No. RSE_3322_B3	Rev: V1
Drawn By: AGM	Date: 26/06/2020
Scale: 1:400

- viii Eight surveyors were positioned optimally to view the Main House, Buildings 1, 2 and 4. Sunset was at 21:32, the survey began at 21:17 and ended at 23:02. The first recorded bat was a soprano pipistrelle foraging at 21:58. Three emergences were recorded during this survey.

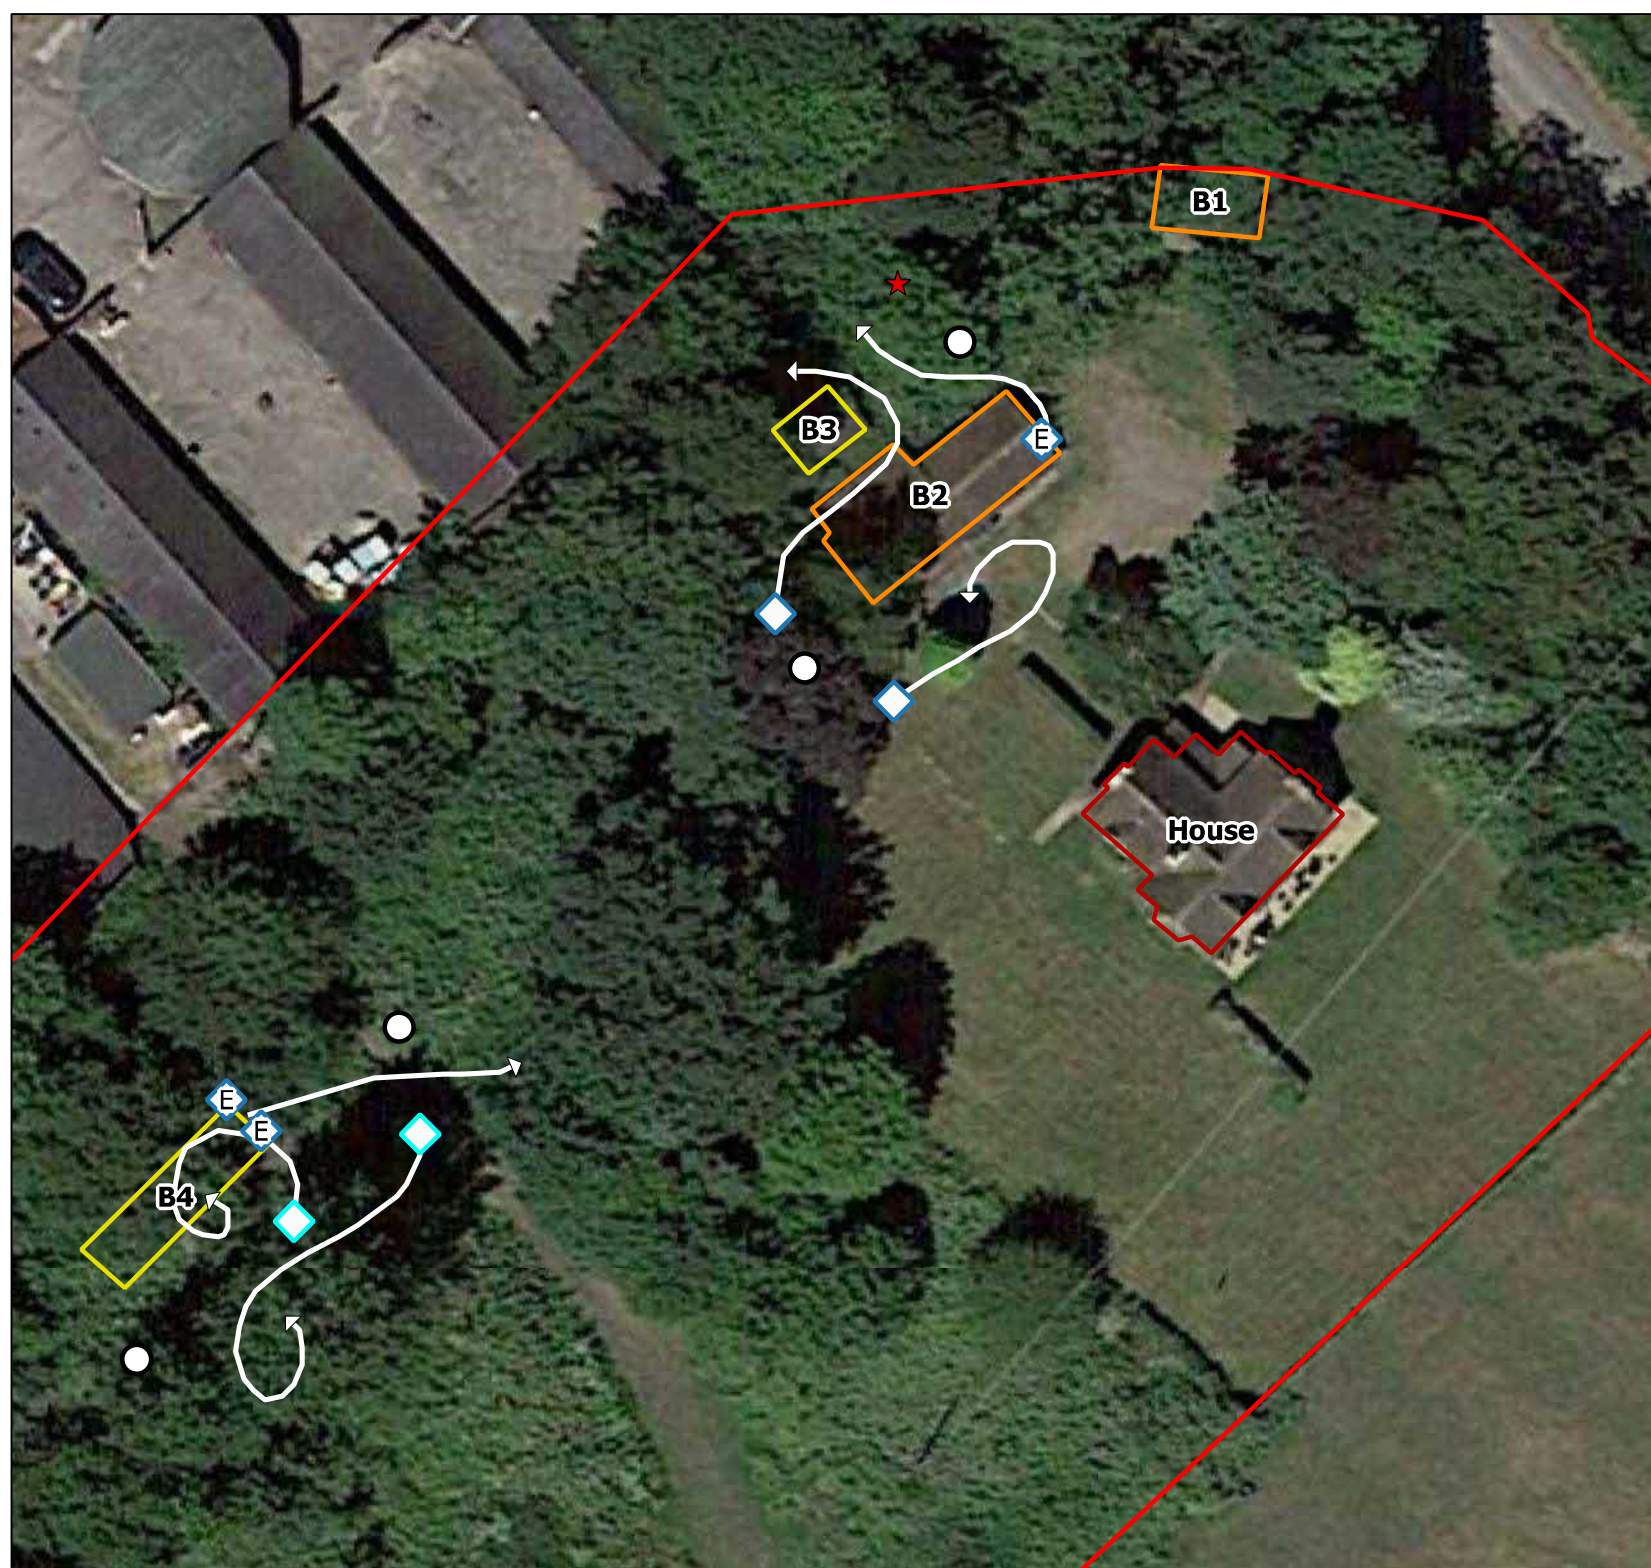
- xii Four surveyors were positioned optimally to view Buildings 2 and 4. Sunset was at 21:33, the survey began at 21:18 and ended at 23:03. The first recorded bat was a common pipistrelle commuting past B2 at 21:57. Three emergences were recorded during this survey.
