Report prepared for: Mr. Mahmood

For the Site of: 47 Chestnut Avenue, Epsom, Surrey KT19 0SY

# Preliminary Roost Assessment (PRA)

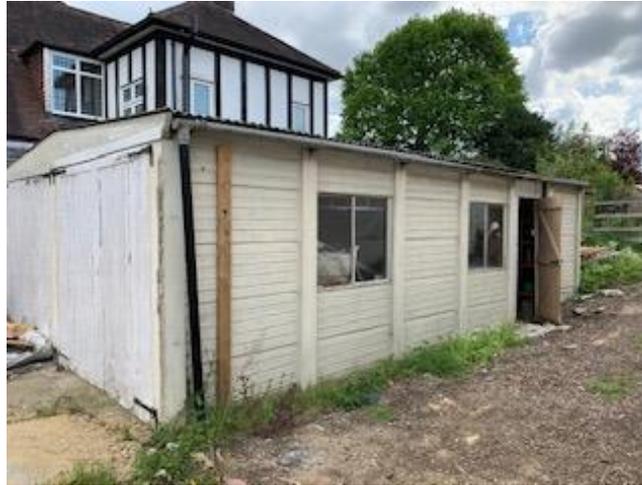
Figure 2: Front aspect B1

A small prefabricated brick garage with a corrugated asbestos single skin roof (see Figures 2 and 3).

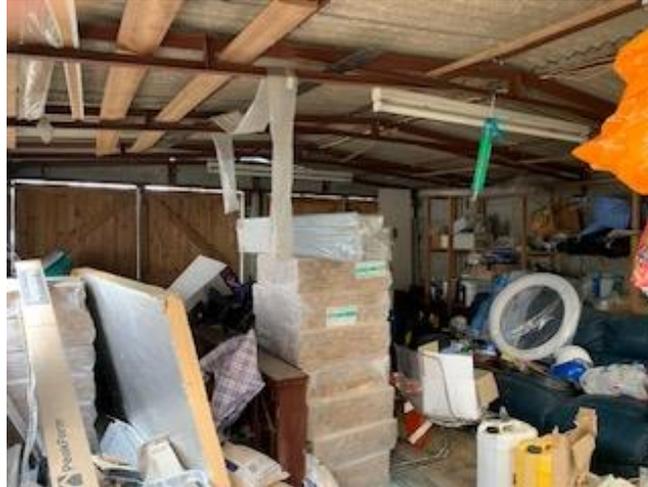
Figure 4: Internal B1

No loft space, vaulted internally with no lining (see Figures 5 and 6).

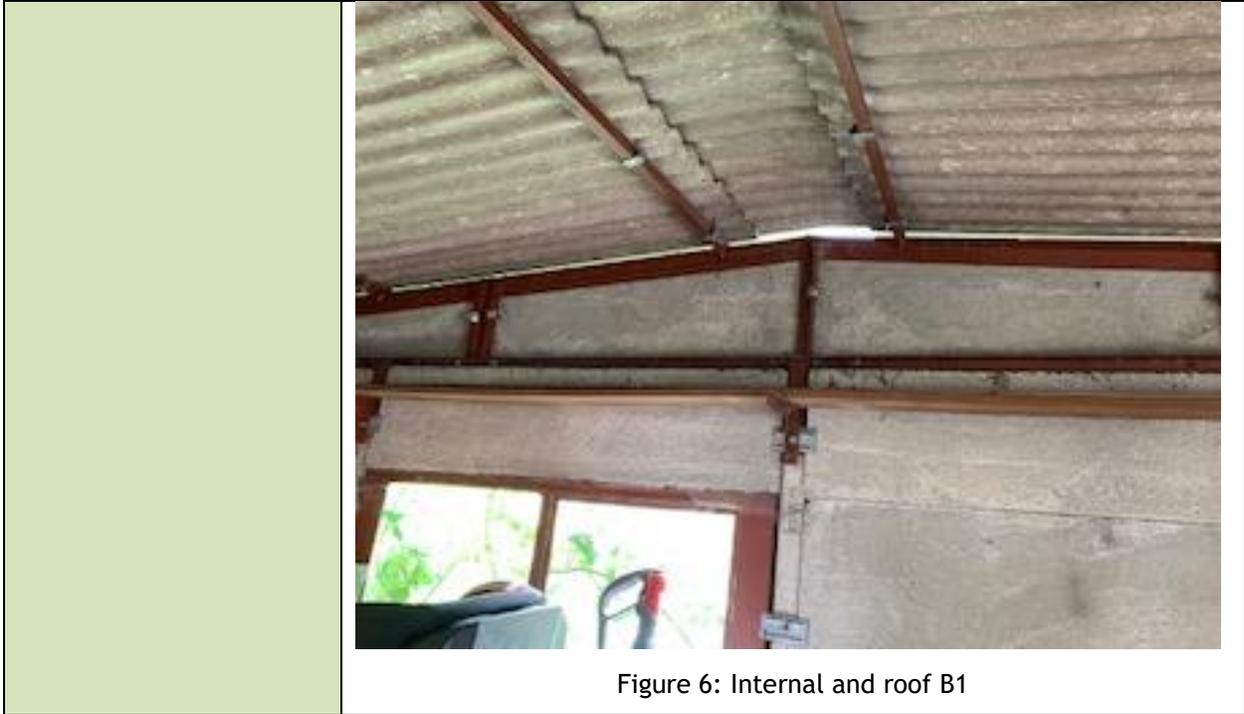
Figure 6: Internal and roof B1

The site consists of a small brick single storey detached garage (B1) circa 1960's, with a single skin, asbestos roof. B1 has negligible potential to support bats.

| Potential for bat use | Level of likelihood of presence - negligible<br>There is know potential for this structure to be used as roosting area for bats. |

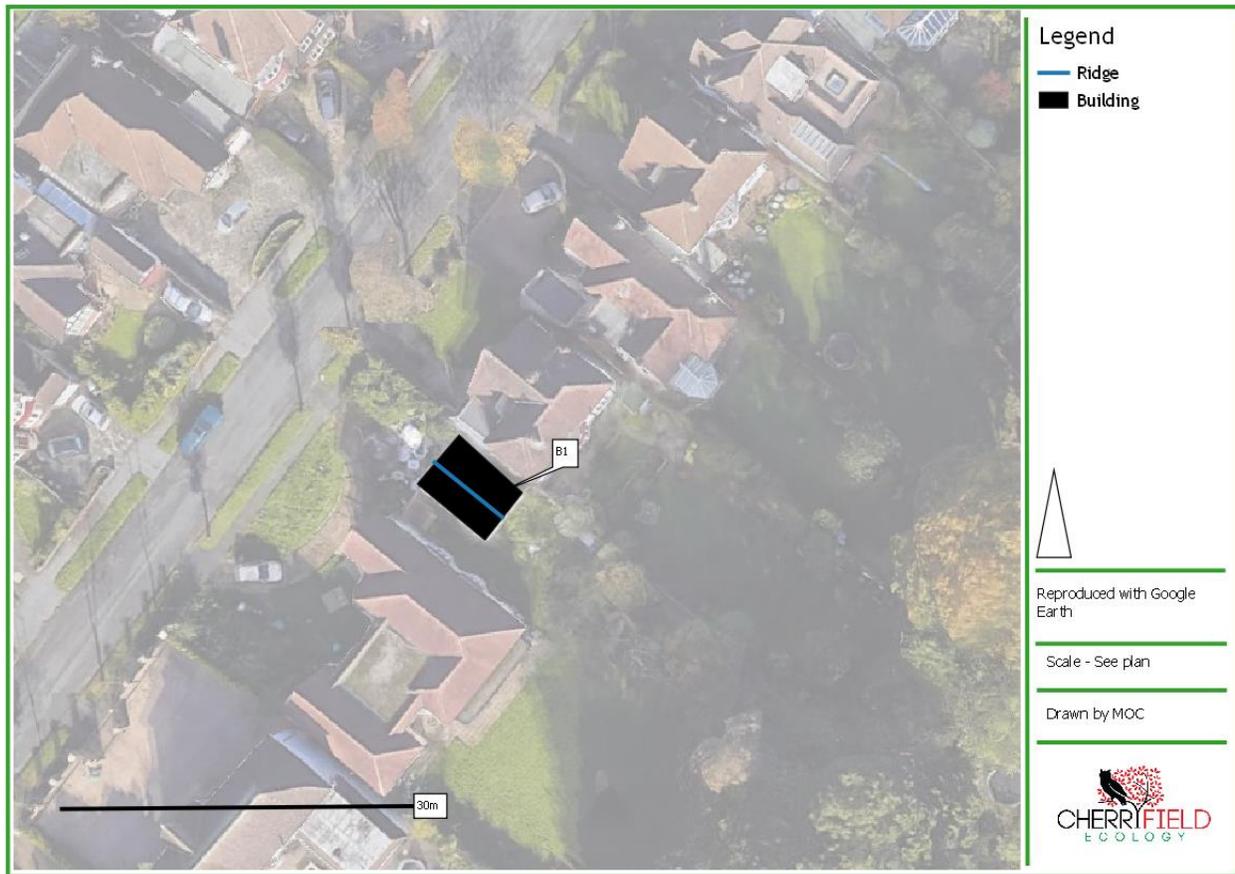
Figure 7: Site plan

This section details the structures reference, and description (see Figure 7 for site plan).
