EXTENDED PHASE 1 HABITAT SURVEY & DAYTIME BAT SURVEY

BRUNSWICK PLACE, BRADFORD ROAD, MANCHESTER

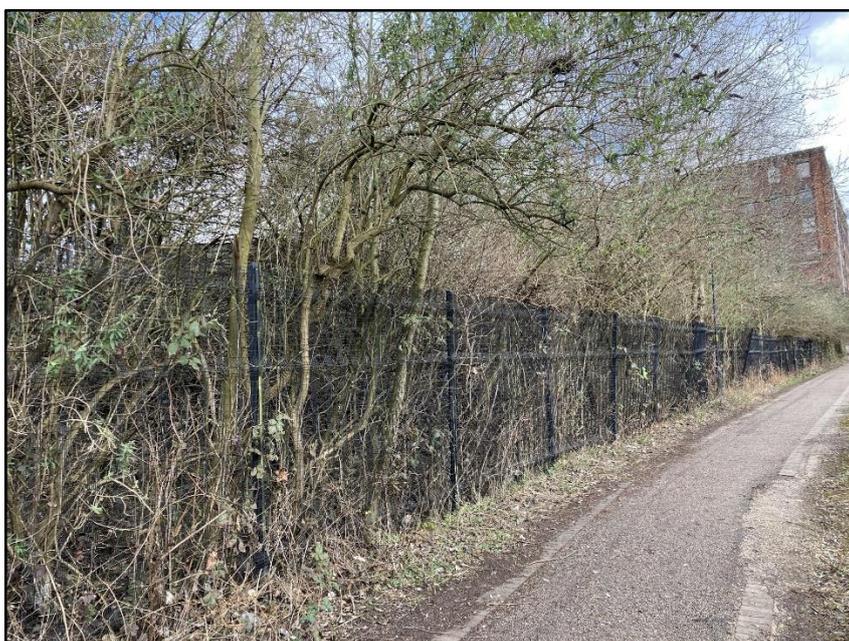
- 3.2 Continuous scrub is present along part of the southern boundary of the site between two fences (see Photograph 1). This habitat is dominated by Bramble *Rubus fruticosus* agg., Elder *Sambucus nigra*, Butterfly Bush *Buddleja davidii*, Ash *Fraxinus excelsior*, Goat Willow *Salix caprea*, Sycamore *Acer pseudoplatanus* and Common Nettle *Urtica dioica*.

Photograph 1 showing the continuous scrub

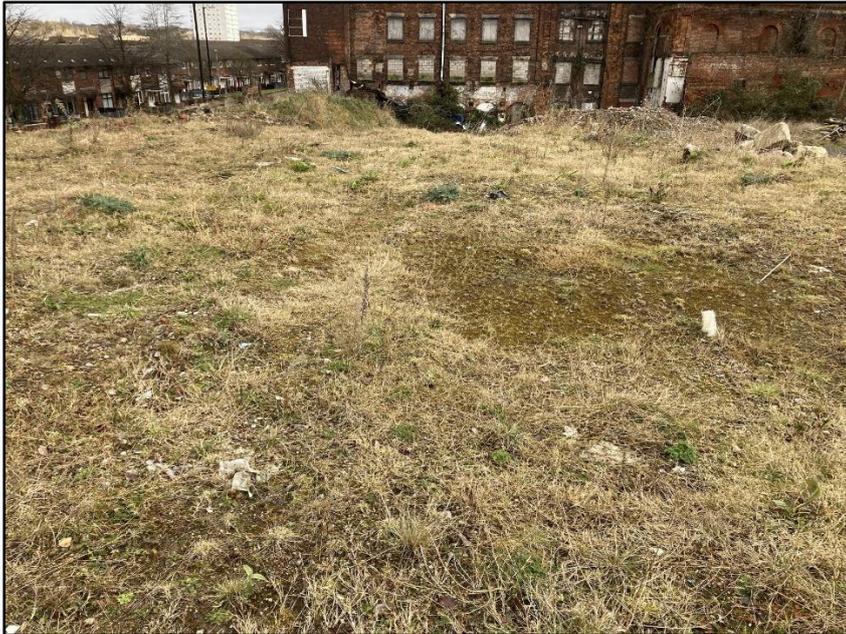
- 3.3 This habitat is abundant across the western part of the site and has established over large spoil piles and across areas of bare ground (see Photograph 2). Species present include Mugwort *Artemisia vulgaris*, Perennial Rye-grass *Lolium perenne*, Stinging Nettle *Urtica dioica*, Dandelion *Taraxacum officinale* agg., Annual Meadow-grass *Poa annua*, Broad-leaved Dock *Rumex obtusifolius*, Ribwort Plantain *Plantago lanceolata*, Greater Plantain *Plantago major*, Wavy Bitter-cress *Cardamine flexuosa*, Creeping Bent *Agrostis stolonifera*, Bird's-foot Trefoil *Lotus corniculatus*, Common Mouse-ear *Cerastium fontanum*, Creeping Buttercup *Ranunculus repens*, Spear Thistle *Cirsium vulgare*, Colt's-foot *Tussilago farfara*, Dove's-foot Crane's-bill *Geranium molle*, Herb-Robert *Geranium robertianum*, Great Mullein *Verbascum thapsus*, Knotgrass *Polygonum aviculare*, Yorkshire Fog *Holcus lanatus*, Common Vetch *Vicia sativa* and Oxeye Daisy *Leucanthemum vulgare*.

Photograph 2 showing an area of ephemeral/short perennial on site

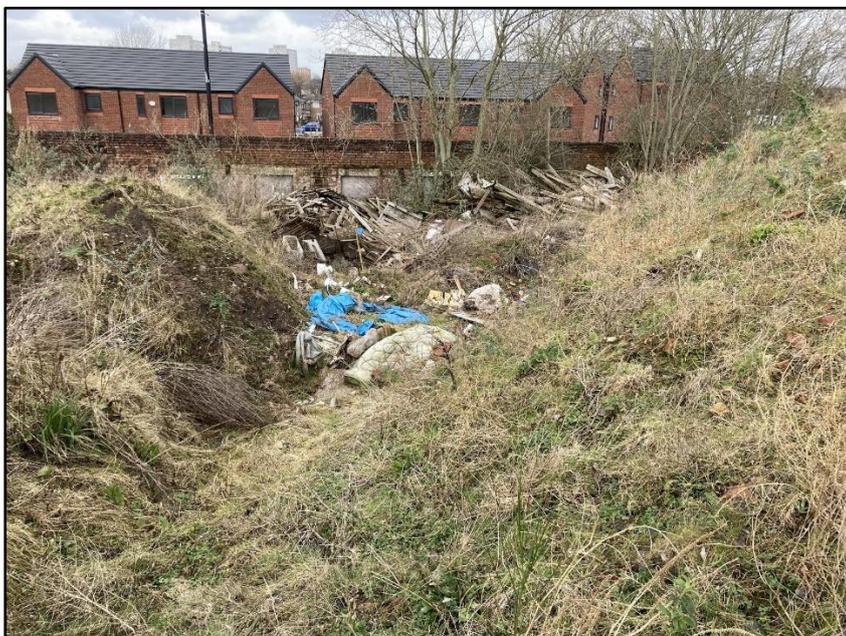
- 3.5 Scattered trees are found within the area of continuous scrub and long the site boundaries (see Photograph 1 above and 4 below). The trees are all self-seeded and of a similar semi-mature age. Tree species are dominated by Sycamore *Acer pseudoplatanus*, Ash *Fraxinus excelsior* and Goat Willow *Salix caprea* with Alder *Alnus glutinosa* also present.

Photograph 4 showing some of the trees on site

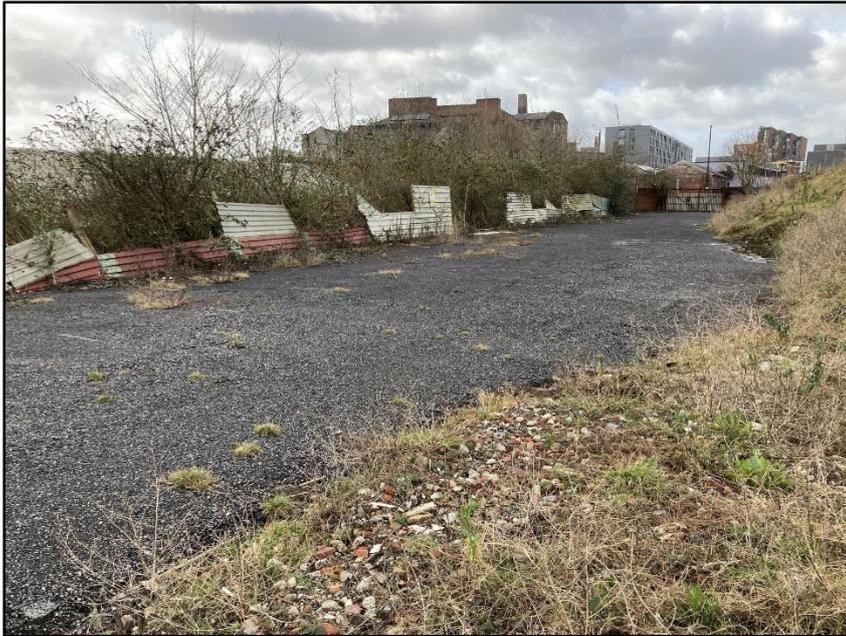
- 3.6 This habitat is present across the site comprising areas of hardstanding, compact crush-and-run and bare earth (see Photograph 5). Ephemeral/short perennial species have established within cracks and crevices and around the peripheries of the hardstanding areas.

Photograph 5 showing an area of compact crush-and-run

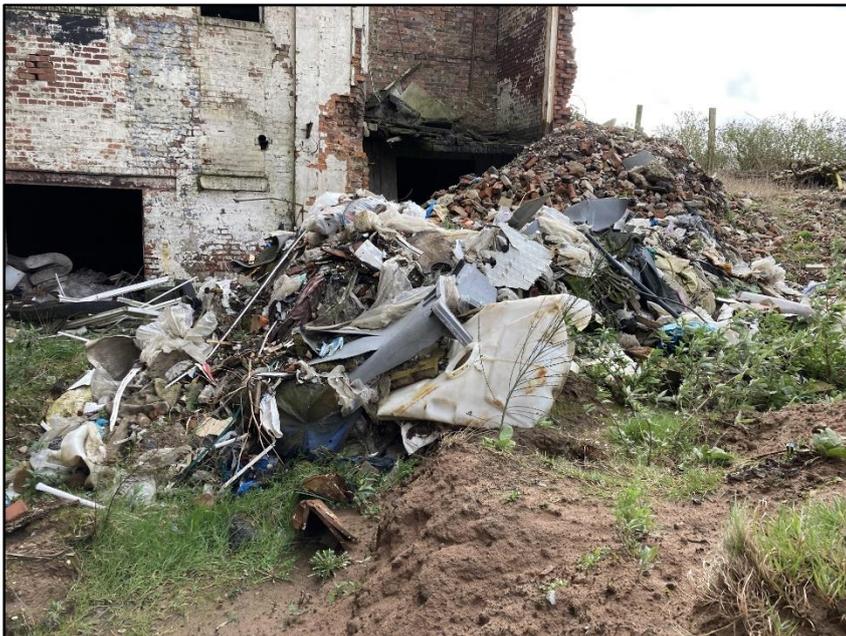
- 3.7 Spoil piles are located across the south-western half of the site and comprise building material and general waste (see Photograph 6).

Photograph 6 showing one of the spoil piles on site

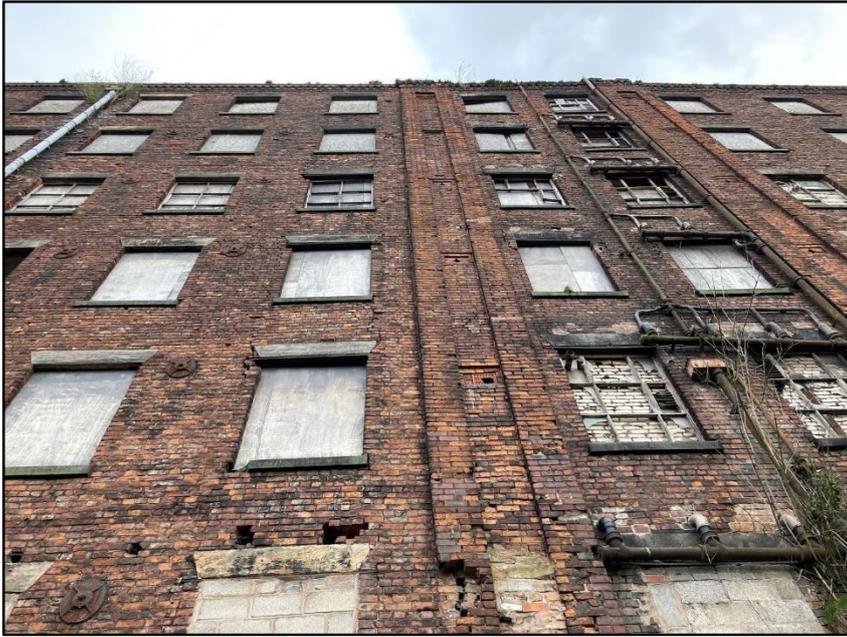
- 3.13 The mill building proposed to be affected by the plans is large and set over multiple floors. The external masonry is a mixed condition with the majority in reasonable condition and well-sealed with mortar. However, sections of the brickwork, particularly across the southern gable, have holes, cracks and sections missing offering potential entry points into the internal spaces and cavies (see Photographs 7, 8 and 9).

Photograph 7 showing the south-west gable wall of the mill building

- 4.6 The large mill building on site has been the subject of a daytime bat survey. No evidence of bat activity was found. However, due to the size of the building, not all areas could be surveyed. Countless potential entry points and bat roost features were found across the building's exterior and interior spaces. Open access into the internal spaces through missing windows increases the suitability of the internal features. Due to this, and the presence of suitable foraging and commuting habitat along Ashton Canal, it is considered the mill building offers **high bat roost suitability**. Further bat survey work is necessary to determine presence/likely absence of bats at the mill building, and the type of bat roost present. Three bat activity surveys are required.

- **Bats** - Further bat survey work is necessary on the mill building due to the reduced access available across parts of the building's exterior and countless number of potential roosting features across the building's interior and exterior. This is to determine presence/likely absence within the building and if so, the type of bat roost present. Three bat activity surveys are required. The surveys must be undertaken between May and September inclusive, in suitable weather conditions and with enough surveyors to observe the building.

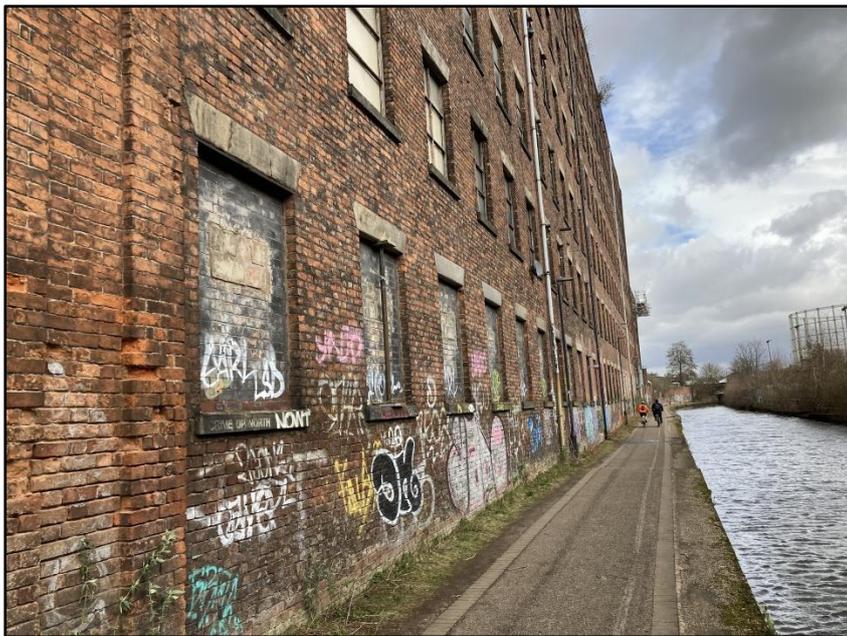
Photograph 8 showing the south-east facing external wall of the mill building

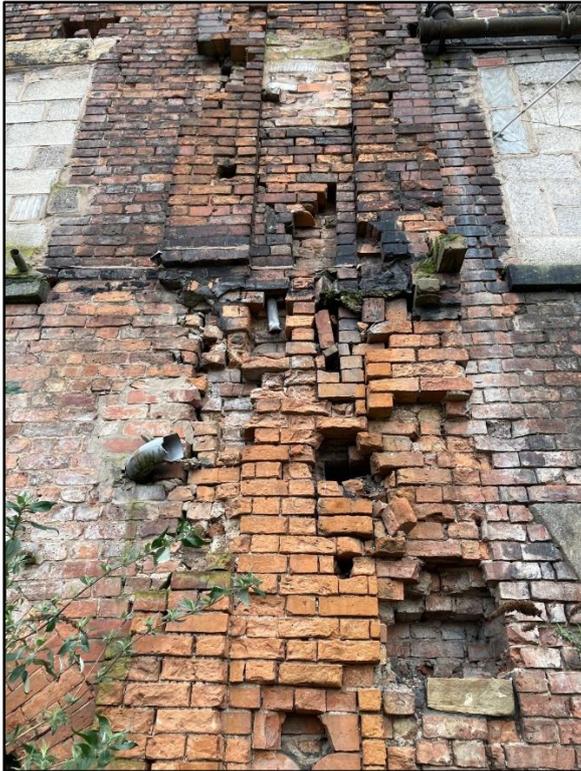
Photograph 9 showing some of the cracks and missing sections of masonry on the south-west facing gable of the mill building

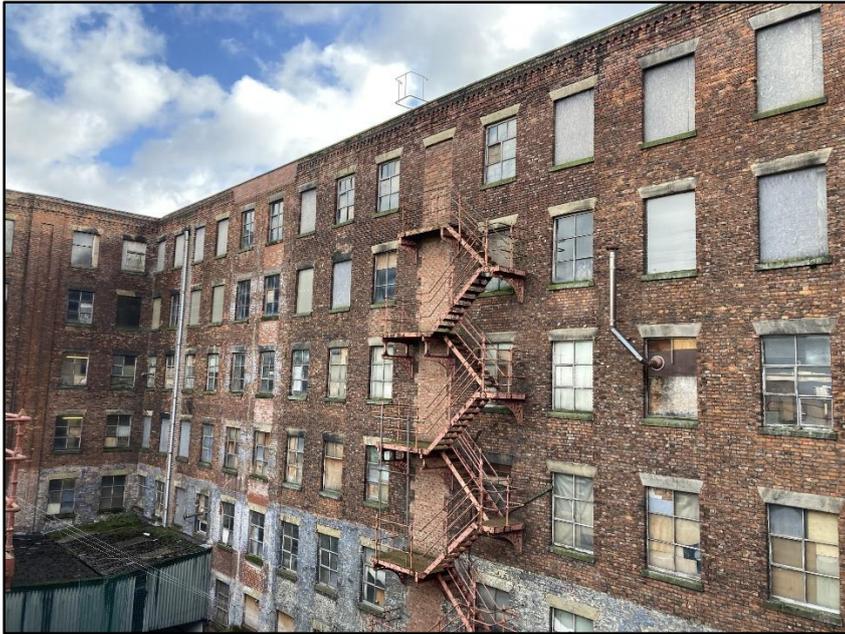
- 3.14 The window and door frames across the building are wood. These are showing signs of age, however, are sealed to the surrounding masonry (see Photograph 10). Many of the windows are bricked/boarded up on the internal side. Small gaps and crevices are present between the external walls and the walls blocking the window (see Photograph 11). Many windows across the upper floors of the building are missing resulting in open access into the internal spaces (see Photograph 12).

Photograph 10 showing the exterior of the mill building

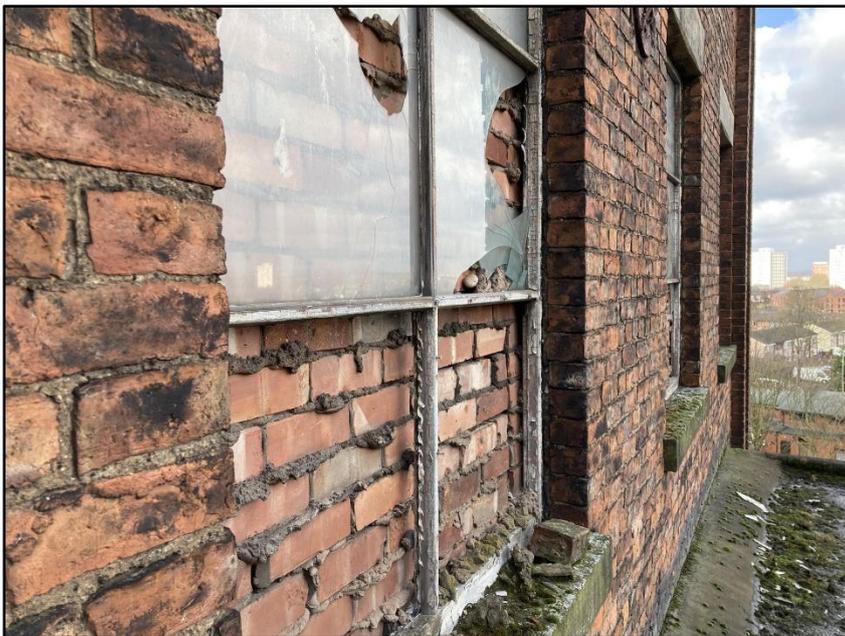
Photograph 11 showing some of the gaps between the external wall and the masonry blocking the window

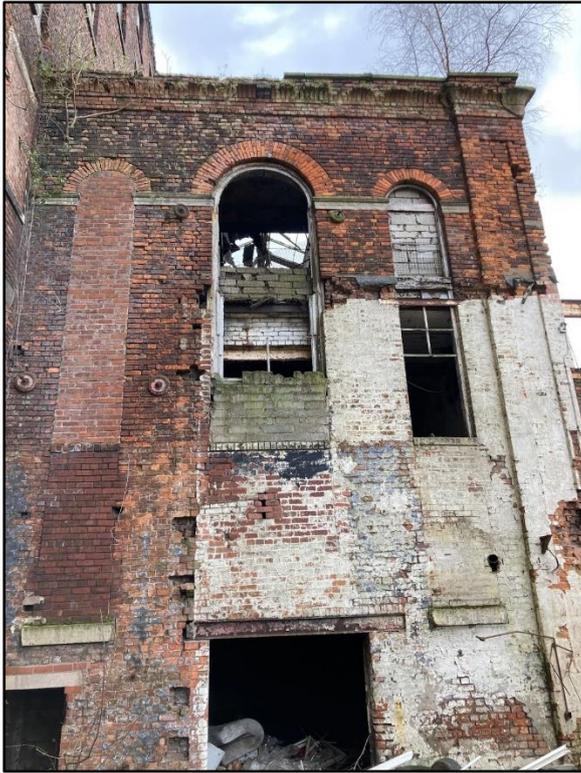
Photograph 12 showing some of the missing windows across the mill building

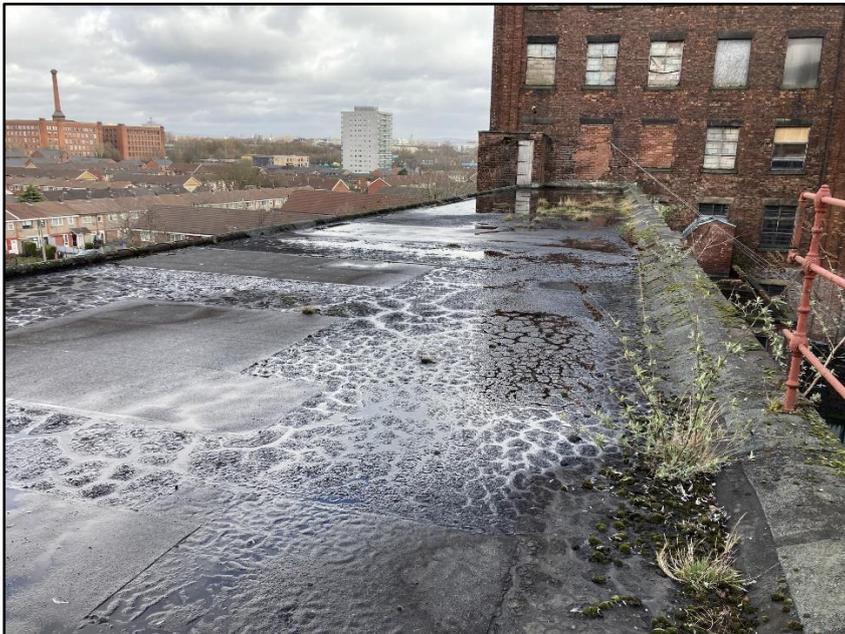
- 3.15 The majority of the mill has flat roofs covered with bitumen-based membranes (see Photographs 13, 14 and 15). The roofs are showing signs of age but appear to be in reasonable condition with standing water present. No obvious rips or tears are present, and the roof edges are well-sealed to the surrounding masonry.

Photograph 13 showing one of the flat roofs of the mill building

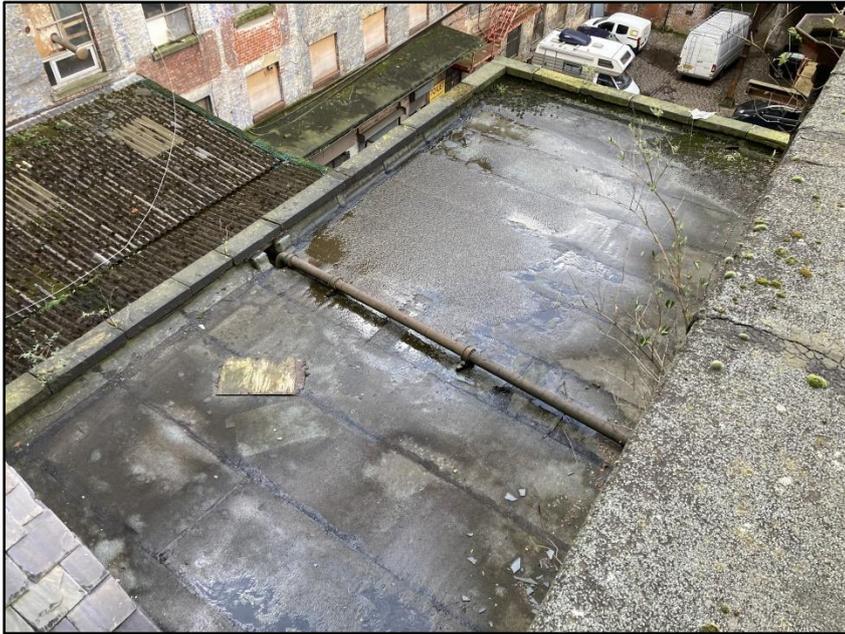
Photograph 14 showing one of the flat roofs of the mill building

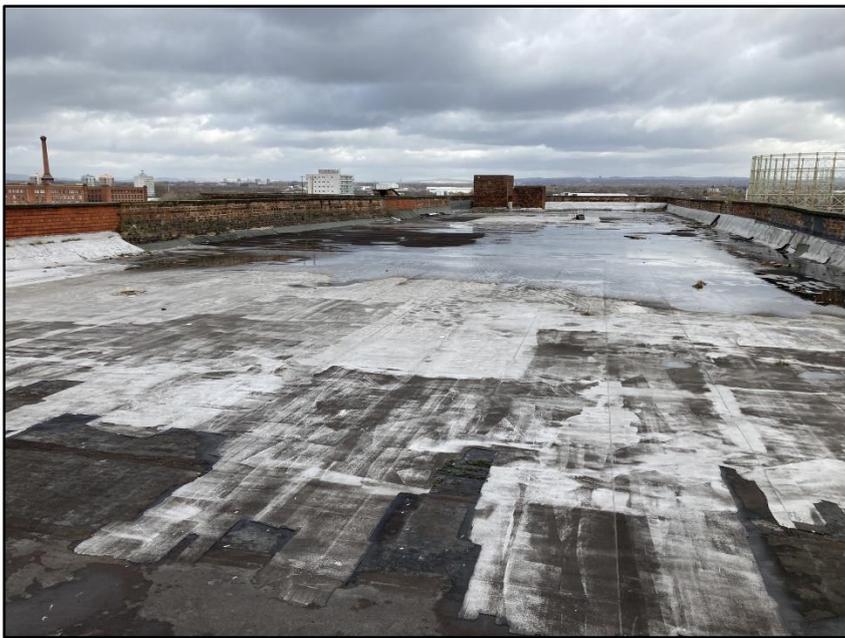
Photograph 15 showing one of the flat roofs of the mill building

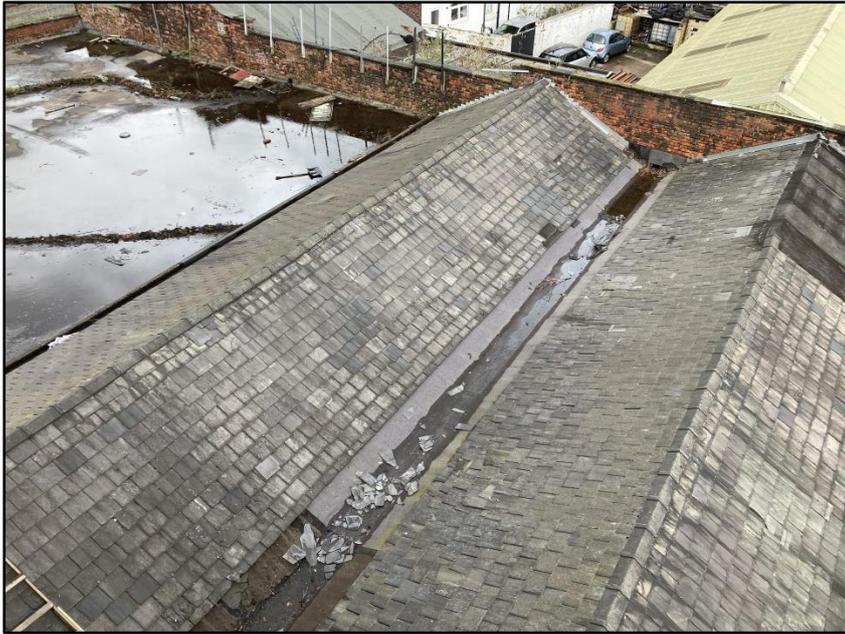
- 3.16 Two pitched roofs sections are located towards the northern boundary of the site covering parts of the single-storey section of the mill (see Photograph 16). These are covered in slate roof tiles of which are in good condition with no slipped or missing tiles found. The lead flashings are also in good condition and fitted flush to the surrounding masonry and tiles.

Photograph 16 showing the two pitched roof sections of the building

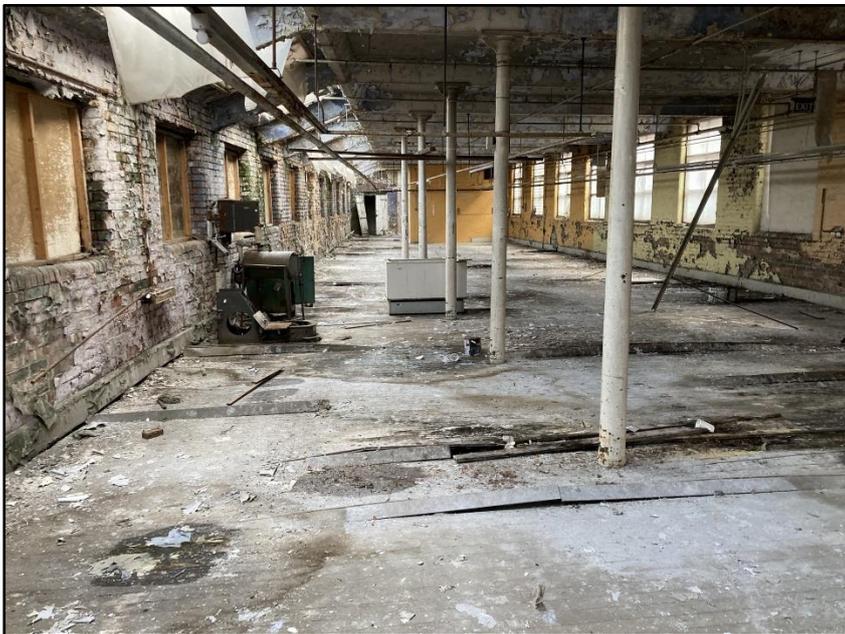
- 3.17 The internal spaces are set over multiple floors, many of which consist large open spaces currently not in use (see Photographs 17, 18 and 19). Small commercial unit spaces are occupied within the lower floors of the mill building.

Photograph 17 showing one of the internal spaces

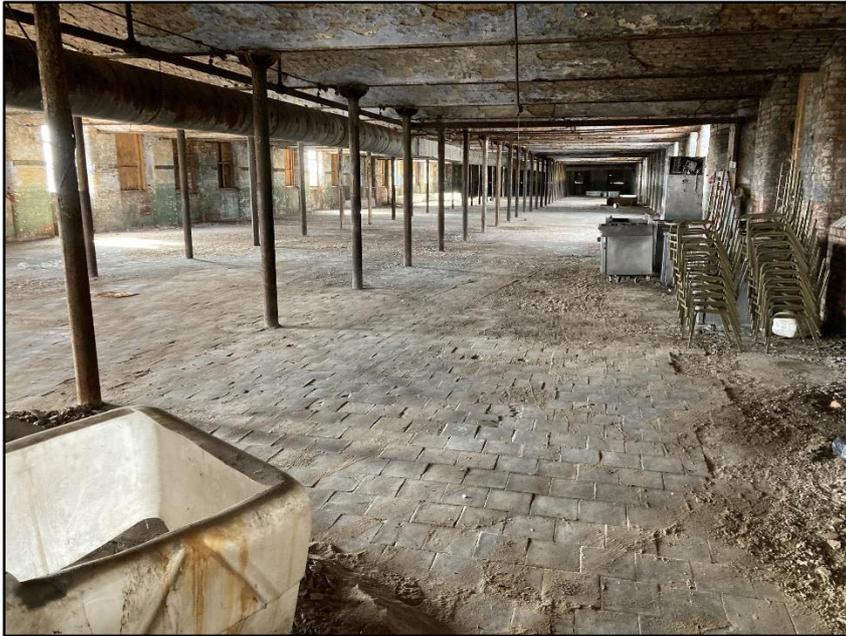
Photograph 18 showing one of the internal spaces

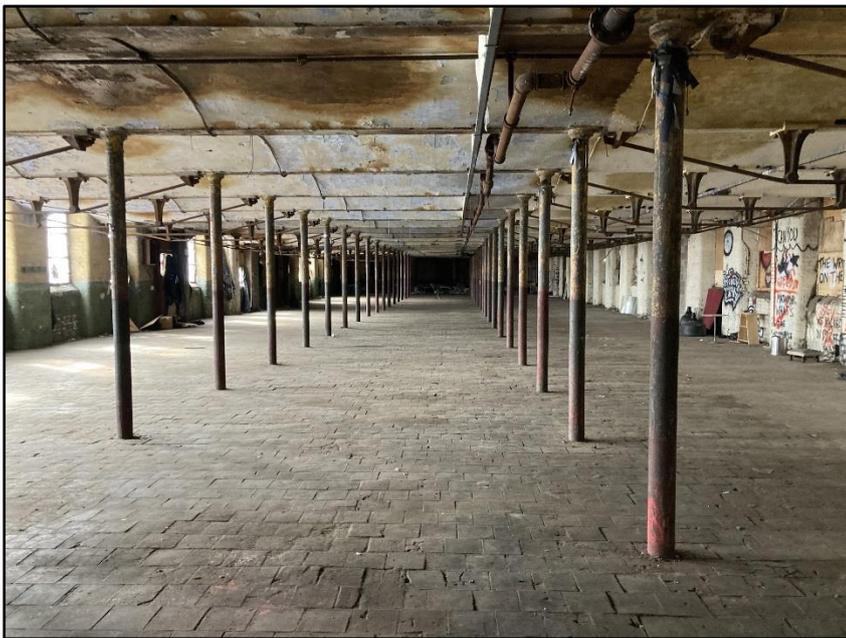
Photograph 19 showing one of the internal spaces

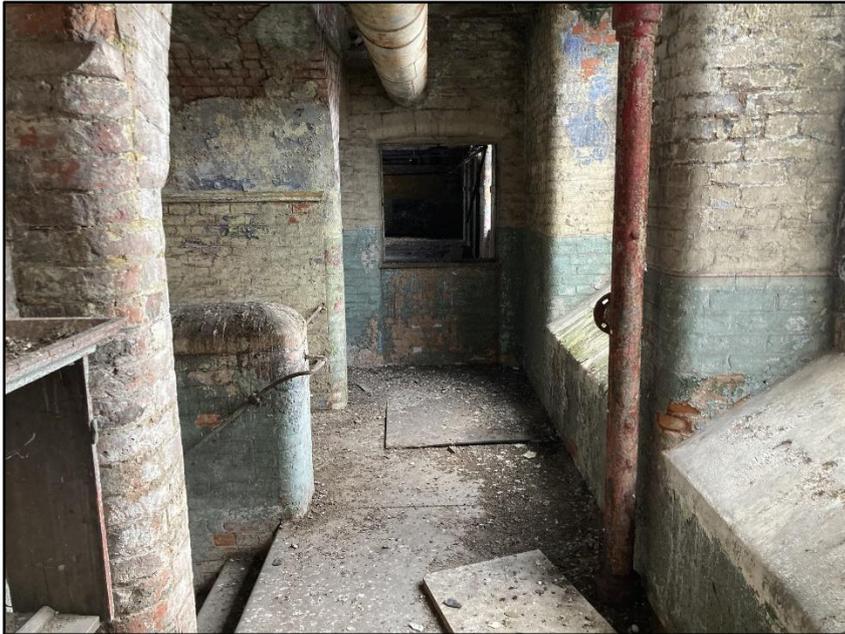
- 3.18 The internal walls are constructed from brick. These are in reasonable condition and well-sealed with mortar (see Photograph 20). Small cracks and crevices appear where mortar is missing and window and door frames are missing. Heavy use of Pigeon is located across most of the upper floor spaces, gaining access through the missing window sections (see Photograph 21).

Photograph 20 showing one of the internal spaces

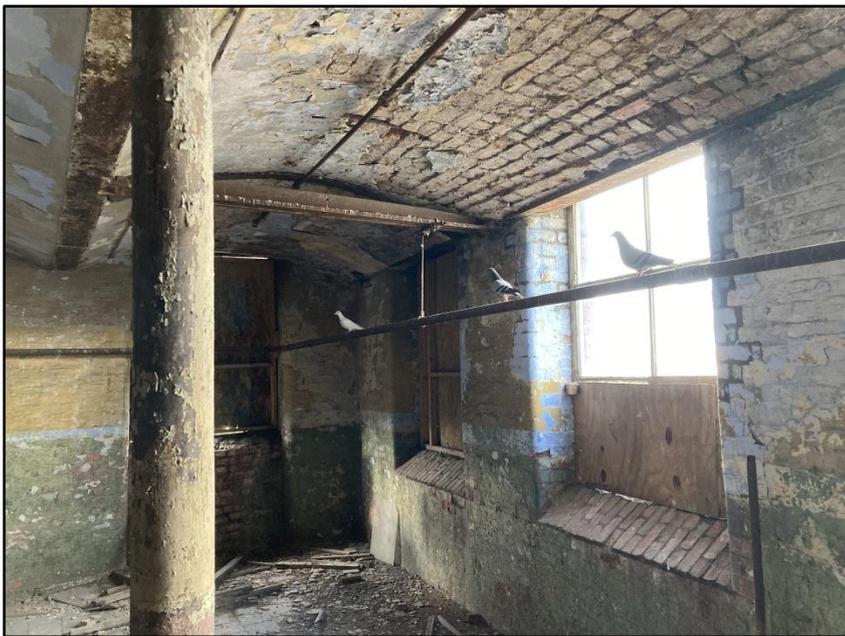
Photograph 21 showing evidence of Pigeon

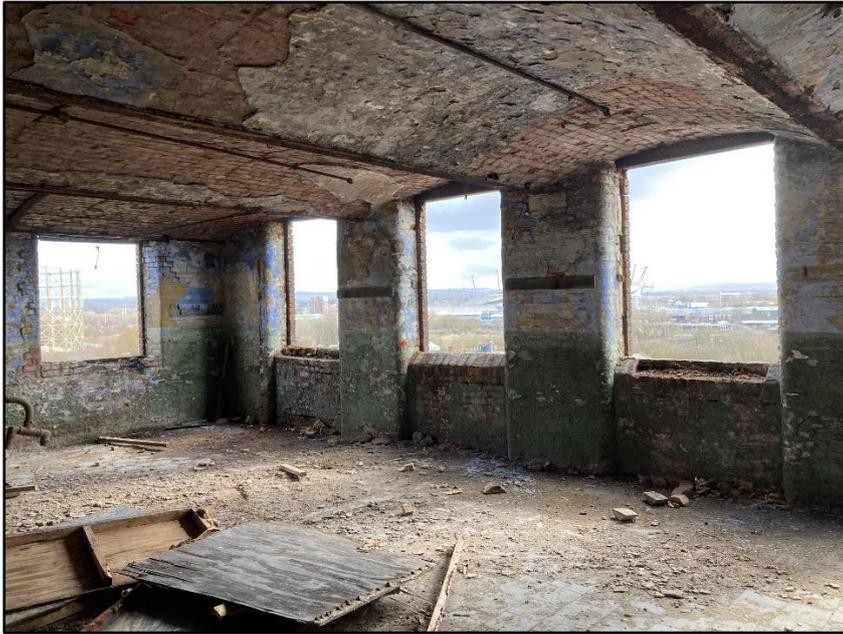
- 3.19 The upper internal spaces are cold, draughty and damp due to the missing window sections (see Photograph 22). Flaking render and cracks and crevices are abundant offering potential bat roost habitat.

Photograph 22 showing a section of missing windows on the north-east corner of the mill building

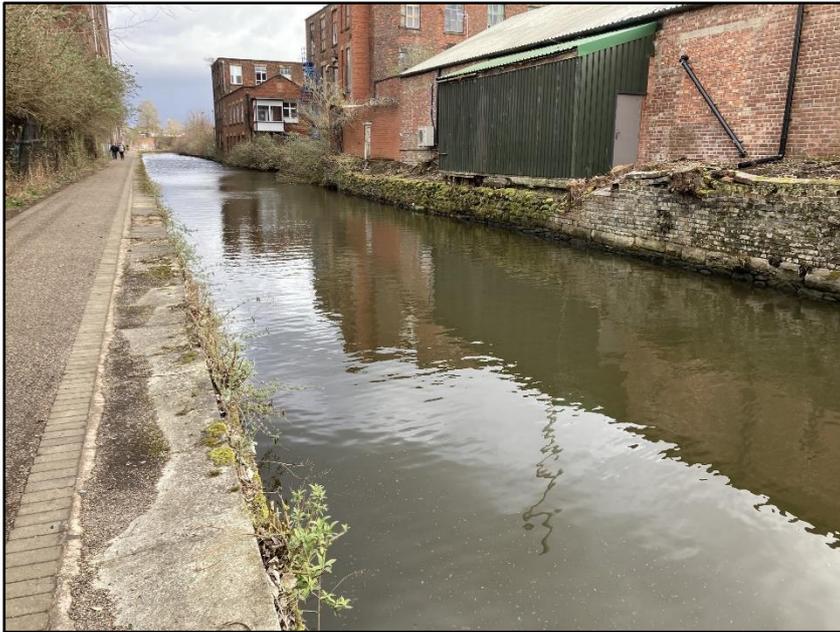
3.26 The Ashton Canal is approximately 12 meters wide with vertical man-made banks (see Photograph 23). The 'site side' bank consists of a busy, hard standing towpath. The water quality is deemed to be poor with no aquatic or marginal vegetation present. No evidence of Water Vole was found along either bank of the canal.

Photograph 23 showing a stretch of the Ashton Canal adjacent to the site

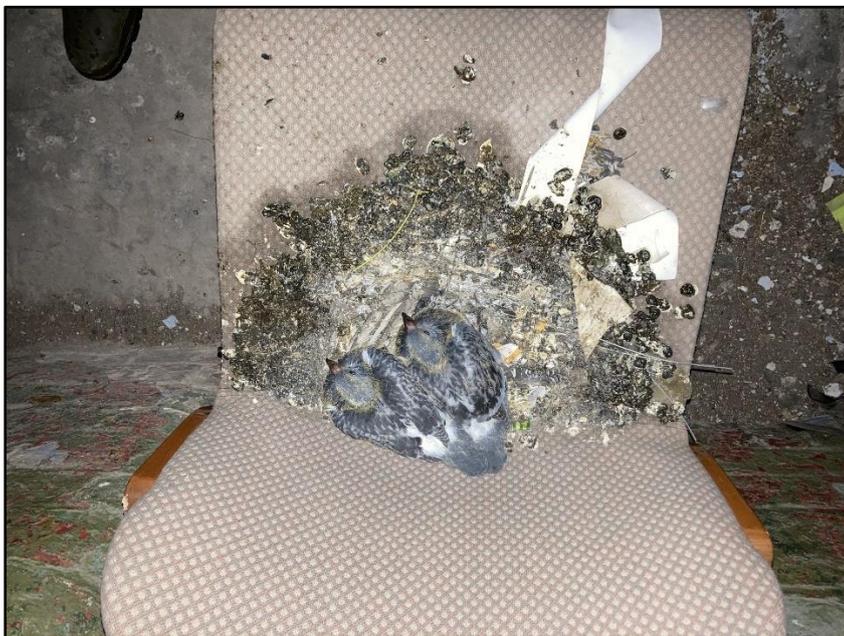
- 3.30 All bird species are protected at their nest under the Wildlife and Countryside Act 1981. Evidence of nesting Pidgeon was found across all the floors of the mill building (see Photograph 24). The continuous scrub and trees on site offer good bird nesting habitat. Evidence of nesting bird was also found amongst the continuous scrub.

Photograph 24 showing two squabs on a nest

- **Nesting Birds** – It is recommended the conversion/renovation of the mill building and any vegetation clearance works is carried out outside the nesting bird season (generally March – August). If the conversion/clearance work needs to be carried out within the bird nesting season, then a nesting bird survey will be required immediately prior to work commencing.

- **Bird Nest Boxes** – Bird nest boxes are to be erected on the external walls of the mill building and newly constructed buildings. This is to mitigate for the loss of nesting habitat on site. This can be secured by way of a suitably worded condition on the full planning permission.

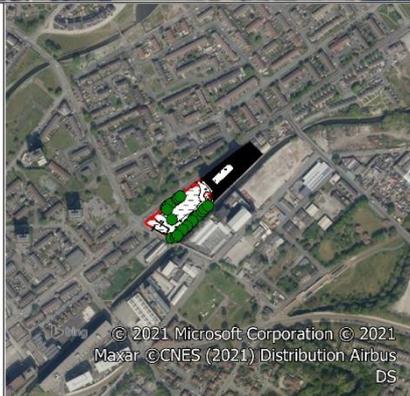
PHASE 1 HABITAT MAP

- 3.1 The Phase 1 Habitat Map can be found at the back of the report. The habitats on the proposed development site are described below.

Building
	Bare Ground
	Continuous Scrub
	Ephemeral/Short Perennial
	Spoil
	Tall, Ruderal Herb
	Fence
	Wall
	Scattered Tree
