Job Title
Brunswick Place

Prepared for
Maryland Securities

Report Type
Technical Feasibility Study

Structural Appraisal

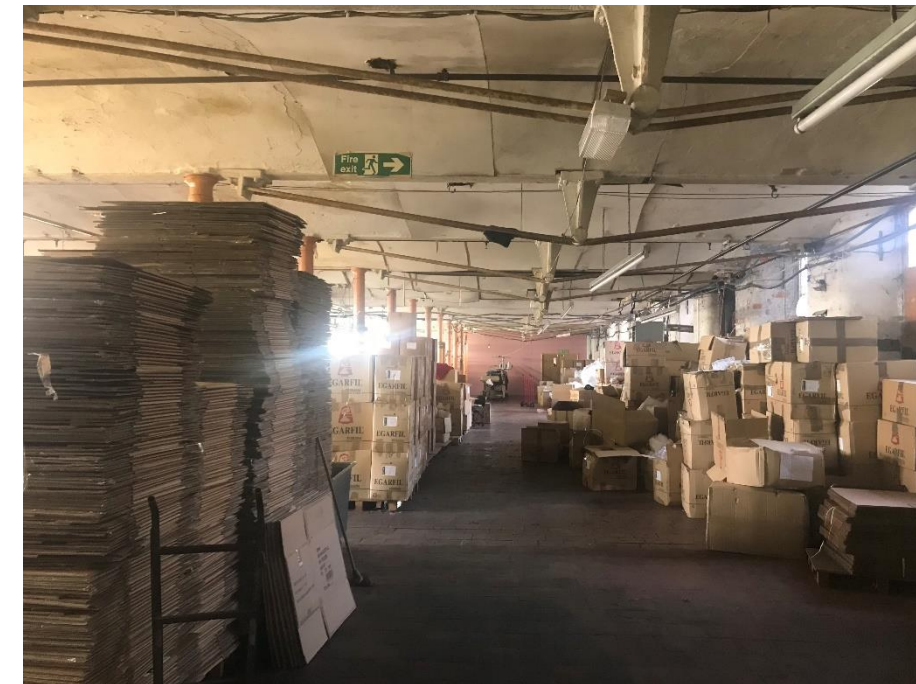
Floor slabs are formed as masonry jack arches spanning between presumed cast iron beams. It would be expected that masonry jack arches are topped with a layer of concrete though this has not yet been confirmed.

Figure 1: Masonry Jack Arch Floor Slabs on Cast Iron Frame

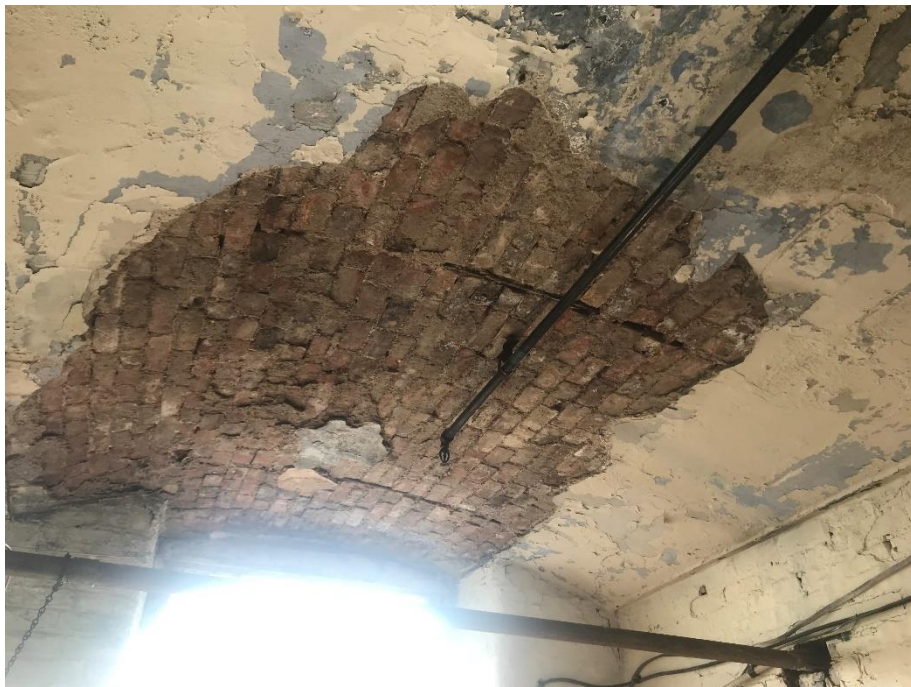
Presumed cast iron beams span between external masonry piers and internal cast iron columns. In the seven storeys south, eastern wing (fronting the Ashton Canal) there are two internal rows of cast iron columns whereas in the remaining three wings there is a single row of internal columns. Thrust tie bars are evident within the depth of the jack-arch floor between cast iron beams to counteract thrust forces induced by arch action of the floors.

Figure 2: Thrust Tie Bars in Masonry Jack Arch

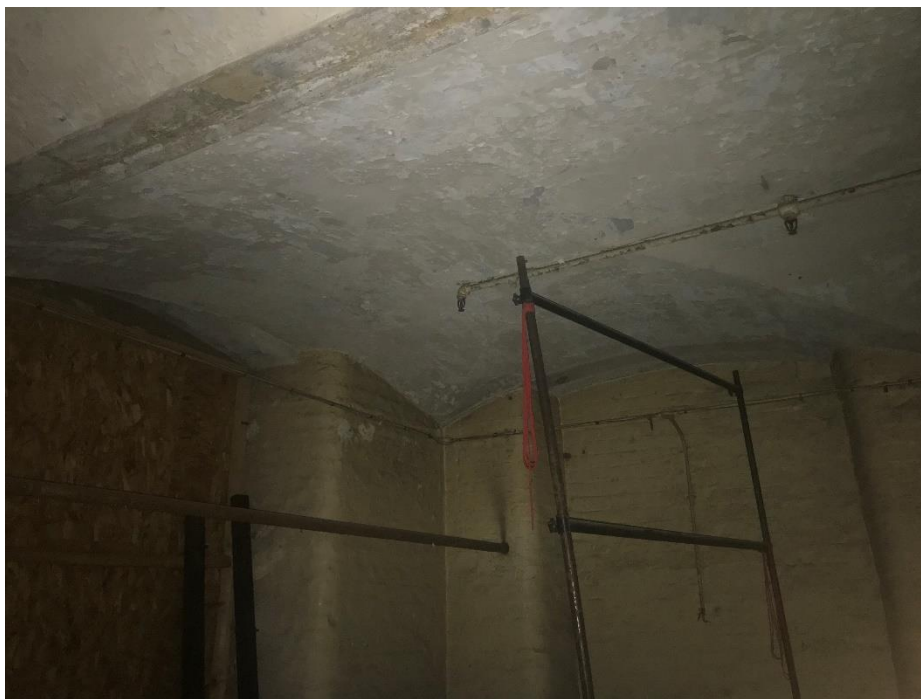
Within the south facing short wing, in the outer bays (fronting Bradford Road) of jack arches are reversed perpendicular to avoid thrust forces in masonry walls and piers. In the corner bays floors are cast in a squinch type arrangement. Refer to Figure 3.

Figure 3: Squinch Corner Slab

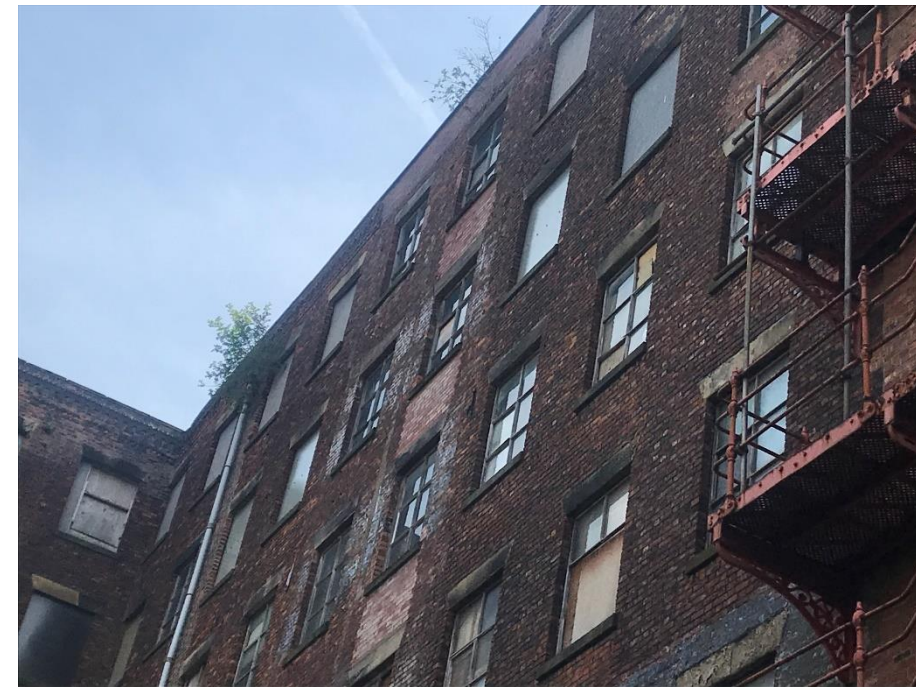
External masonry walls and piers are most likely to be solid owing to the era of construction though this should be confirmed via intrusive investigations during detailed design.

Figure 4: External Solid Masonry Walls

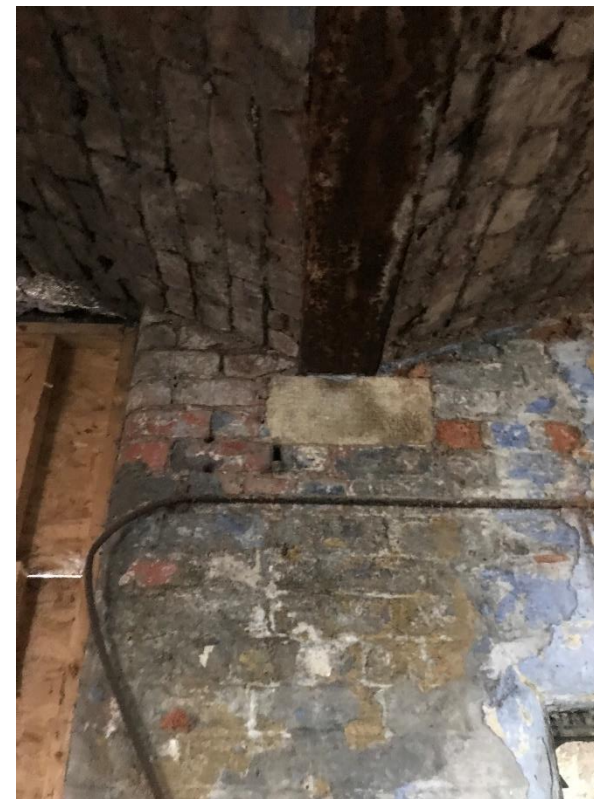
Masonry piers are 1200mm wide x 385mm deep and are evenly spaced to support structural beams. Structural beams are supported on masonry piers via concrete padstones as shown in the figure below.

Figure 5: Padstone supporting structural beam.

Existing stresses in the masonry piers due to the permanent loads associated with the current structural arrangement were calculated to be in the region of 1.1N/mm². This is based on assumption of padstone width which would need to be confirmed during detailed design.

The existing stresses were compared with stresses due the above assumed loads (6.1.4) as part of the mill conversion. The results of this analysis show an approximate stress in brickwork of 1.58N/mm² which equates to a percentage increase of 42%. Although this increase is large the magnitude of stress is still within limits which would be deemed

acceptable for masonry. However, this would need to be verified through material testing of the masonry to understand the true strength of the material.
