# Interim Bat Survey Report

# Preliminary Roost Assessment (PRA)

10 Tower Street

Date: April 2021

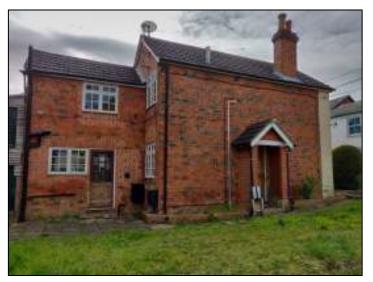
**Building B1:** The existing dwelling is a two-storey detached brick building, with a pitched interlocking tiled roof (**Photo 4.1**). The building extends out to the east. A small open porch extension and chimney are present on the north-western aspect of the property. The main roof tiles are in a good state of repair and appear to be well sealed, with the exception of one piece of missing mortar on the north-eastern corner of the roof.

Photo 4.1: Building B1, facing south-west.

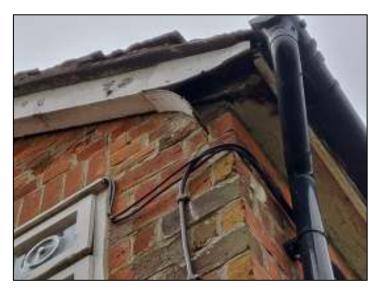
Wooden soffits are present on the northern and southern aspects of the building. A gap is present in the corner of the soffit on the lower section of the roof where the lead flashing is raised, and this may provide a suitable crevice for roosting bats. In addition, there is a gap present on the northern corner of the roof (**Photo 4.2**), where the wooden soffit has rotted away, which offers suitable roosting habitat for bats and potential access into the internal roof space.

Photo 4.2: Building B1, rotten soffit on the northern corner of the building.

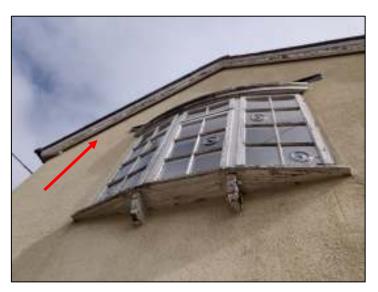
The south-western gable end of the property offers limited roosting habitat for bats, however there are some gaps present beneath the wooden fascia board and rendered wall (**Photo 4.3**). These are generally shallow in depth but may offer some opportunities for crevice seeking bats.

Photo 4.3: Building B1, gaps beneath the fascia on the south-western gable end (red arrow).

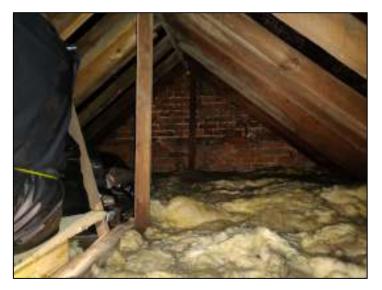
Internally, Building B1 has a small roof void (c. 0.5m in height) and is lined behind the rafters with bitumastic felt (**Photo 4.4**). Rockwool insulation is present at ceiling level and has been packed around the eaves. There is a water tank above the loft hatch and a central wooden ridge beam is present. There is no visible access at the eaves however gaps were noted around the northern end of the roof void, allowing visible daylight to spill in. The brickwork on the internal gable walls is well sealed and does not offer any suitable features for roosting bats.

Photo 4.4: Internal loft space in Building B1.

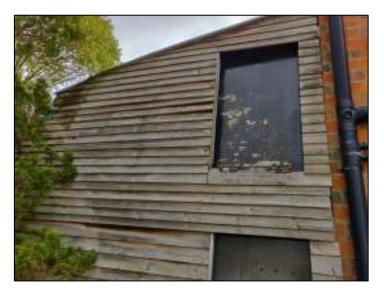
**Building B2:** A small lean-to extension adjoins the main dwelling to the east. The extension is of timber construction with a sloping corrugated metal roof (**Photo 4.5**). The lower level of this building is currently being used as a garage / storage space. There are multiple gaps beneath the timber slats on both the northern and southern aspects of the lean-to which offer suitable roosting habitat for bats and direct access into the internals of the building (**Photo 4.6**).

Photo 4.5: Building B2, facing east.

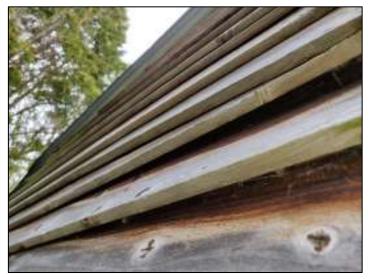
Gaps are also present in the corrugated roof to the east and south, particularly where the lean-to extension meets the brickwork of the existing dwelling. A door is present on the upper level of the extension to the north and there are also gaps around the door frame which offer direct access into the internals.

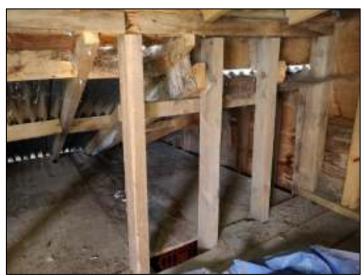
Internally, the lower level of the extension is cluttered, and a high number of cobwebs were noted. The roof space of the upper level is c. 1.5m in height at its highest point and this gradually slopes down towards the east (**Photo 4.7**). The upper level is boarded and there is no insulation or liner present. Historic nesting bird material was found in the corner of the roof; however no bats / evidence of bats was found. There are multiple access points into the internals via the corrugated roof and gaps around the door frame to the north.
