Sevenoaks Wildlife Reserve

Bat Presence/Likely Absence Survey Report

Client	Kent Wildlife Trust
Site/Job	Sevenoaks Wildlife Reserve, Bradbourne Vale Road, Sevenoaks, TN13 3DH
Central Grid Reference	TQ 51941 56691
Report Title	Bat Survey Report
Report reference	ECOSERV003

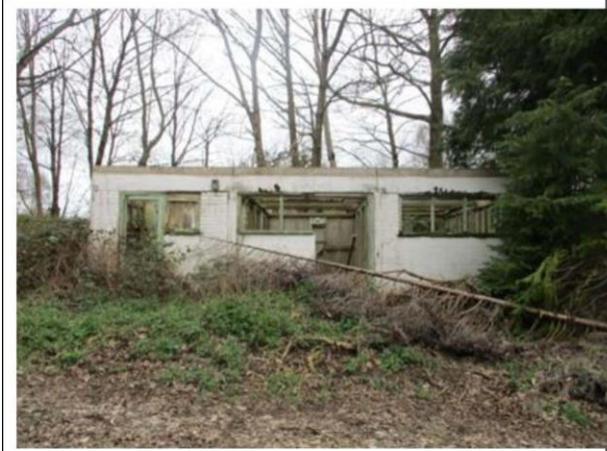
B1 – Derelict brick and concrete structure without roof, windows and doors

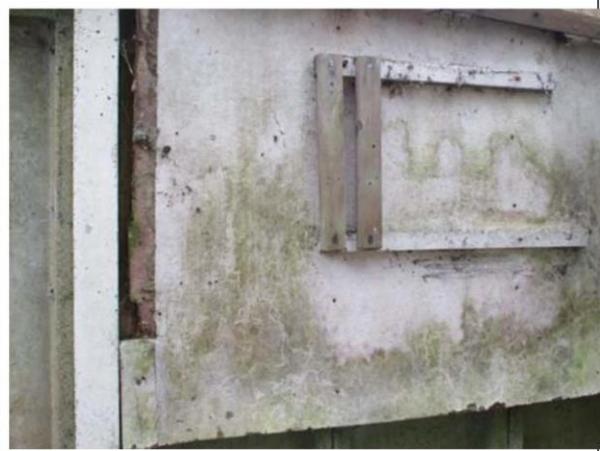
B1 – Plywood attached to concrete walls

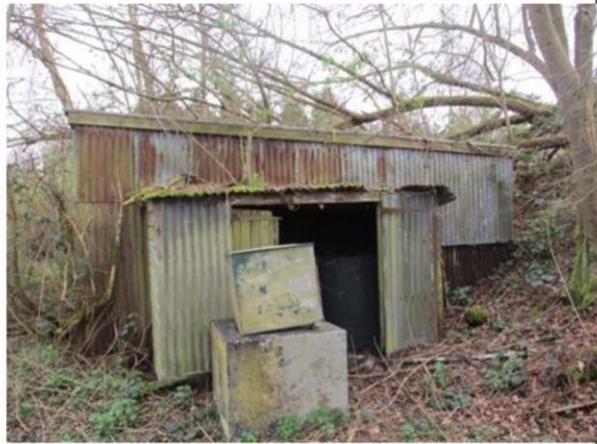
B2 - Timber framed outbuilding with corrugated metal roof and walls with open-sided extension

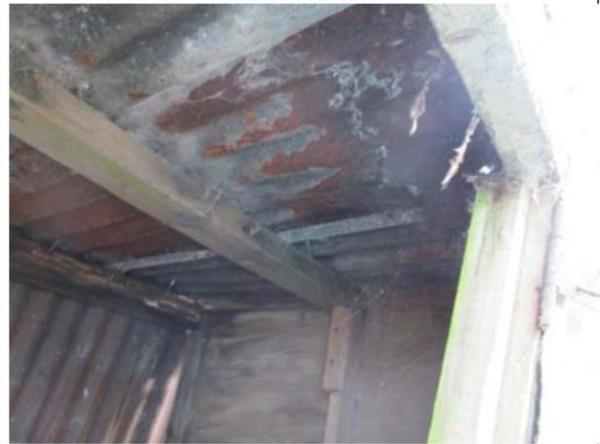
B2 - open-sided extension showing timber beams

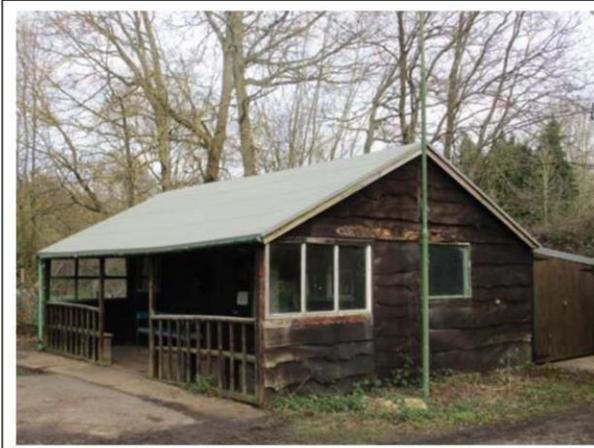
B3 – Single storey building with weatherboard cladding

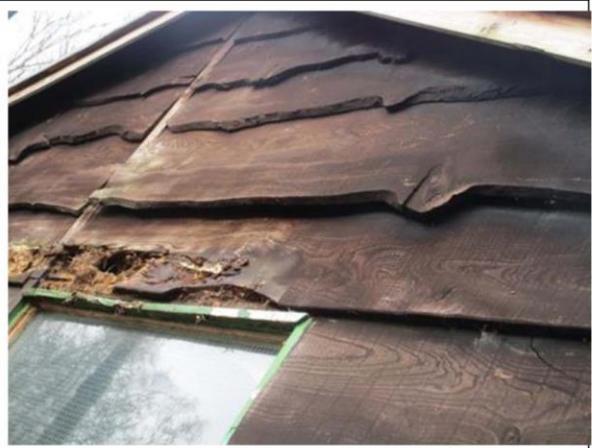
During the first dusk emergence survey, the first record was of one Nathusius' pipistrelle which was observed emerging from beneath lifted timber cladding on the western elevation at 19 minutes after sunset – the expected range for emergence of this species is 11-50 minutes after sunset (Andrews & Pearson, 2016). No bats were observed emerging from or entering B3 during the second survey; on inspection after the second survey, bird nesting material was noted within the roost feature. The first recording of a bat during the second survey was of *Myotis* at 21.11, two minutes after sunset. *Myotis* emergence times range from 25 minutes before to 1.5 hours after sunset (Andrews & Pearson, 2016) – the time of emergence could indicate that a *Myotis* roost is located nearby.

B3 - Gaps behind timbers on western elevation

B3 – Prior to works on the building, an endoscope check of the feature on the western elevation will be undertaken, followed by the fitting of a one-way bat exclusion device. This will remain in place for a minimum of five consecutive nights in suitable weather conditions. An endoscope will then be used to check the feature again. During renovation works, the timbers on the western elevation will need to be removed by hand under Ecological Watching Brief with a licensed bat worker or accredited agent present in case bats are found. Any bats found will be removed by hand and placed in a suitable bat box installed on a nearby tree. Once the timbers have been removed, the renovation of the remainder of the building can proceed without supervision.

B3 – The roosting requirements of Nathusius’ pipistrelle are not well understood and it is therefore recommended that the existing feature is re-instated post-renovation of the building by installing artificially ‘lifted’ timbers at the same height, location and elevation. It is recommended that, where appropriate, undamaged timbers from the existing feature are used during the re-instatement of the roost.

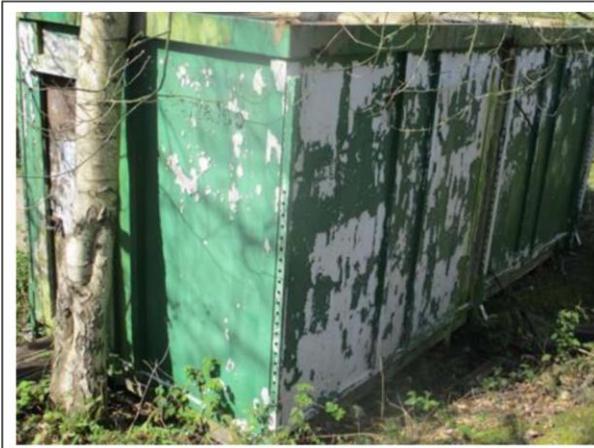
Building B4 comprises two adjoined metal containers previously used as public conveniences. The containers were locked and not accessible for an internal inspection. There were no access features or evidence of bats noted and the building materials are unlikely to be suitable for roosting bats due to lack of crevices or hanging places and thermal instability. The results of the PRA are therefore considered reliable.

B4 - Metal container structures

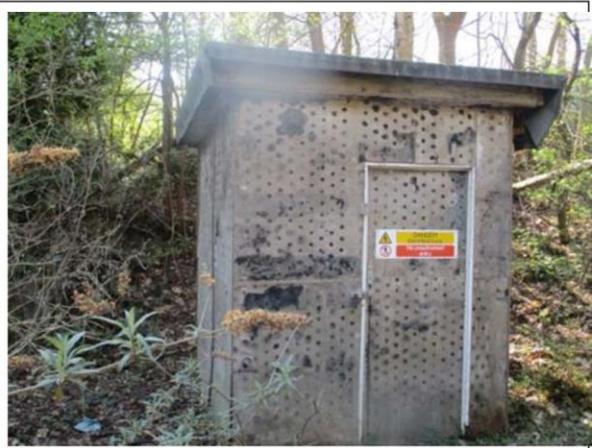
B5 - Timber structure showing overhanging felt

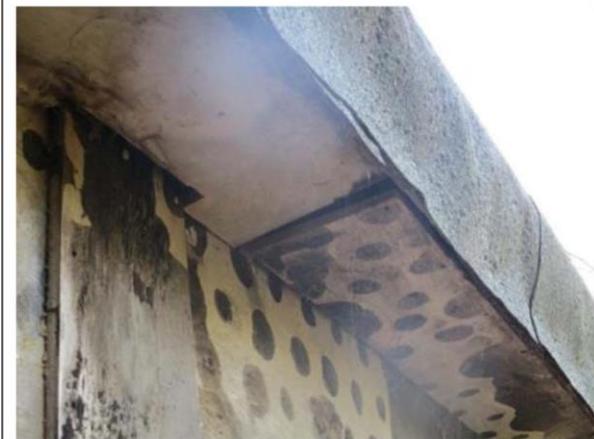
B5 - Crevice in timber soffit box

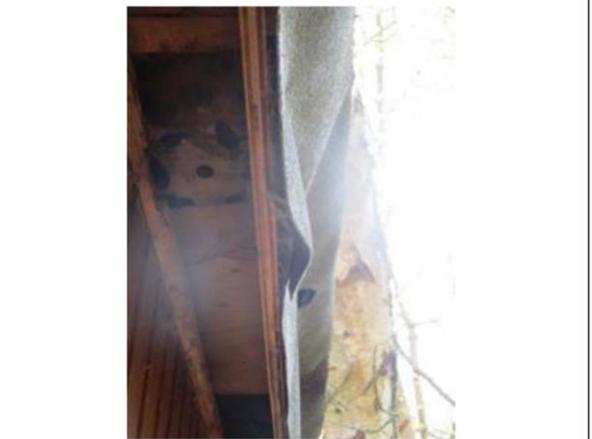
B5 - Lifted roofing felt on western elevation

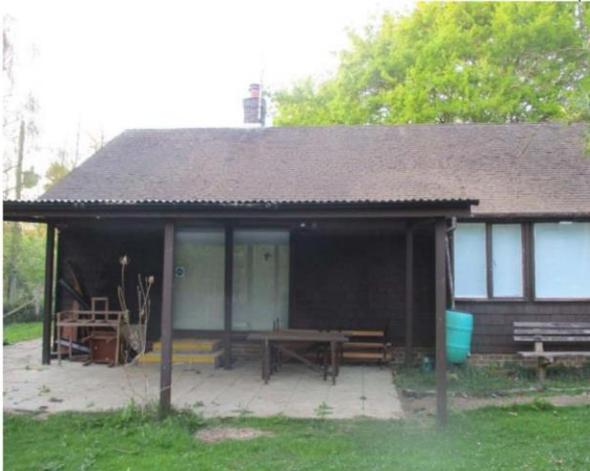
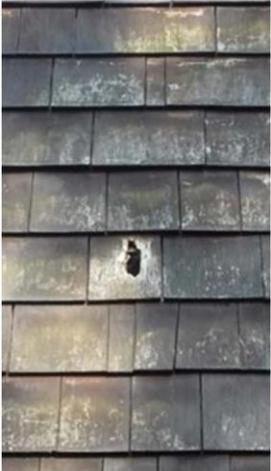
<p>B6 Brick built structure with wooden tile clad walls</p>	<p>B6 Hole in tile on western elevation at c. 2.5m height.</p>

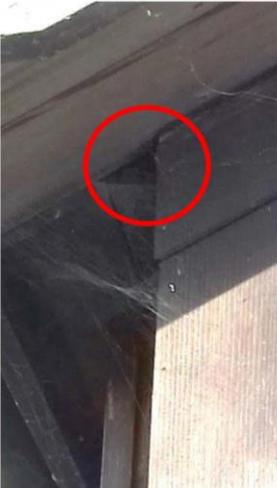
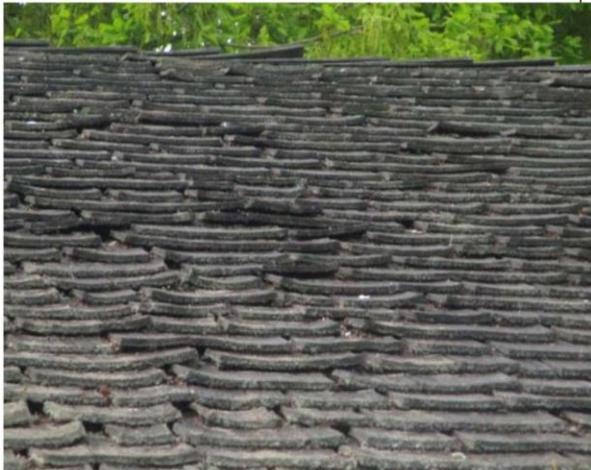
<p>B6 Hole at the end of the timber soffit on north-western corner of building</p>	<p>B6 Lifted roof and ridge tiles on southern elevation</p>

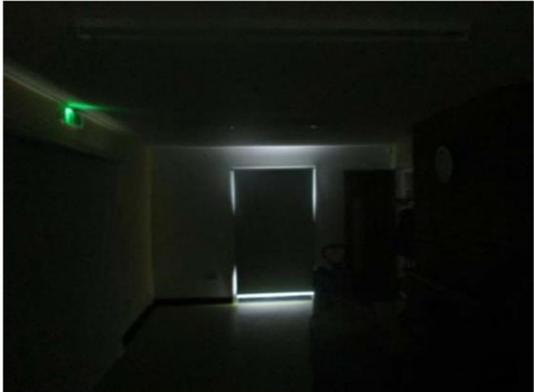
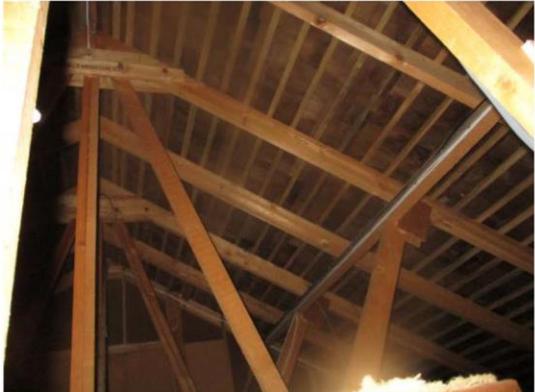
<p>B6 – Dark classroom interior</p>	<p>B6 – Trussed roof showing underside of wooden roof tiles</p>

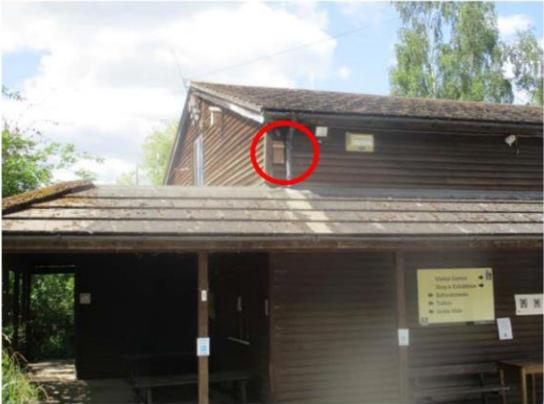
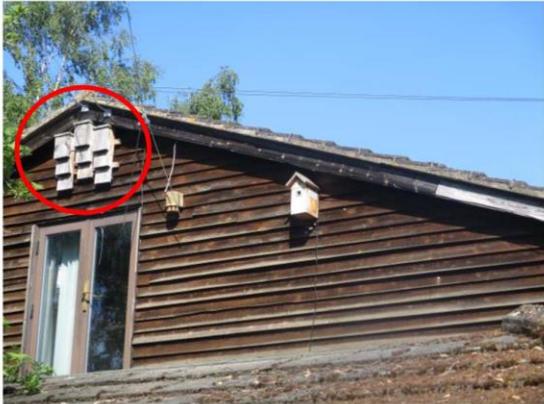
<p>B8 – Southern and eastern elevation – bat box on SE corner where pipistrelle roost was recorded</p>	<p>B8 – Bat boxes on southern elevation where pipistrelle bat roost was recorded</p>

B8 – The boxes are potentially used all year round. There was no evidence of a maternity roost, and as such it is recommended that the removal and relocation of bat boxes can be carried out during the period May-October, avoiding the hibernation period. Should a maternity roost be identified during the pre-works check detailed below then works to remove the relevant box will be delayed until September/October.

western elevations. If bats are found, the entrance of the relevant box/es will be soft-stopped while the box is removed and securely placed within a nearby tree to allow the bat to emerge during the evening. Once empty, the box/es will be stored in a dry place until they can be re-positioned in the original location on completion of works – new boxes will be provided to replace any that have deteriorated beyond suitability for use by bats.

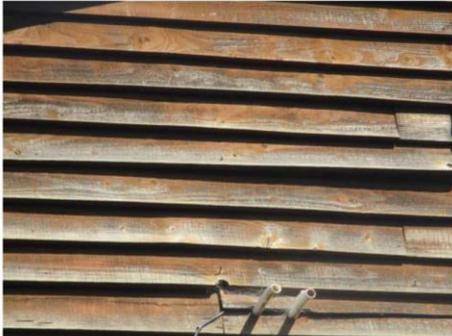
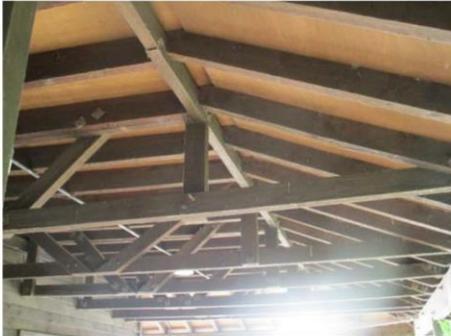
<p>B8 – Lifted timbers typical of southern and western elevations</p>	<p>B8 – Trussed roof of porch on southern and eastern elevation</p>

There are numerous suitable features beneath lifted timbers on the southern and western elevations of B8 and it is recommended that these are removed under the supervision of a licensed bat worker or accredited agent. To avoid the risk of disturbing hibernating bats it is recommended that the removal of these timbers, and also the roof tiles, is not carried out during the winter months; if this is not feasible then works may start but if bats are found then all works would need to stop until March/April.

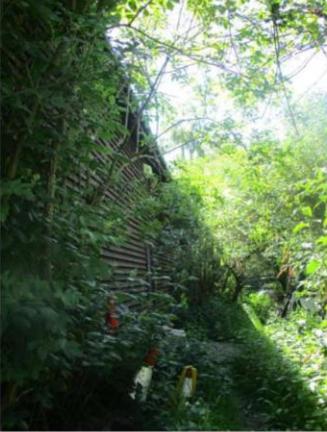
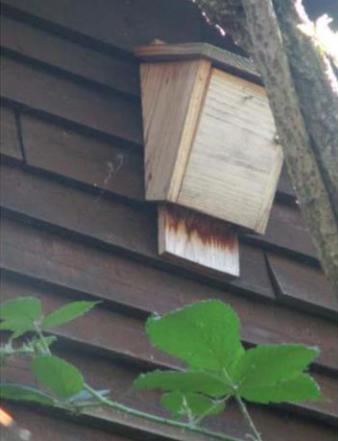
<p>B8 – Western elevation with dense elder growth</p>	<p>B8 – Bat box on western elevation together with lifted timbers</p>

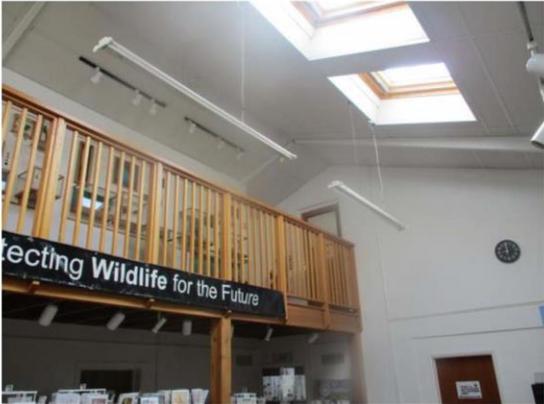
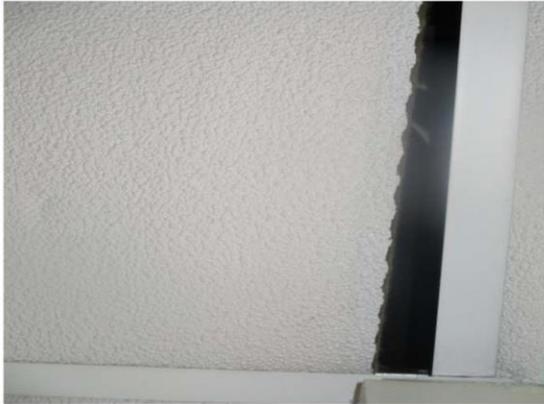
<p>B8 – Interior showing sky lights and vaulted ceiling</p>	<p>B8 – Damaged ceiling tiles with potential access from space beneath roof tiles</p>

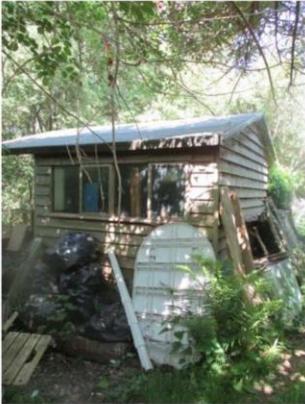
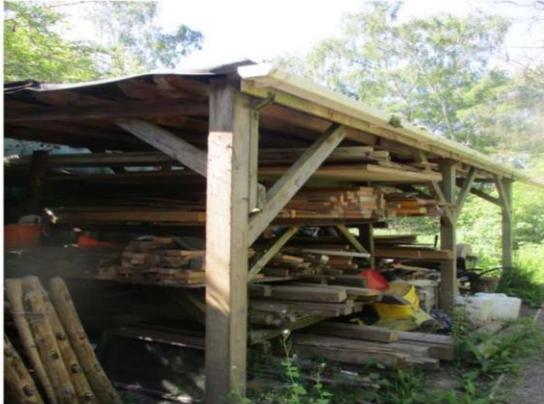
<p>B8 Outbuilding – small shed adjacent to western elevation</p>	<p>B8 Outbuilding – woodstore adjacent to northern elevation</p>

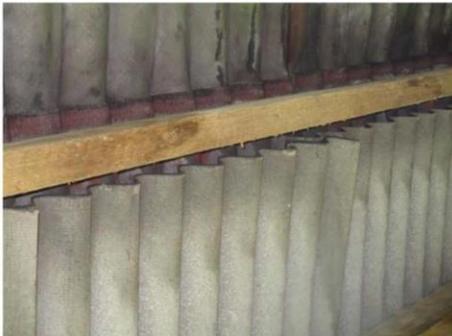
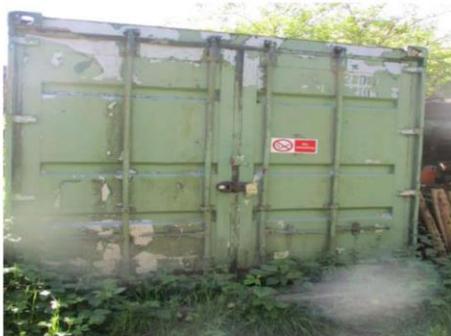
<p>Woodstore – double skin roof of corrugated rubber sheeting</p>	<p>B8 Outbuilding – Containers adjacent to the northern elevation</p>

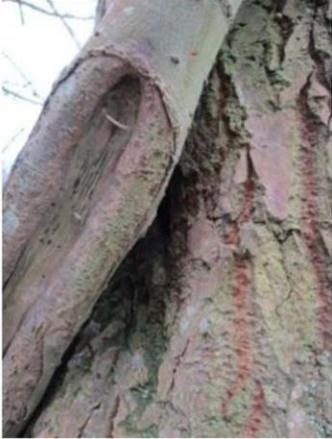
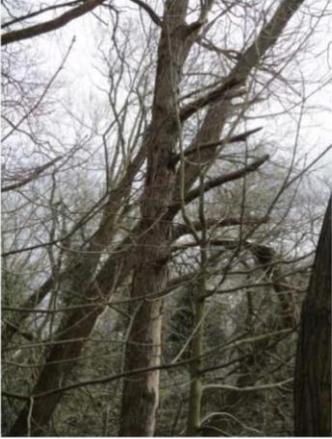
<p>T4 – Crevices between adjacent stems at low height. Low potential.</p>	<p>T10 – Standing dead wood on eastern shoreline of West lake. Hollow with holes on NW elevation. Moderate bat potential.</p>

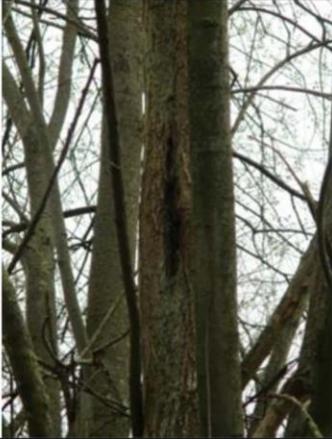
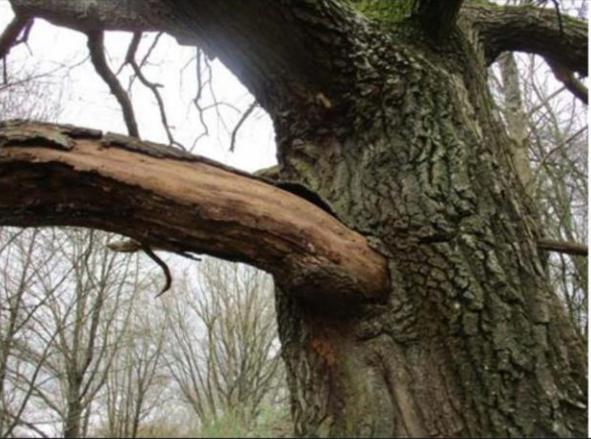
<p>T13 - Feature at 4m on southern elevation with Low potential.</p>	<p>T14 - Mature oak showing example of lifted bark. Low potential.</p>

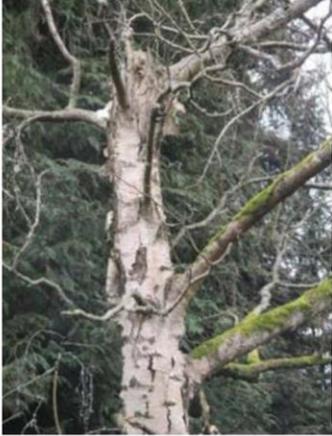
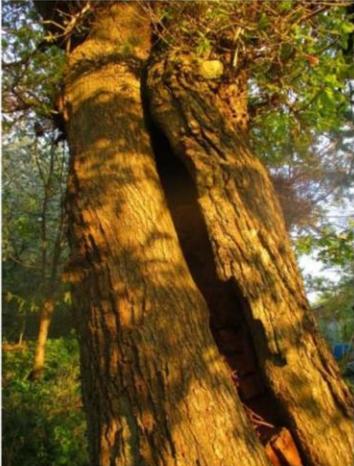
<p>T17 - Decaying potentially hollow silver birch with numerous features. Moderate potential.</p>	<p>T27- showing lightning strike on western aspect</p>
