## **Tree Survey and Arboricultural Constraints**

### **MINERVA STREET, GLASGOW**

### **AMBASSADOR HOMES**

18 May 2021

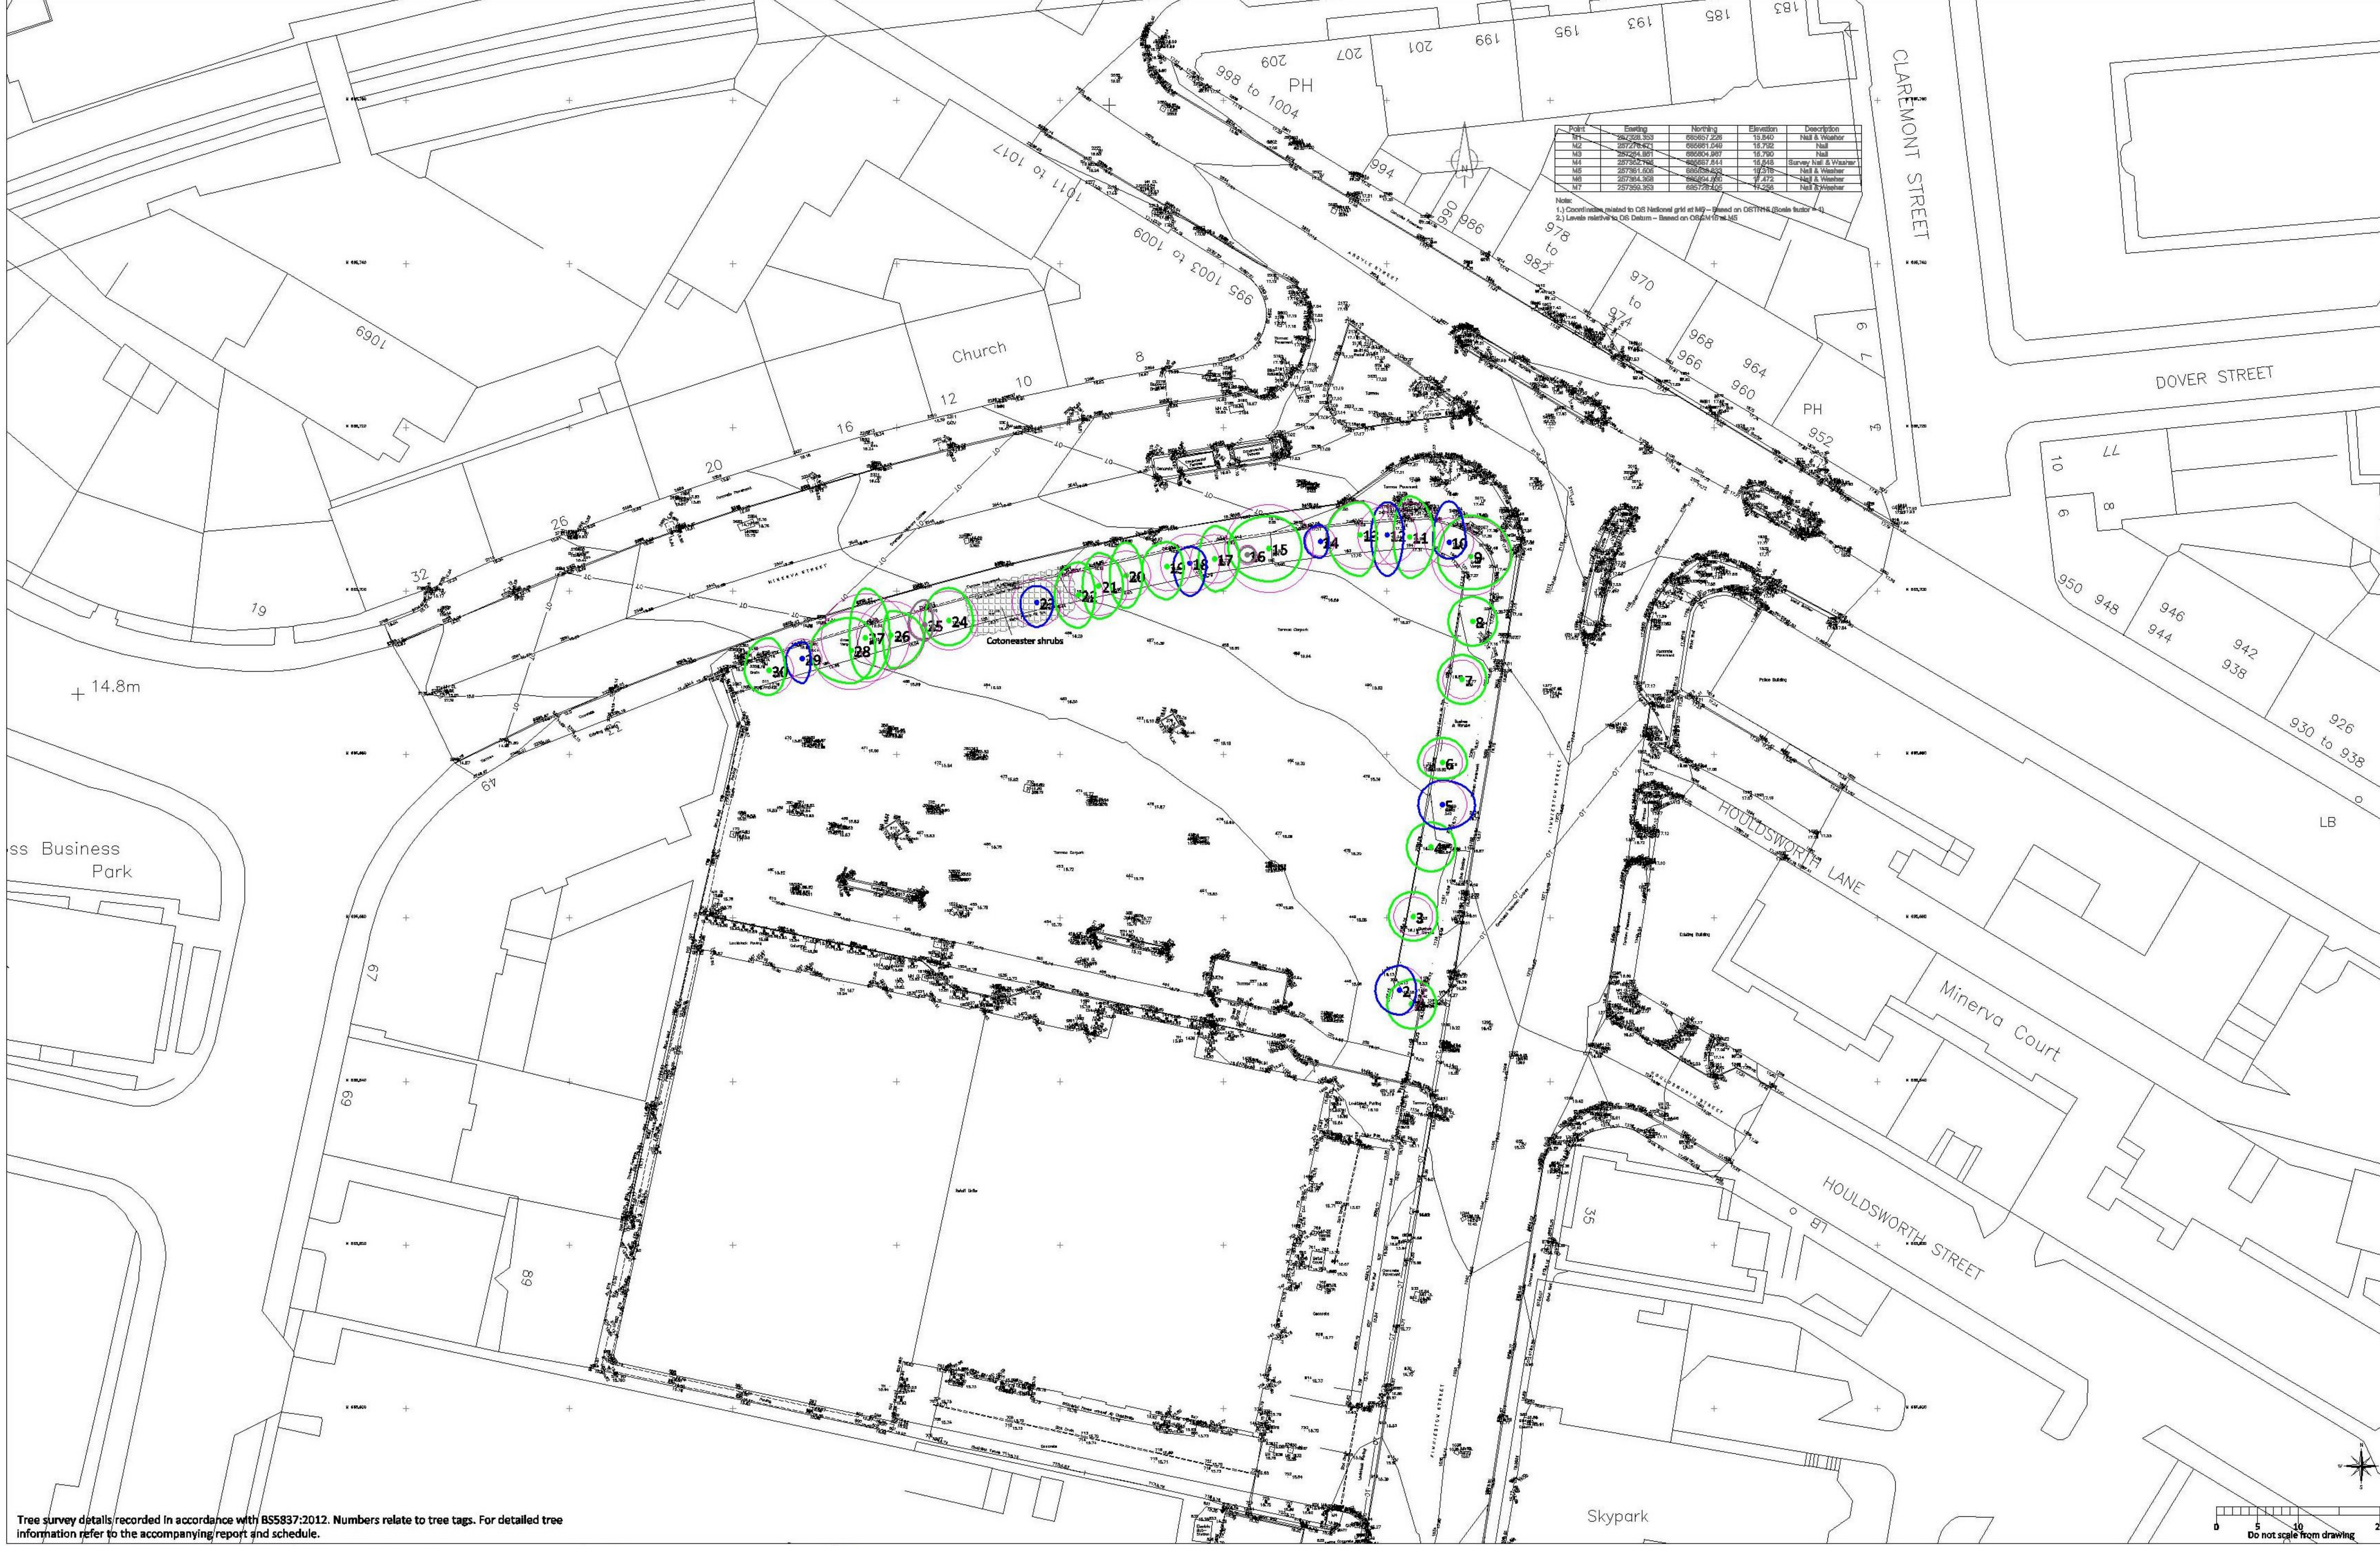
DRAWING No: TS-01

5.1. A visual assessment has been carried out from the ground level of 30 trees within and immediately adjacent to the site. The location of the trees is plotted on the attached Tree Survey plan, and their condition and any recommended remedial works are recorded in detail in Table 2 - Tree Survey Schedule. This records relevant details in accordance with the recommendations contained in BS 5837:2012, and includes:

5.3. The trees are not tagged (those on Finnieston Steet were inaccessible due to shrub undergrowth) They are numbered 1-30, running from the car park entrance off Finnieston Steet, to the end of the site on Minerva Street.

DRAWING TITLE: Tree Survey as existing
