Pumpkin Cottage,  
6 St Andrew's Lane, Headington, Oxford

Heritage Statement for the  
installation of CCTV cameras

Dr Kathryn Davies  
BA (Hons), MA, DPhil, Dip TP, FSA, MRTPI, IHBC

May 2021

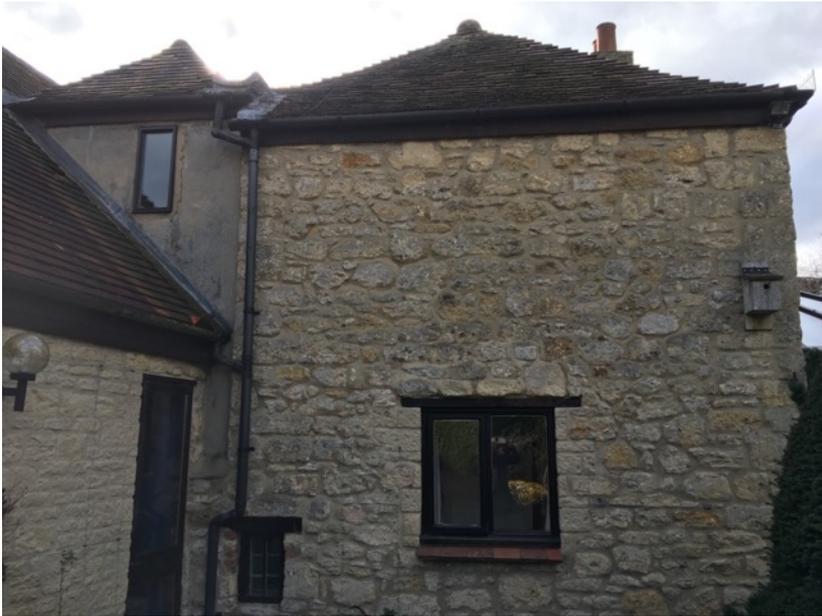
Figure 2. Rear range showing hipped roofs of unequal width

The house is of random stone rubble with dressed quoins and plain tile roofs. It comprises two ranges. The front, south range is of two units and one and a half storeys under a pitched roof with end stacks. The rear range is two storey and roofed in a complex of two historic hipped roofs of unequal width and different construction, see figure 2, and a late twentieth century hipped roof over the west part, formerly a catslide roof. The whole rear range is much narrower than the front range.

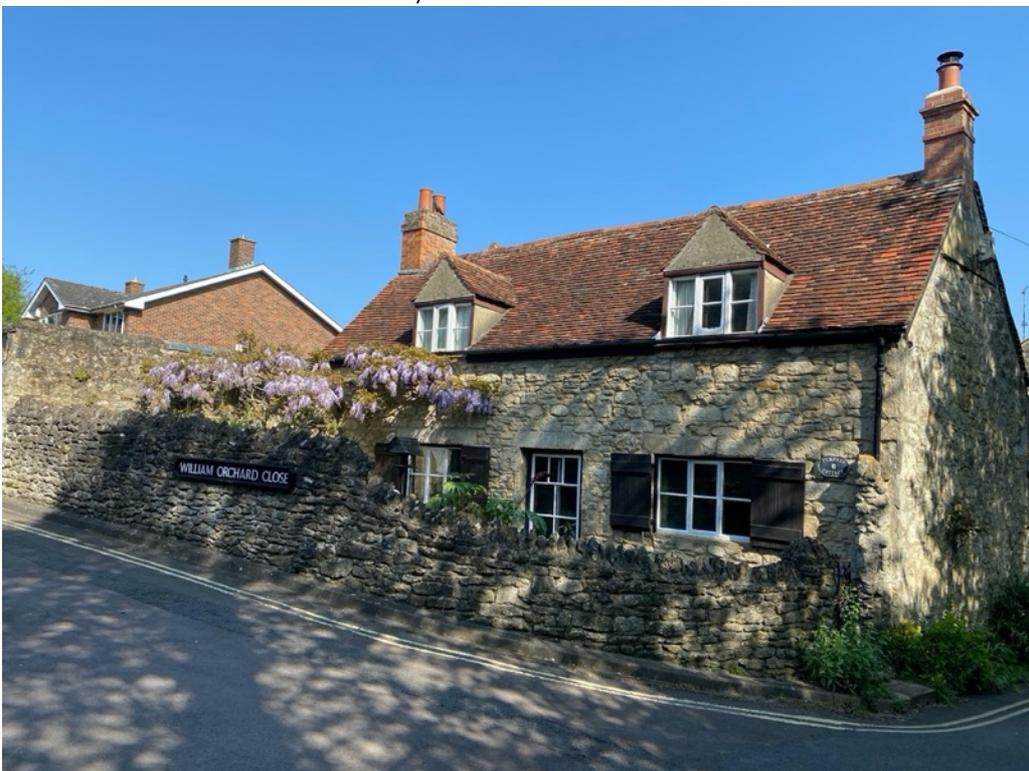
Figure 3. South elevation of front range with central doorway and three light windows and dormers to either side

The south front is almost symmetrical with a central door (now a window) with three-light casements to either side and three-light dormers above, see figure 3. There is evidence of extensive lime washing in the past with some remaining fragments of red ochres, yellow ochres and grey. The west stack has two flues and the east stack has only one. Both are in brick. The west bay of the rear range has one two-light casement at ground floor level, which looks like a twentieth century insertion, and one small leaded light at low level. The east bay of north elevation is obscured by a modern extension.

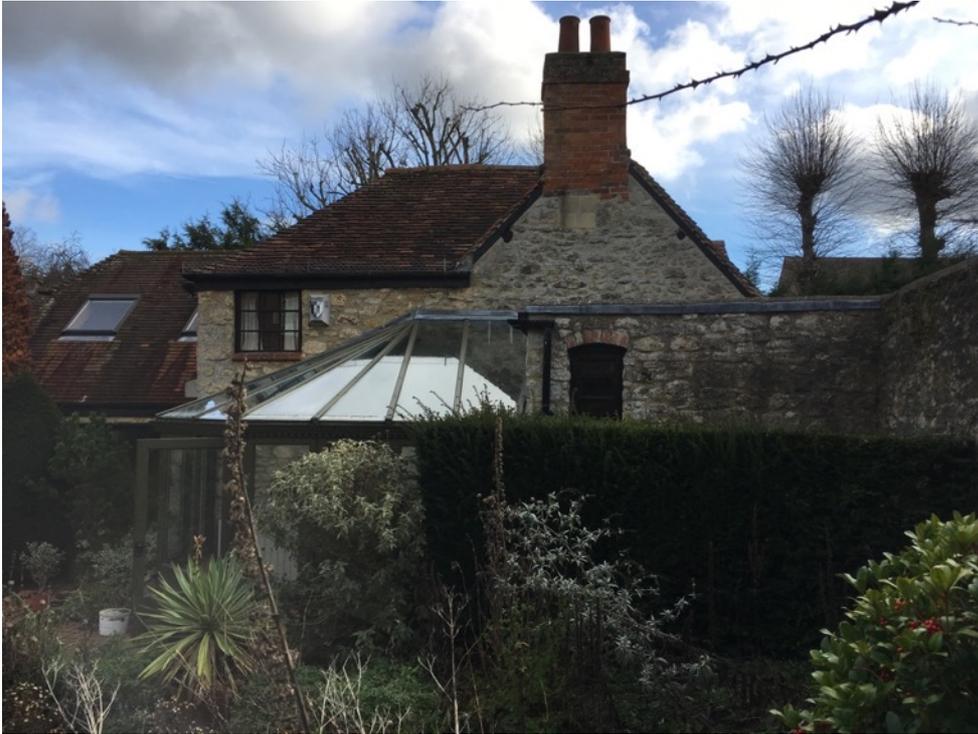
*Figure 4. West elevation partially blocked by garage and conservatory*

The west gable is partially obscured by the garage and conservatory, see figure 4. There is a door from the rear range into the conservatory and a three-light window at first floor level in the rear range. The ends of the purlins on the front range are exposed. Of particular interest is what may be part of a bricked-up window just at the entrance to the garage. It is expressed as recessed stonework, which is either crudely-carved or badly damaged, with the proportions of a window, see figure 5. It is unusual to have a window in a flank elevation. It backs on to where a flue must be although this is likely to be a later insertion.

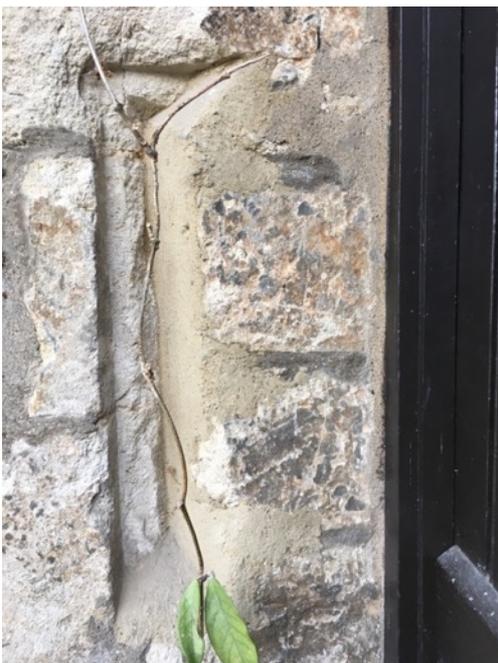
*Figure 5. Blocked up opening in rear range, west elevation*

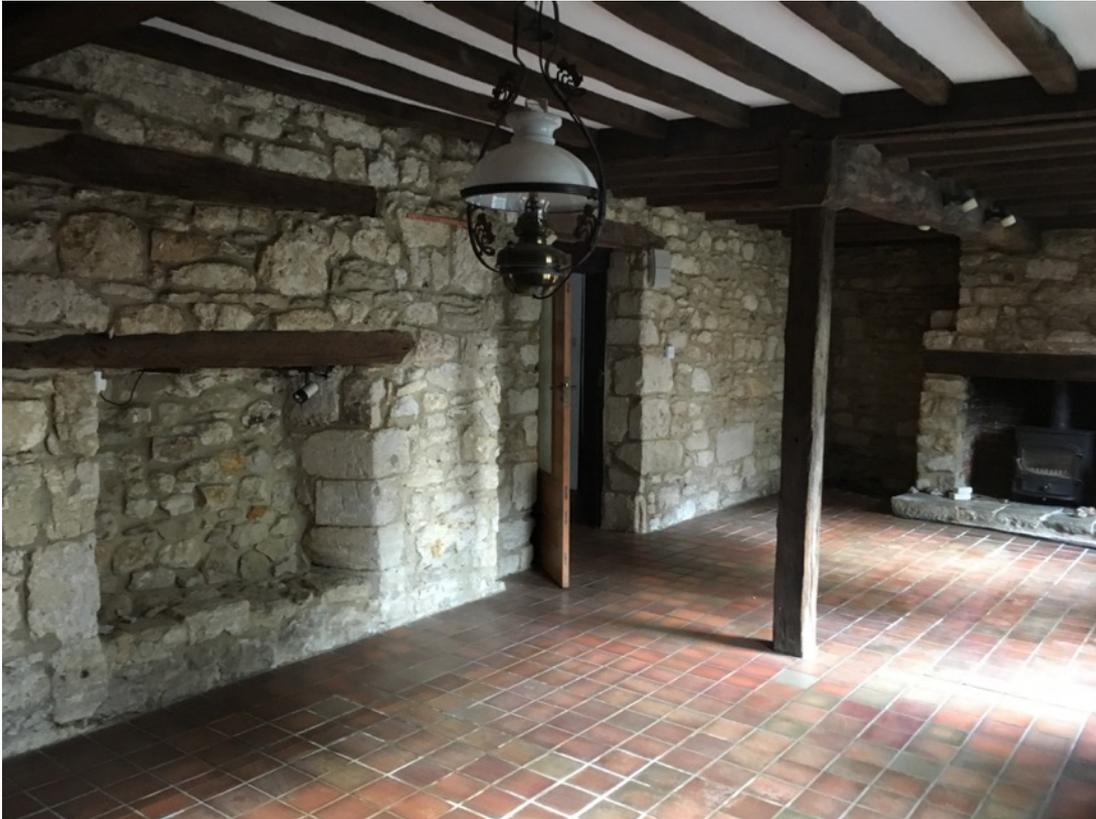
*Figure 6. Ground floor of front range, formerly two rooms, with the site of the original partition marked by the timber post*

The interior of the front range now comprises a single room though this was clearly formerly two rooms, see figure 6. This is indicated on plans dating from the latter half of the twentieth century and it is obvious from the ceiling structure and supporting pillar in the middle of the room. The main entrance was into the east bay which is slightly larger than the west bay. There is a stone-built main stack on the east gable with a chamfered and stopped bressumer. A spine beam, centrally positioned, runs east-west. Although this has suffered some decay, it appears to have a chamfer possibly with stops, though these are barely discernible.

To the north of the blocked stack is an exposed section of stonework. This is probably an internal expression of the blocked window, mentioned above and shown in figure 6.

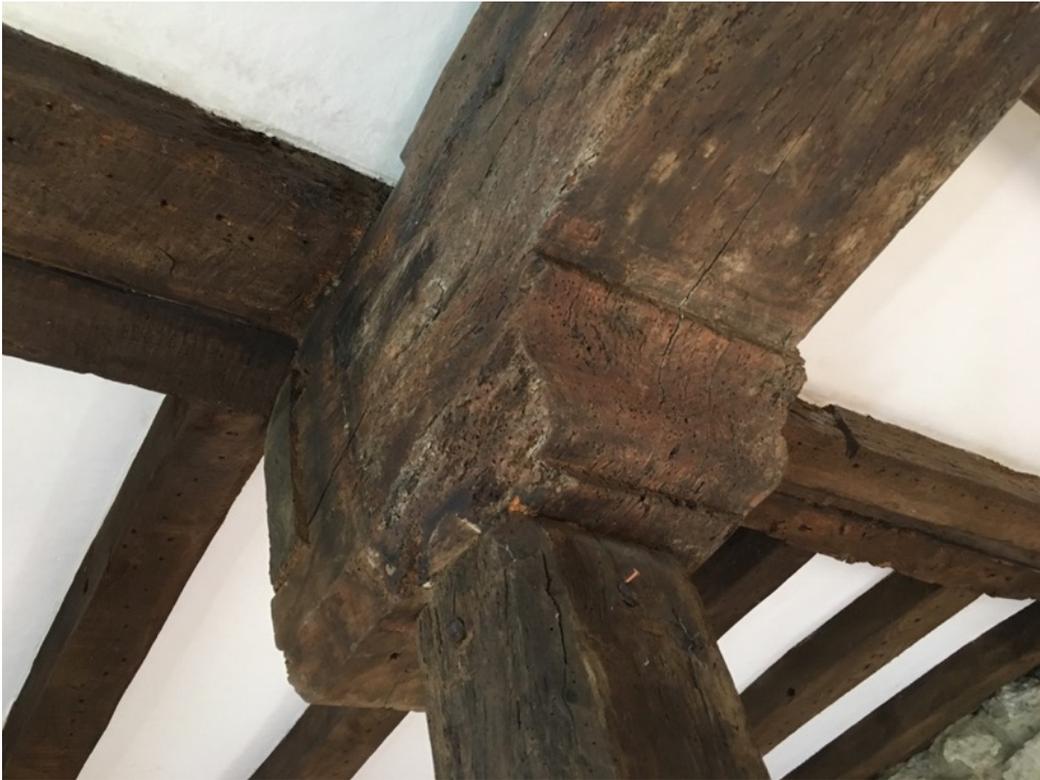
*Figure 7. Spine beam end in east bay showing decorative scroll with traces of red paint*

This spine beam is most unusual. The west end, now supported by the post, is thicker and carved into a scroll-like bracket, clearly demarcating the end of the exposed beam, see figure 7. The beam continues beyond this scroll decoration and appears to be a junction, as beyond this is a cut-out to house another beam. This may not be contemporary. The short section of the beam below the cut-out has a narrow chamfer, typically seventeenth century. The line of a partition can be seen between the scroll and the cut-out. There must have been something structural in this partition to support the beam end, although there is no evidence of this. The beam has remnants of red ochre paint. The joists, running at right angles, are fairly roughly sawn and also have narrow chamfers with run-out stops. These look typically seventeenth century. They look contemporary with the beam as the irregularly shaped joists fit comfortably into their housings. All have nails indicating the ceiling was plastered at some stage. However, it may be that this beam was introduced from elsewhere when the house was renovated in the late twentieth century. This would explain why the detailing at the end of the beam makes no sense in this location.

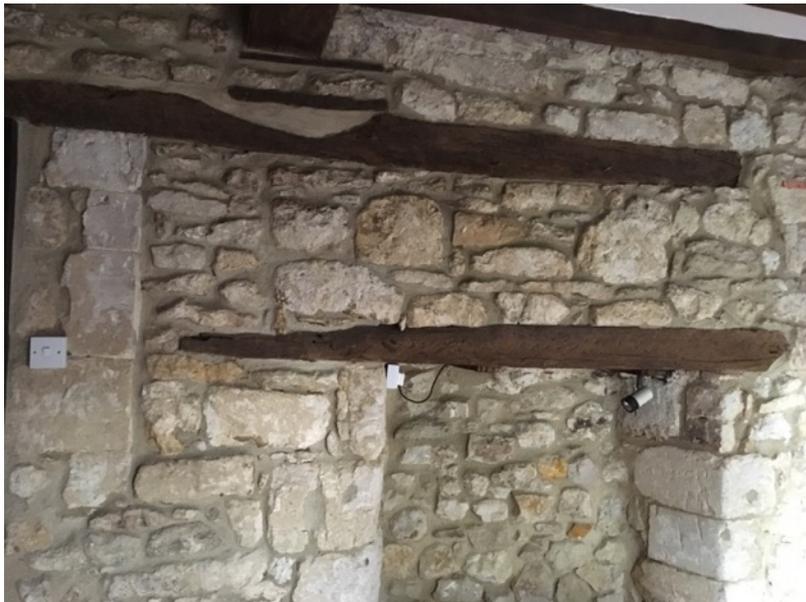
*Figure 8. North wall of west bay showing blocked lateral hearth, straight joint of former wall end or opening and embedded timber lintel*

Of particular interest is the north wall. Here, located towards the east end of the bay, there is a lateral hearth, with the flue now blocked, see figure 8. This makes no sense with the current configuration of the floor plan. The hearth appears to have had a chamfered stone surround, although the upper stones do not match the lower ones. The chamfered ones however do not appear to be reused. They relate to each other and all have extensive layers of lime wash, some with evidence of black paint. This black paint also extends onto the adjacent wall. Whether this is a plain wash or part of a decorative scheme is not possible to determine because it is so fragmentary. The flue, now blocked, has soot deposits. The timber lintel over the opening has no decoration and is hacked to take a plaster finish. It is possible that the upper stones of the fire surround and this timber lintel constitute a late twentieth-century repair to the hearth.

Also of considerable interest on this wall, to the west of the hearth, is a straight joint formed with dressed stone quoins indicating what was formerly the end of a wall or an opening, see figure 8. Above this a rough, plain, embedded timber spans from the door opening across the straight joint and over the hearth. Two small sections of timber are also in the wall below the spine beam. These have no obvious function and may also relate to late twentieth-century repairs.

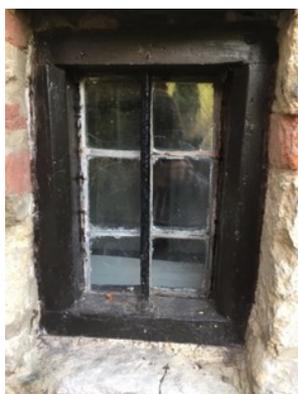
*Figure 9. Small single leaded light window on north wall of rear range*

The rear range is also of several builds and has been altered in the late twentieth century. Of historic interest is the stub of wall projecting into the west bay. It is of the same thickness as the external walls and may represent an earlier external wall or a cross wall, though there would be no need to have a cross wall this thick. It does not relate to any feature in the front range. Adjacent to this, to the rear of the lateral hearth, but not exactly mirroring its position, is a timber embedded in the wall, with no obvious function. There is a small, single leaded light window set in a chunky pegged frame on the rear elevation and evidence of a blocked-up window on the stairs, see figure 9.

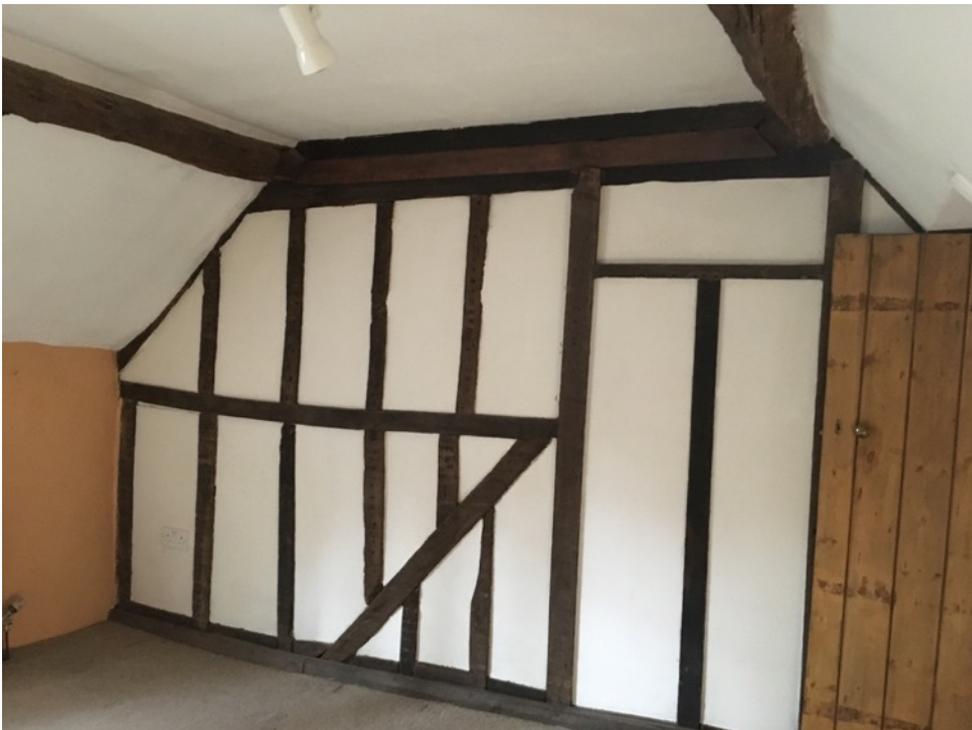
Figure 10. Timber-framed partition between the first floor bedrooms in the front range, showing the blocked up opening between the two

The two front range bedrooms are divided by a timber-framed cross wall with evidence of an opening between the two, see figure 10. Purlins are partially exposed and appear to be trenched into the tie beam. The main stone stack projects into the east bay and a brick stack with small fireplace survives in the west bay. This room is about 6 inches narrower than the east room. None of the timbers appears to have ever been exposed to weathering.

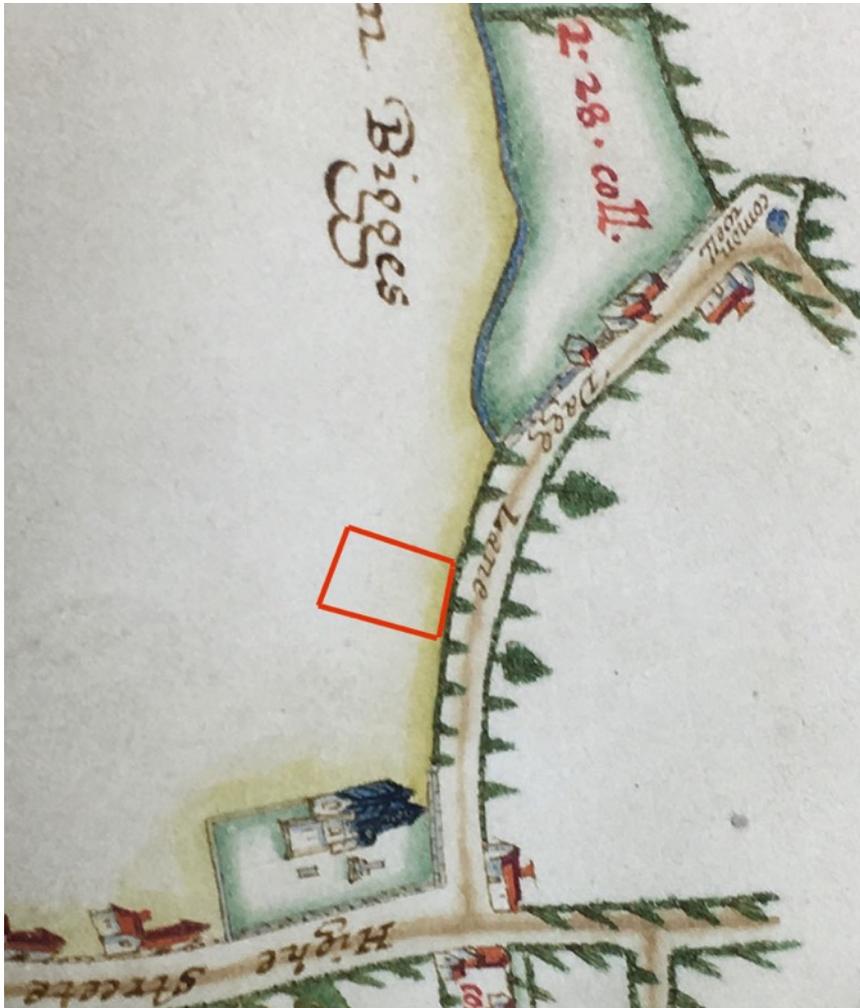
Figure 11. 1605 Estate Map of Corpus Christi College land holding in Headington (Corpus Christi College archive MS 533/1/17)

An estate map of Corpus Christi College holdings dating from 1605, shows the centre of the village around the church, see figure 11. This includes St Andrew's Lane, then called Dagg Lane, and the common well at its junction with Larkin's Lane<sup>2</sup>. Although this map is

concerned with accurately showing the College land holding, and it omits details of the surrounding land, it does indicate other buildings along the principal routes, including the church. There is no building shown on the application site. This suggests that the site was not developed in 1605 but negative evidence is not necessarily confirmation of this.

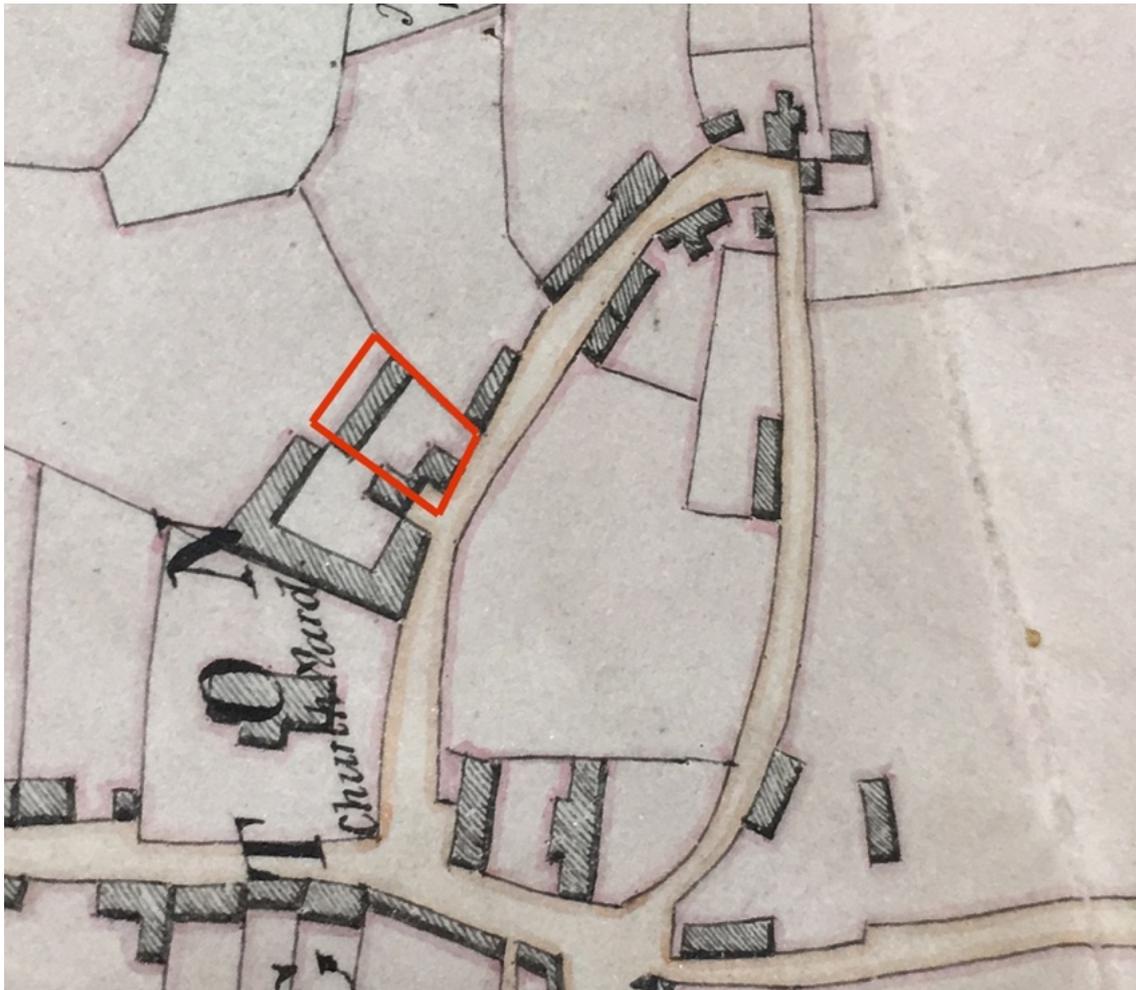
Figure 12. 1802 enclosure map (Oxfordshire History Centre)

The earliest detailed map evidence showing the building on the application site is the 1802 enclosure map of Headington<sup>3</sup>, see figure 12. The land in the centre of the village, including St Andrew's Lane, is referred to as 'Old Inclosure' belonging to Corpus Christi College and not subject to the enclosure exercise in hand. The buildings, therefore, may be accurately positioned but not necessarily accurately detailed. The application site simply shows a rectangular building to the rear of the plot and a smaller building which would fit the dimension of the historic house as it survives today. There is another small building shown adjoining the southwest corner occupying what is now the access road to William Orchard Close. The remnant of stonework forming the west wall of the front garden could be part of this. At this time the land was leased to Richard Pancutt<sup>4</sup>.

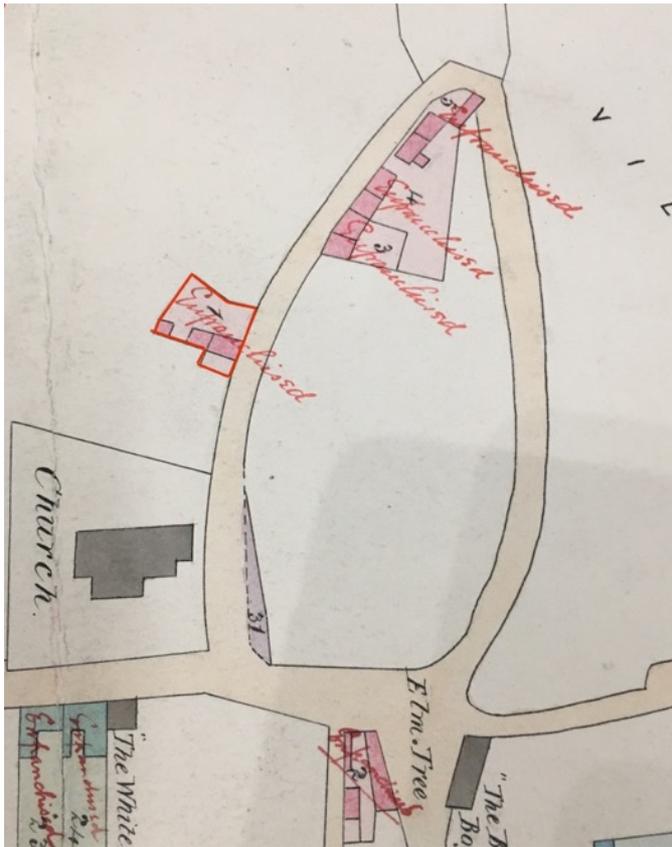
Figure 13. 1870 map of 'Heddington Manor' (Oxfordshire History Centre)

A map of the 'Manor of Heddington' from 1870 records properties where the leases have been enfranchised. This shows only properties affected, see figure 13. Pumpkin Cottage is shown as two adjoining structures with the front garden and a small outbuilding on the site of the present outbuilding. The 1879 25-inch OS map shows the present historic house with a building adjoining to the south west, see figure 14. The small outbuilding mentioned above is also present. The land to the west is shown as garden and orchard. Subsequent editions of 1899, 1921 and 1939 do not show any significant change. The adjoining building was presumably demolished to make way for the William Orchard Close.

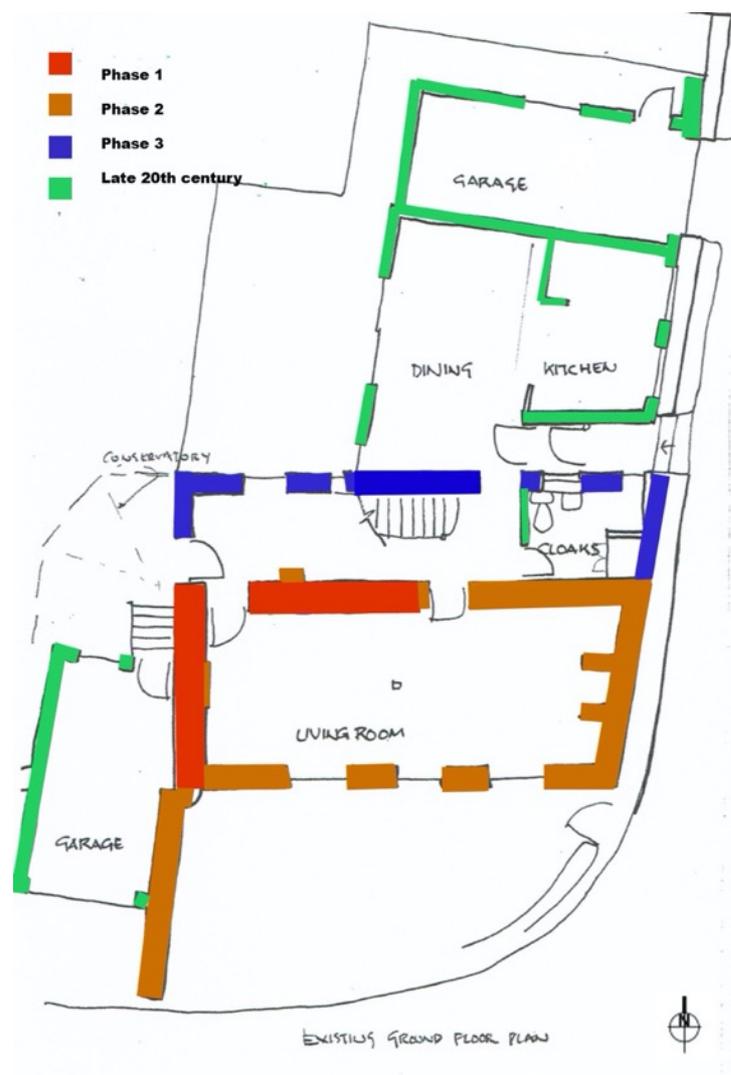
Figure 15. Suggested phases of development

This is a multiphase house of at least three identifiable historic builds. A suggested phasing plan is shown in figure 15.

The front range clearly predates the rear range. The east-west alignment is typical of the early houses in the area. The thickness of the walls in the west bay, the lateral hearth and the dressed stone quoins from an earlier build all point to the west bay being the first phase of the surviving buildings. This may be a late sixteenth century or, more probably, an early

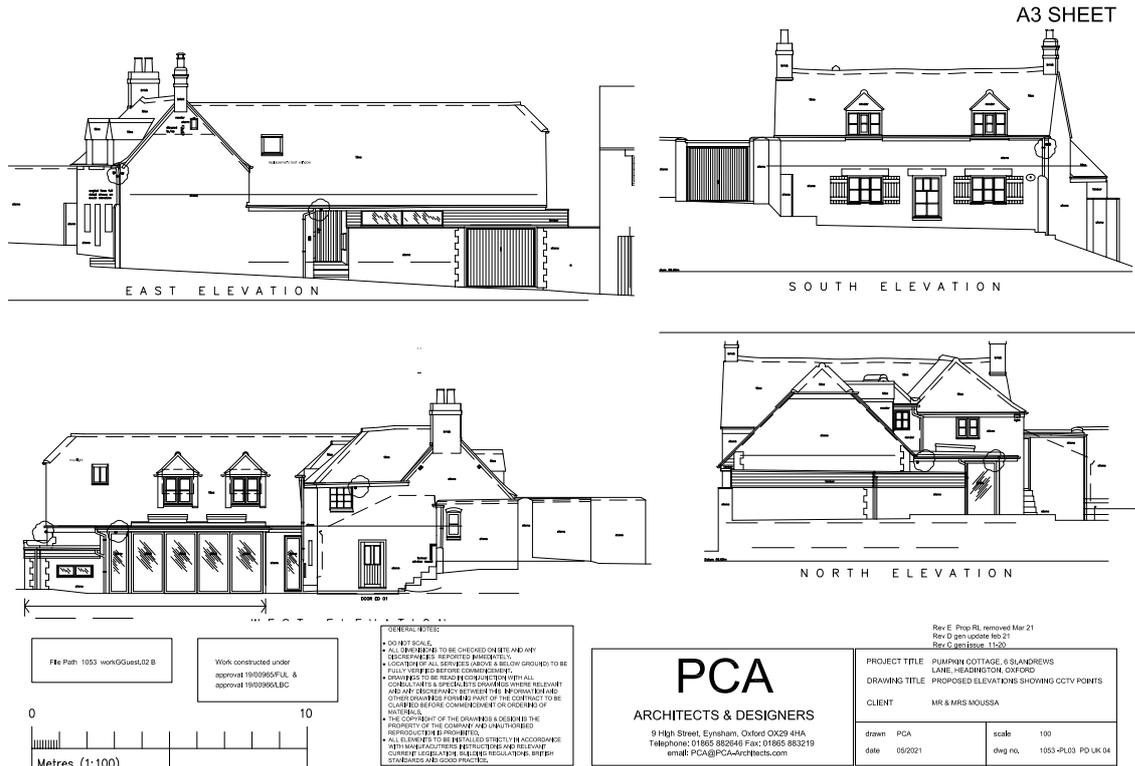
Figure 16. Location of proposed CCTV cameras on building (highlighted)

The proposal involves the installation of 6 CCTV cameras on the listed building and 2 CCTV cameras installed on a pole in the garden. The cameras would be black in colour and just over 9cm by 8 cm. They would be located in the positions shown in figure 16.

The proposed cameras would form only a very small element in each wall affected. Their simple design and neutral colour would render them unobtrusive. They would have a neutral impact on significance.

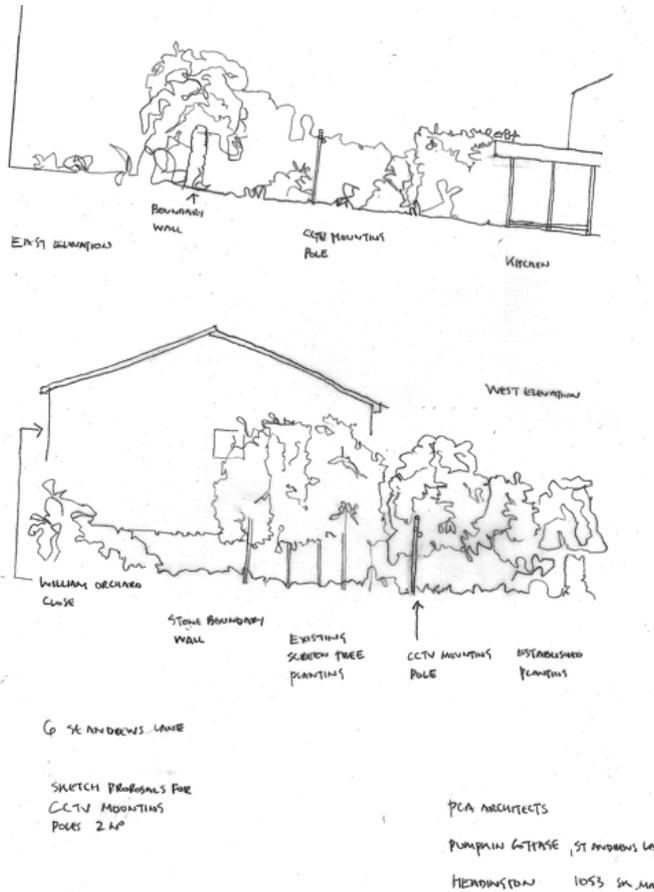
Figure 17. Location of pole mounted CCTV cameras in garden

It is proposed to install two CCTV cameras on a single pole within the garden, see figure 17. This would be 7m away from the nearest part of the building, which is a modern extension, and 10m away from the historic rear range. The pole would be approximately 2.7 m high and would be read against existing vegetation which exceeds this height. It would not detract from the appreciation of the historic building nor impact in any way on its significance.
