JWS Development

Stubbins House, Stubbins Lane
*Phase 2 Geo-Environmental Investigation
and Assessment Report*

G3472

March 2021

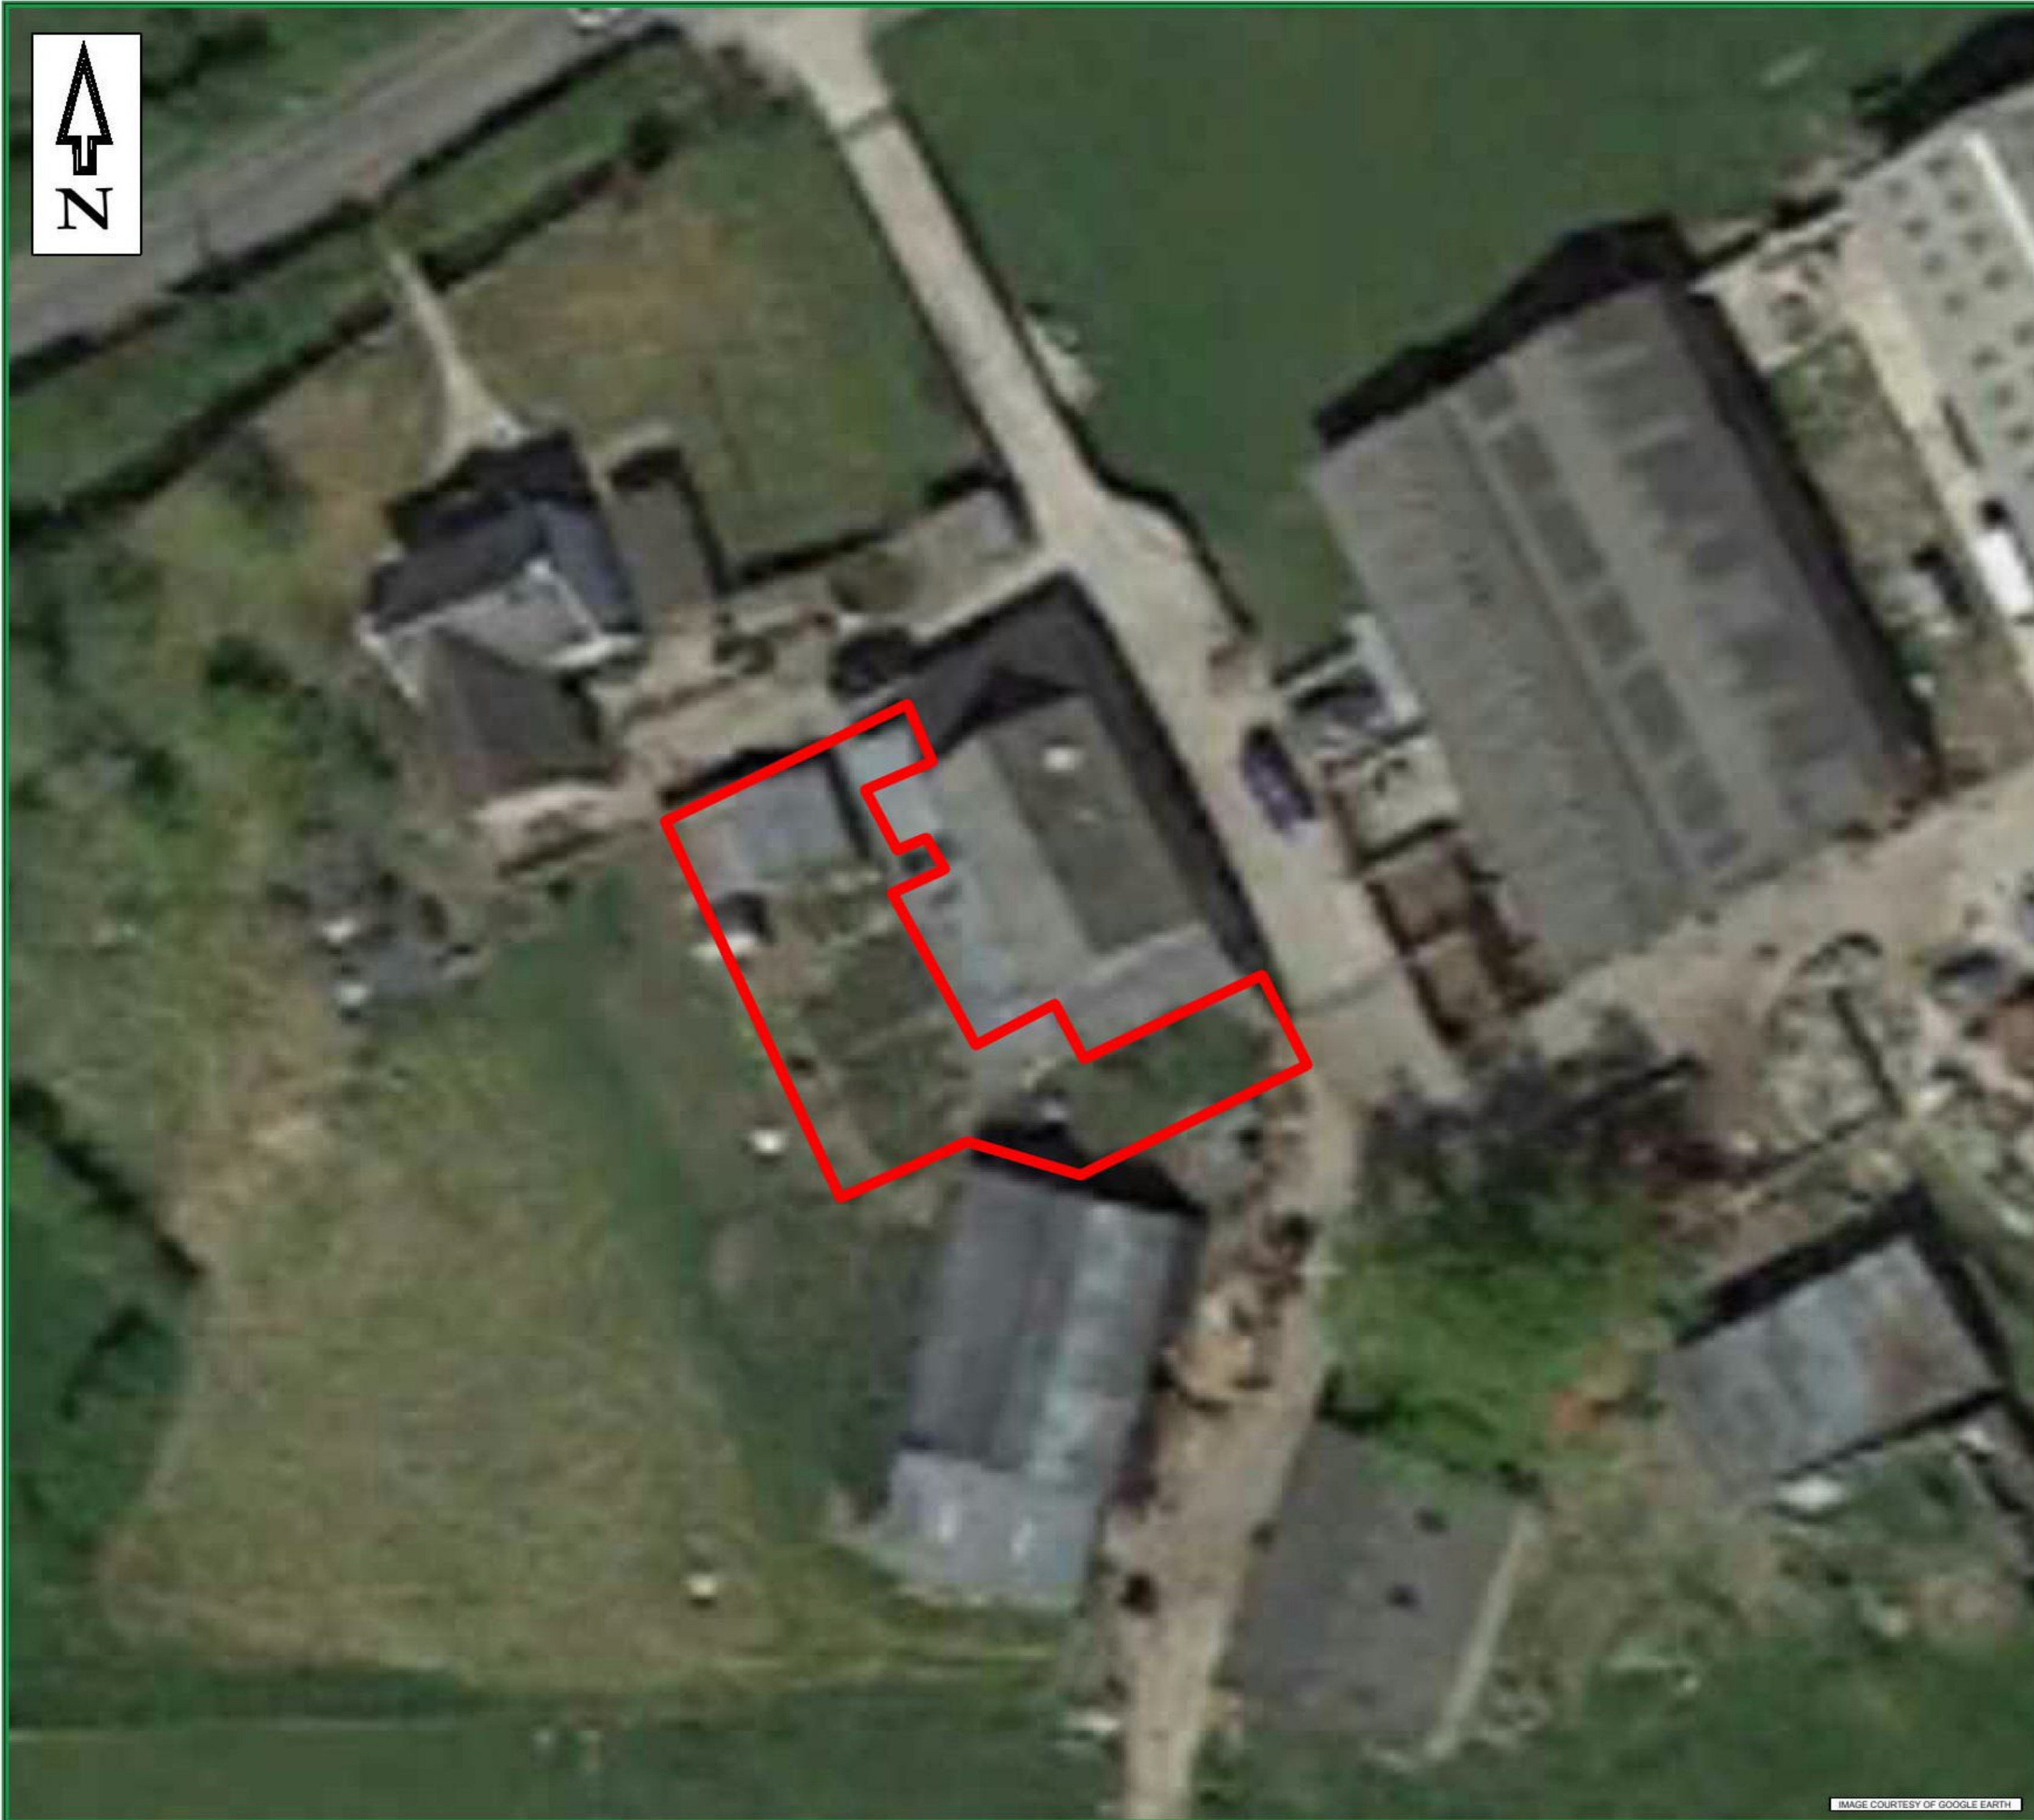
DRAWING No. G3472/G/02	REV. -
---------------------------	-----------

3.2.4 The buildings on site comprise a stone built two storey barn with a corrugated steel roof (north-east) with an attached single storey block work lean-to with a corrugated steel roof, a Timber/metal/asbestos dilapidated shed (north of the site and a corrugated steel and timber shed, with diesel tank inside (south-east).

3.2.7 Existing salient features are shown in Drawing Number G3472/G/02.

3.1.1 The site location is shown on Drawing Number G3472/G/01. Site details are summarised in the Table below. Current site layout plan shown in Drawing Number G3472/G/02. The site is situated in a rural location.
