GA Site Investigation Limited

GA1027.20

SITE INVESTIGATION: 9 TARN MOOR CRESCENT, SKIPTON, BD23 1LT

APPENDIX A BOREHOLE LOCATIONS

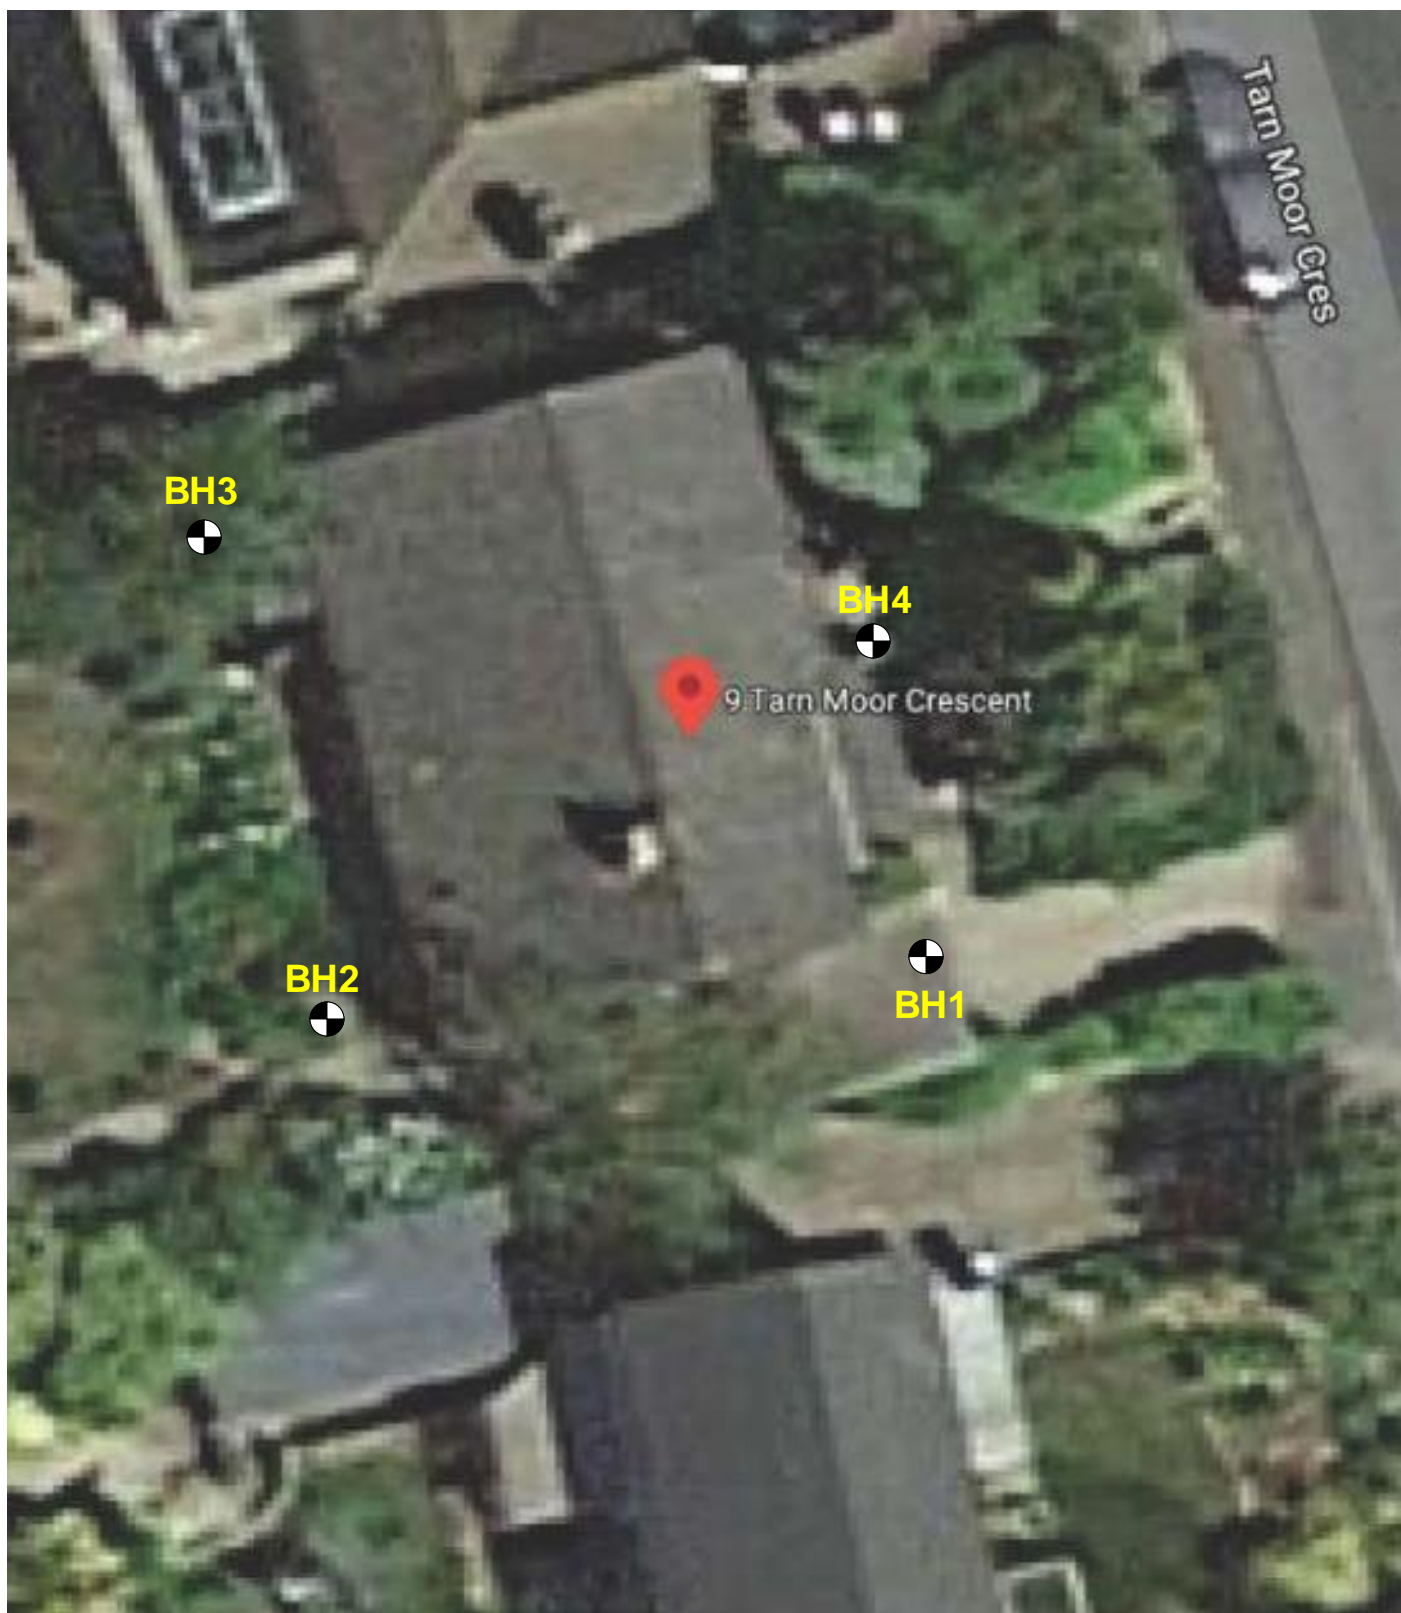
SITE ADDRESS	9 Tarn Moor Crescent, Skipton, BD23 1LT	CONTRACT No.	GA1027.20
CLIENT	Mr M Siddall	TITLE	Indicative Borehole Locations

The indicative locations of the boreholes are contained in Appendix A.

The boreholes, referenced BH1 to BH4 inclusive, were to the front left (SE) and both rear (NW and SW) corners of the building, with the fourth being located approximately mid-way along the front elevation due to access restriction to the NE corner.
