VOLUME TWO

GAZETTEER

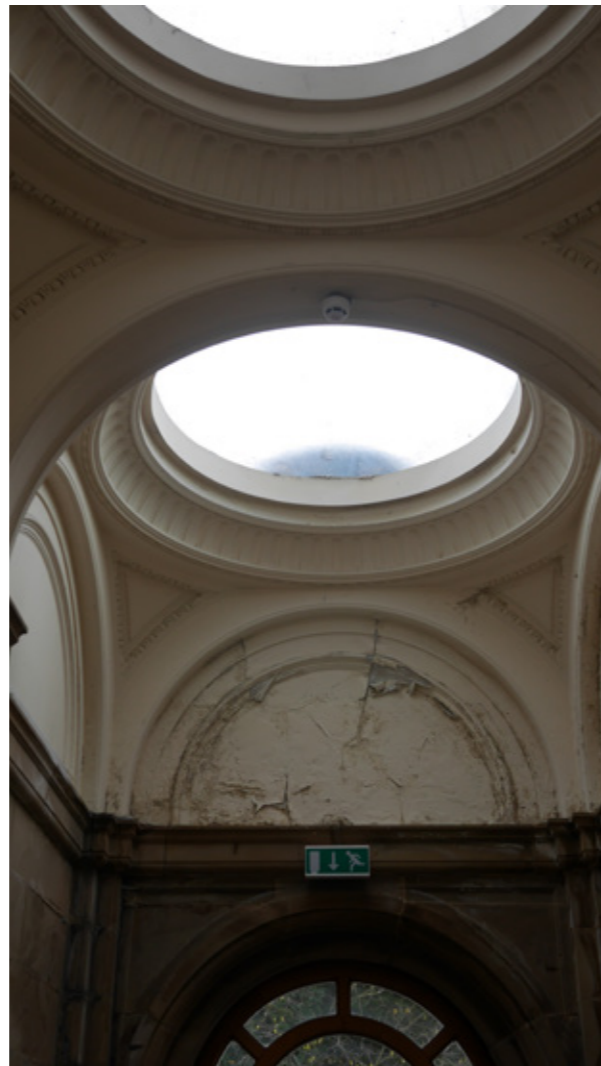
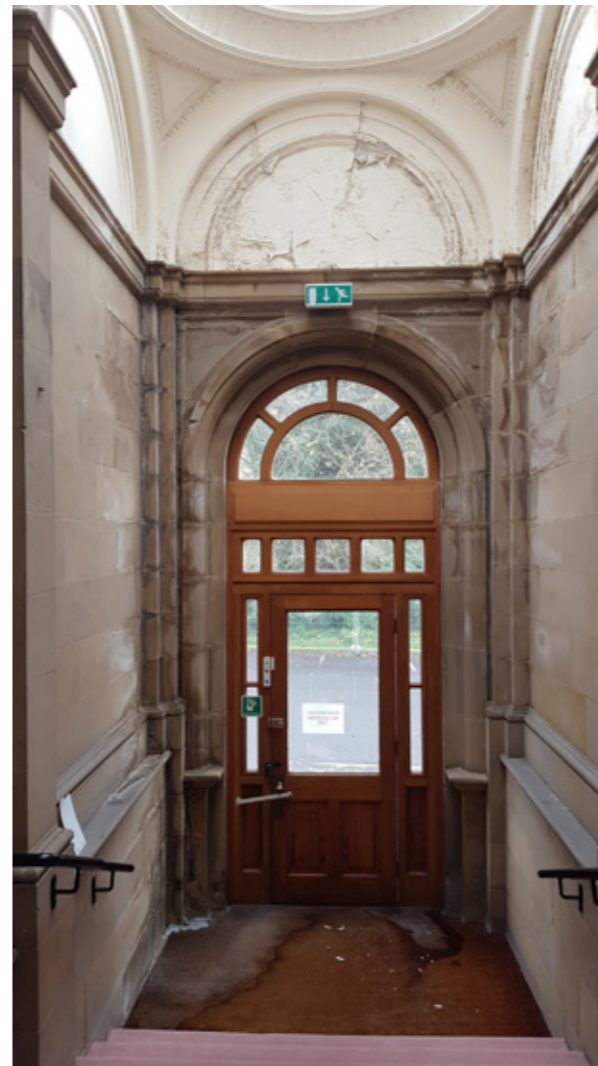
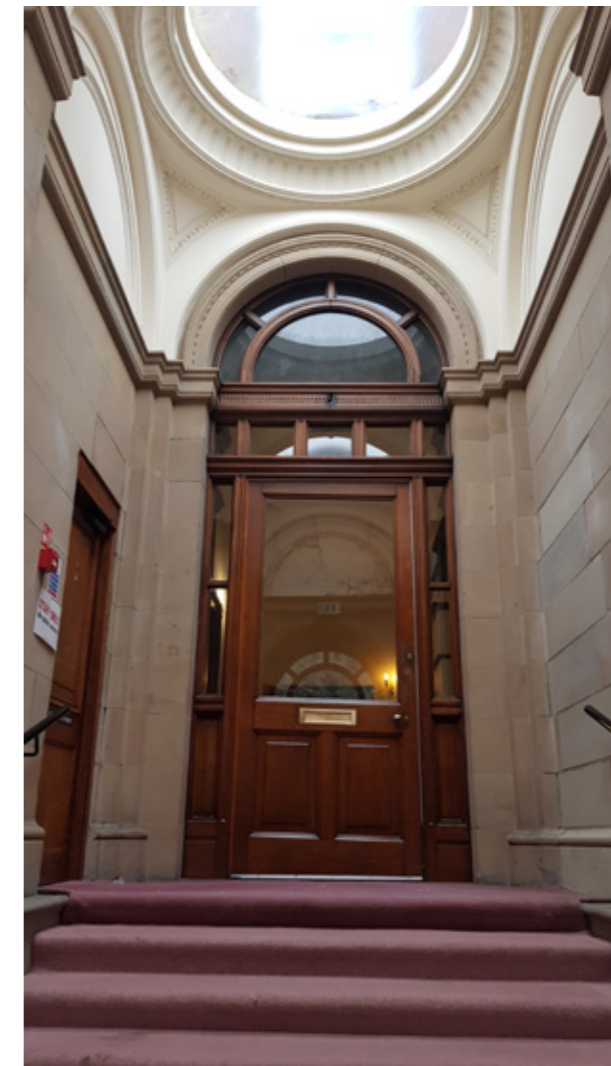
GROUND FLOOR: WYATT WING – GI.01

Room Number:	GI.01
Current Room Use:	Entrance Hall
Historic Room Use:	Porch
Date of Structure:	1817
Date of Fixtures / Fittings:	1817
Date of Decoration:	1817 with replacement doors and skylights.
Major Alterations:	Wyatt porch enclosed within later room extensions of GI.08 and GI.15. Side door punches through original stonework.

Overall Significance Level:	Very High
Key Historic Features:	Internal stonework and decorative ceiling plaster, some early C20 joinery
Detrimental Features:	Non-breathable carpet and paint, modern handrails and entrance doors. Replacement skylights are poor quality.
Condition Level:	Poor
Condition Comments:	Water ingress to main external entrance, stonework damaged
Other Comments:

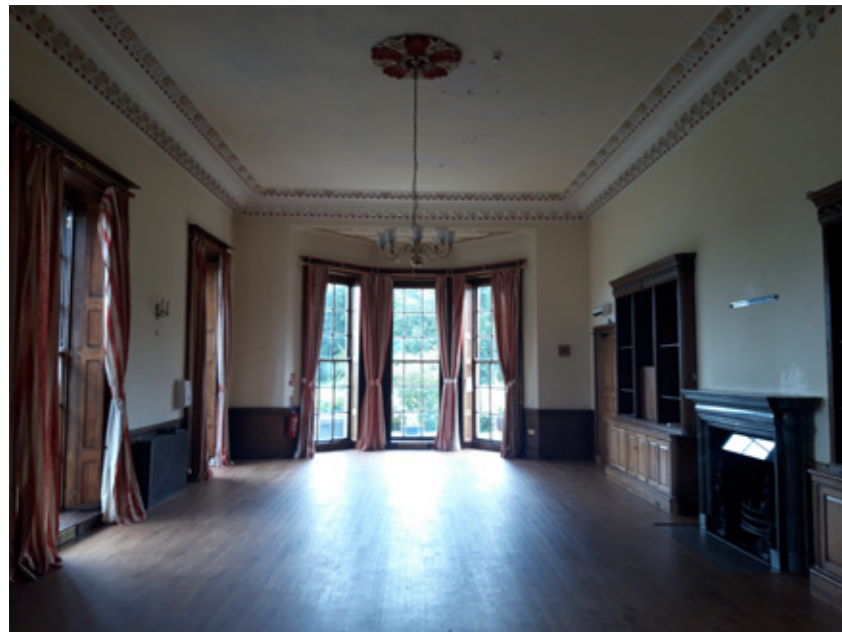
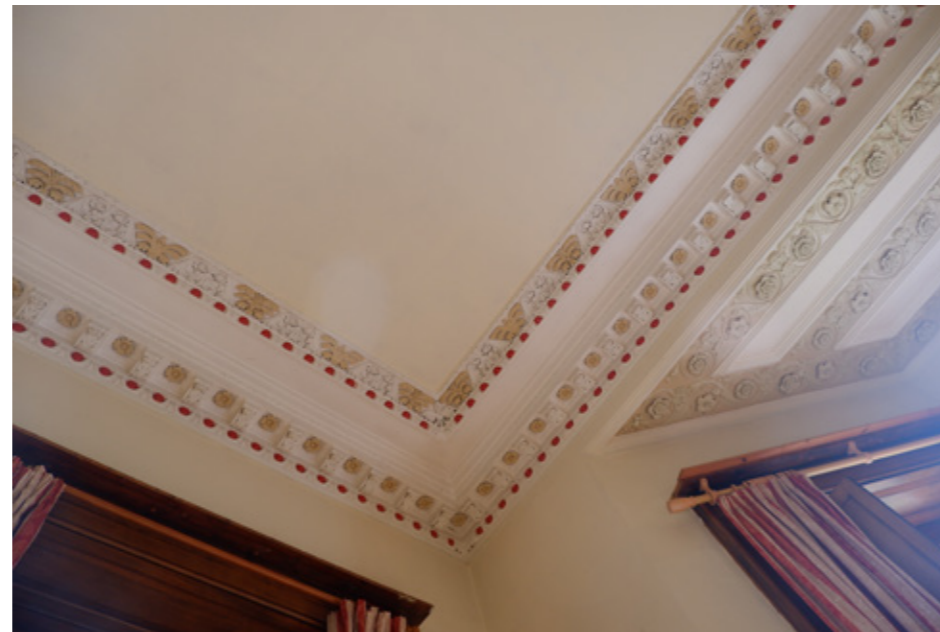
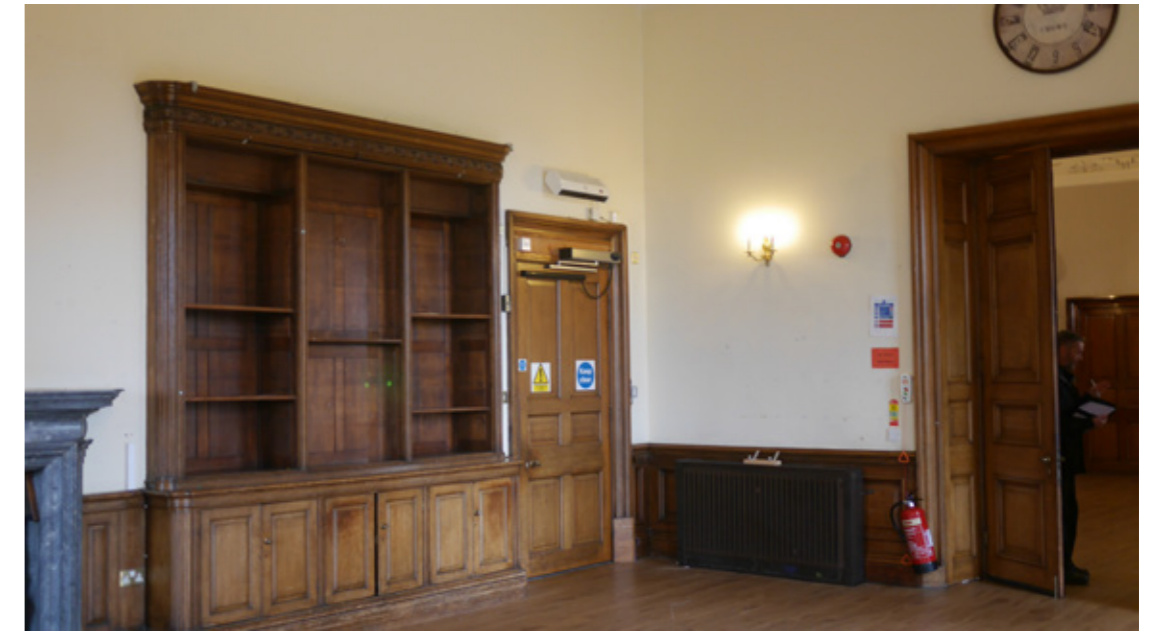
GROUND FLOOR: WYATT WING – GI.09

Detrimental Features: Modern paint finishes (especially to ceiling) and sprung floor. Unsympathetic M&E including heaters and door closers, modern wall light pendants. Small amount of replacement panelling.

Condition Level: Fair

Condition Comments: Non-breathable ceiling paint peeling

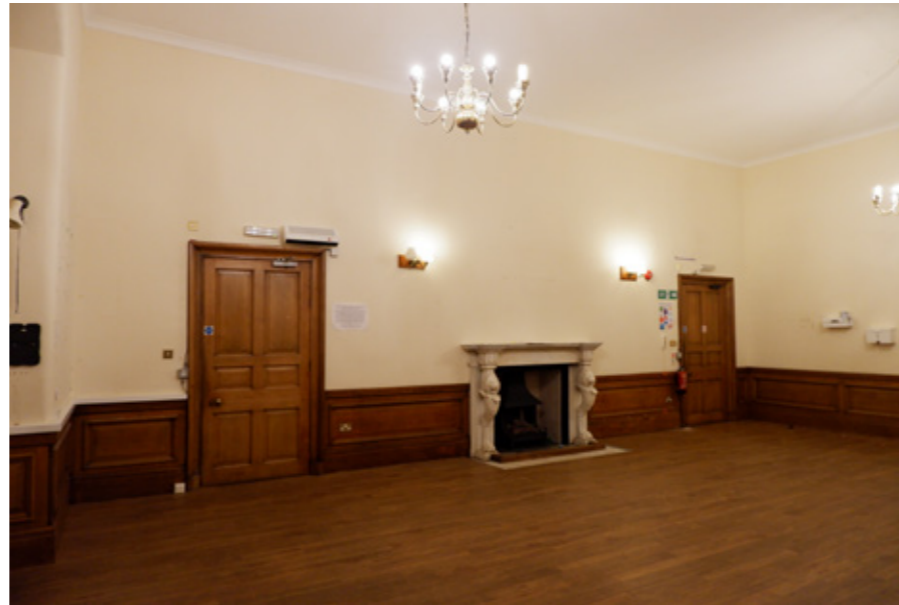
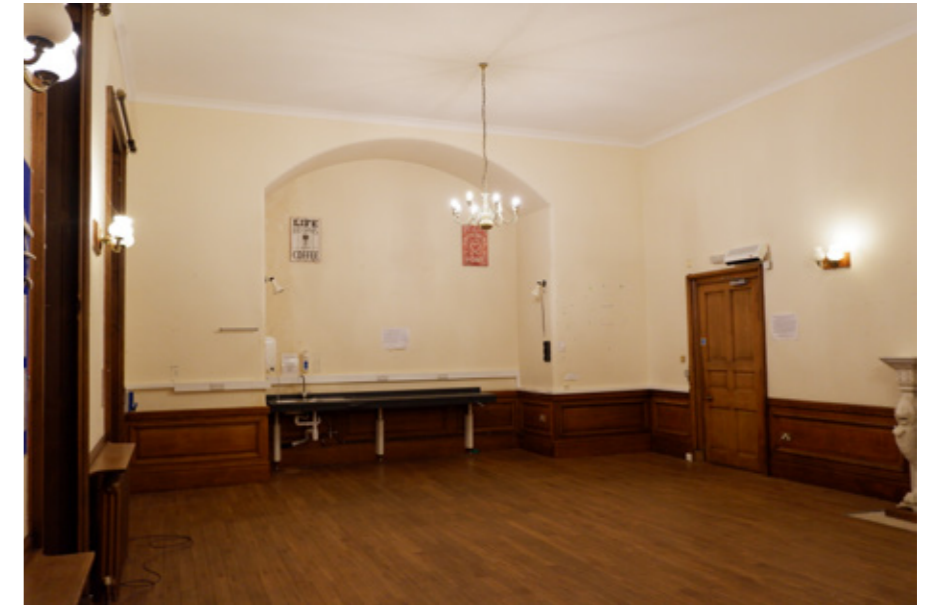
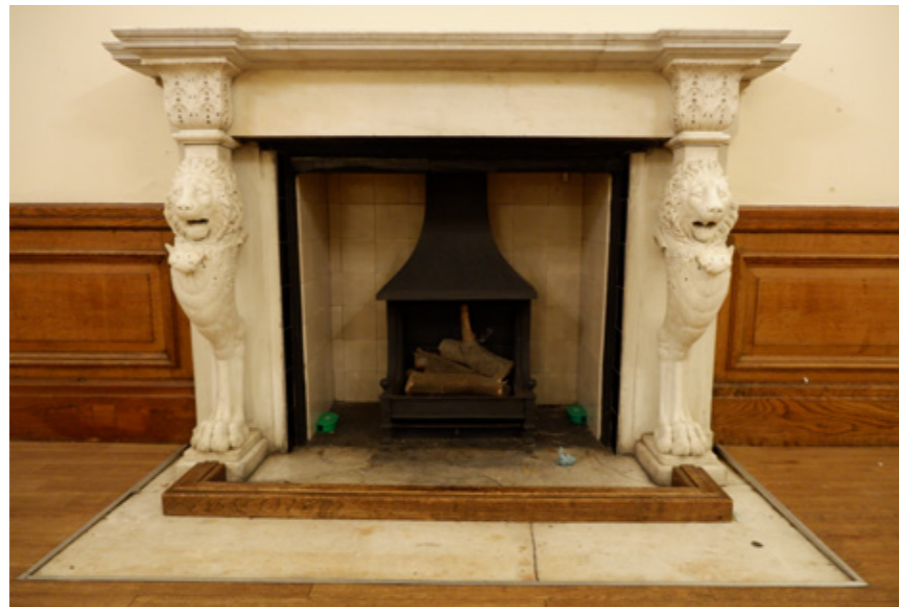
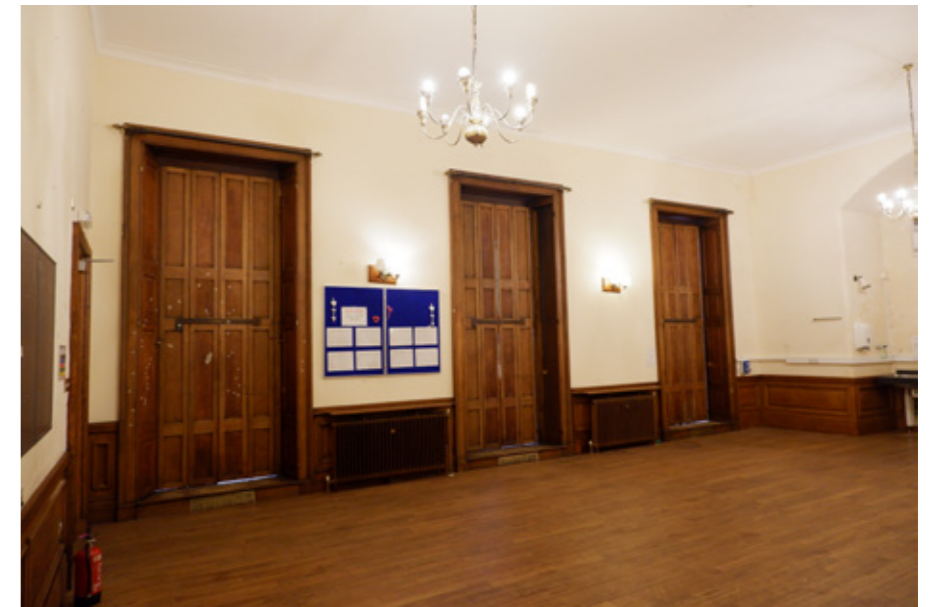
GROUND FLOOR: WYATT WING – GI.10

Room Number:	GI.10
Current Room Use:	Welfare
Historic Room Use:	Dining Room
Date of Structure:	1817
Date of Fixtures / Fittings:	1817
Date of Decoration:	Late 20th century
Major Alterations:	Decorative plaster ceiling may have been removed - ceiling is plain.
Overall Significance Level:	Very High
Key Historic Features:	Large alcove to end of room, floor length sash windows and shutters, fireplace and hearth, Wyatt doors, architraves and panelling.
Detrimental Features:	Modern paint finishes and sprung floor. Unsympathetic M&E including sink, modern wall light pendants. Small amount of replacement panelling. Replacement stove in fireplace.
Condition Level:	Fair
Condition Comments:	
Other Comments:

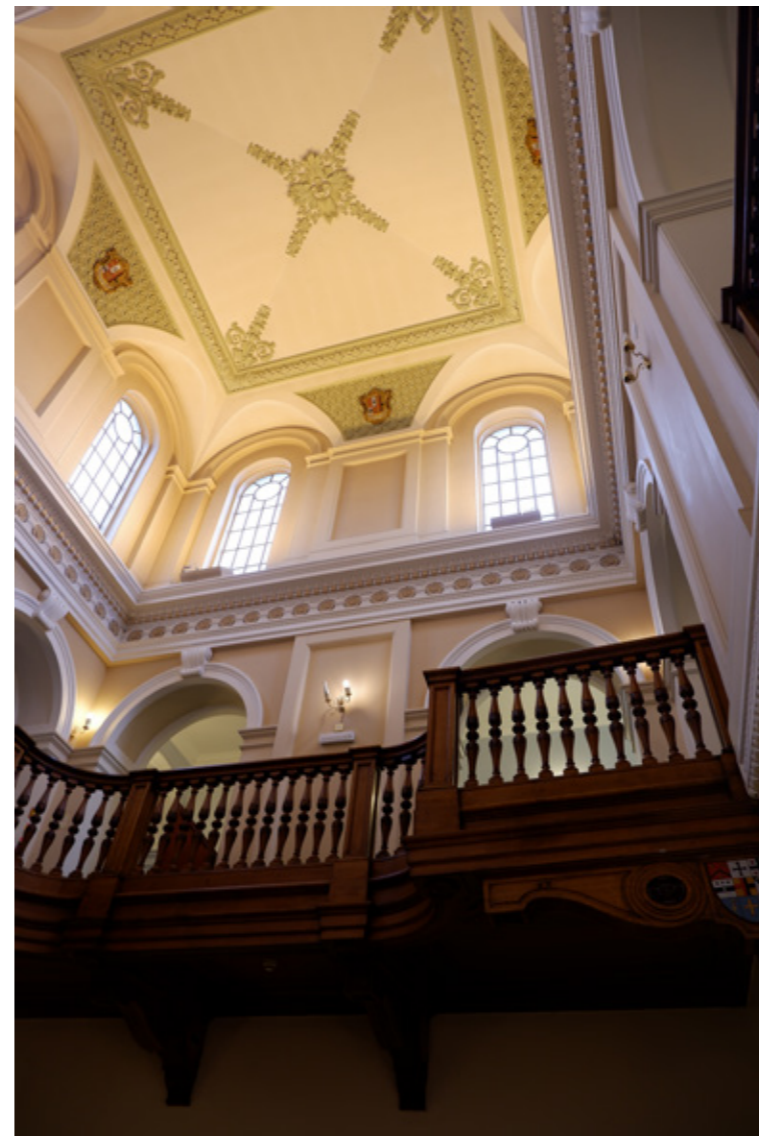
GROUND FLOOR: WYATT WING – GI.13

Key Historic Features:	Decorative early C19 joinery with fluted columns and Greek key downstands. Coved ceiling decoration. Paneling and doors appear to be C20 replacements.
Detrimental Features:	C20 lightweight partitions to GI.14/GI.15, modern carpet and paint.
Condition Level:	Good
Condition Comments:	
Other Comments:

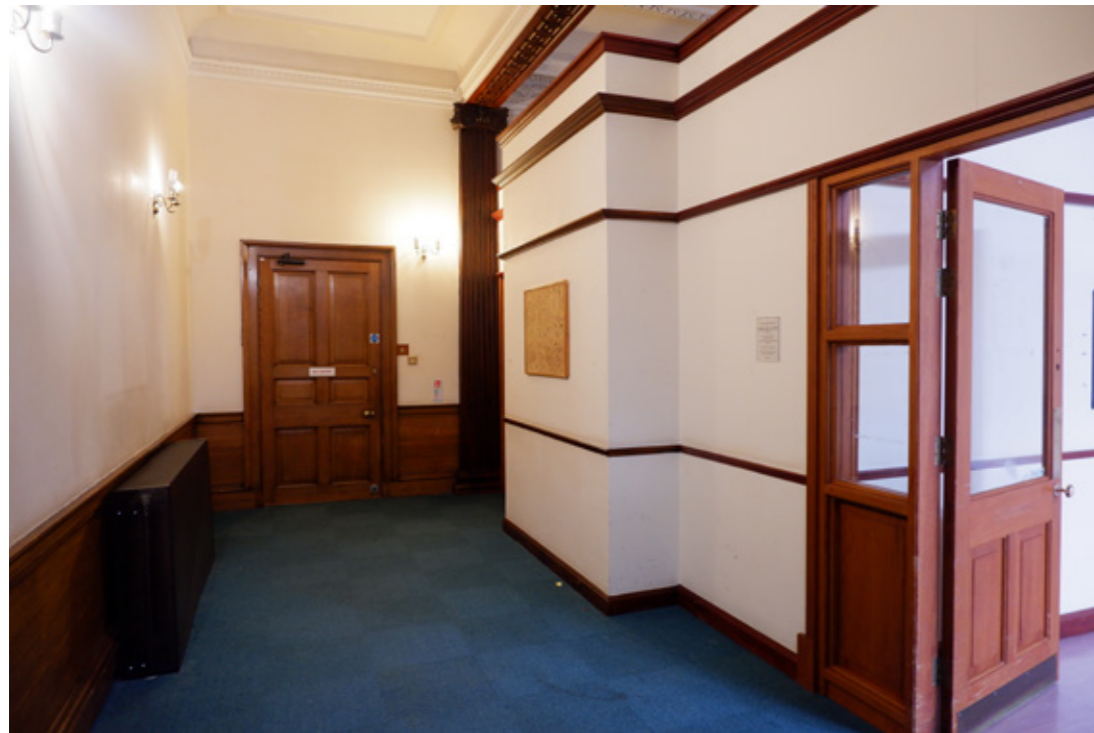
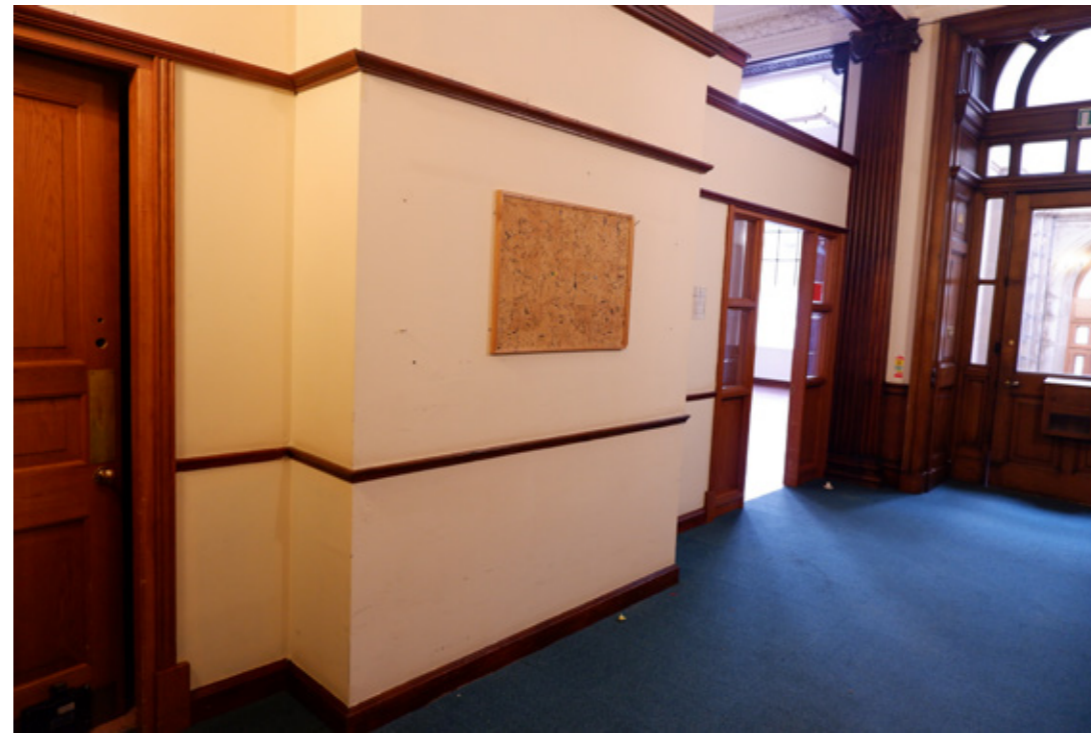
Room Number:	GI.13
Current Room Use:	Main Hall
Historic Room Use:	Hall and Billiard Room
Date of Structure:	1817
Date of Fixtures / Fittings:	First half of 19th century
Date of Decoration:	Late 20th century
Major Alterations:	Wall removed to open space into GI.14 and GI.15, first half 19th century
Overall Significance Level:	High

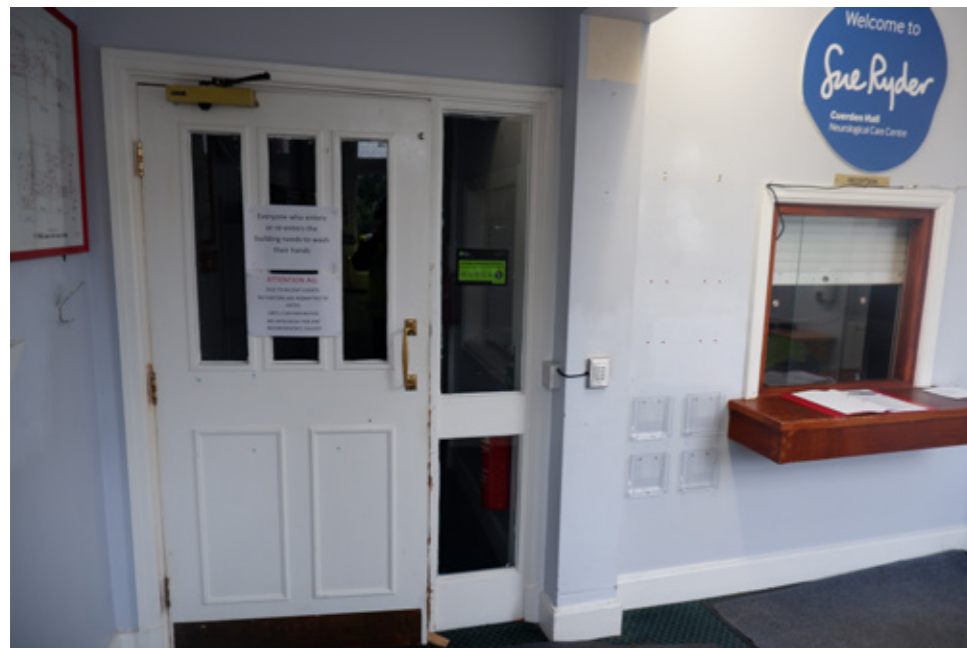
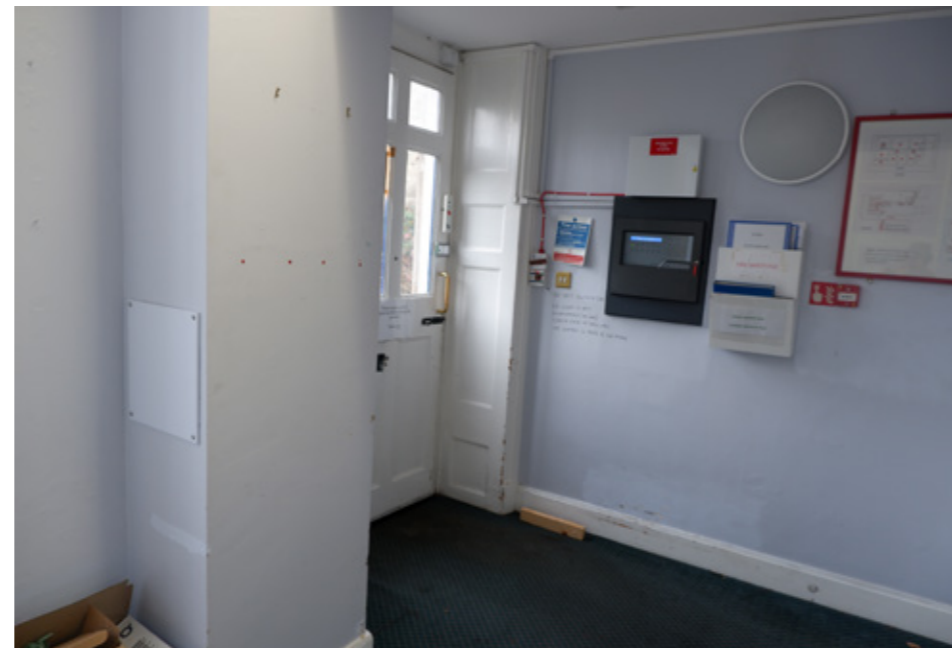
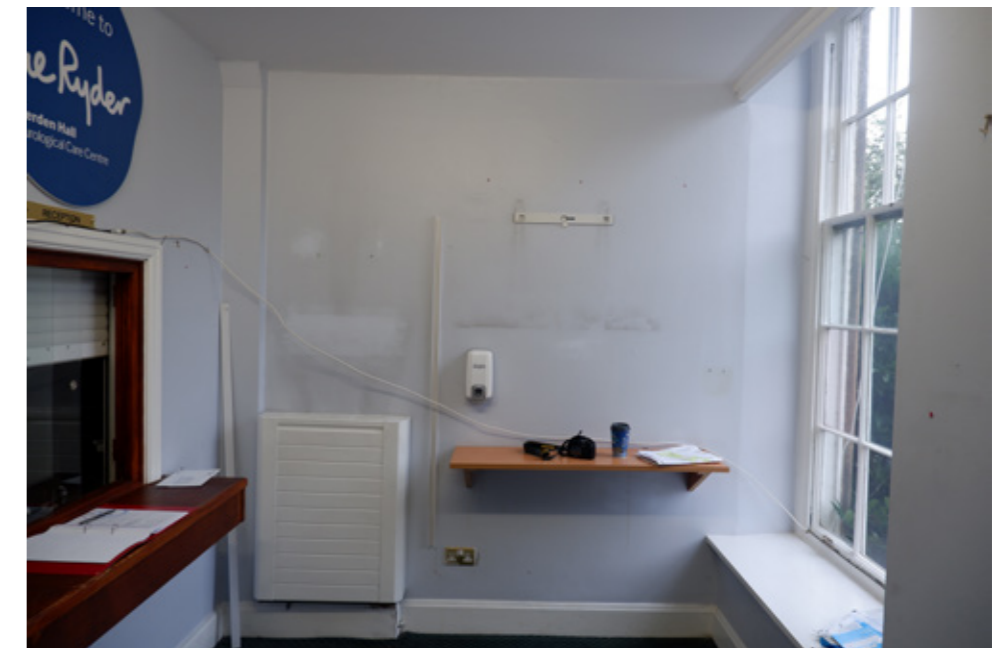
GROUND FLOOR: 1717 HOUSE – G2.01

Room Number:	G2.01
Current Room Use:	Circulation
Historic Room Use:	
Date of Structure:	1717
Date of Fixtures / Fittings:	
Date of Decoration:	Late 20th century
Major Alterations:	Late 20th century reconfiguration into reception
Overall Significance Level:	Low
Key Historic Features:	Sash windows, timber doorcase

Detrimental Features:	Lowered ceiling, partition wall and reception window, M&E, modern radiator inserted opening, modern carpets
Condition Level:	
Condition Comments:	
Other Comments:

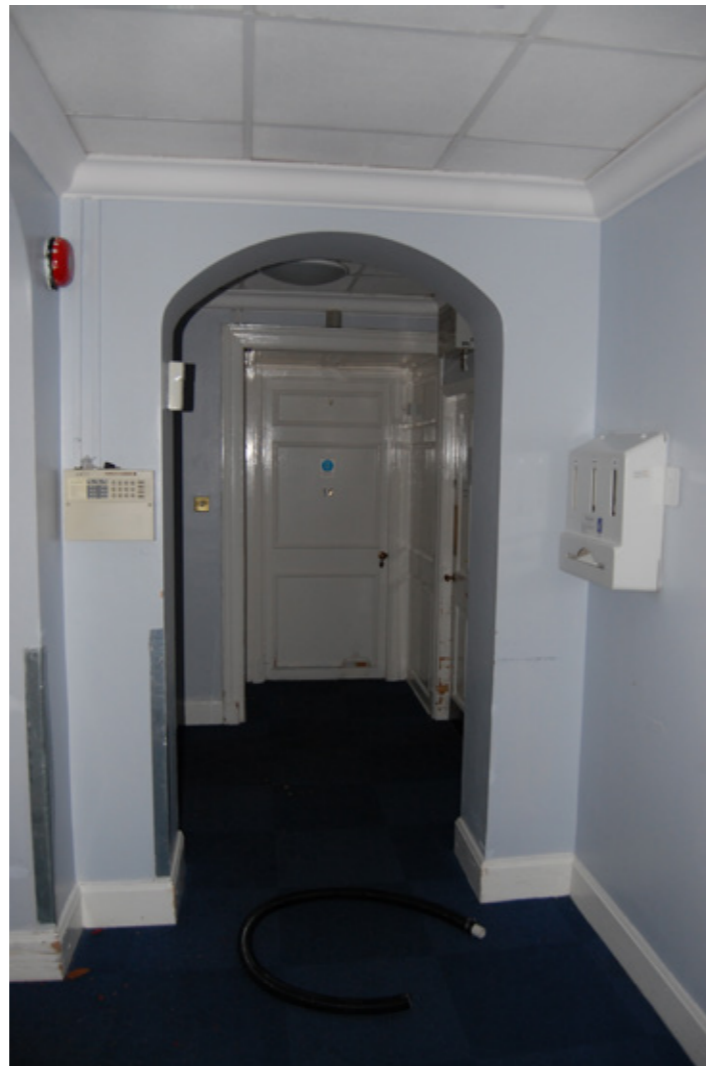
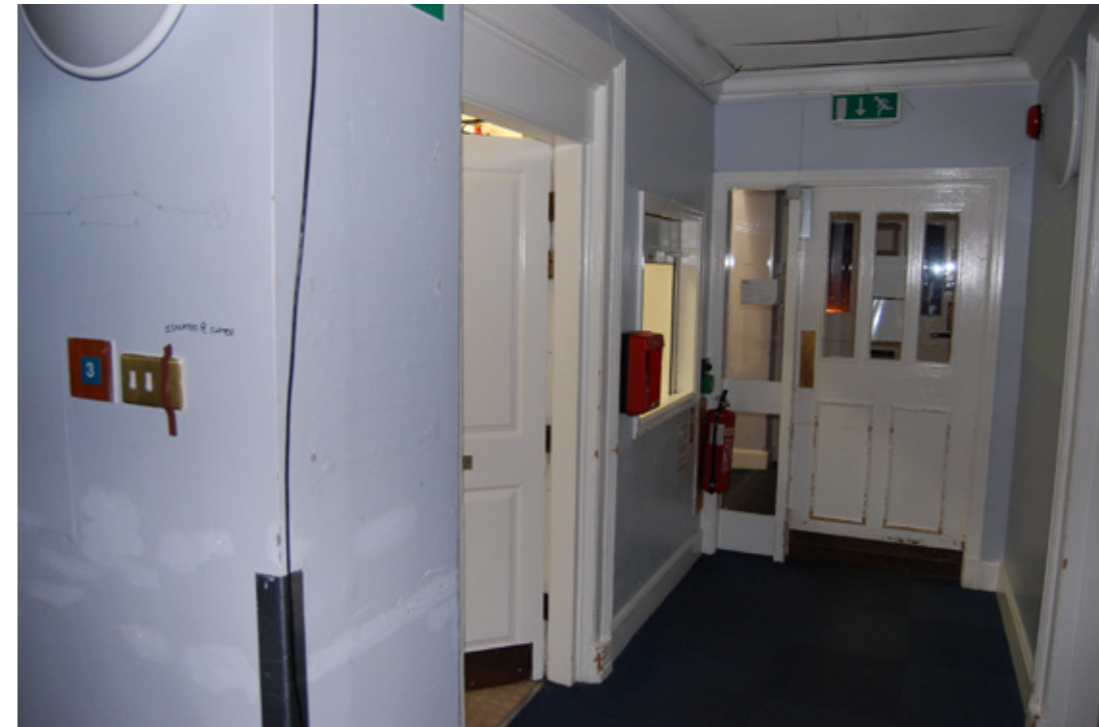
Room Number:	G2.02
Current Room Use:	Corridor
Historic Room Use:	Corridor (Wyatt plan)
Date of Structure:	1717
Date of Fixtures / Fittings:	20th century
Date of Decoration:	Late 20th century
Major Alterations:	Opening up of Butler's bed and plate store to corridor. Fire door subdivisions.
Overall Significance Level:	Medium
Key Historic Features:	Original 1717 central corridor, utilised by Wyatt in refurbishment.

Detrimental Features:	Modern fit out.
Condition Level:	Fair
Condition Comments:	
Other Comments:

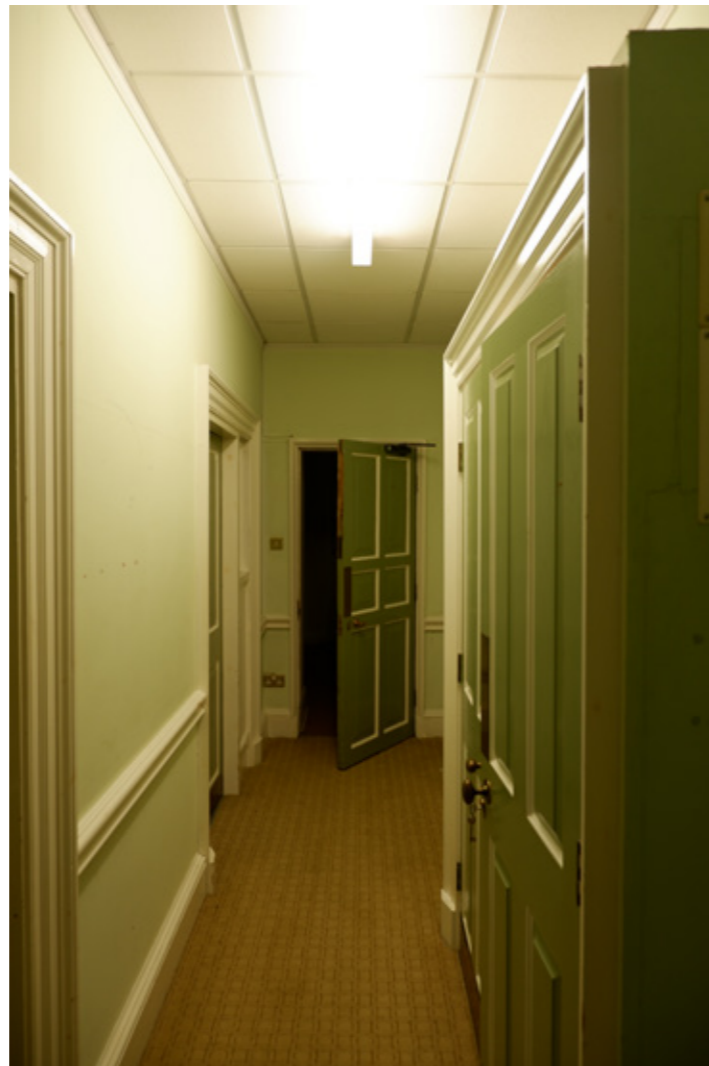
GROUND FLOOR: 1717 HOUSE – G2.03

Room Number:	G2.03
Current Room Use:	Corridor
Historic Room Use:	Mr Parker's Room
Date of Structure:	1717
Date of Fixtures / Fittings:	20th century
Date of Decoration:	Late 20th century
Major Alterations:	20th century sub-division of Mr Parker's Room into corridor.
Overall Significance Level:	Negligible
Key Historic Features:	Some early 20th century joinery.

Detrimental Features:	Modern fit out.
Condition Level:	Good
Condition Comments:	
Other Comments:

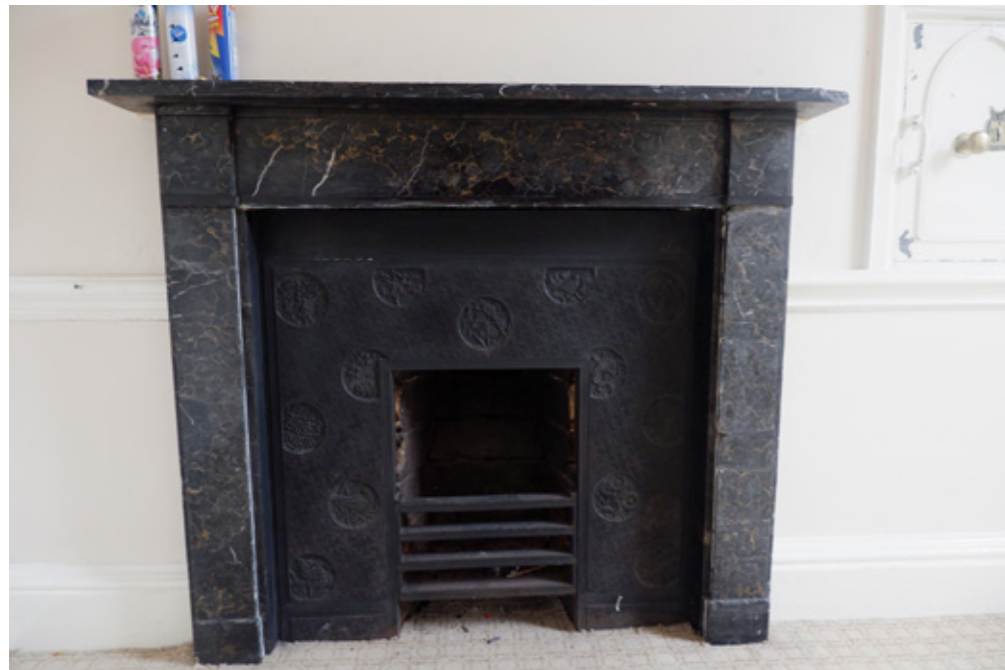
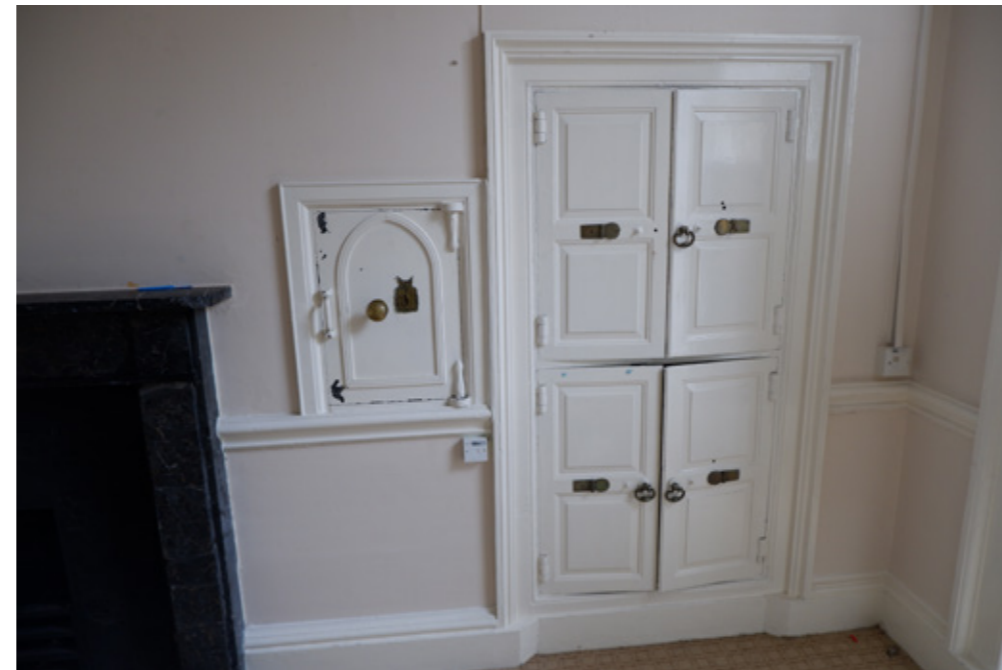
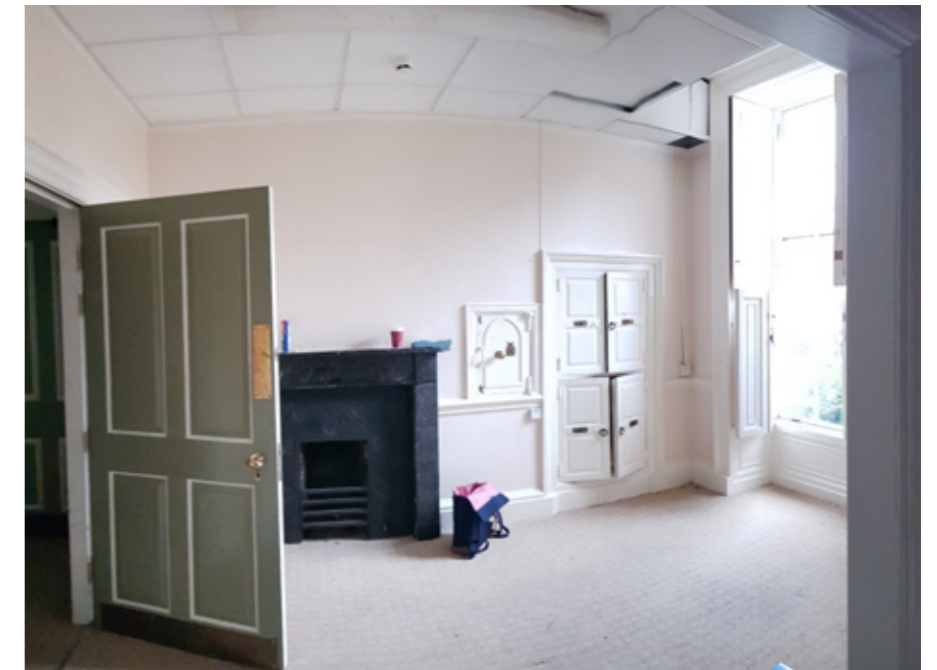
GROUND FLOOR: 1717 HOUSE – G2.04

Room Number:	G2.04
Current Room Use:	Office
Historic Room Use:	Mr Parker's Room
Date of Structure:	1717
Date of Fixtures / Fittings:	1817
Date of Decoration:	Late 20th century
Major Alterations:	Late 20th century sub-division of Mr Parker's Room and subsequent reopening with nibs and downstands.
Overall Significance Level:	High

Key Historic Features:	Wyatt features including shutters, large cabinet, closet, safes, dado and fireplace. Possible late C19 fire surround with Japan/Aesthetic influences.
Detrimental Features:	Modern carpet, suspended ceiling, M&E and dividing wall/corridor.
Condition Level:	Good
Condition Comments:	
Other Comments:

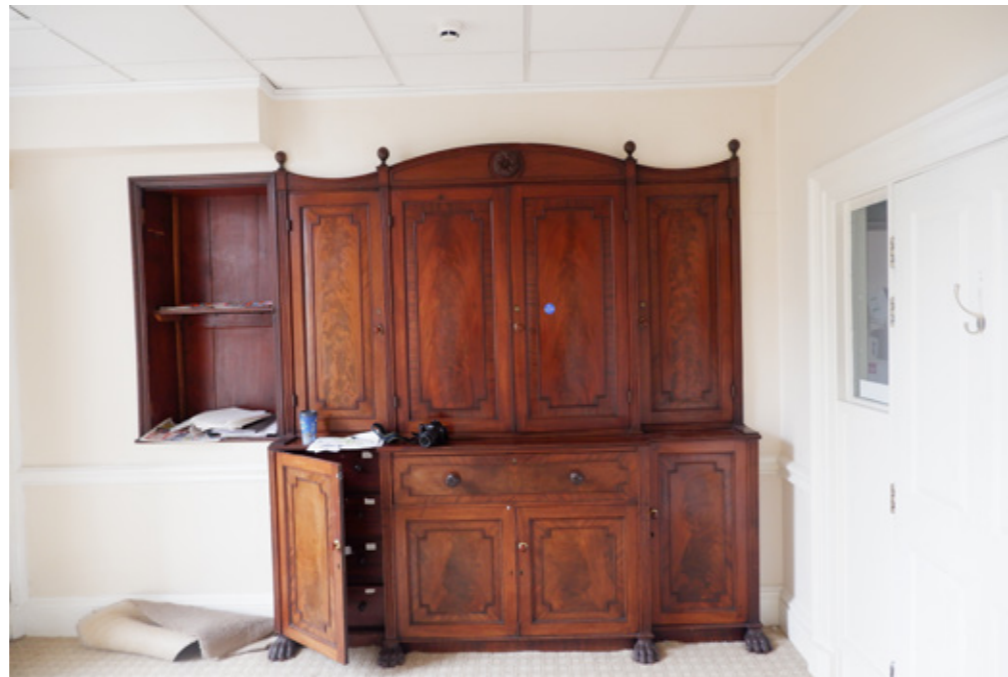
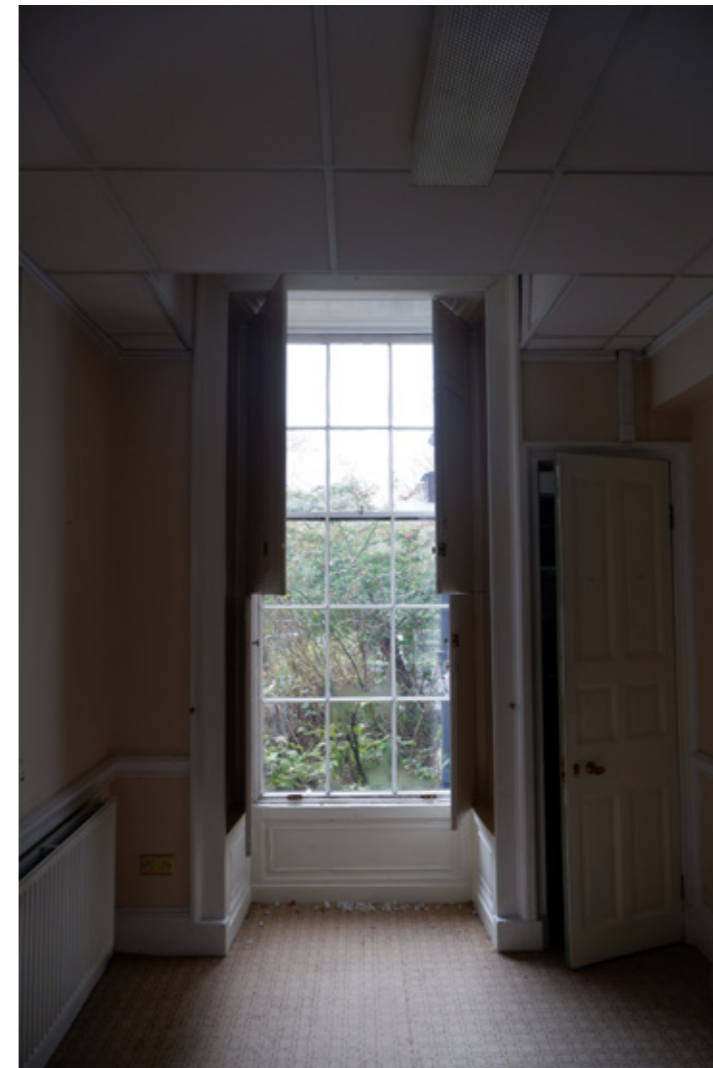
GROUND FLOOR: 1717 HOUSE – G2.05

Room Number:	G2.05
Current Room Use:	Office
Historic Room Use:	Mr Parker's Room
Date of Structure:	1717
Date of Fixtures / Fittings:	1817
Date of Decoration:	Late 20th century
Major Alterations:	Late 20th century sub-division of Mr Parker's Room and subsequent reopening with nibs and downstands.
Overall Significance Level:	High

Key Historic Features:	Wyatt features including shutters, large cabinet, closet, safes, dado and fireplace. Possible late C19 fire surround with Japan/Aesthetic influences.
Detrimental Features:	Modern carpet, suspended ceiling, M&E and dividing wall/corridor.
Condition Level:	Good
Condition Comments:	
Other Comments:

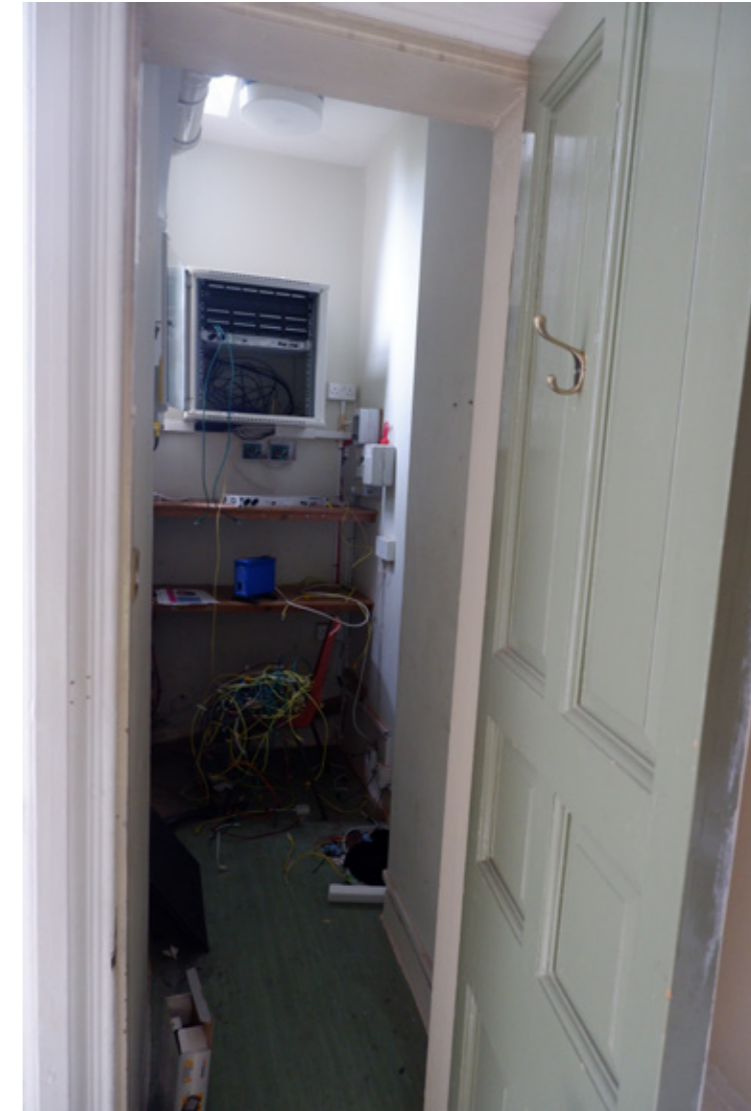
GROUND FLOOR: 1717 HOUSE – G2.06

Room Number:	G2.06
Current Room Use:	Storage/Plant
Historic Room Use:	
Date of Structure:	1717
Date of Fixtures / Fittings:	1817
Date of Decoration:	20th century
Major Alterations:	None
Overall Significance Level:	Low
Key Historic Features:	6-panel door
Detrimental Features:	Modern plant
Condition Level:	Good
Condition Comments:	
Other Comments:

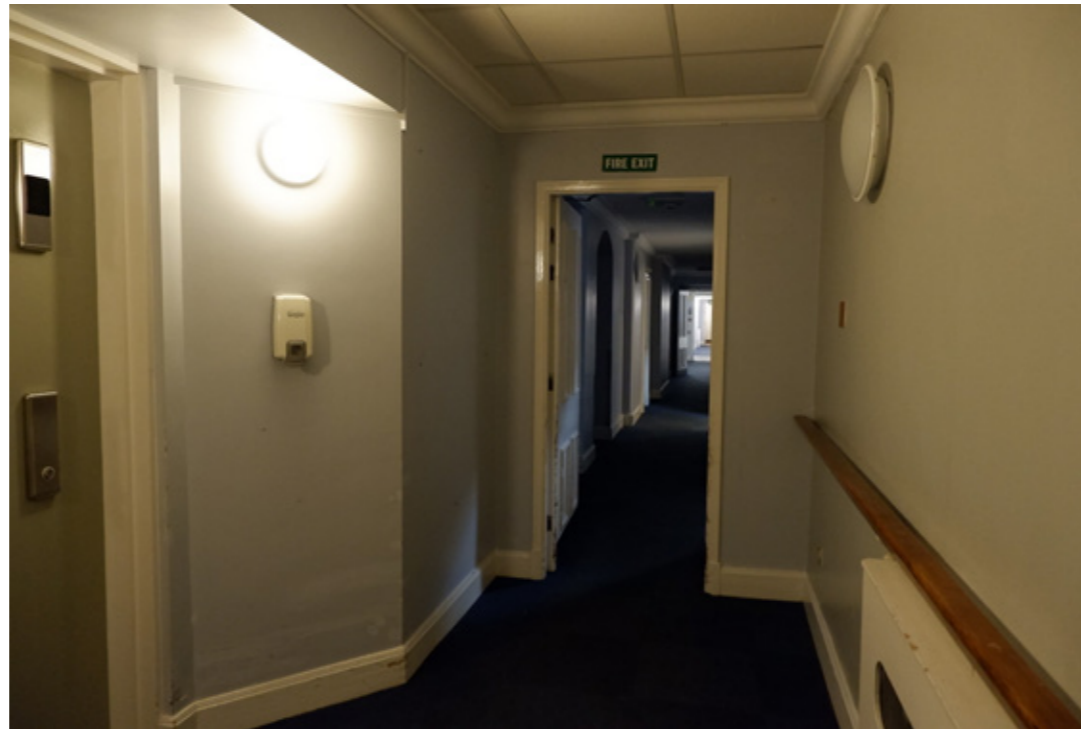
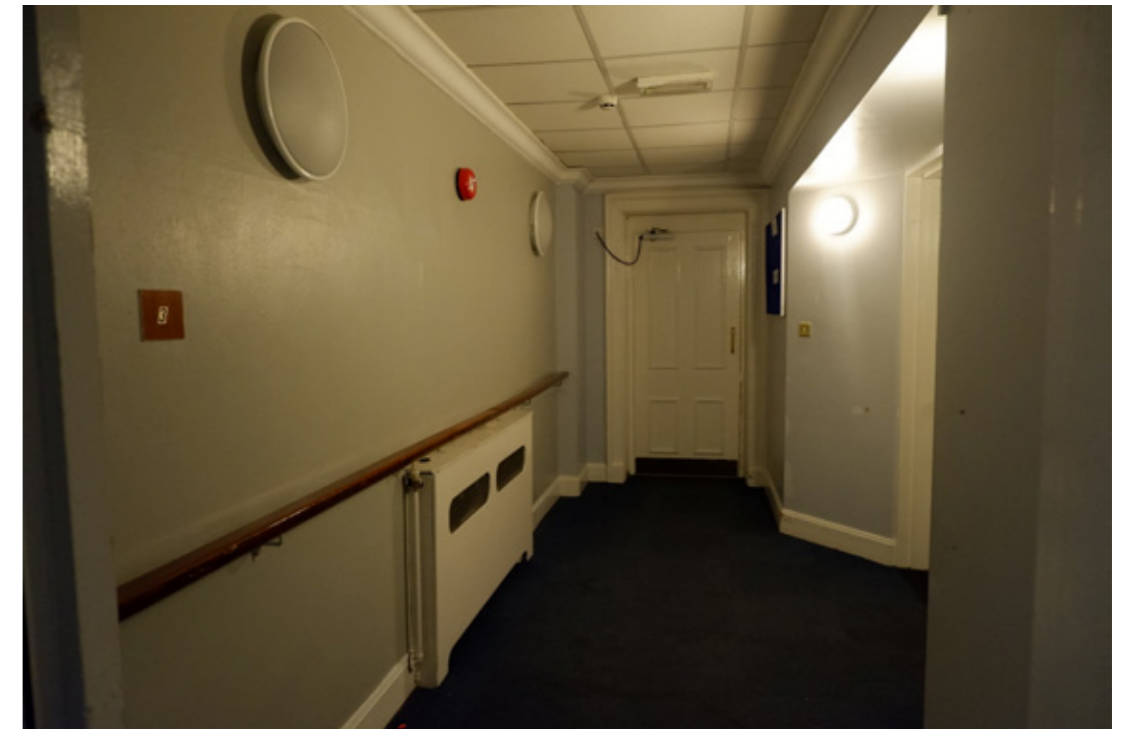
GROUND FLOOR: 1717 HOUSE – G2.07

Room Number:	G2.07
Current Room Use:	Corridor
Historic Room Use:	Corridor (Wyatt plan)
Date of Structure:	1717
Date of Fixtures / Fittings:	20th century
Date of Decoration:	Late 20th century
Major Alterations:	Late C20 opening in 1717 wall to create lift access.

Overall Significance Level:	Medium
Key Historic Features:	Original 1717 central corridor, utilised by Wyatt in refurbishment.
Detrimental Features:	Subdivisions, modern fit out.
Condition Level:	Fair
Condition Comments:	
Other Comments:

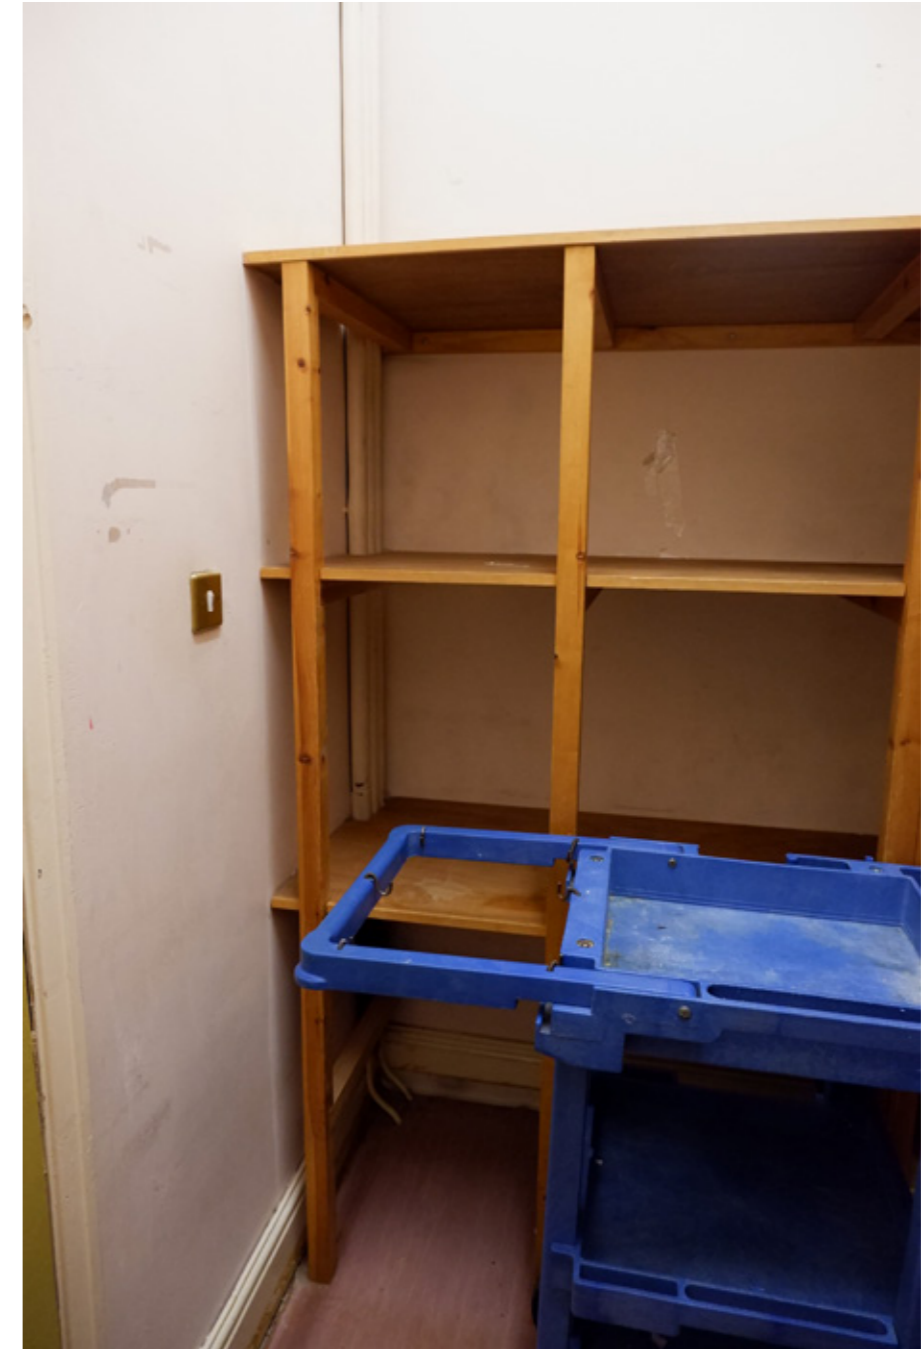
GROUND FLOOR: 1717 HOUSE – G2.10

Overall Significance Level:	Medium
Key Historic Features:	Dentilled coricing, sash windows, and chimney breast
Detrimental Features:	Modern sanitaryware, floor, paint. Sub-division to form lift and blocked door to Butler's bedroom (G2.11/G.12).
Condition Level:	Fair
Condition Comments:	
Other Comments:
